HISTORIC AND DESIGN REVIEW COMMISSION

HDRC CASE NO: 2016-051
ADDRESS: 304 E TRAVIS ST
LEGAL DESCRIPTION: NCB 415 BLK 18 LOT A-7, A- 8, A-9, P-100, P-101 & P-102
ZONING: D HE
CITY COUNCIL DIST.: 1
LANDMARK: St Anthony Hotel
APPLICANT: Brandon Raney
OWNER: BCL St. Anthony ML, LP
TYPE OF WORK: Tax Verification
REQUEST:

St. Anthony Hotel
Scope Summary of Exterior Rehabilitation

ST. ANTHONY HOTEL RENOVATION
 PHOTO KEY PLAN - EXISTING 1ST FLOOR

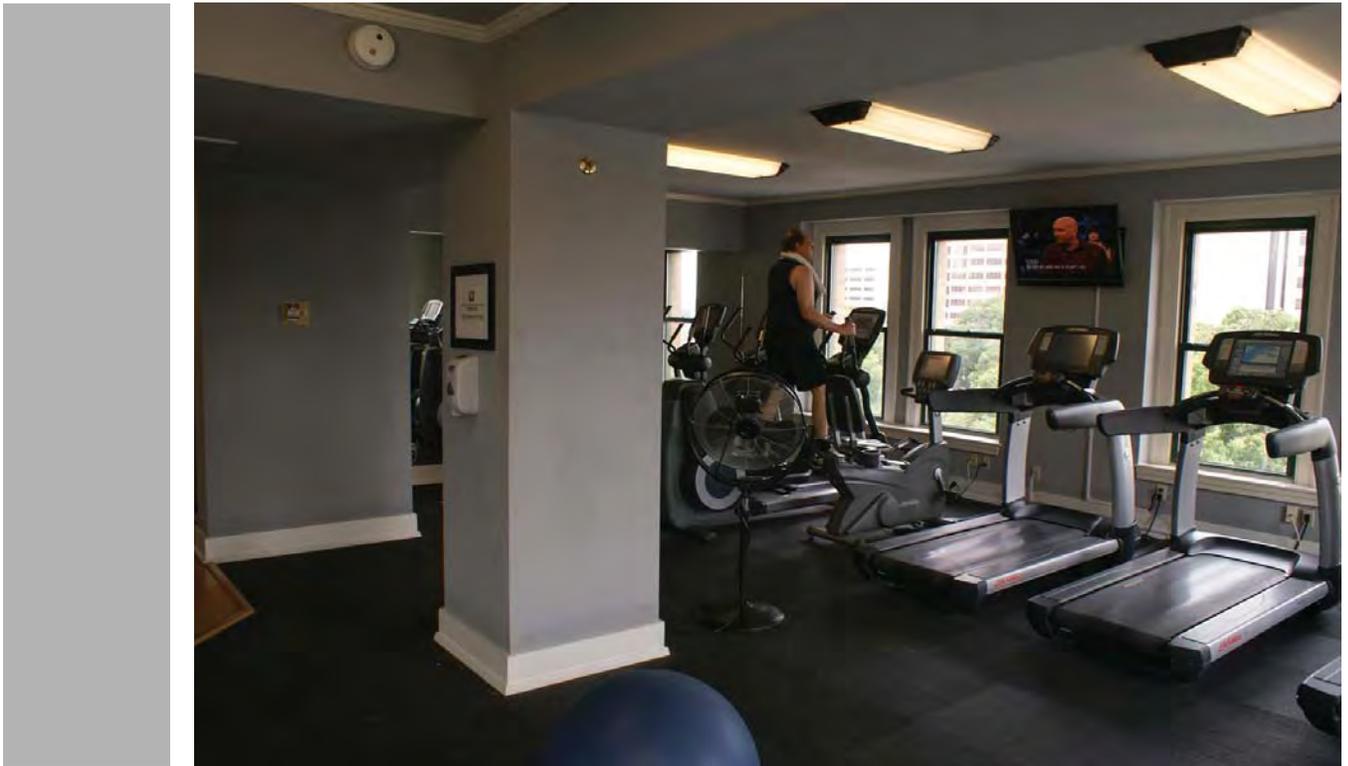
SAH-344

Name: Saint Anthony Hotel, 300 East Travis Street, San Antonio, Texas
View: Sixth Level Fitness Center, looking northwest
Description: Non-historic space to be renovated and expanded
Date: November 2012

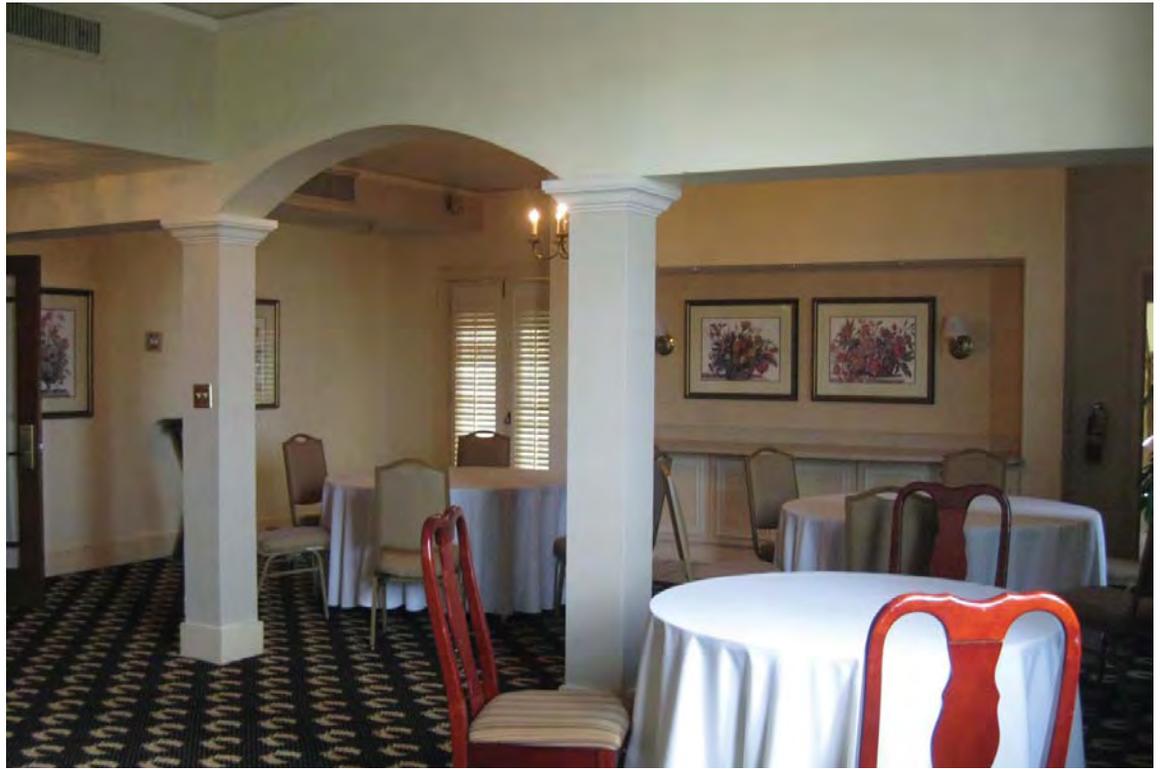
Photograph No.
SAH-346

Name: Saint Anthony Hotel, 300 East Travis Street, San Antonio, Texas
View: Tenth Level Starlight Terrace Event Room, looking southwest
Description: Non-historic finishes renovated; historic relationship to terrace re-established
Date: November 2012

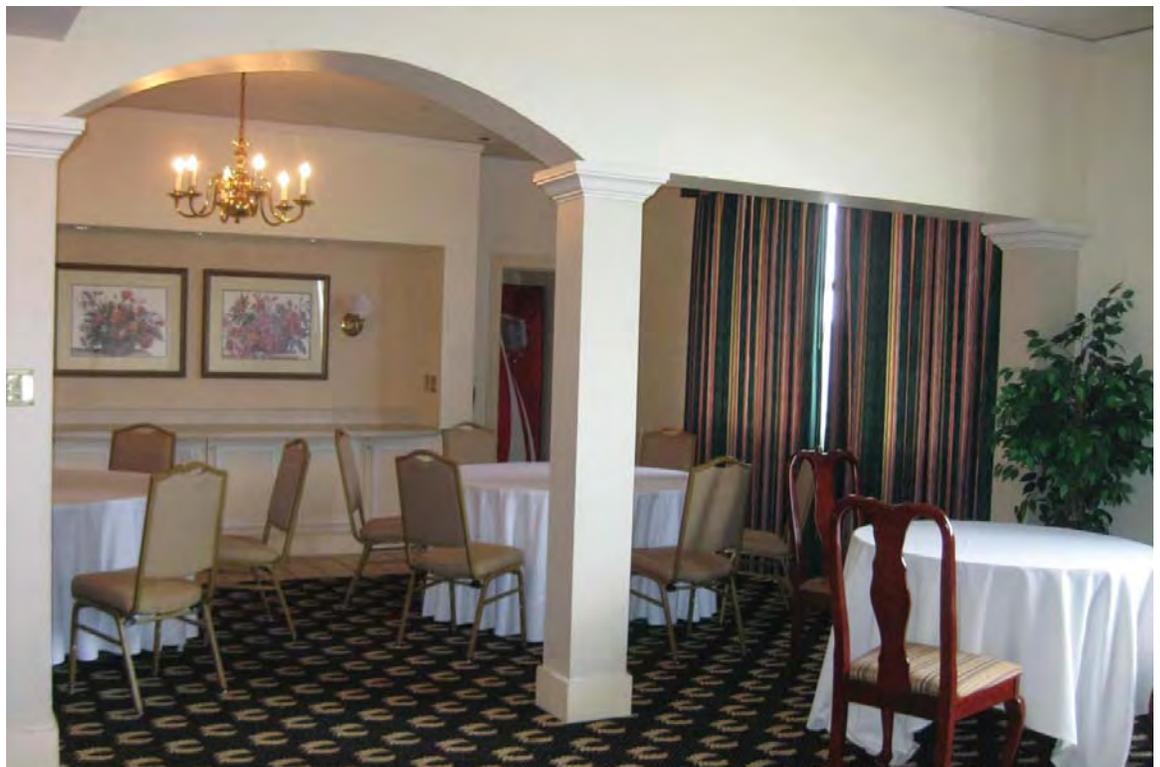
SAH-347

Name: Saint Anthony Hotel, 300 East Travis Street, San Antonio, Texas
View: Tenth Level Starlight Terrace Event Room, looking northwest
Description: Non-historic finishes renovated; historic relationship to terrace re-established
Date: November 2012

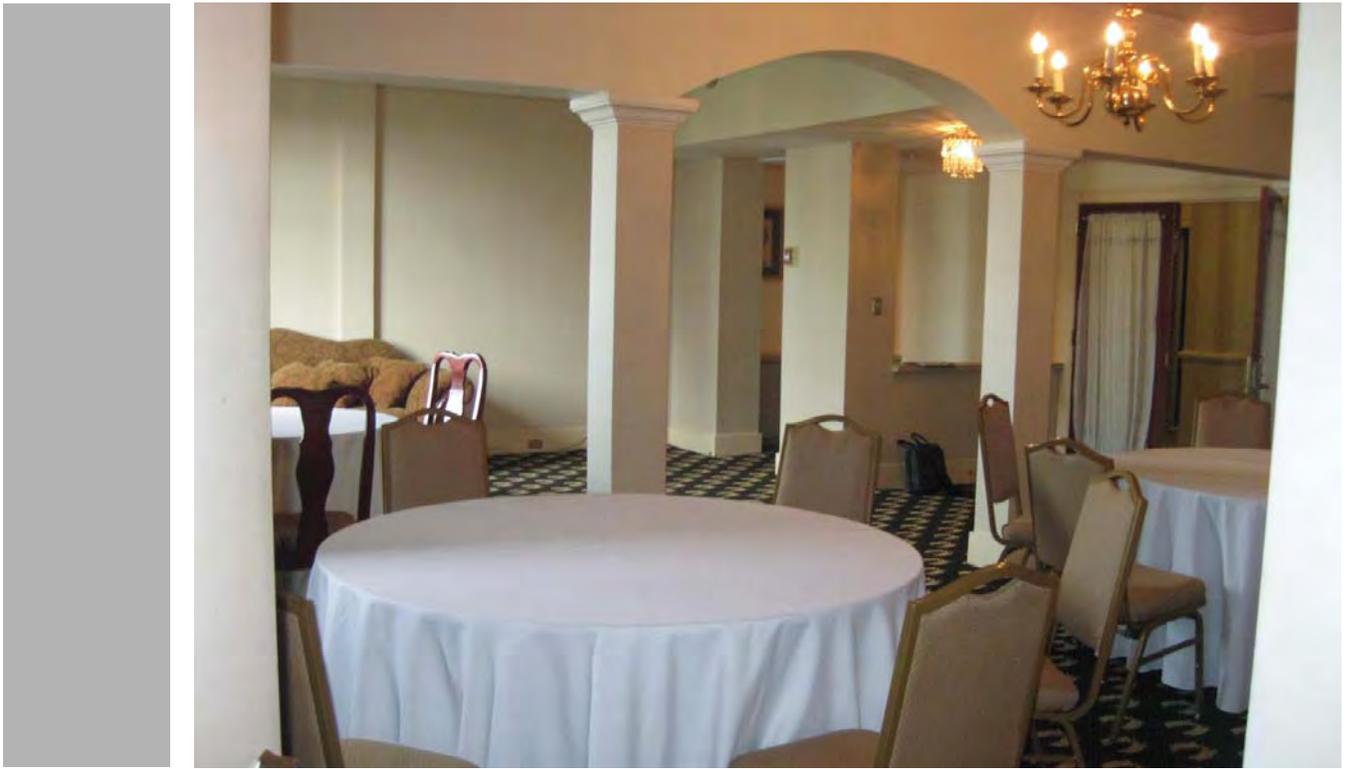
SAH-348

Name: Saint Anthony Hotel, 300 East Travis Street, San Antonio, Texas
View: Tenth Level Starlight Terrace Event Room, looking southeast
Description: Non-historic finishes renovated; historic relationship to terrace re-established
Date: November 2012

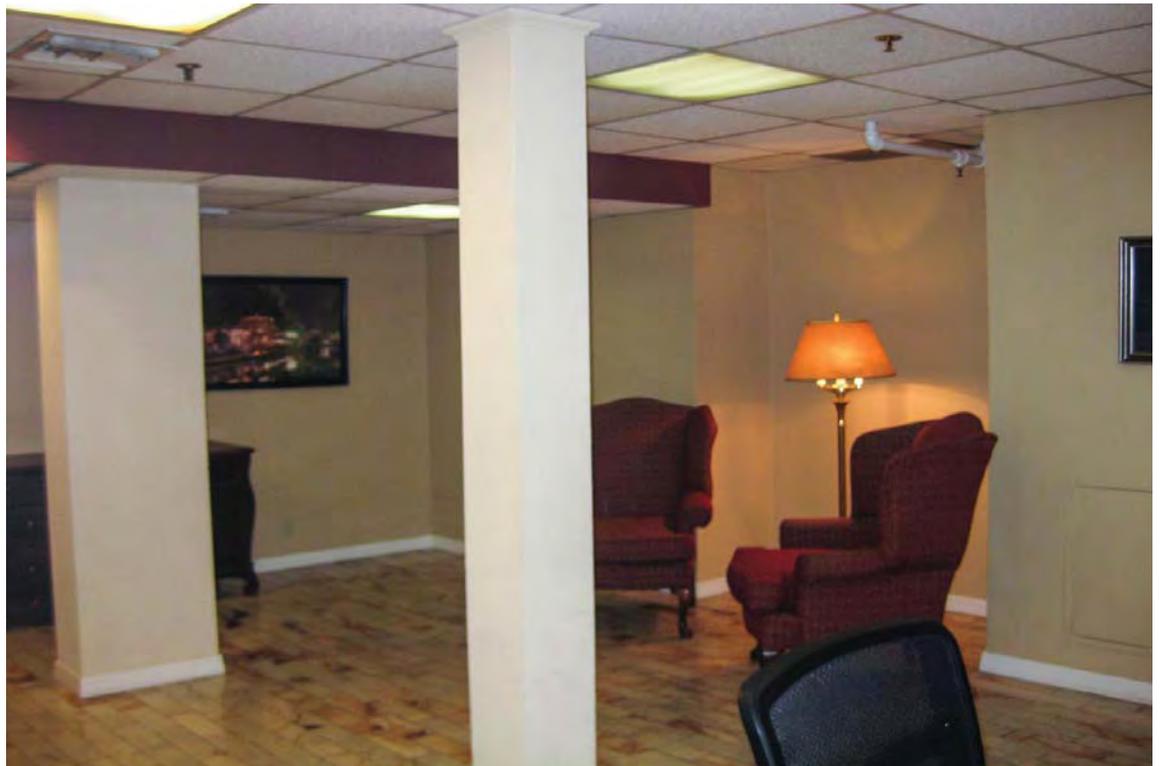
SAH-350

Name: Saint Anthony Hotel, 300 East Travis Street, San Antonio, Texas
View: First Level Concierge Office, looking southwest
Description: Non-historic finishes (1983 or later) renovated to create boutique
Date: November 2012

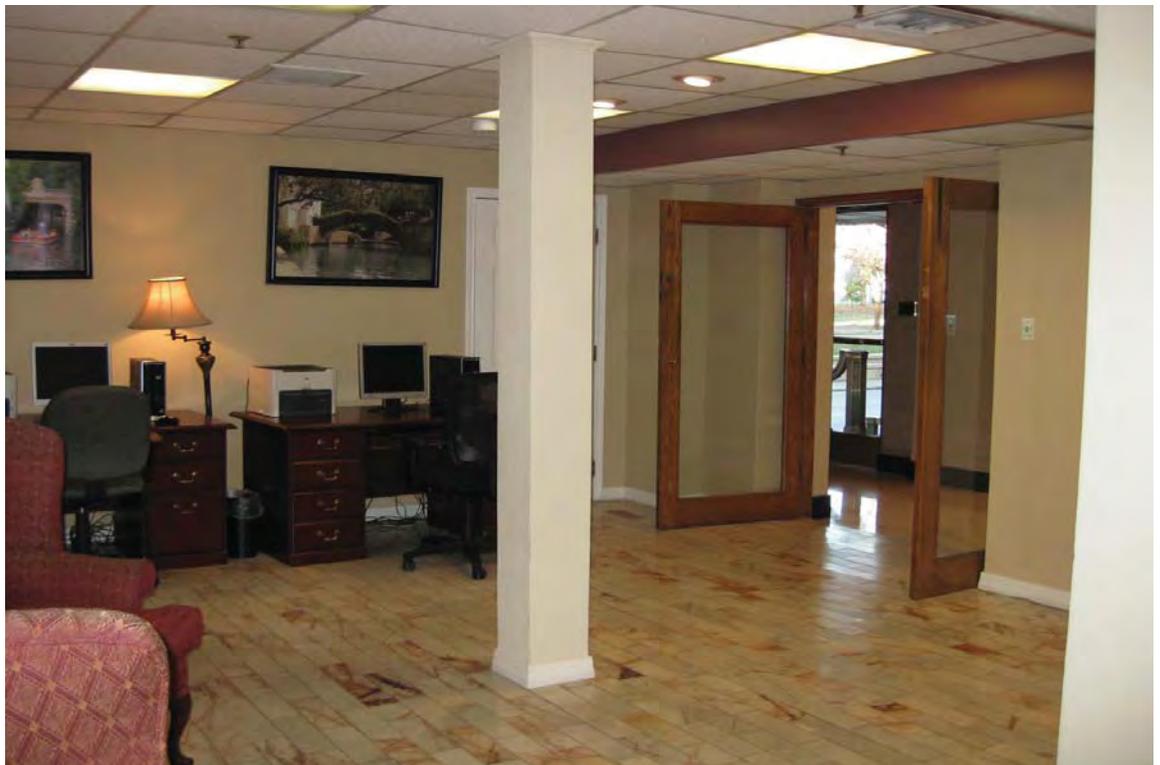
SAH-351

Name: Saint Anthony Hotel, 300 East Travis Street, San Antonio, Texas
View: First Level Concierge Office, looking northeast toward Travis Entrance
Description: Non-historic finishes (1983 or later) renovated to create boutique
Date: November 2012

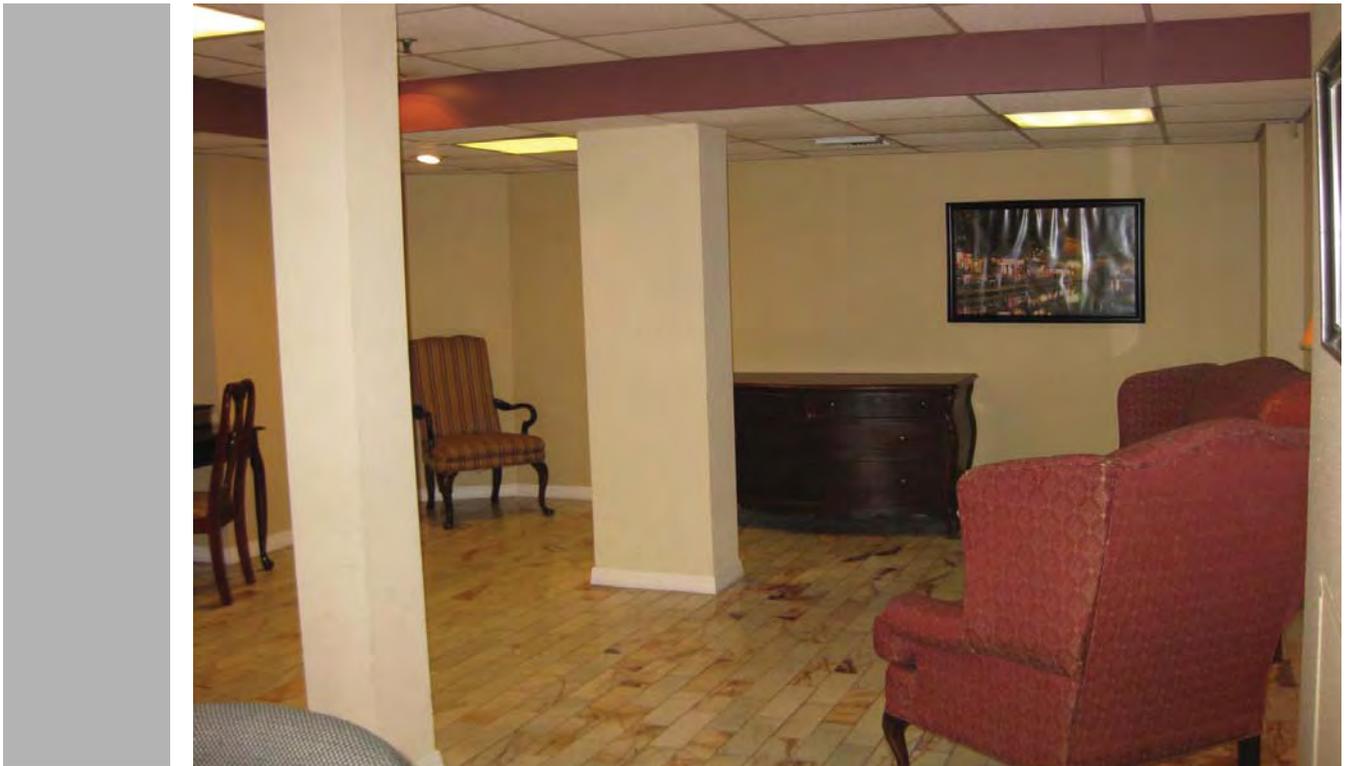
SAH-352

Name: Saint Anthony Hotel, 300 East Travis Street, San Antonio, Texas
View: First Level Concierge Office, looking southeast
Description: Non-historic finishes (1983 or later) renovated to create boutique
Date: November 2012

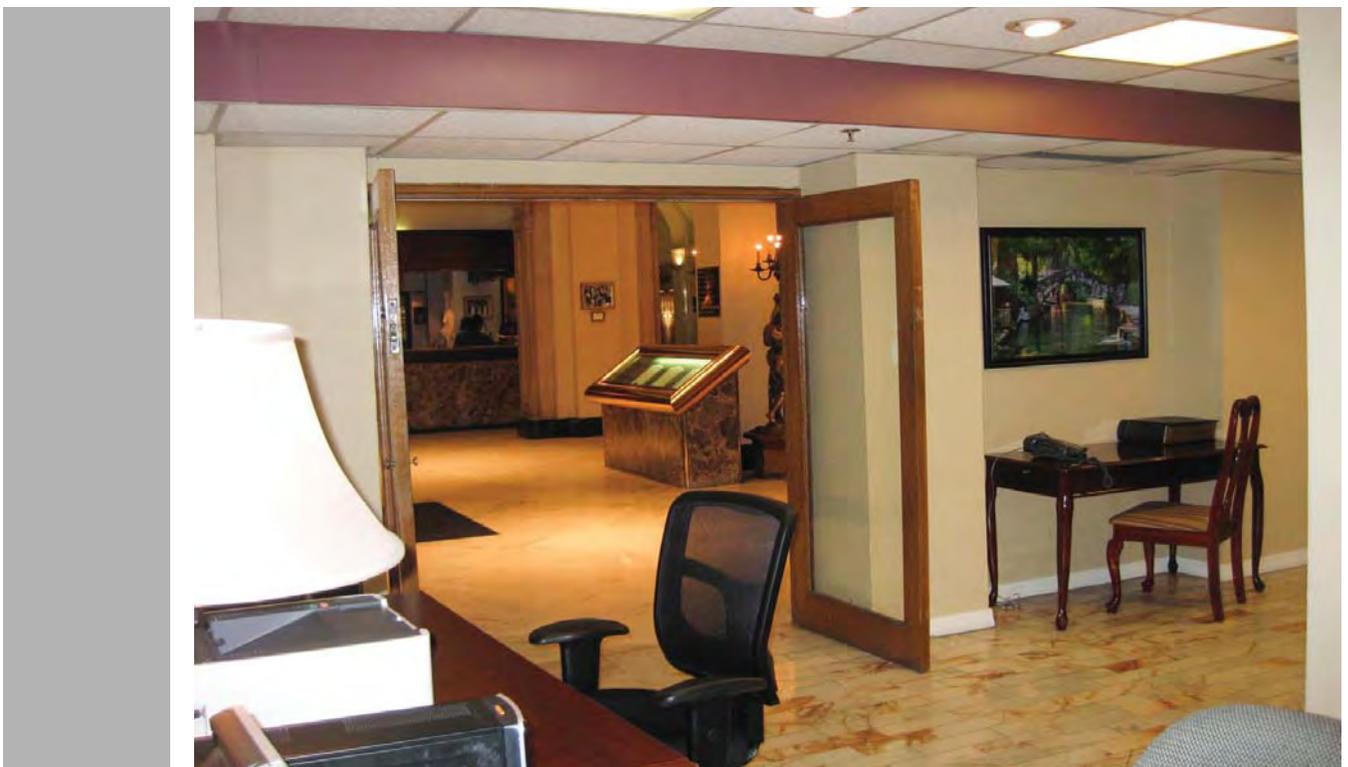
SAH-353

Name: Saint Anthony Hotel, 300 East Travis Street, San Antonio, Texas
View: First Level Concierge Office, looking east-southeast toward Grand Lobby
Description: Non-historic finishes (1983 or later) renovated to create boutique
Date: November 2012

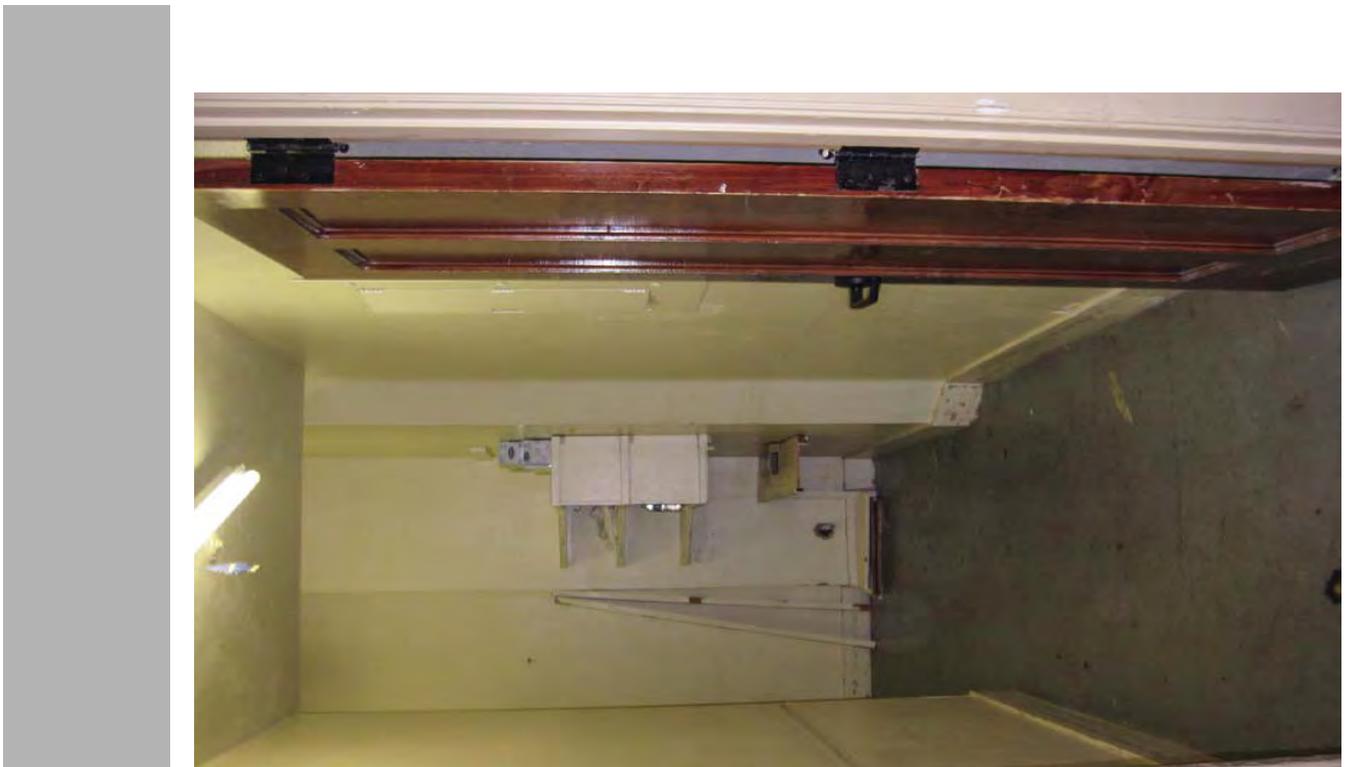
SAH-355

Name: Saint Anthony Hotel, 300 East Travis Street, San Antonio, Texas
View: First Level Front Desk back offices, looking east
Description: Area to receive routine maintenance, repairs & life safety upgrades
Date: November 2012
