# HISTORIC AND DESIGN REVIEW COMMISSION

**HDRC CASE NO:** 2020-027  
**ADDRESS:** 1425 S FLORES ST  
**LEGAL DESCRIPTION:** NCB 1009 BLK LOT 40B  
**ZONING:** IDZ, H, RIO-7  
**CITY COUNCIL DIST.:** 1  
**LANDMARK:** Fest Block  
**APPLICANT:** Kris Feldmann/Creoarc, LLC  
**OWNER:** Jacob Harris/HB PROPERTIES I LLC  
**TYPE OF WORK:** Storefront restoration, cleaning  
**APPLICATION RECEIVED:** January 17, 2020  
**60-DAY REVIEW:** March 17, 2020  
**CASE MANAGER:** Edward Hall

# Fest Block

HDRC SUBMITTAL | 2020.1.17

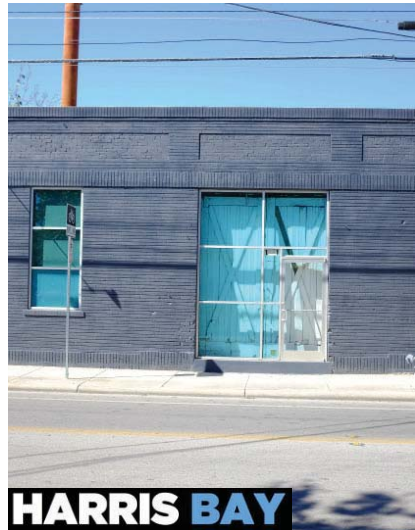
**F** EXHIBIT F  
PAINTED BRICK FACADE AND  
NON- HISTORIC ALUMINUM  
STOREFRONT ON EXISTING  
OPENINGS

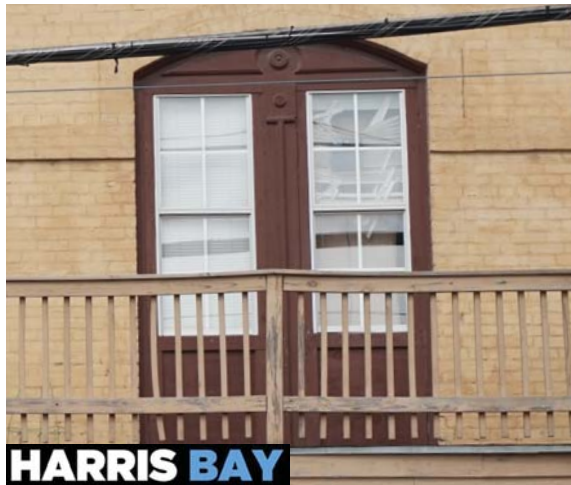
**① EXISTING NON-ORIGINAL WINDOW. NON-ORIGINAL WINDOWS ARE INSTALLED THROUGHOUT THE ENTIRE BUILDING**

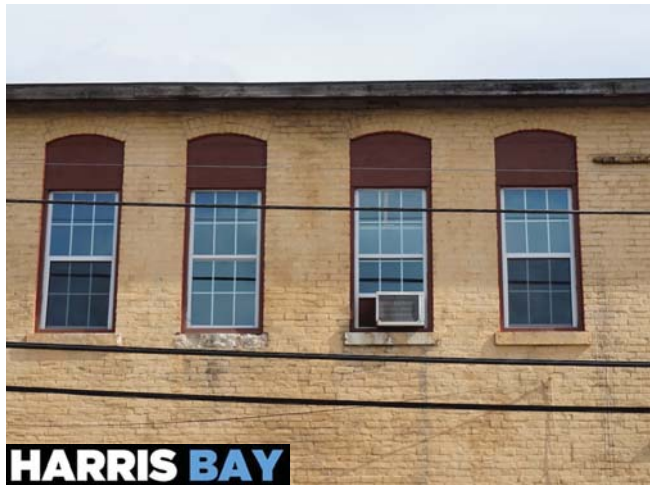
**① EXISTING NON-ORIGINAL WINDOW. NON-ORIGINAL WINDOWS ARE INSTALLED THROUGHOUT THE ENTIRE BUILDING**

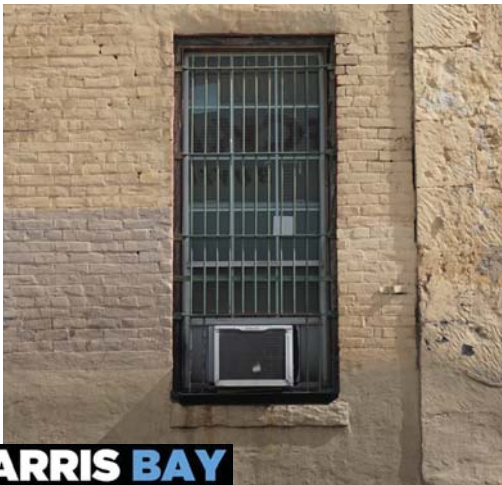
**1** EXISTING NON-ORIGINAL WINDOW. NON-ORIGINAL WINDOWS ARE INSTALLED THROUGHOUT THE ENTIRE BUILDING
