## HISTORIC AND DESIGN REVIEW COMMISSION

October 03, 2018

**HDRC CASE NO:** 2018-486  
**ADDRESS:** 1018 BURNET ST  
**LEGAL DESCRIPTION:** NCB 1660 BLK 1 LOT 5  
**ZONING:** R-6, H  
**CITY COUNCIL DIST.:** 2  
**DISTRICT:** Dignowity Hill Historic District  
**APPLICANT:** Cory Johnson  
**OWNER:** Nicole Johnson  
**TYPE OF WORK:** Rear addition, replacement of windows, door, and columns, wood element repairs  
**APPLICATION RECEIVED:** September 17, 2018  
**60-DAY REVIEW:** November 16, 2018  
**REQUEST:**

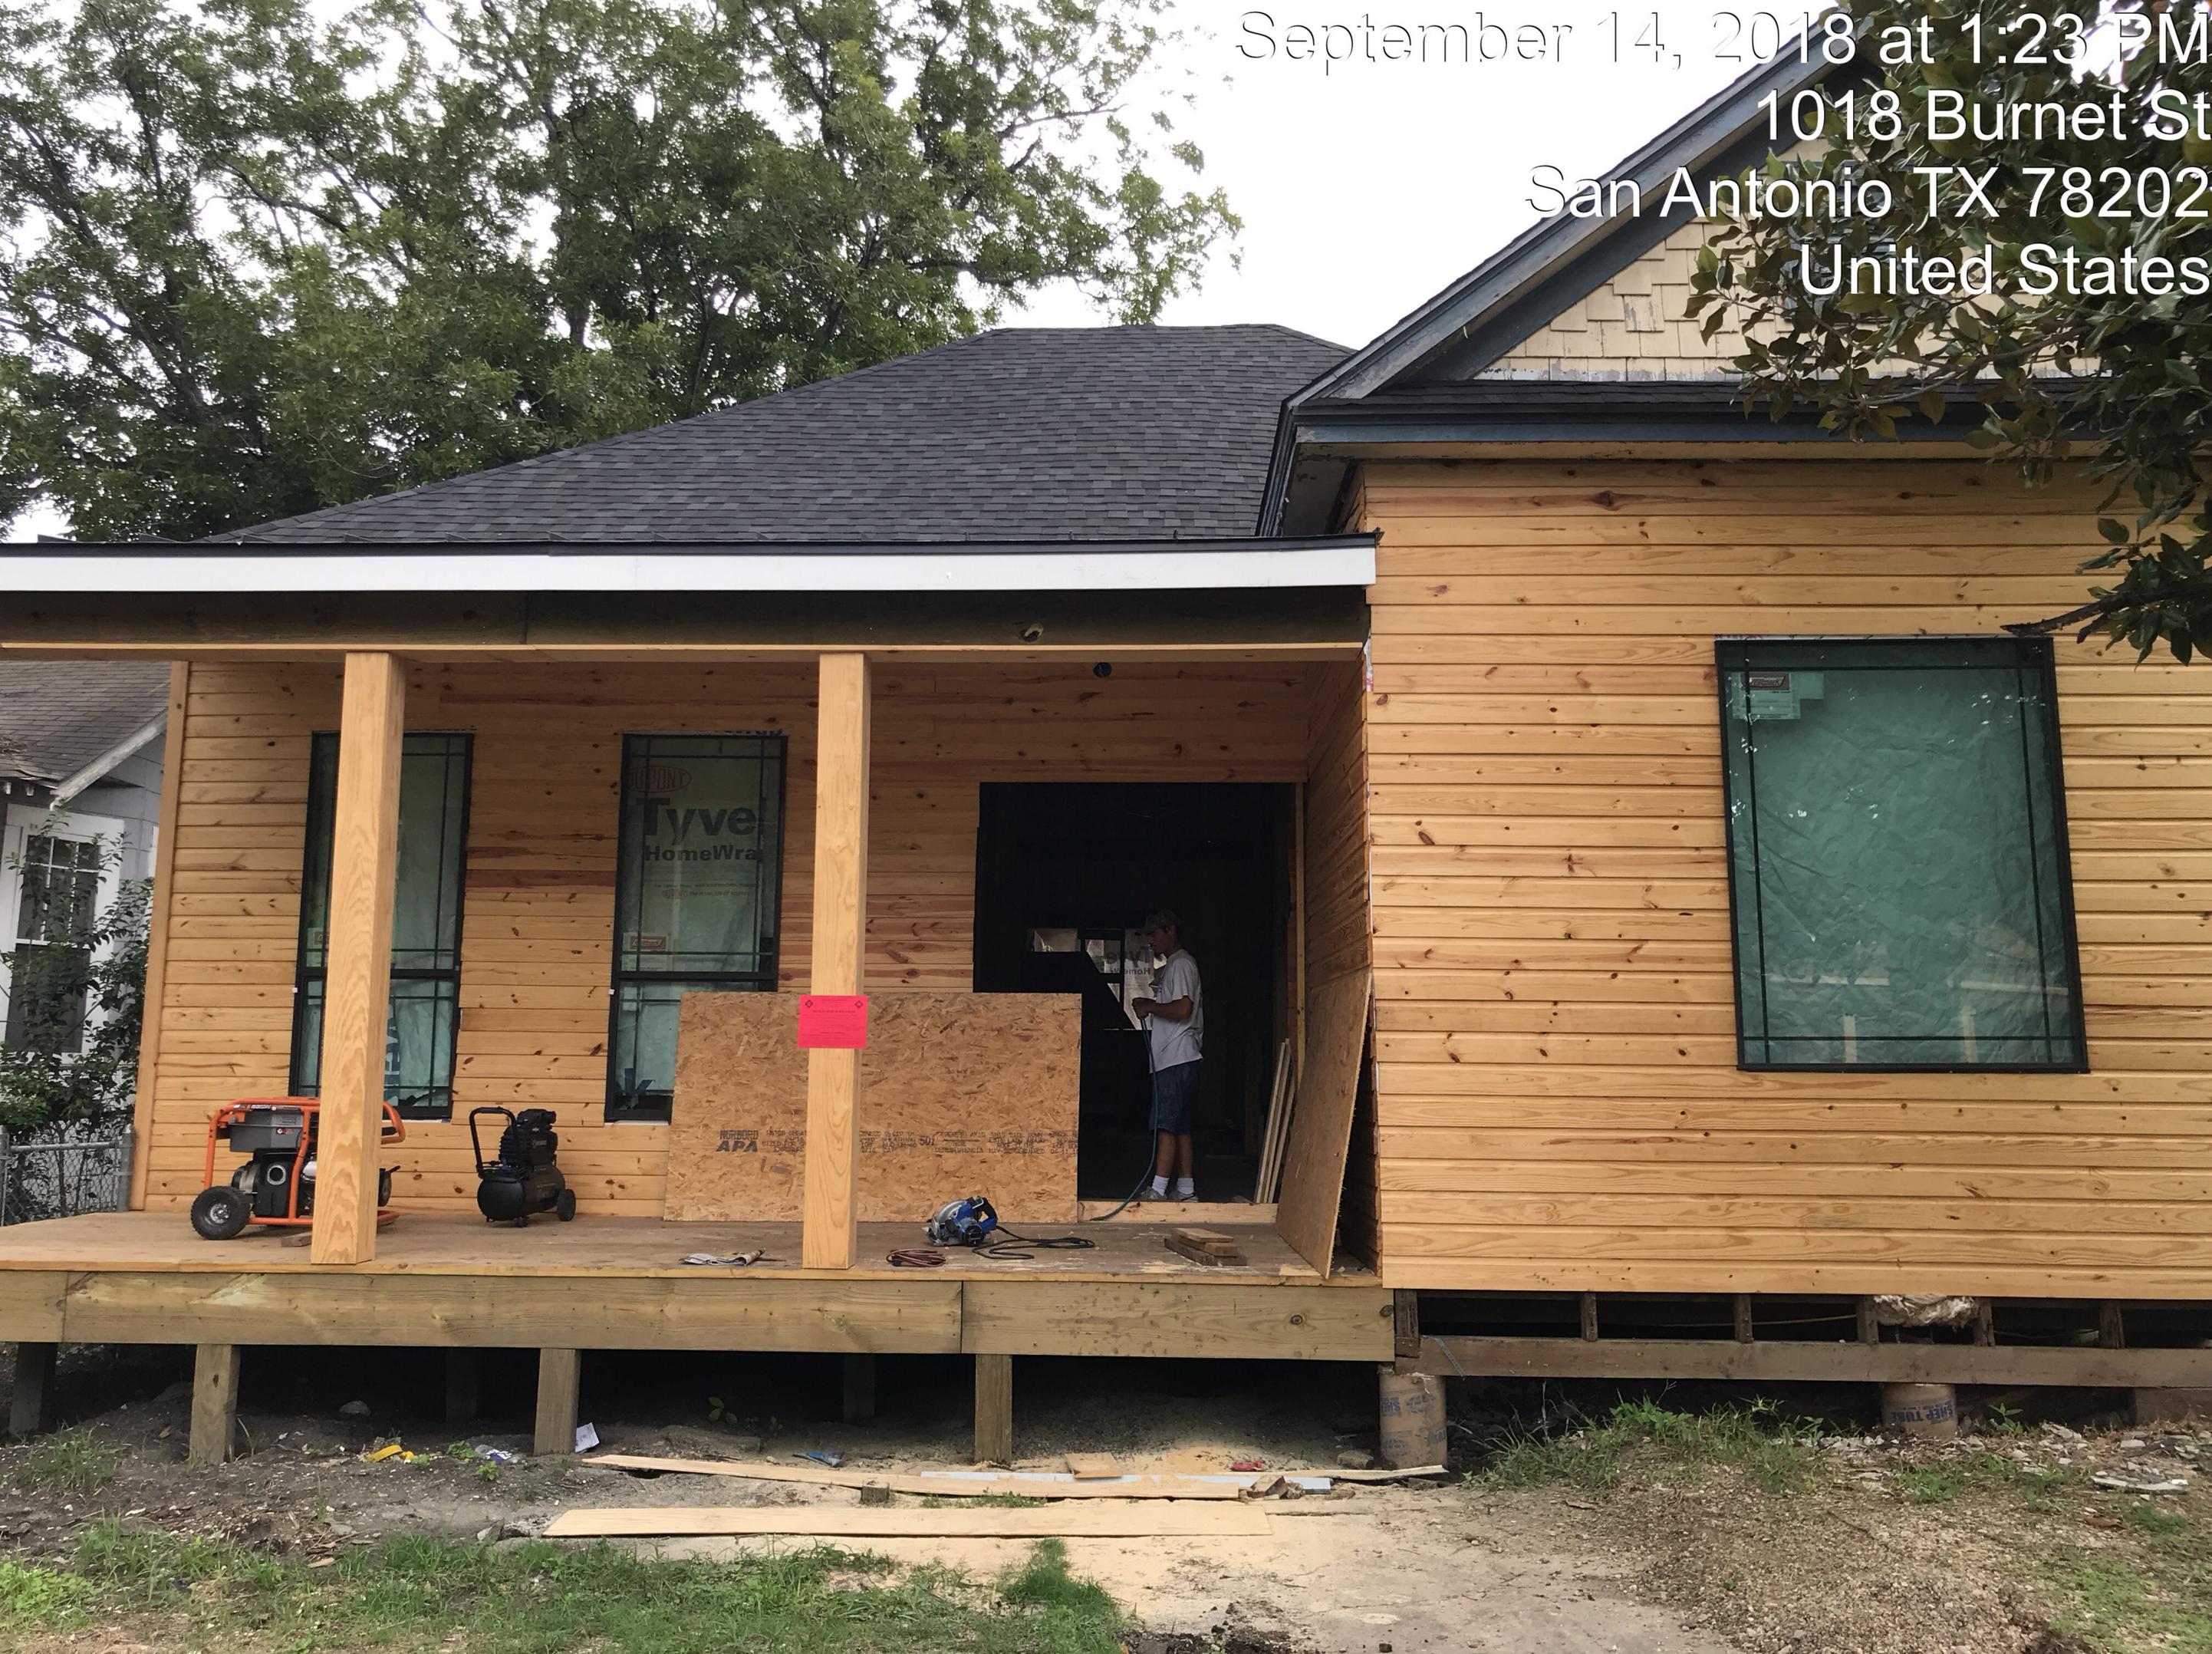
September 14, 2018 at 1:23 PM  
1018 Burnet St  
San Antonio TX 78202  
United States

On a site visit conducted on September 14, 2018, staff found that the following work has occurred prior to the issuance of a Certificate of Appropriateness and permits: 1) construction of a rear addition, 2) modifications and relocations of window openings, 3) the installation of sashed and picture aluminum windows, and 4) the replacement of turned columns with square columns. The work that was performed prior to approval is generally inconsistent with the Guidelines and contributes to the historic structure's loss of integrity regarding its materials, fenestration, and subtle but character defining architectural details. The applicant submitted a request to be heard by the HDRC on September 21, 2018. The application also included a number of request item that are eligible for administrative approval pending the commission approval of the remaining outstanding items. Outstanding violations also prevents eligibility to receive the Substantial Rehabilitation Tax Incentives. The \$500 post work application fee has not been paid at this time.
