HISTORIC AND DESIGN REVIEW COMMISSION

October 07, 2020

HDRC CASE NO: 2020-431
ADDRESS: 109 CANAL ST
LEGAL DESCRIPTION: NCB 924 BLK 5 LOT S 43 FT OF 7 & S 46 FT OF E 12 FT OF 6
ZONING: RM-4, H
CITY COUNCIL DIST.: 1
DISTRICT: Lavaca Historic District
APPLICANT: Martin Lopez/LOPEZ MARTIN & MARIA
OWNER: Martin Lopez/LOPEZ MARTIN & MARIA
TYPE OF WORK: Window replacement
APPLICATION RECEIVED: September 15, 2020
60-DAY REVIEW: Not applicable due to City Council Emergency Orders
CASE MANAGER: Huy Pham

Investigation Report

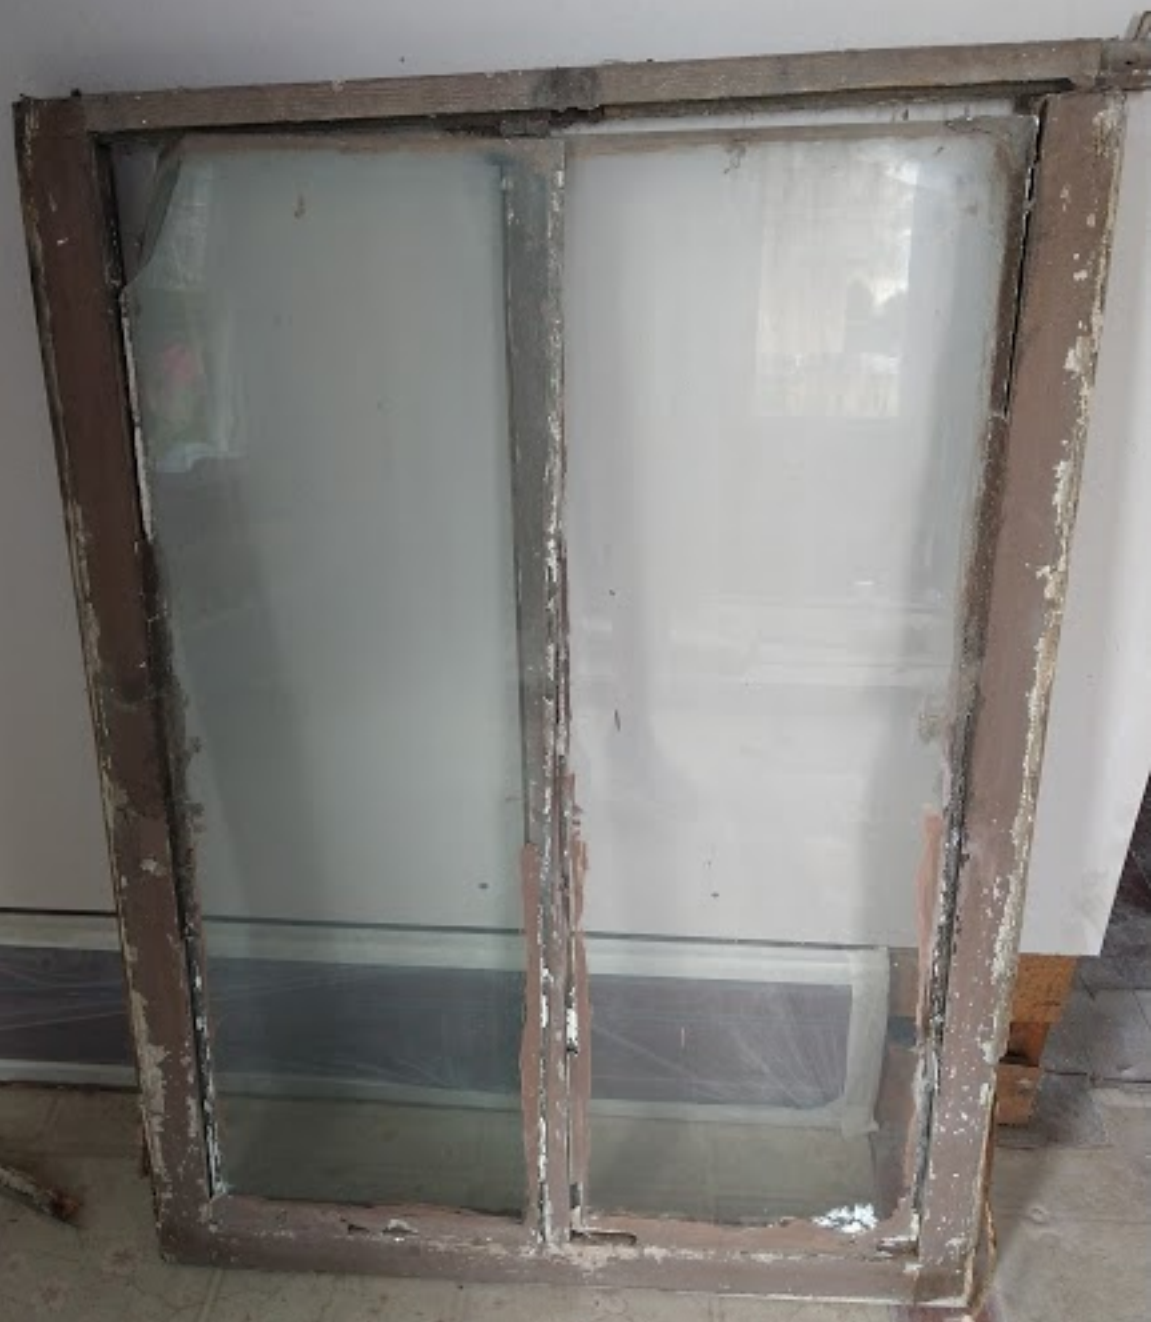
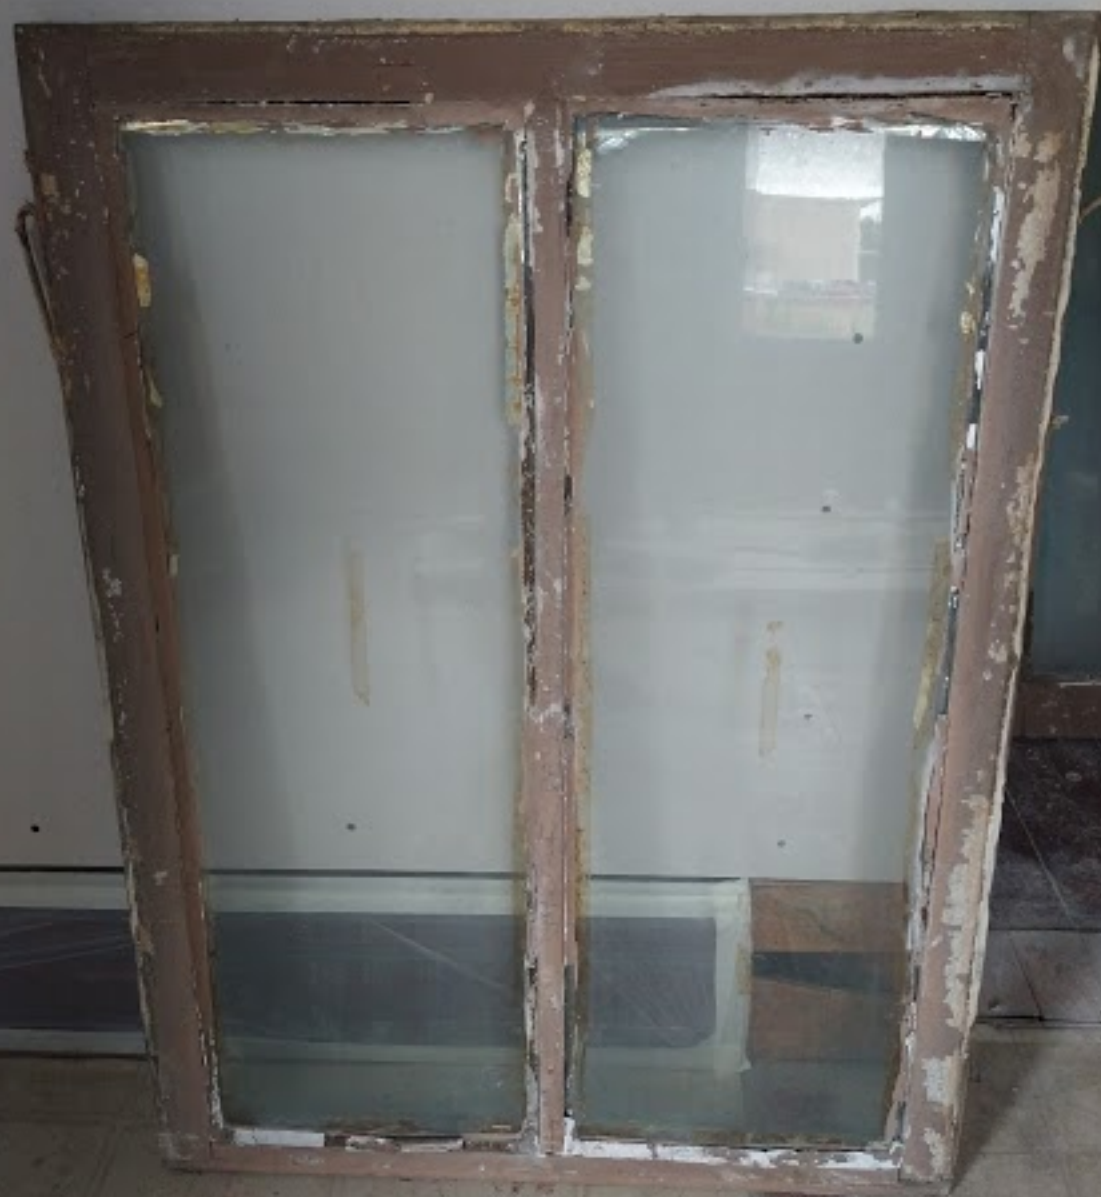
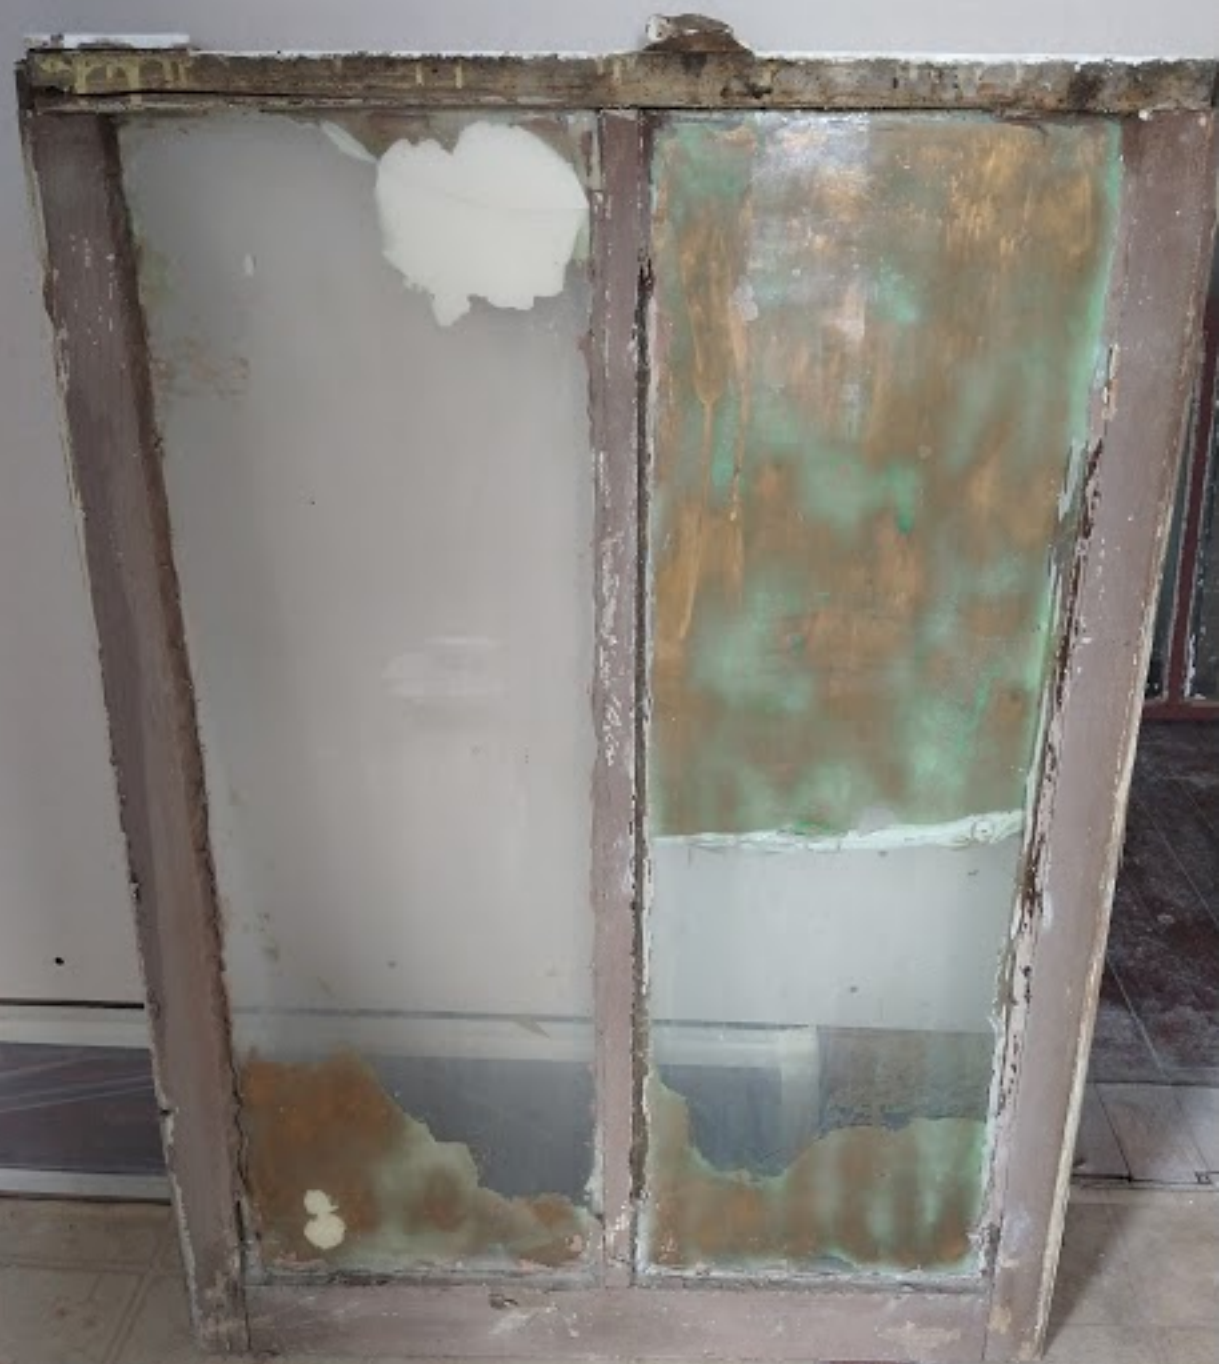
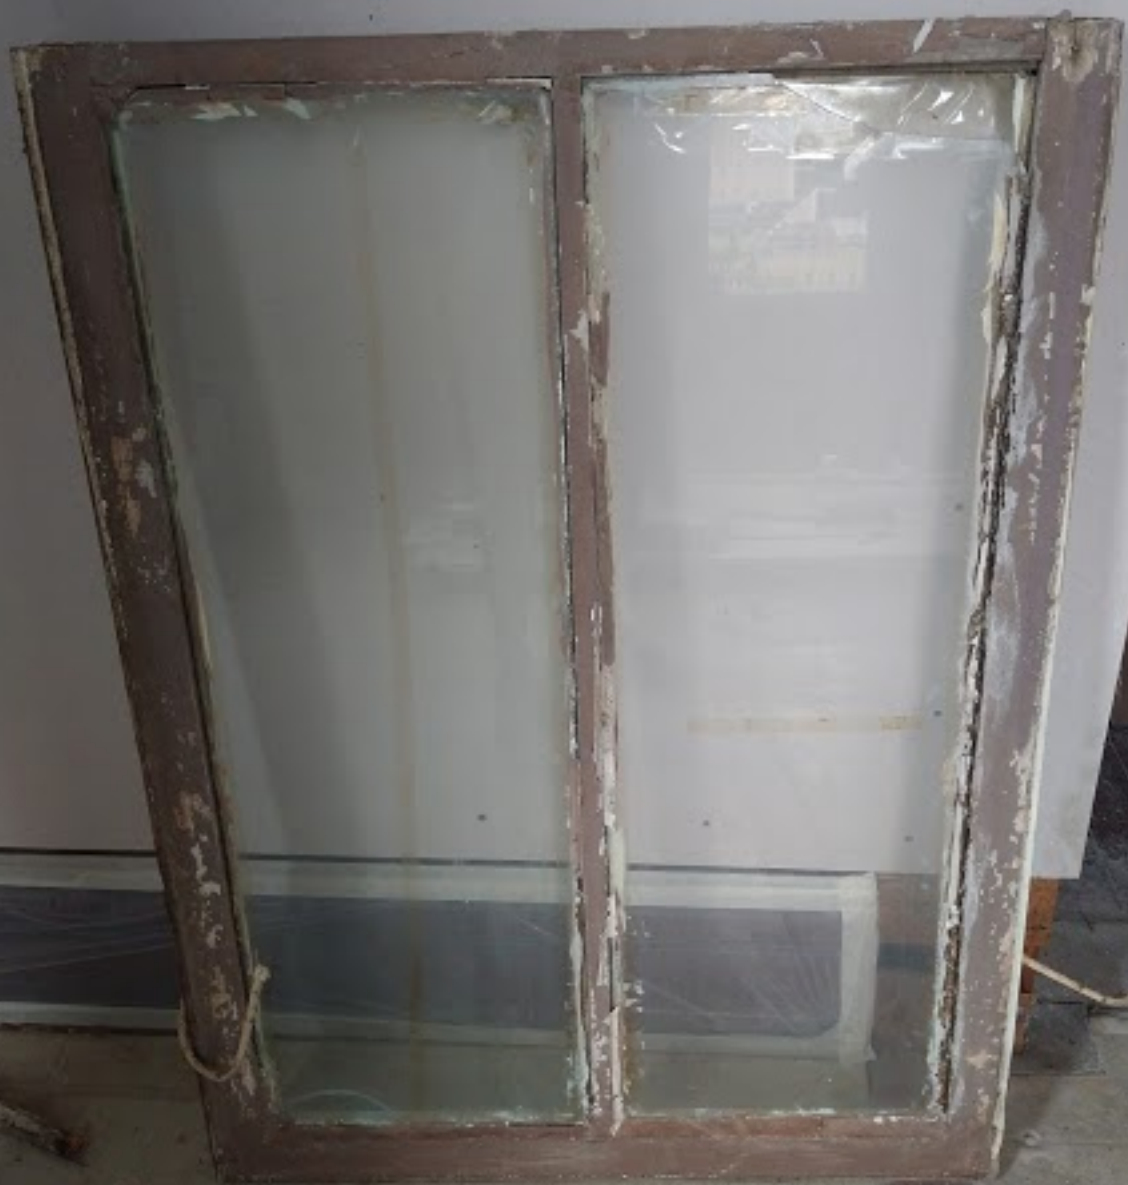
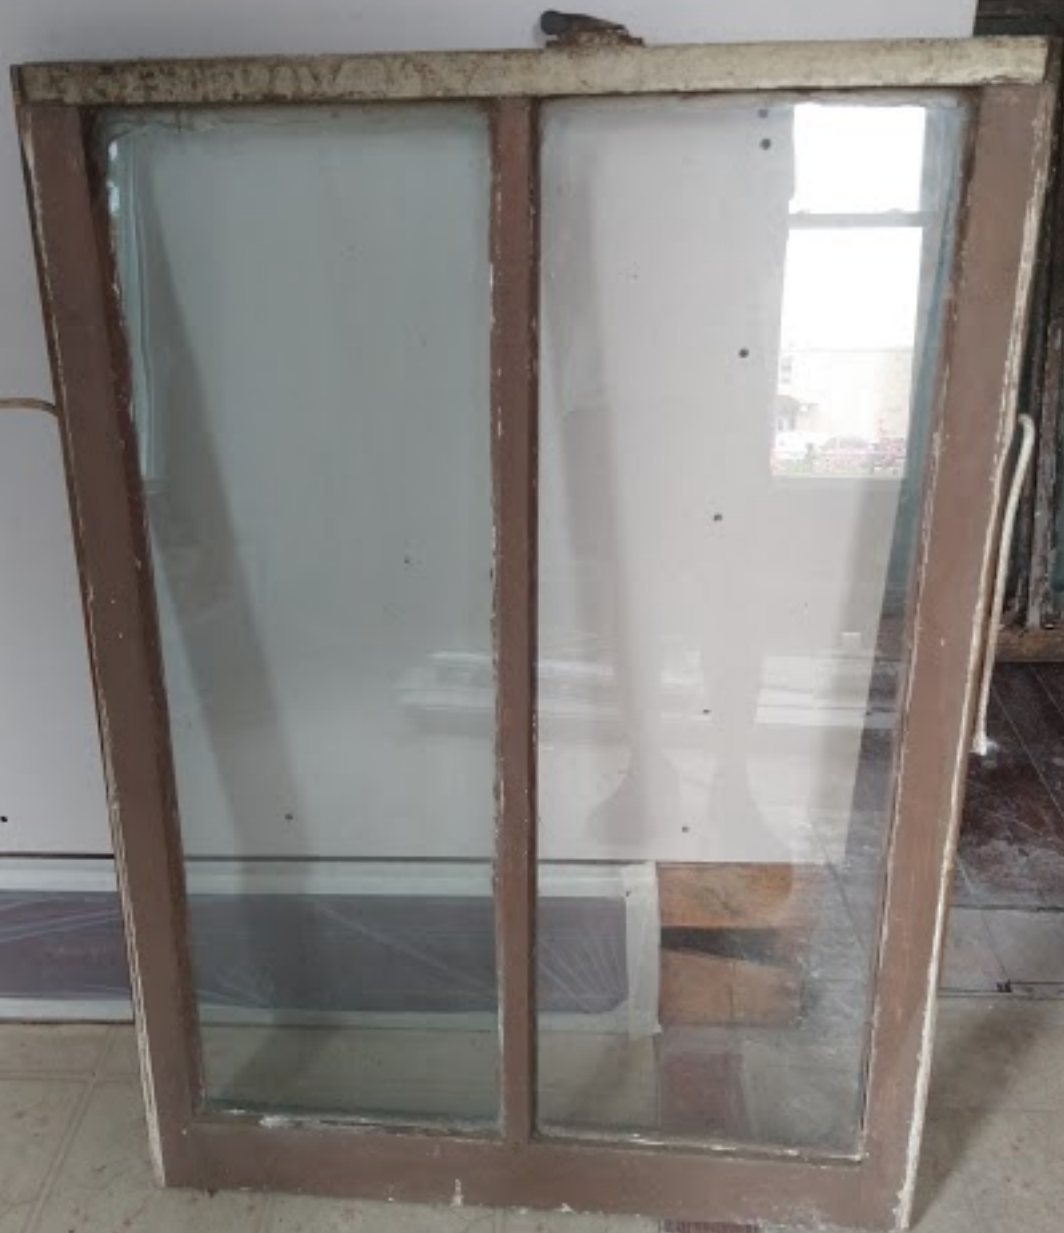
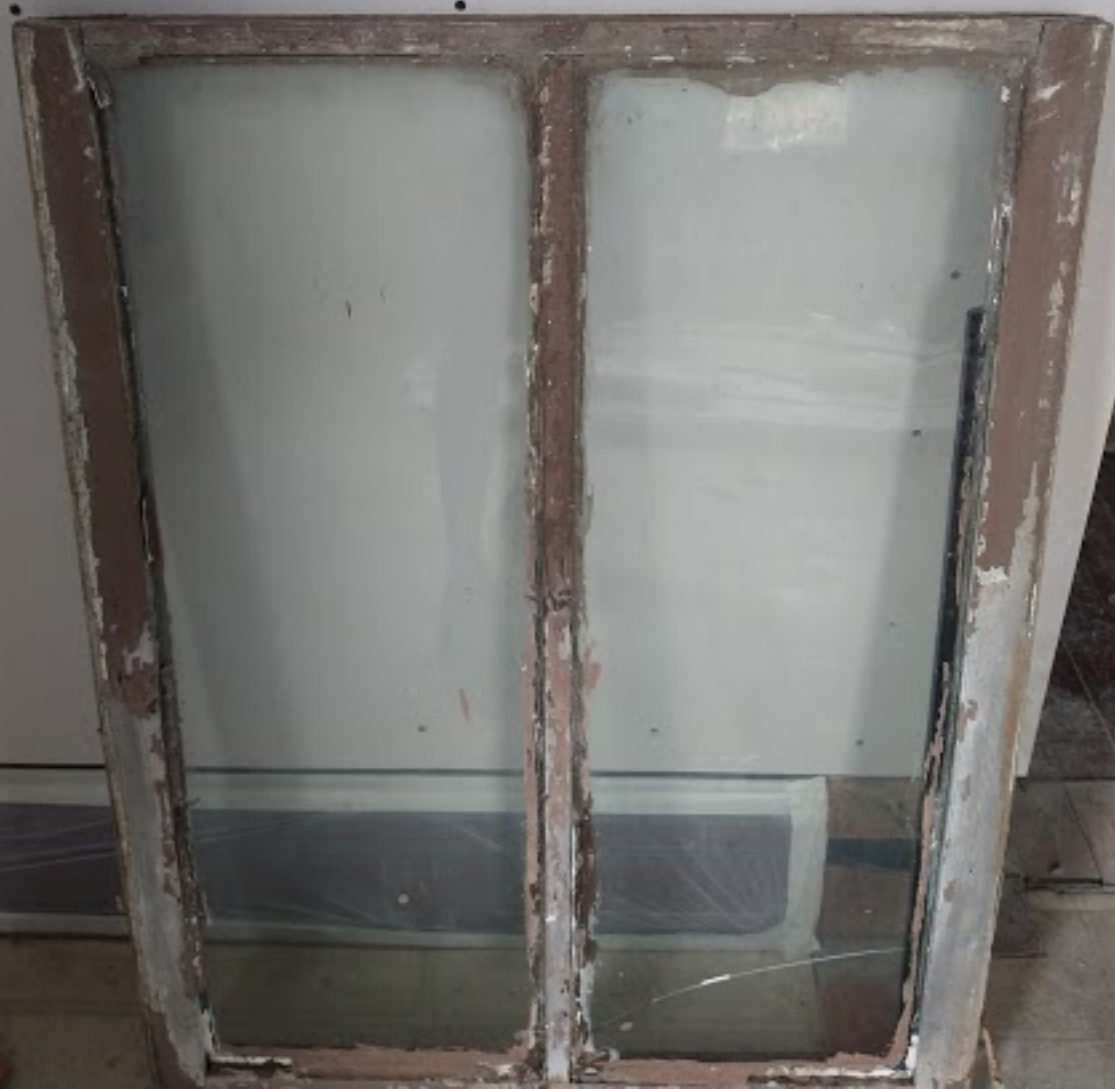
The above address did have wood windows that were unrepairable. The windows were replaced because they did not open and close properly. If they are reinstalled, the wood windows still will not open and close properly thus effecting the requirements for egress.

Staff does not recommend approval of window replacement based on findings b through c. The removed, wood windows should be repaired and reinstalled.

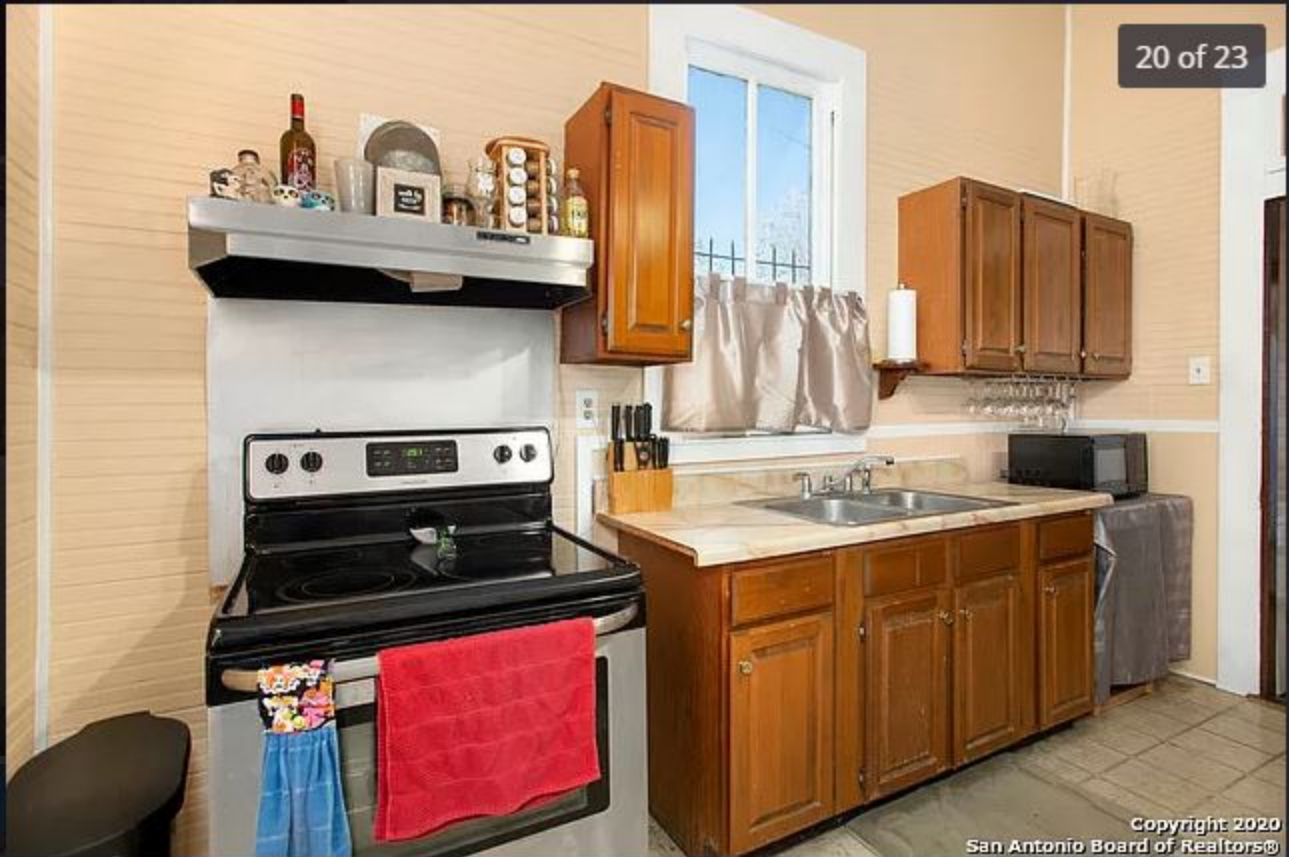
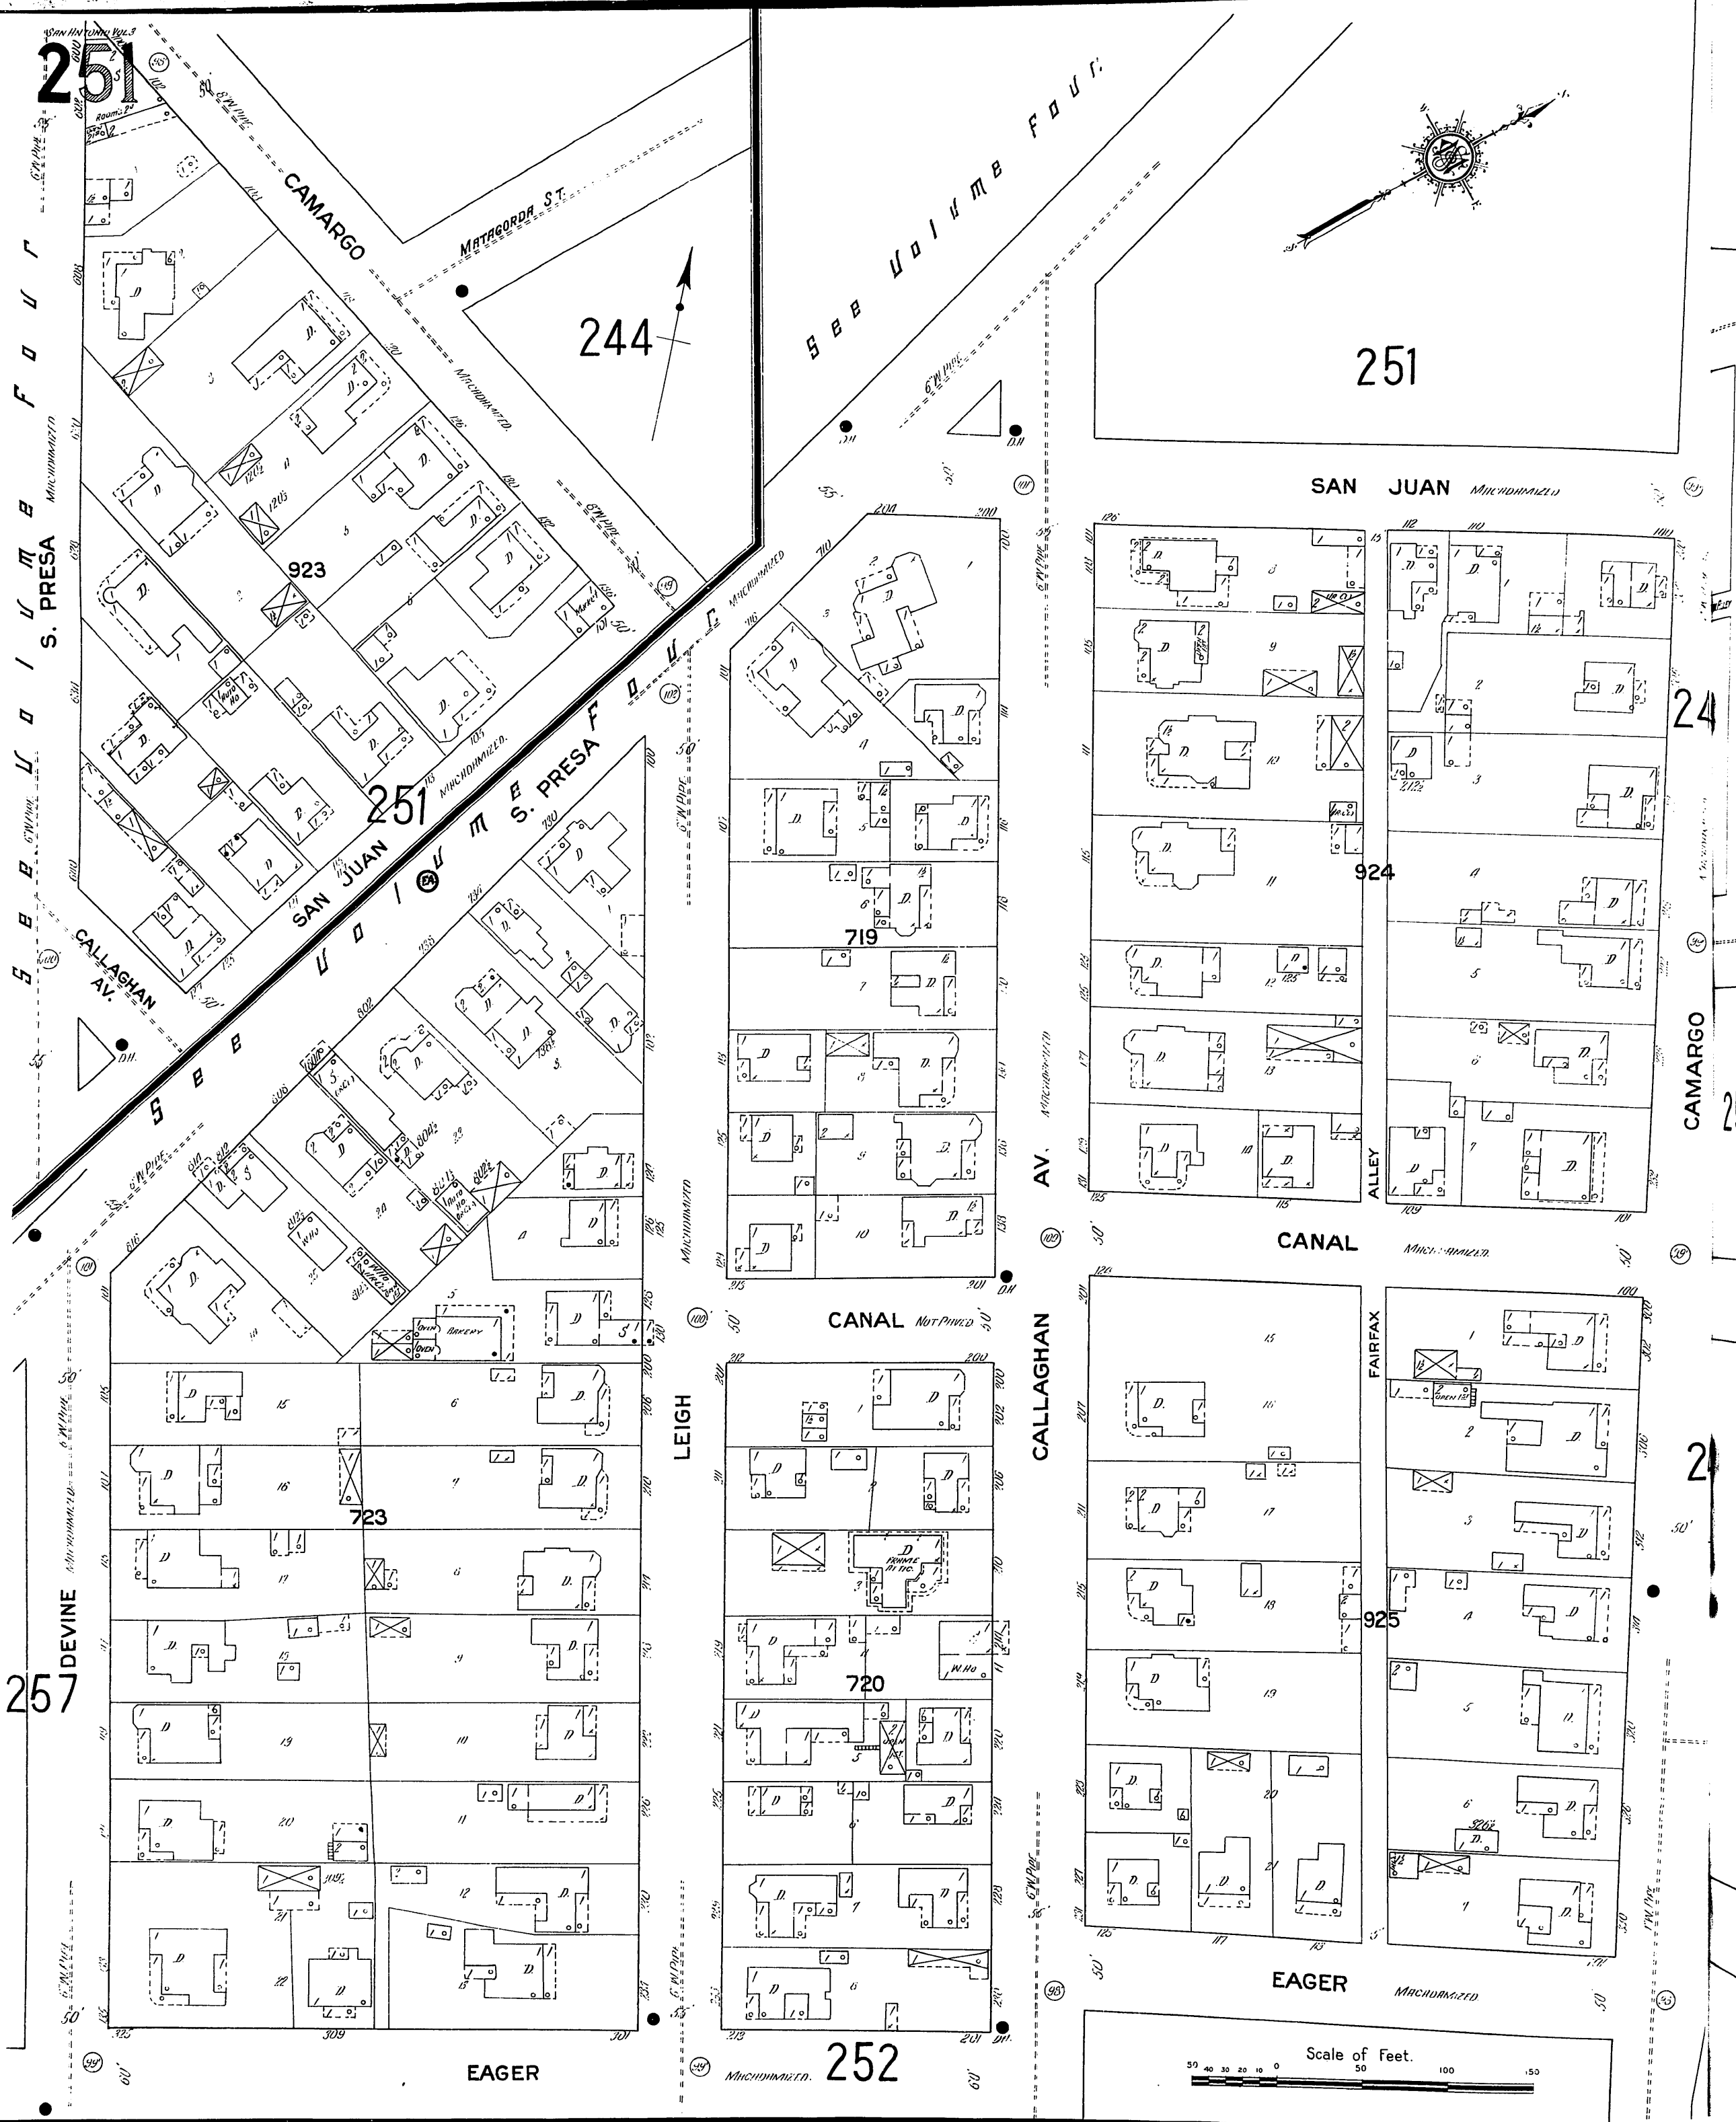
- c. WINDOW REPLACEMENT – The applicant has proposed to replace all 10 two-over-two, wood sash windows with new one-over-one, vinyl windows of approximately the same size. Per the Guidelines for Exterior Maintenance and Alterations 6.B.iv., applicants should install new windows to match the historic or existing windows in terms of size, type, configuration, material, form, appearance, and detail when original windows are deteriorated beyond repair. The proposed vinyl windows are not consistent with the Guidelines. Additionally, during the site visit conducted on September 14, 2020, staff found the existing sashes to be in good condition. Staff finds that the existing wood sashes should be repaired and re-installed.
