HISTORIC AND DESIGN REVIEW COMMISSION

HDRC CASE NO: 2017-365
ADDRESS: 1126 N ST MARYS
LEGAL DESCRIPTION: NCB 819 BLK 30 LOT N IRR 200 FT OF A2 NCB 834 BLK 19 LOT S
ZONING: TRI 156.35 OF N 205 OF A1
CITY COUNCIL DIST.: FBZ T6-2 RIO-2
APPLICANT: 1
OWNER: Benito Polendo
TYPE OF WORK: Luis Kernion
REQUEST: Exterior modifications, landscaping and hardscaping modifications

Arrow Upholstery Building

Structural Evaluation

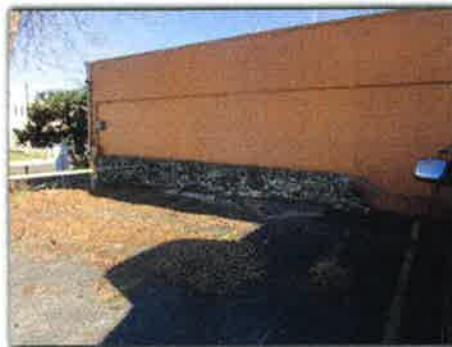
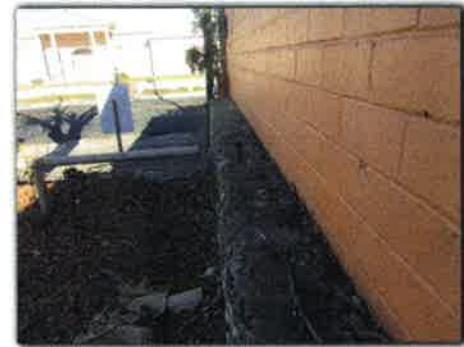
Noted cracking in the front concrete curbs.

It is recommended that further investigation with appropriate service and/or repair contractors is made to determine the full costs involved in correcting the drainage and repairs to the walks/parking areas.
