## HISTORIC AND DESIGN REVIEW COMMISSION

**HDRC CASE NO:** 2021-213  
**ADDRESS:** 222 BEAUREGARD  
**LEGAL DESCRIPTION:** NCB 743 BLK 2 LOT 1 MASTERFILE & COMMON ELEMENT -MADISON CONDOMINIUMS  
**ZONING:** RM-4, H  
**CITY COUNCIL DIST.:** 1  
**DISTRICT:** King William Historic District  
**APPLICANT:** Lyndsay Thorn/Thorn Architects, PLLC  
**OWNER:** Sean Moore (Wife: Blythe Evans)/MADISON CONDOMINIUM OWNERS ASSOCIATION INC  
**TYPE OF WORK:** Window sash replacement  
**APPLICATION RECEIVED:** April 23, 2021  
**60-DAY REVIEW:** Not applicable due to City Council Emergency Orders  
**CASE MANAGER:** Huy Pham  
**REQUEST:**

The applicant is requesting a Certificate of Appropriateness for approval to replace non-original window windows with new aluminum-clad wood windows matching historic specifications (Pella Reserve Traditional Series)

MOORE-EVANS RESIDENCE, UNIT 2  
222 Beauregard San Antonio Texas 78209

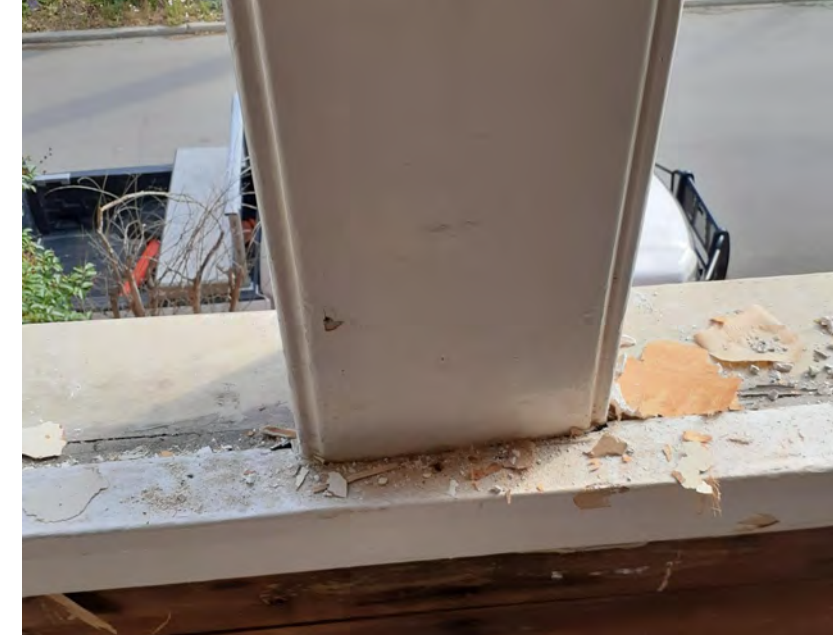
Overall Window 2: Multiple layers of paint and caulk over water damaged wood, typical.

Window glass appears to be a standard glass, not milk,

Window Trim+Sill to be preserved were possible and

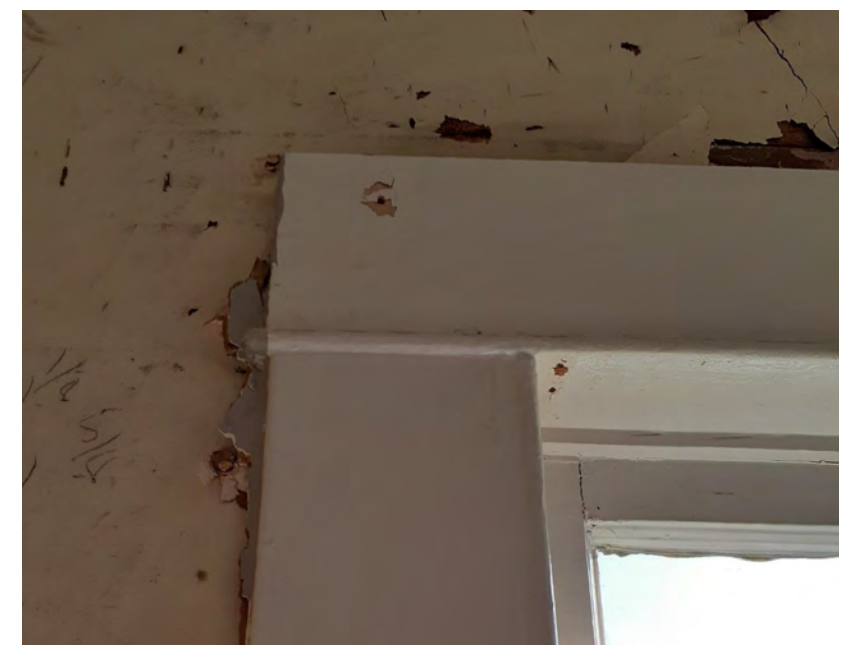
over water damaged wood, typical.

Window glass appears to be a standard glass, not milk,

Window Trim+Sill to be preserved were possible and

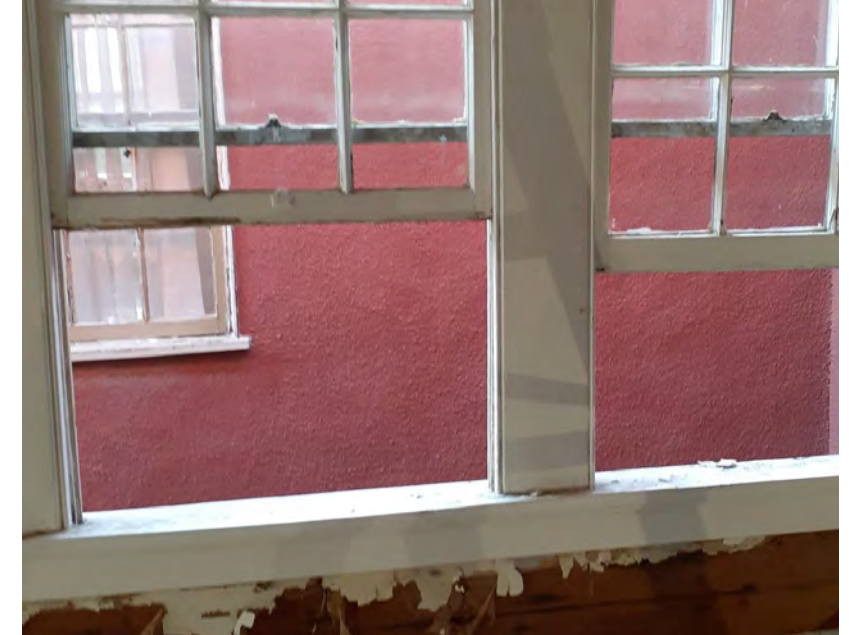
Overall Window 7: Multiple layers of paint and caulk over water damaged wood, typical.

Window does not stay open for long, it slowly lowers on its own.

Notes: We would like to provide a full frame replacement to closely match this "Original Window" in dimensions.

Window Trim+Sill to be preserved were possible and
