HISTORIC AND DESIGN REVIEW COMMISSION

March 06, 2019

HDRC CASE NO: 2019-074
ADDRESS: 413 CLUB DR
LEGAL DESCRIPTION: NCB 7014 BLK LOT W 35 FT OF 4 & E 16.5 FT OF 5
ZONING: RM-4, H
CITY COUNCIL DIST.: 7
DISTRICT: Monticello Park Historic District
APPLICANT: Ramiro Reyes
OWNER: Ramiro Reyes
TYPE OF WORK: Window replacement, exterior painting
APPLICATION RECEIVED: February 14, 2019
60-DAY REVIEW: April 13, 2019

Investigation Report

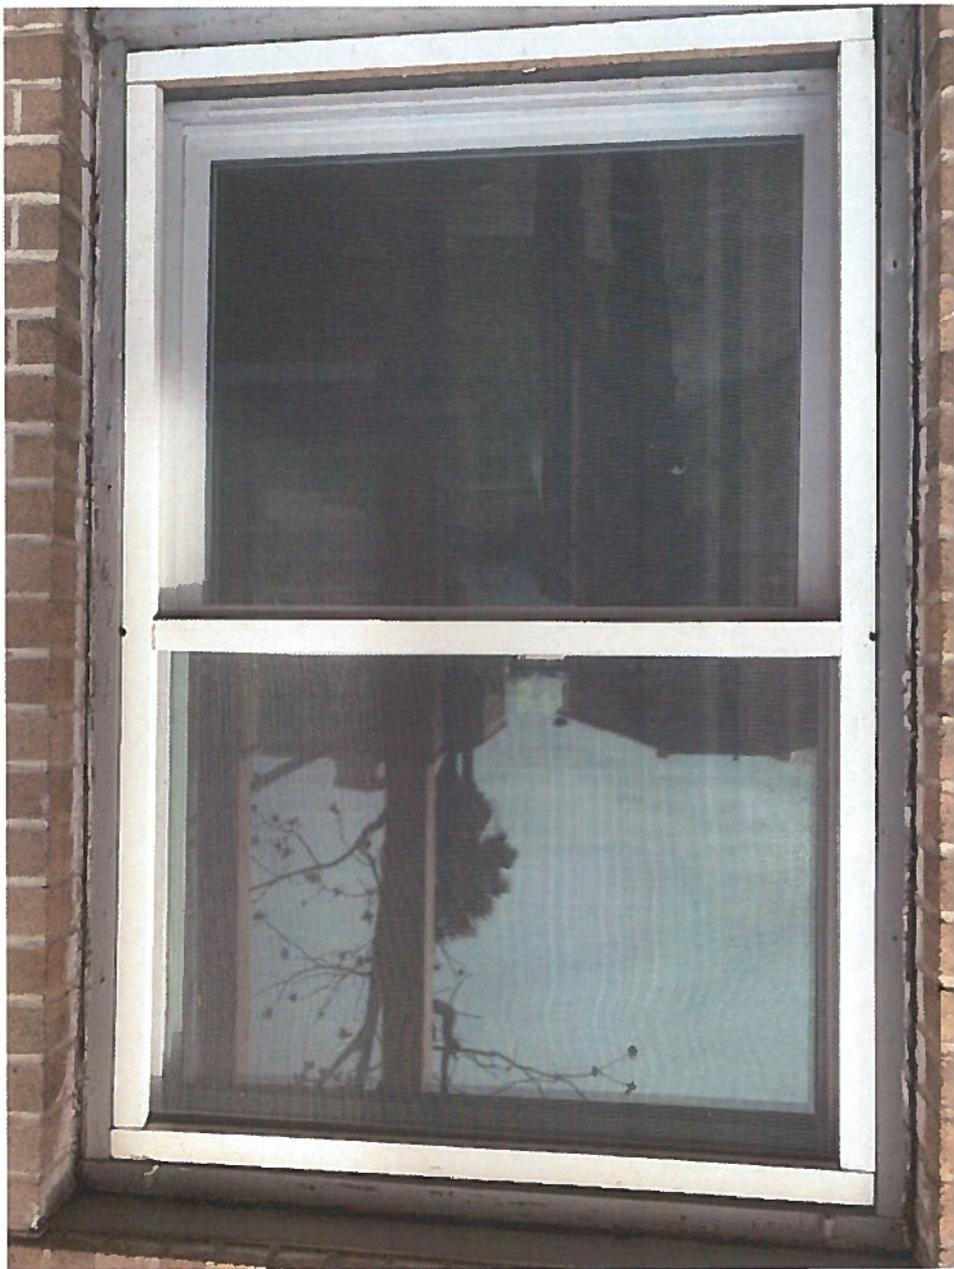
IMG_5981.jpg

New windows

New windows w/ woodsc

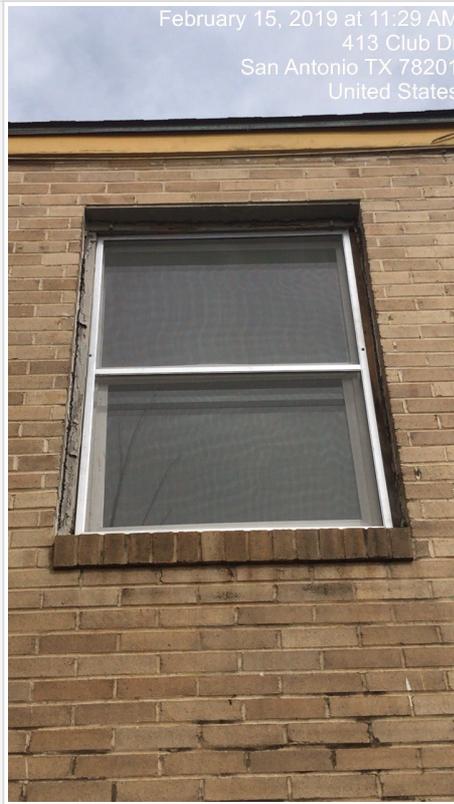
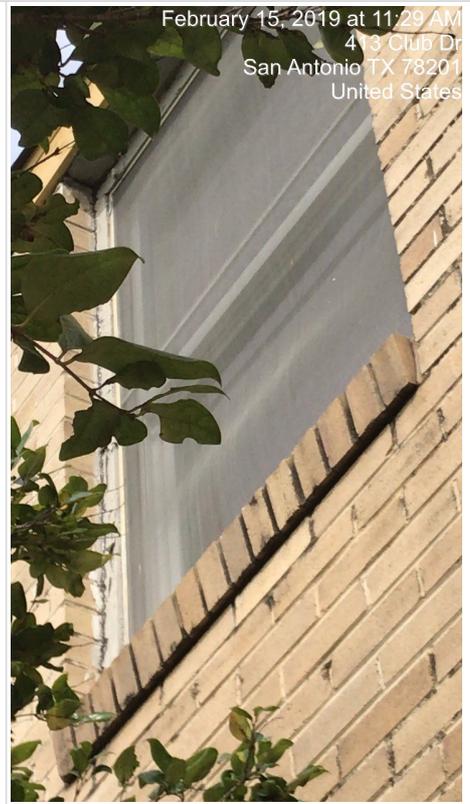
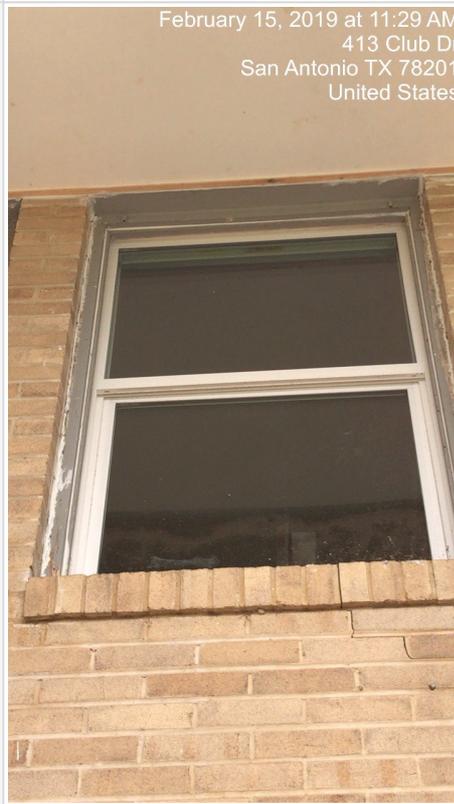
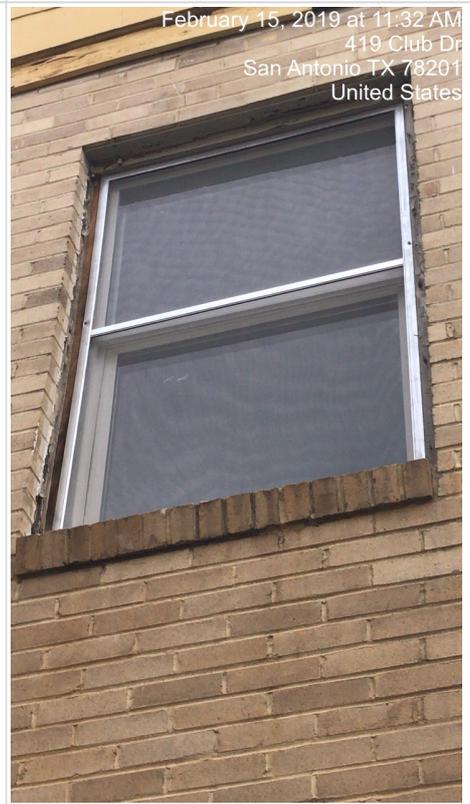
Investigation Report

Date	02/15/2019
Time	11:34 AM (-6 GMT)
Context	follow-up, citizen report
Present Staff	Huy Pham, Other
Present Individuals	Crew member(s)
Types of Work Observed	Exterior Maintenance and Alterations
Amount of Work Completed	75%
Description of work	Windows have been replaced with vinyl windows; some are covered with wood or aluminum screens. Some work was occurring on the rear accessory structure and interior of the property.
Description of interaction	Two crew members were on site who spoke Spanish. Staff provided a stop work order with Spanish translation and posted a Notice of Investigation on the front facade.

Violation Type	No Certificate of Appropriateness (Code 35-451a), Beyond scope of Certificate of Appropriateness (Code 35-451h)
OHP Action	Spoke with contractor(s) and/or crew
Deadline to contact office	02/15/2019
Will post-work application fee apply?	Yes
