HISTORIC AND DESIGN REVIEW COMMISSION

September 19, 2018

HDRC CASE NO: 2018-459
ADDRESS: 1939 W GRAMERCY PLACE
LEGAL DESCRIPTION: NCB 1931 BLK 38 LOT 10
ZONING: R-6, H
CITY COUNCIL DIST.: 7
DISTRICT: Monticello Park Historic District
APPLICANT: Bruce Graham
OWNER: Bruce Graham
TYPE OF WORK: Window replacement
APPLICATION RECEIVED: August 29, 2018
60-DAY REVIEW: October 28, 2018
REQUEST:

The applicant is requesting a Certificate of Appropriateness for approval to replace twelve (12) wood windows with vinyl windows.

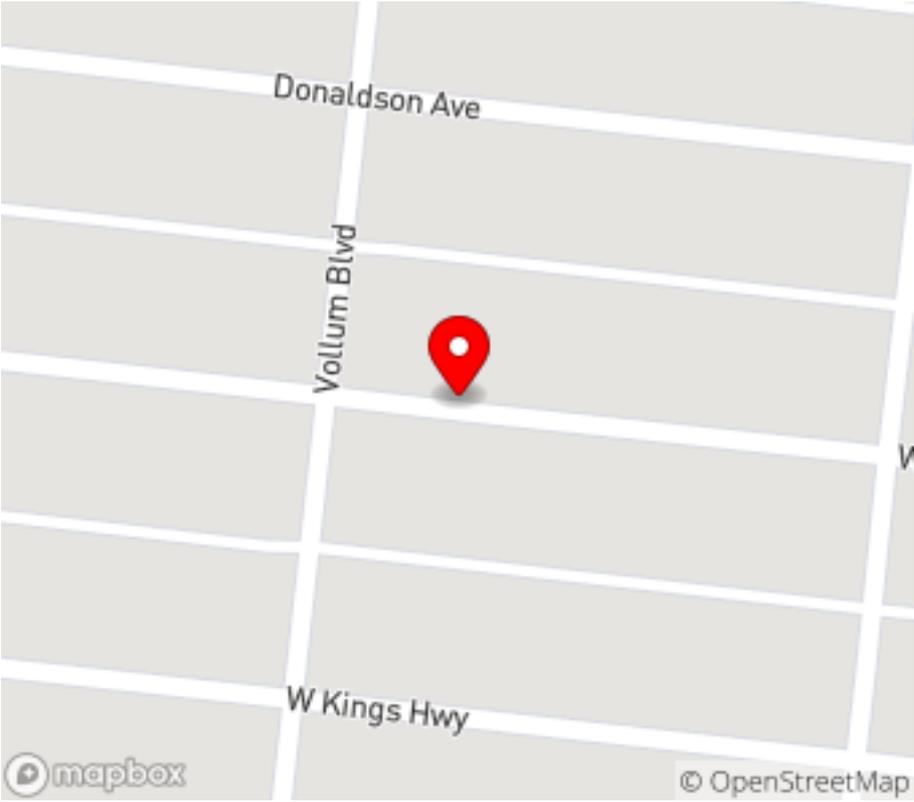
Site Visit

Date	08/22/2018
Time	04:03 PM (-5 GMT)
Context	drive-by
Present Staff	Huy Pham
Present Individuals	None
Types of Work Observed	Exterior Maintenance and Alterations
Amount of Work Completed	Completed
Description of work	Removal of wood windows and installation of vinyl windows and dark mesh window screens. Some wood windows are still on site as of 4pm August 22, 2018.
