# HISTORIC AND DESIGN REVIEW COMMISSION

December 02, 2020

<b>HDRC CASE NO:</b>	<b>2020-505</b>
<b>ADDRESS:</b>	120 CALLAGHAN AVE
<b>LEGAL DESCRIPTION:</b>	NCB 719 BLK 1 LOT N 1-2 OF 5
<b>ZONING:</b>	RM-4,H
<b>CITY COUNCIL DIST.:</b>	1
<b>DISTRICT:</b>	Lavaca Historic District
<b>APPLICANT:</b>	Jim Ferrell/FT Builder Sevices
<b>OWNER:</b>	MENDIOLA MARIO J
<b>TYPE OF WORK:</b>	Window replacement
<b>APPLICATION RECEIVED:</b>	October 29, 2020
<b>60-DAY REVIEW:</b>	Not applicable due to City Council Emergency Orders
<b>CASE MANAGER:</b>	Stephanie Phillips

## Investigation Report

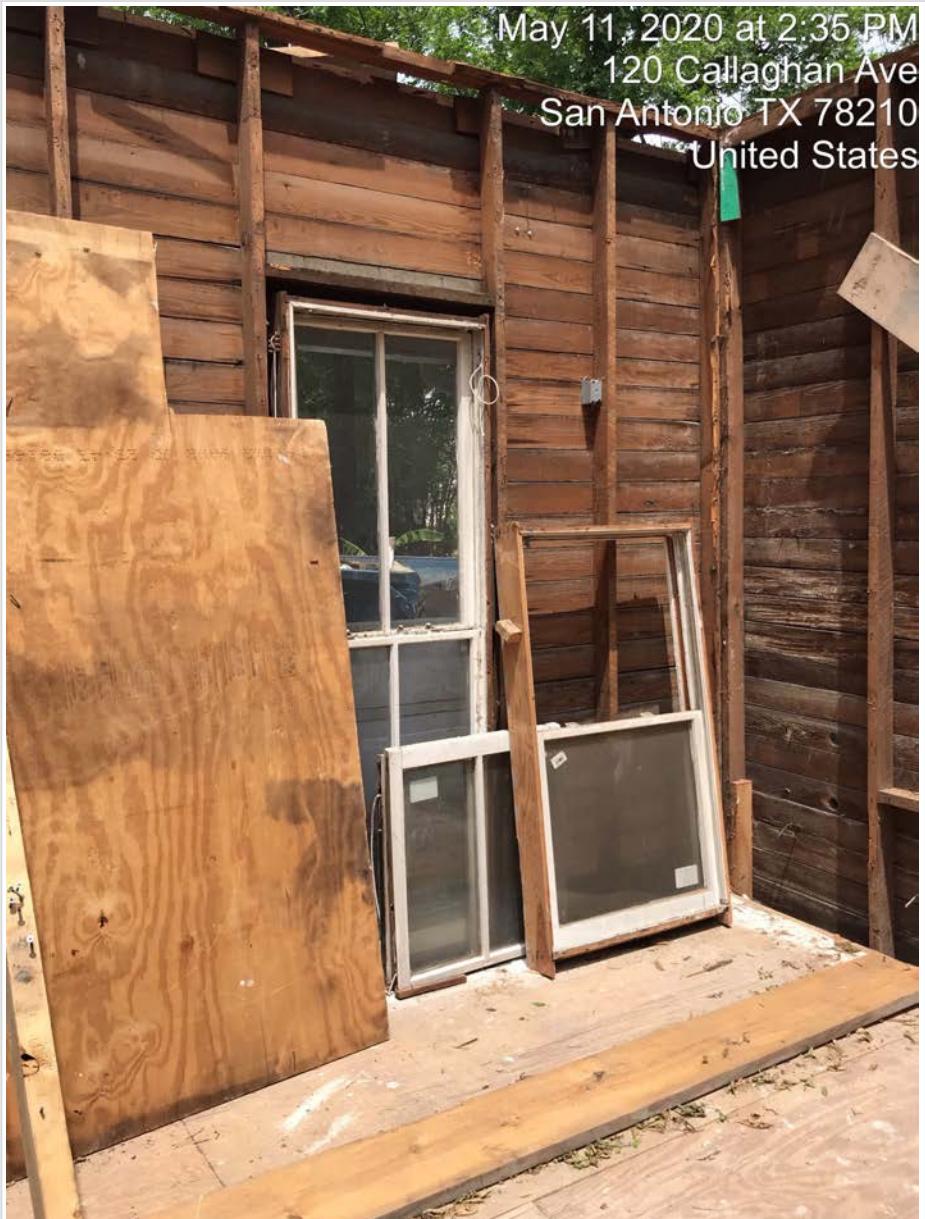
May 11, 2020 at 2:35 PM  
120 Callaghan Ave  
San Antonio TX 78210  
United States

Date	05/11/2020
Time	02:43 PM (-5 GMT)
Context	citizen report
Present Staff	Huy Pham, Edward Hall
Present Individuals	Other
Types of Work Observed	Exterior Maintenance and Alterations, Demolition
Amount of Work Completed	75%
Description of work	Demolition of historic facades and materials beyond the scope of approval for construction of a rear addition
