# HISTORIC AND DESIGN REVIEW COMMISSION

**HDRC CASE NO:** 2019-755

**ADDRESS:** 4101 SWANS LANDING

**LANDMARK:** Perrin House

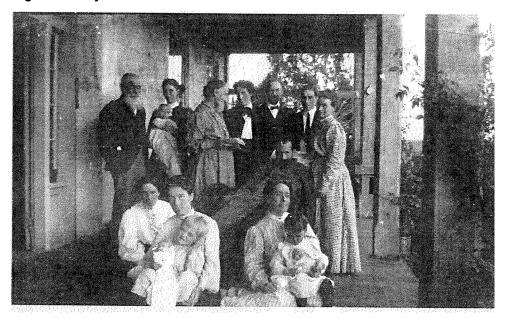
Figure 5:
Perrin home
showing the
first extension
of the house,
a row of rooms
attached to the
back part of
the house. Also
visible is the
roof for the
intended shed
kitchen, which
was never
constructed.

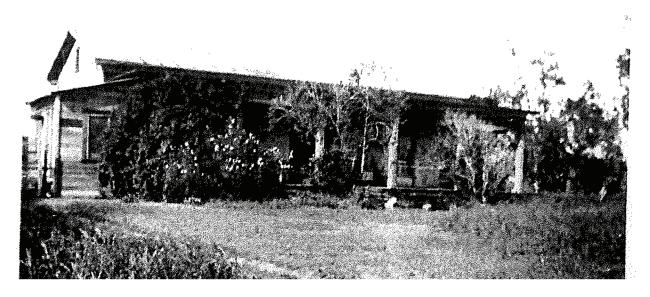
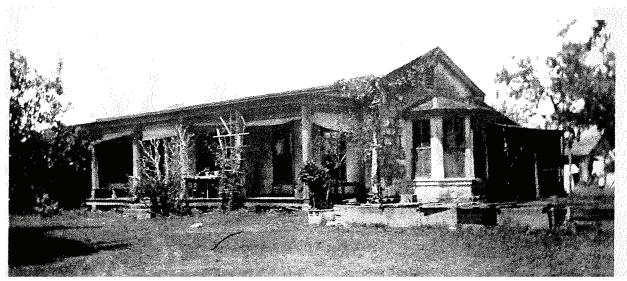
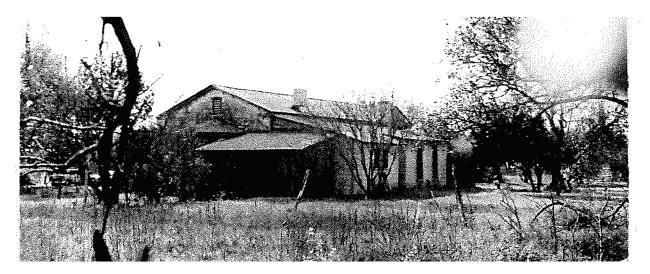
Figures 6–8: Pictures showing the last additions made by the Perrins—two more rooms added to the house, one in the west end of the porch and another in the east wall north of the bay window.

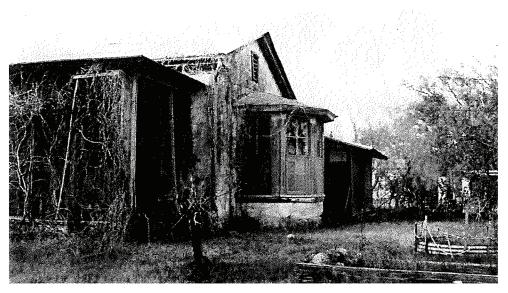
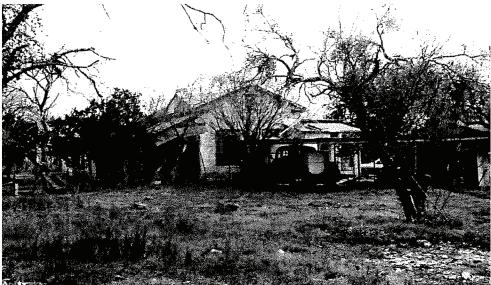
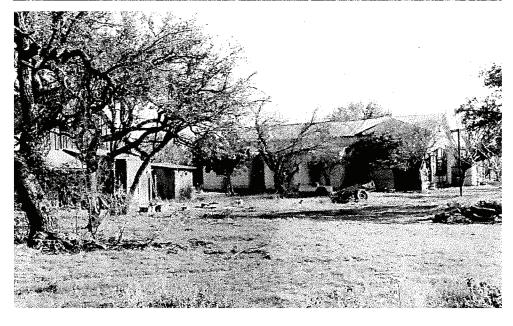
Figures 9–11:
State of the
house prior to
the Swan family
acquisition. The
top photo indicates
the Perrins had
screened-in the
front porch.

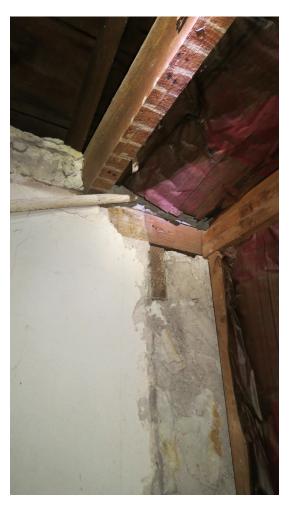
Figures 22 and 23: Traces of plaster indicate the middle area of the house was lowered by the Swans in the 1960s.
