## HISTORIC AND DESIGN REVIEW COMMISSION

### Agenda Item No: 23

**HDRC CASE NO:** 2015-288  
**ADDRESS:** 239 / 241 / 243 CENTER  
**LEGAL DESCRIPTION:** NCB 580 BLK 11 LOT 17 (SUNSET CENTER STREET SUBD) 2012-NEW ACCT PER SPLIT PER PLAT 9621/133-135 FILED 3/11/2011  
**ZONING:** D, H, HE  
**CITY COUNCIL DIST.:** 2  
**DISTRICT:** St. Paul Square Historic District  
**LANDMARK:** Guenther, Colin Building  
**APPLICANT:** Pam Carpenter/Seventh Generation Design  
**OWNER:** Zachry Realty  
**TYPE OF WORK:** Demolition and new construction of multi-family building  
**REQUEST:**

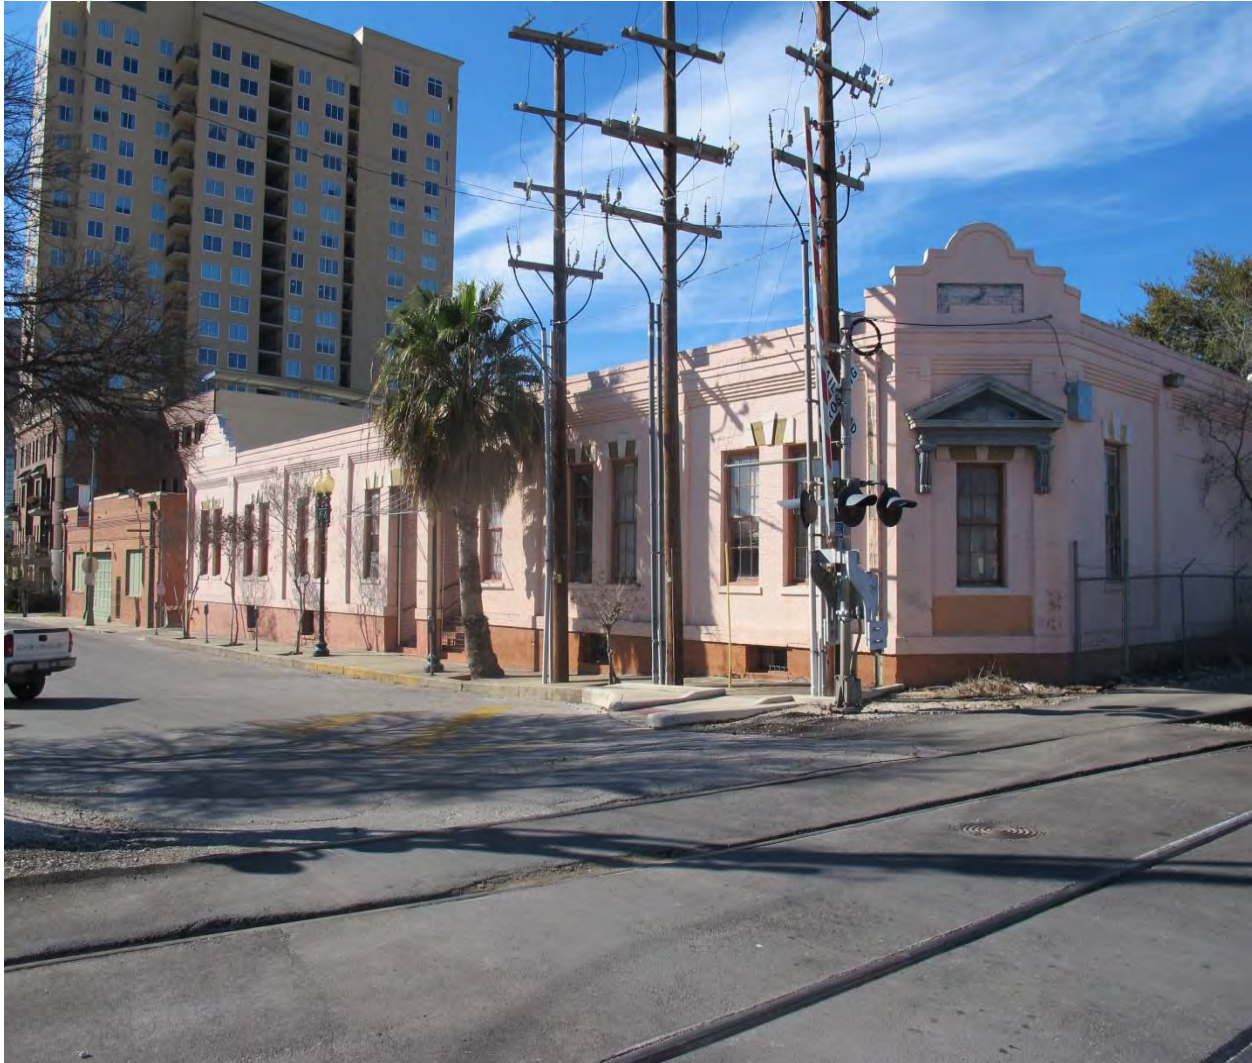
**Photo 1:** An overview looking at the south elevation of 243 Center Street and the return on the east elevation. Note that there is a railroad grade crossing adjacent to the building.

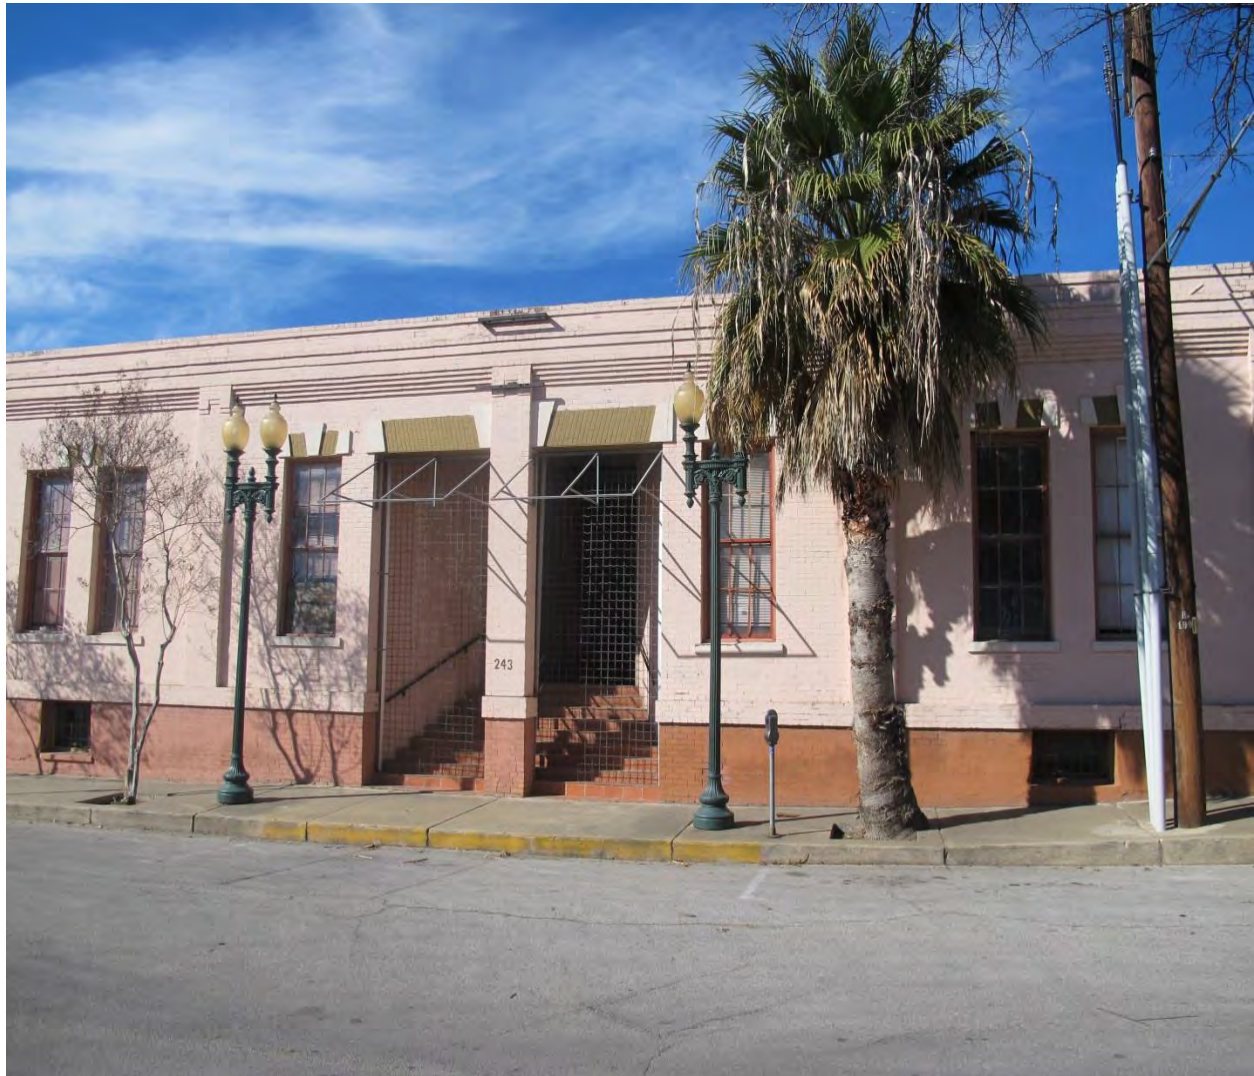
**Photo 2:** Looking at the current main entry near the center of the south elevation. The entry defines a space that extends completely through the building and creates two sections for the first floor.

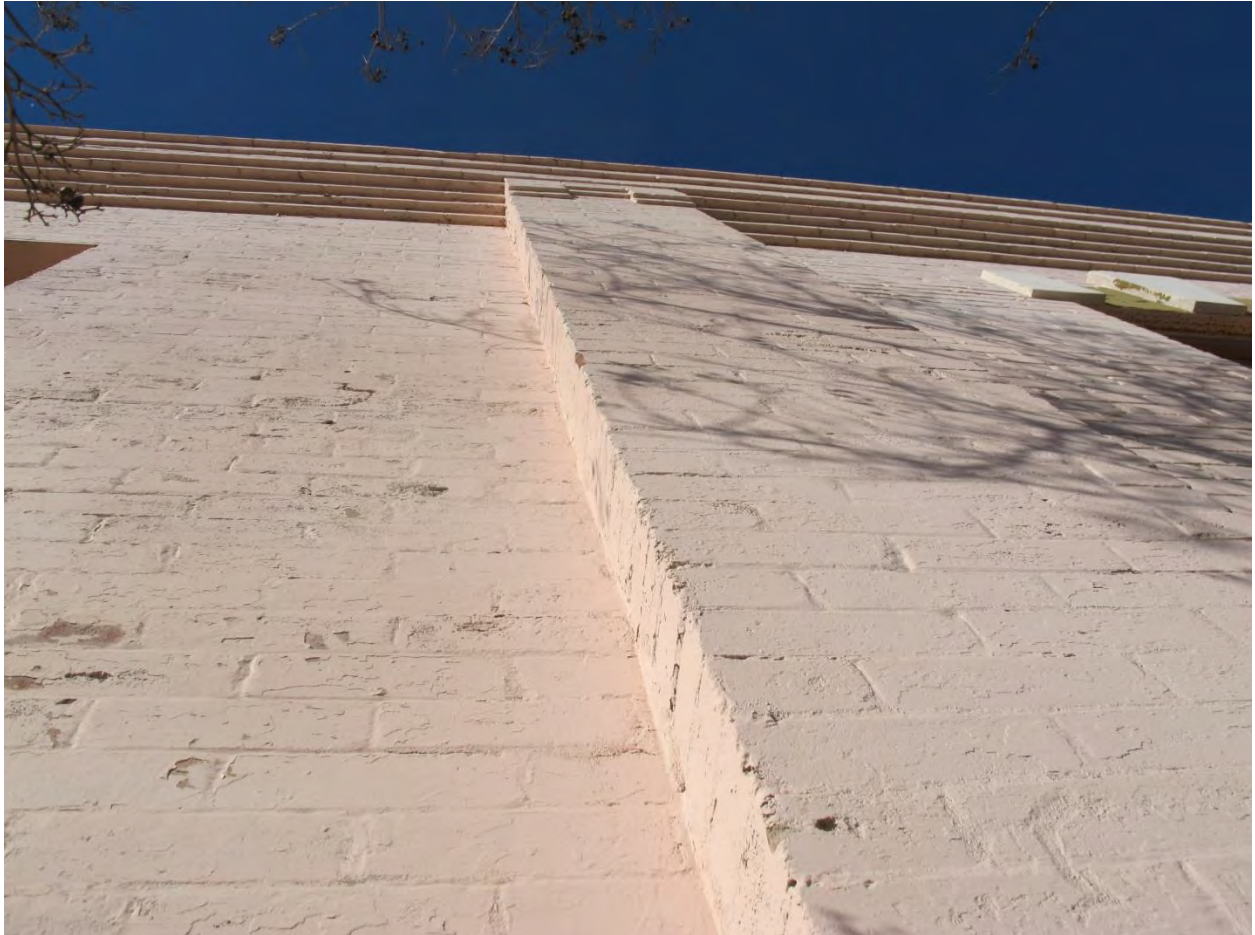
This elevation is the main or street elevation of the building. The façade is punctuated with windows for the first floor and basement. The masonry is detailed with a water table below the first floor and a frieze at the upper area at the roof. The wall is typically 13 inches (actual), but it widens at the parapet (Photos 2, 5 and 12), and below the water table it is about 18 inches in thickness.

**Photo 5:** A view of the projection of the brick (frieze) at the parapet on the south elevation and a pilaster.

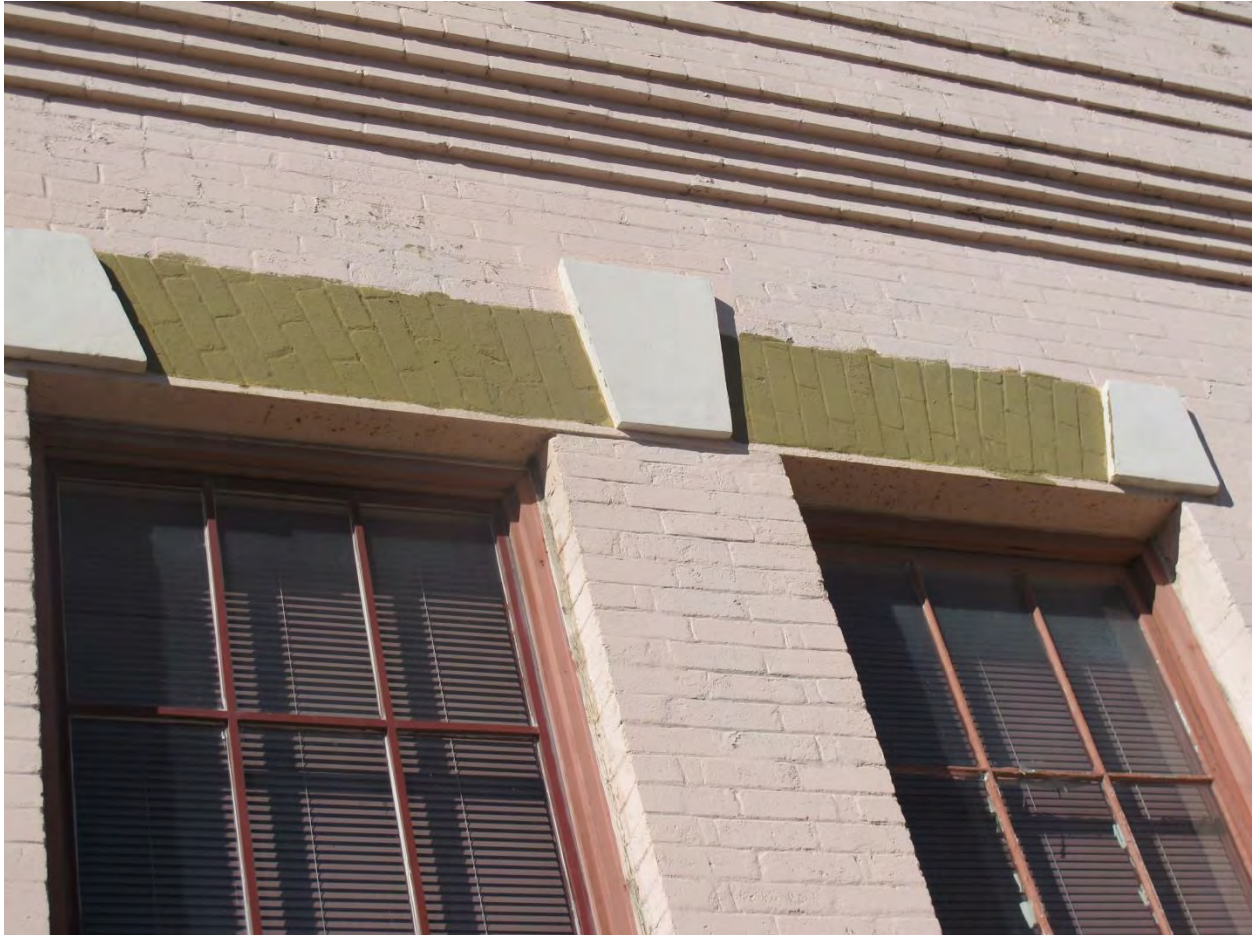
**Photo 6:** A view of a typical flat (gauged) brick arch at the windows of the south elevation. The arch is bearing on a 1 inch thick cast iron (assumed) plate, which is acting as a lintel.

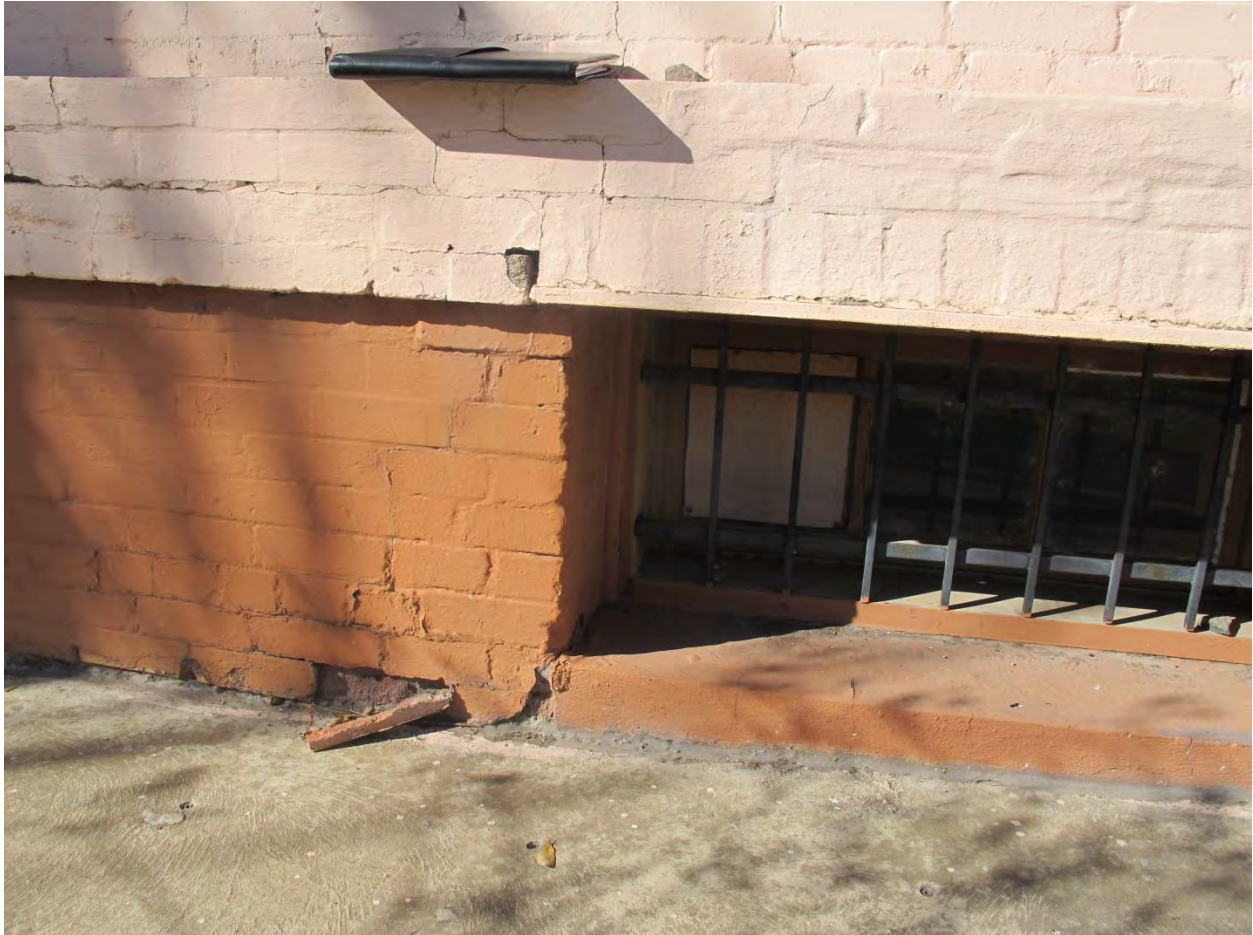
The water table has deterioration with a failed masonry wash and open joints that permit water infiltration (Photo 7). This defect has been allowing water infiltration for some time, and this is the root cause of the majority of the distress and deterioration of the masonry at and below the water table. This distress can be seen in the masonry around the basement windows (Photos 8 and 9). There is

**Photo 8:** A typical view of the masonry below the water table and at the sidewalk with distress on the south elevation.

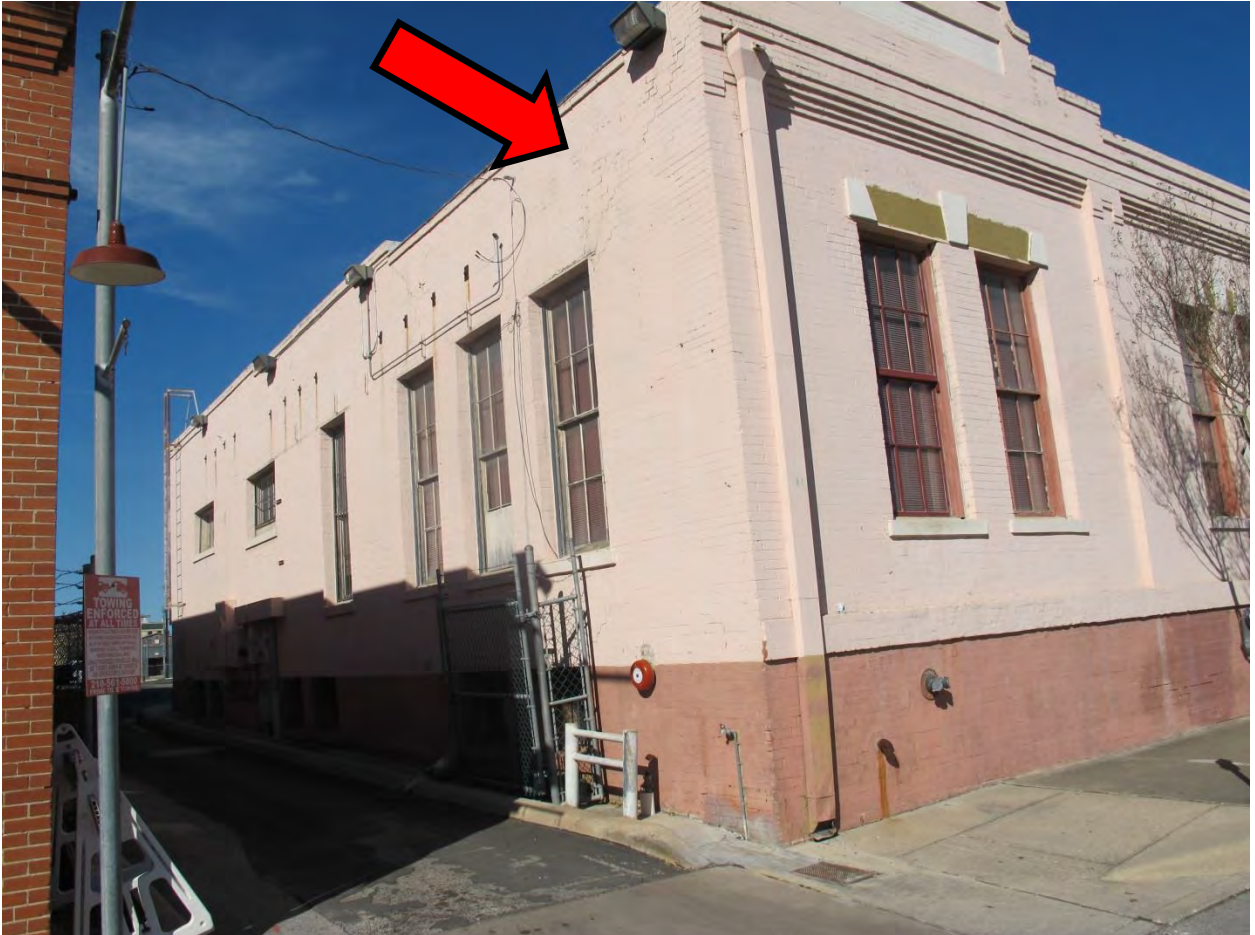
There is some previously repaired masonry cracking near the roof line at the south end of the elevation. This appears to be attributable to prior foundation settlement at the southwest corner of the building.

Of note, there is a roof drain discharge near grade and the southwest corner of the building. In addition, there is a curb which inadvertently acts as drainage flow diverter of the discharged water toward Center Street. This flow is directed along the perimeter of the building, and it appears to be a primary causation for the observed settlement at the southwest corner. Refer to Photo 10.

**Photo 10:** A view of the southwest corner and the west elevation of 243 Center Street. The arrow points to an area of prior masonry distress, which appears to be related to settlement.

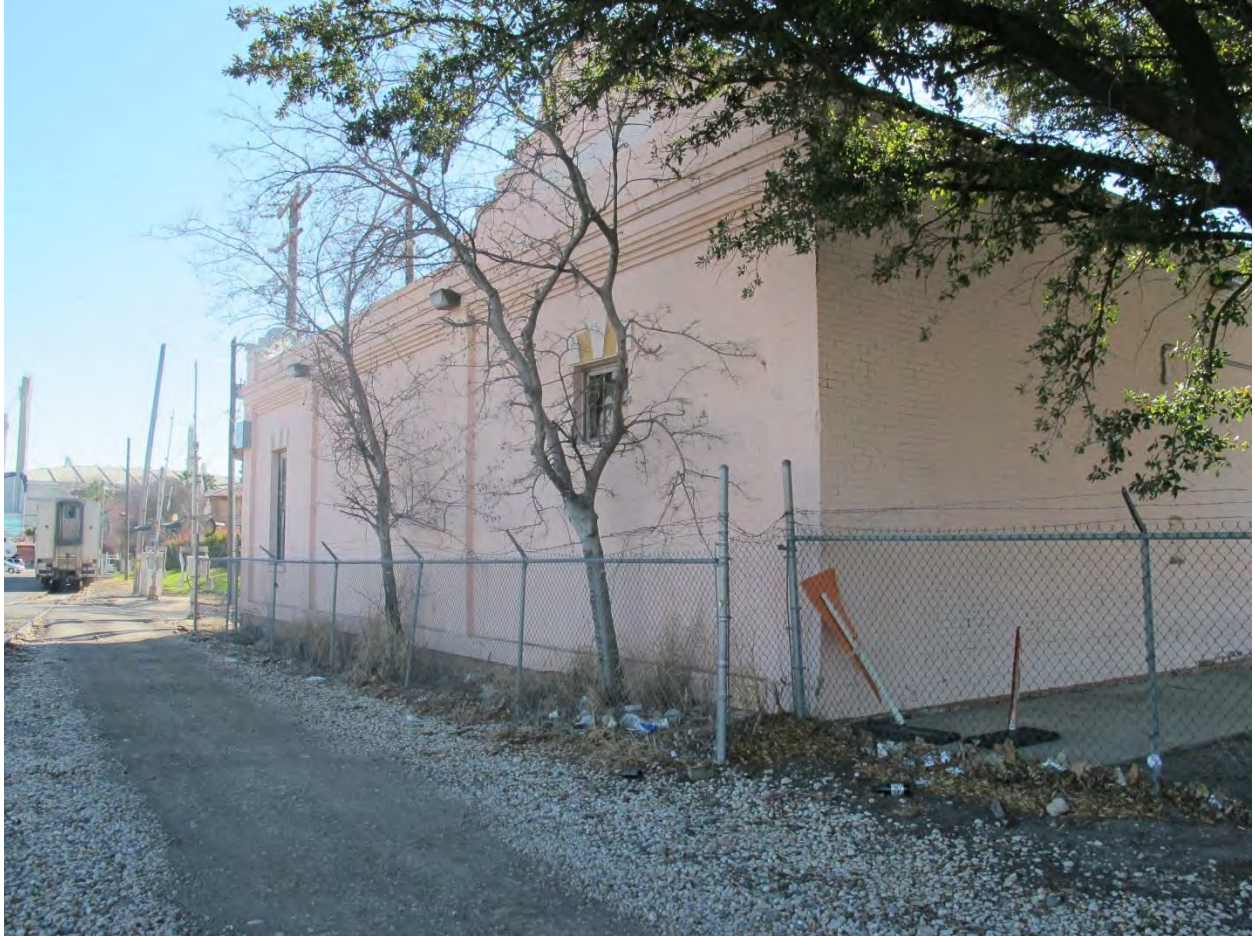
This elevation abuts the Union Pacific rail lines and the east property line (Photo 12). The track is nearest to the building at the southeast corner, and the minimum clearance dimension is about 14 feet.

**Photo 12:** A view of the east elevation looking south.

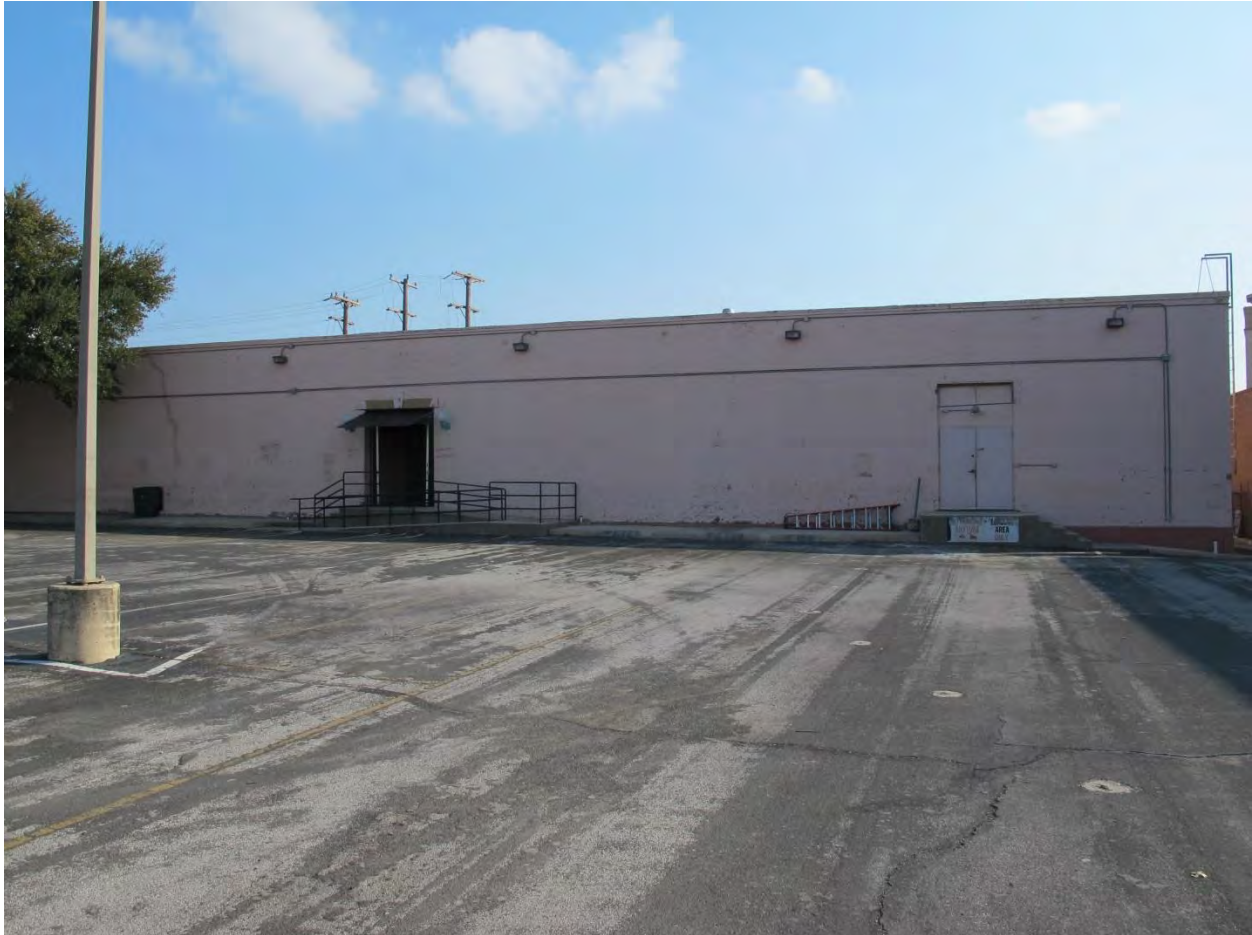
This elevation faces the parking area to the rear of the building (Photo 15). There is an opening for the pass-through area from the south elevation entry. There is some cracking in the masonry, but it is repairable if the wall were to be preserved.

**Photo 15:** A view of the north elevation. The ramp leads to the passageway seen in Photos 2 and 4

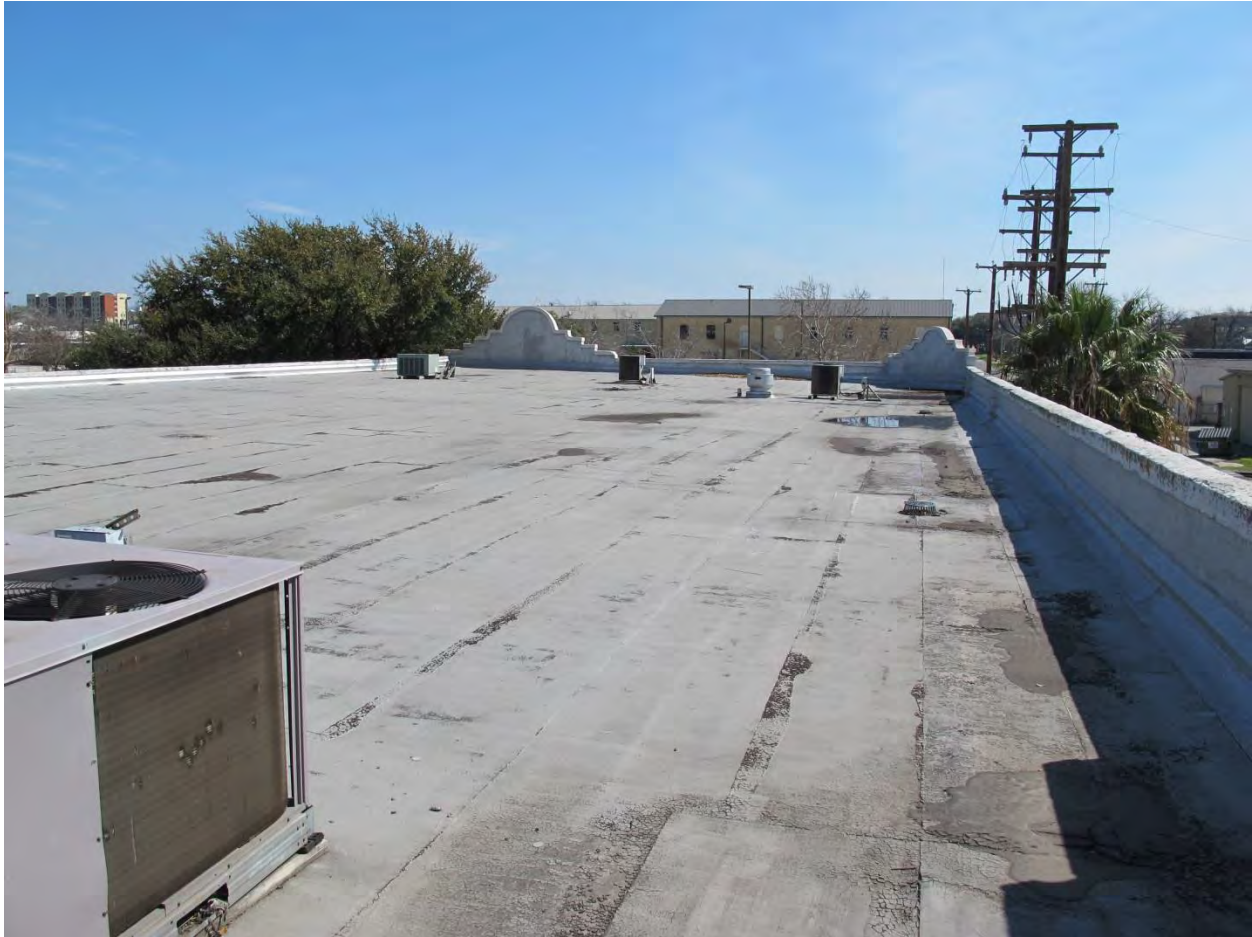
The roof was accessed by the fixed steel ladder on the west elevation, and the roofing membrane was found to be in a serviceable condition. The membrane appeared to be a modified bitumen sheet system with an applied reflective coating. The roof was pitched from its high point, north to south, about 16 inches over its width. Photos 16 through 20 depict the roof, its parapet, and the three ornamental projections from the parapet.

**Photo 16:** Looking east on the roof with the 32 inch tall parapet on the south elevation. Note that the roof drainage is from north to south, and it is a 16 inch difference from high to low.

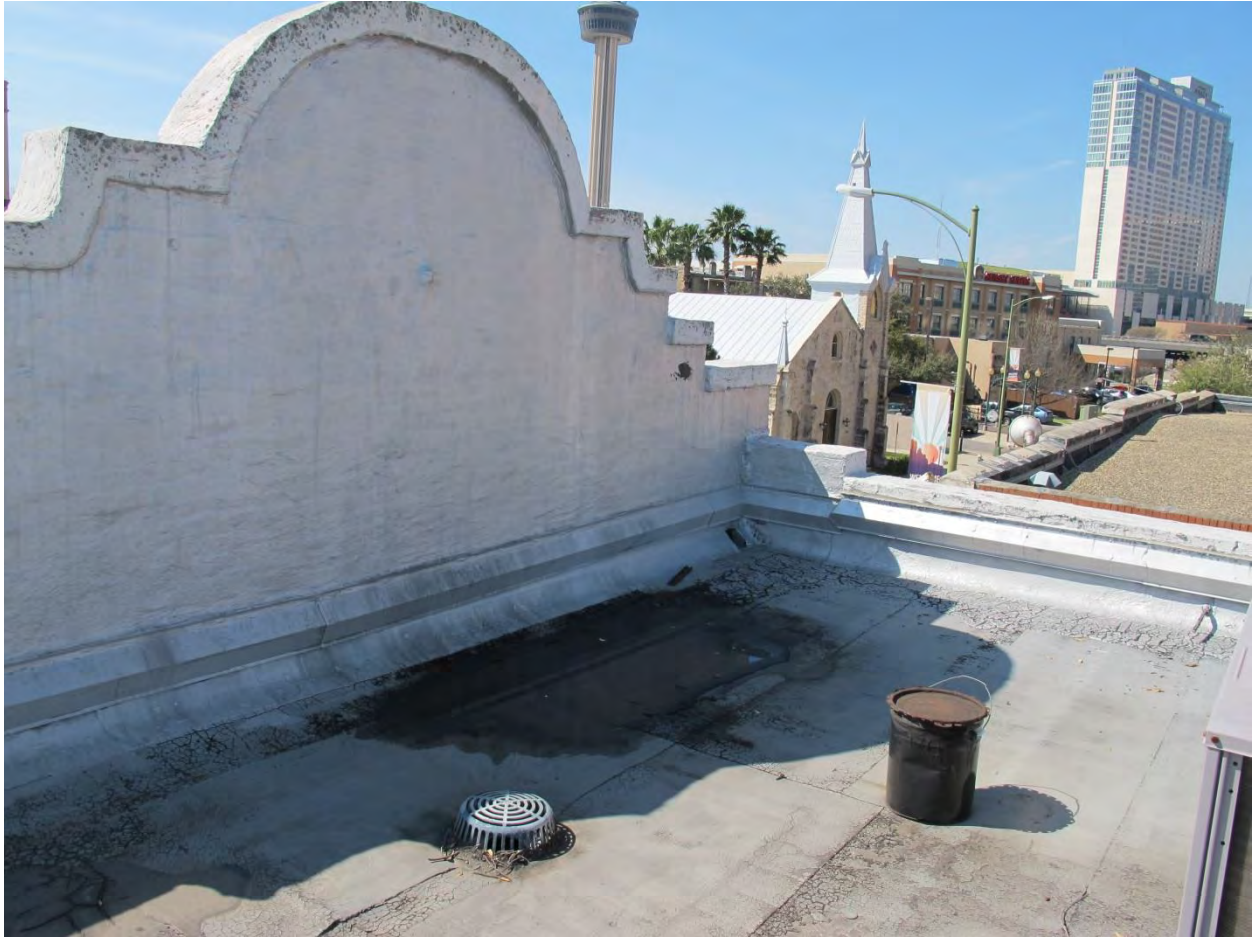
**Photo 17:** Looking at the southwest corner ornamental and pediment-like projection. The top of the masonry is about 88 inches above the roof line at the high point.

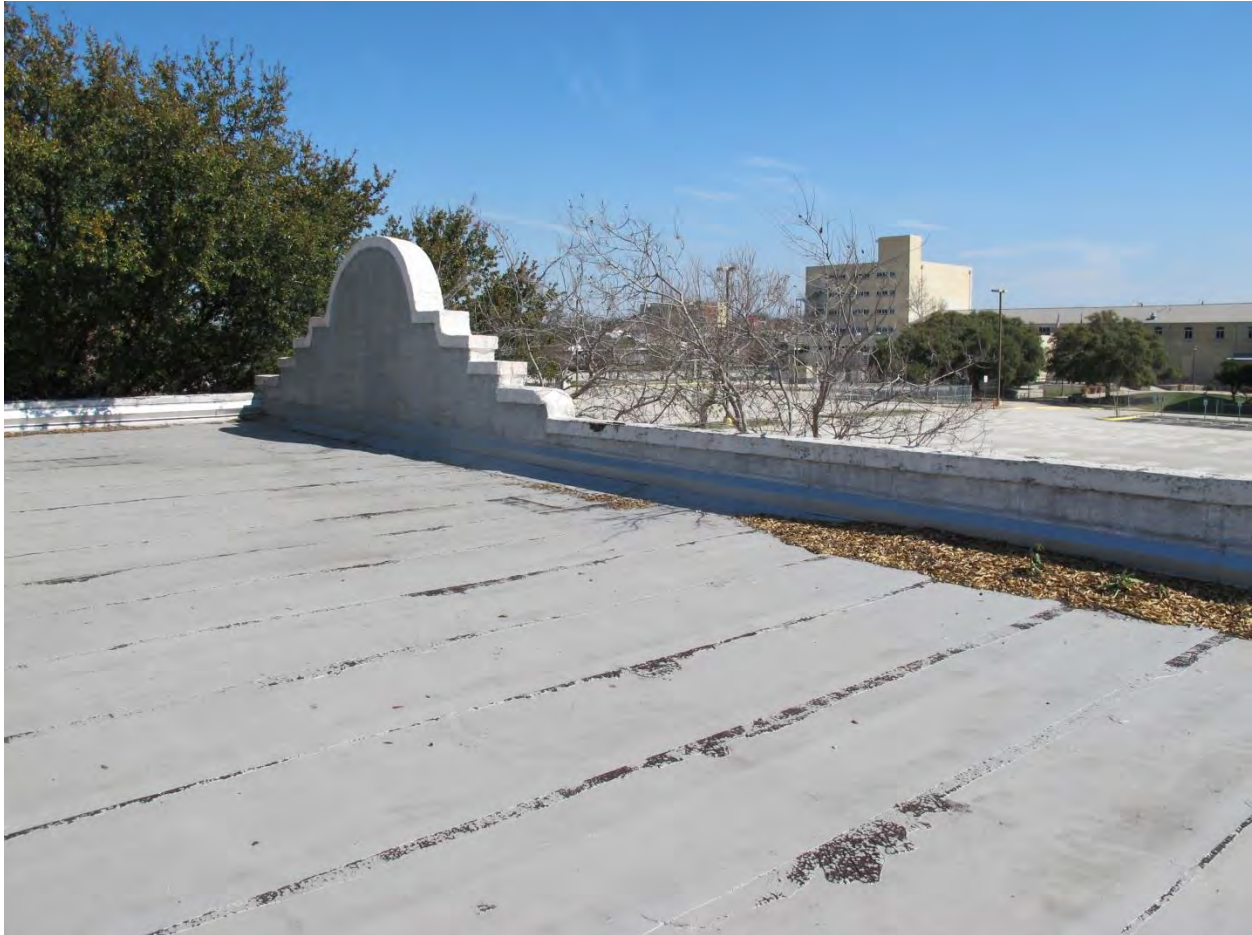
**Photo 19:** A view of the northeast corner of the roof with a pediment-like projection. The top of the projection is about 62 inches above the roof line.

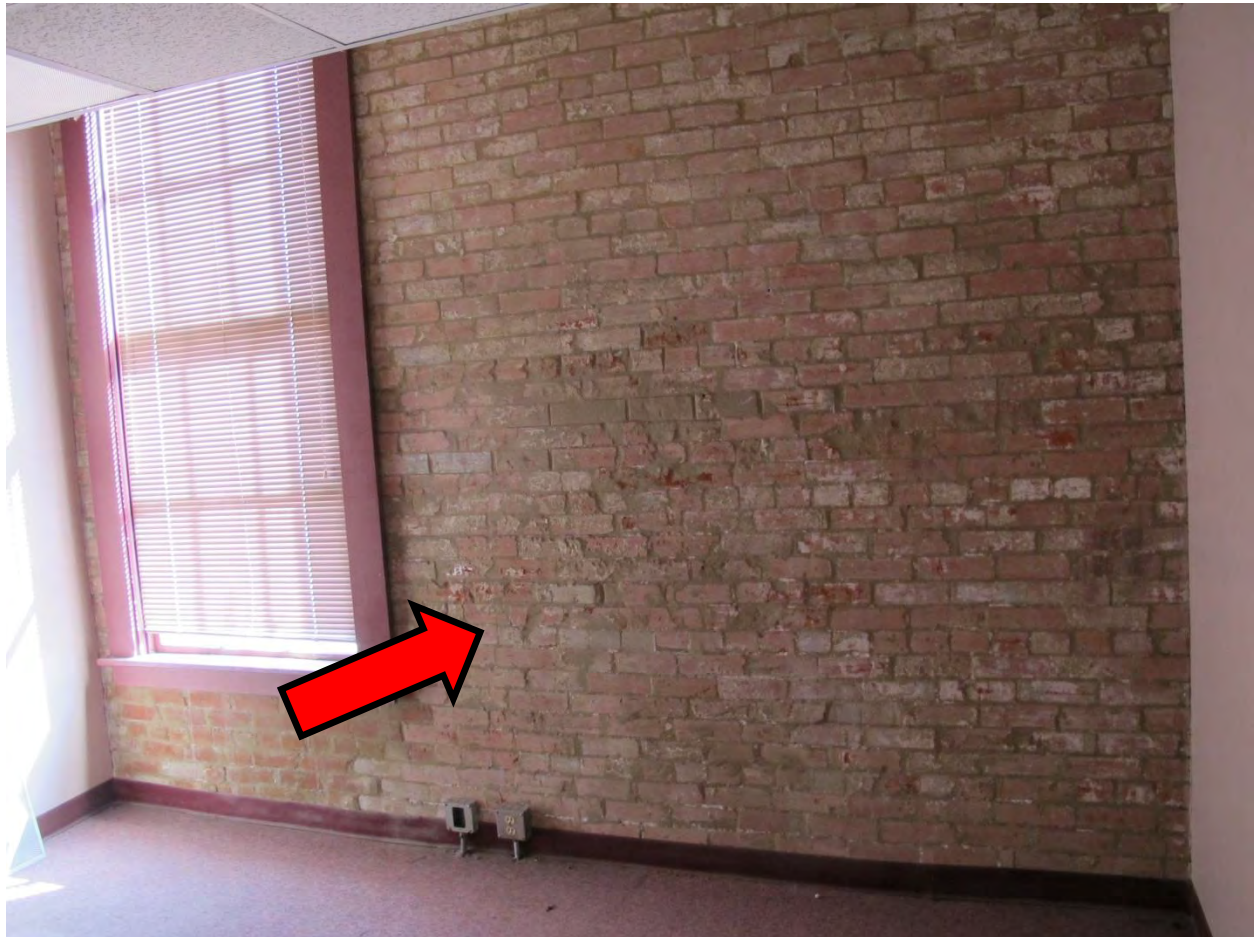
The brick masonry walls were exposed in some areas of the first floor, especially in the office space along the south elevation. The masonry construction had header courses at every sixth course. In general, the observable sections of the interior face of the masonry walls were in a serviceable condition (Photo 24).

**Photo 24:** A view of the typical interior construction long the south elevation of the building. Note that there is a header course every six courses over the height of the wall.

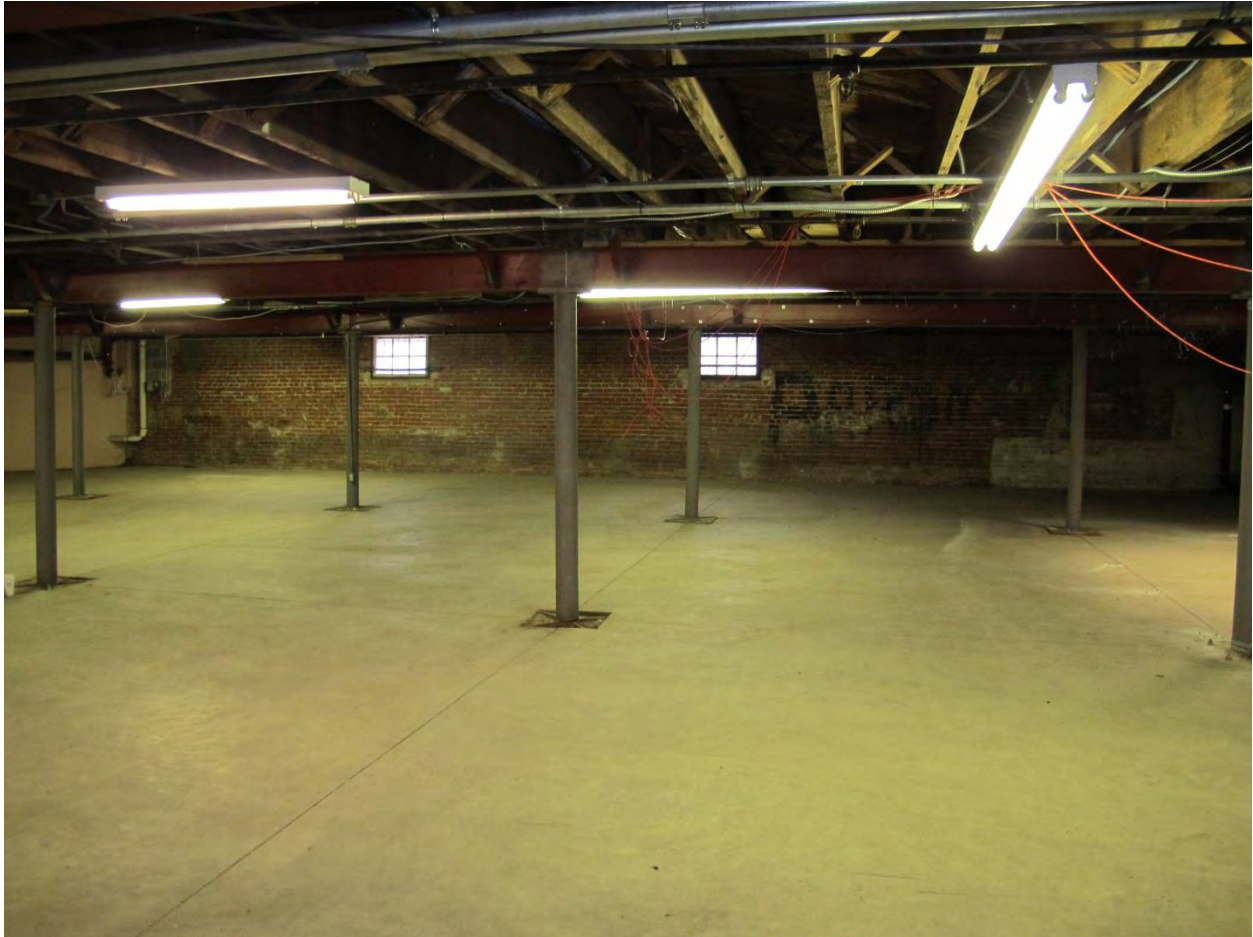
**Photo 25:** Looking south in the basement of 243 Center Street. The columns are 6 inch cast iron sections typically.

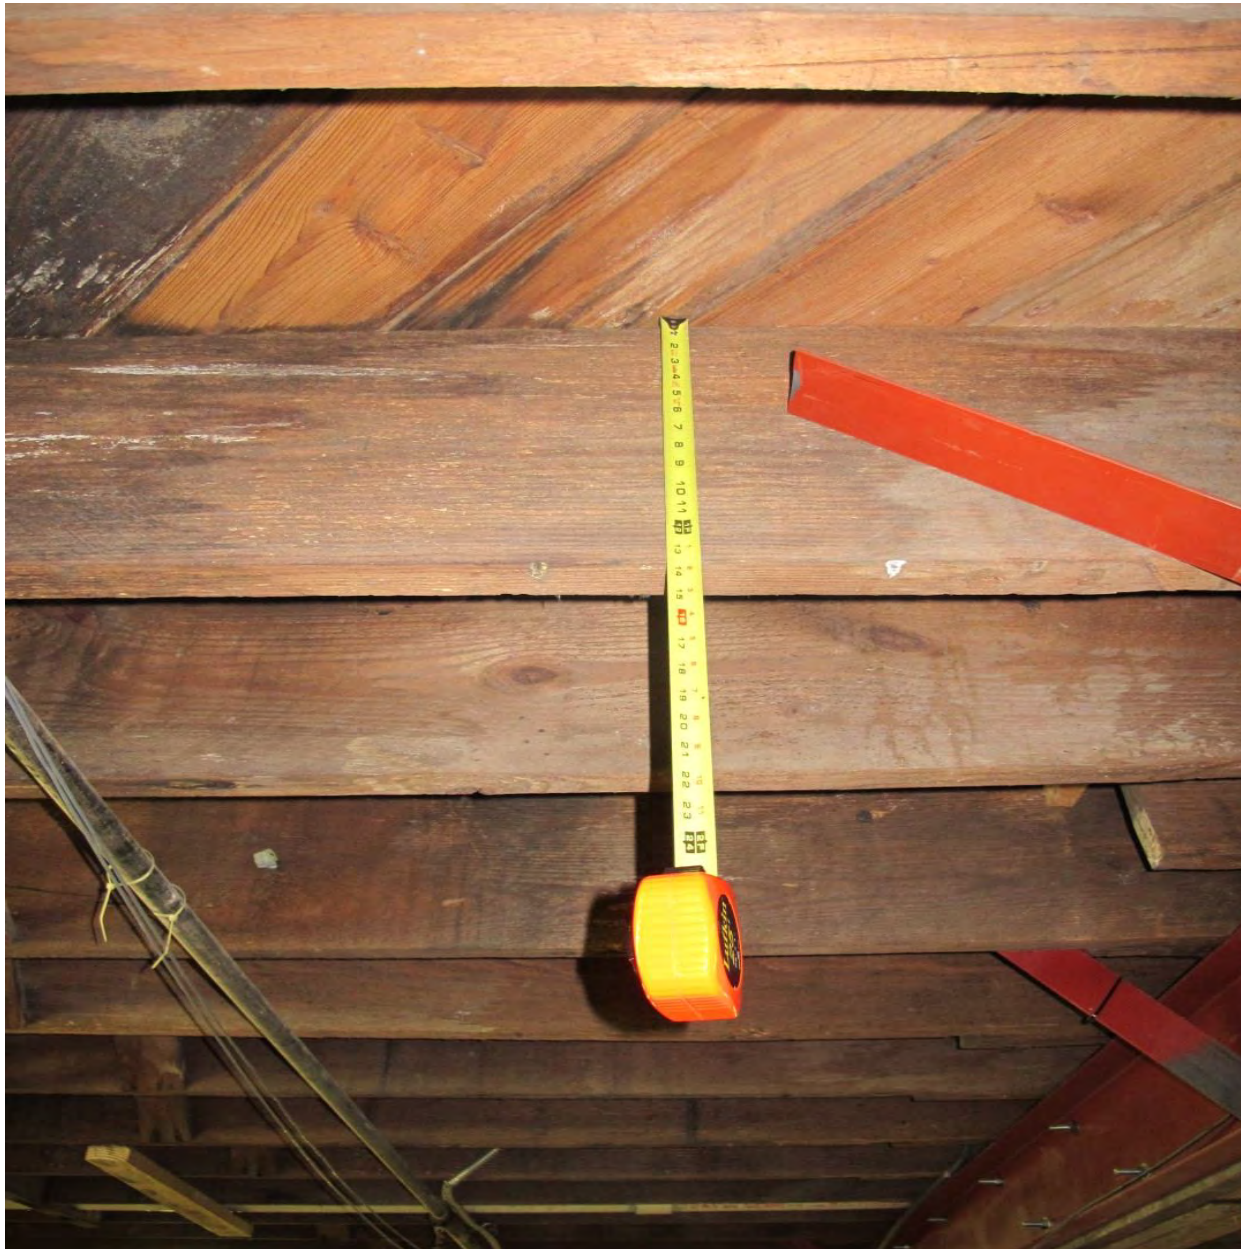
The existing first floor construction is the originally installed 2 inch wide by 13-1/2 inches deep (actual) wood joists spaced at about 18 inches on center (Photo 26). The joist spacing was found to vary, but the 18 inch dimension appeared to be the norm. The joists were originally supported by a four ply, 2 x 10 built-up wood girder that framed onto the original, 6 inch diameter cast iron columns. During the last structural upgrade, some of the girders were reinforced with a pair of through bolted, 10 inch steel channels, and at other locations, a new 10 inch, steel W section replaced the wood girders (Photos 25, 27 and 28). The original floor deck was a 1 by 6 wood decking, nailed to the joists.

**Photo 26:** Typical wood joist construction for the first floor.

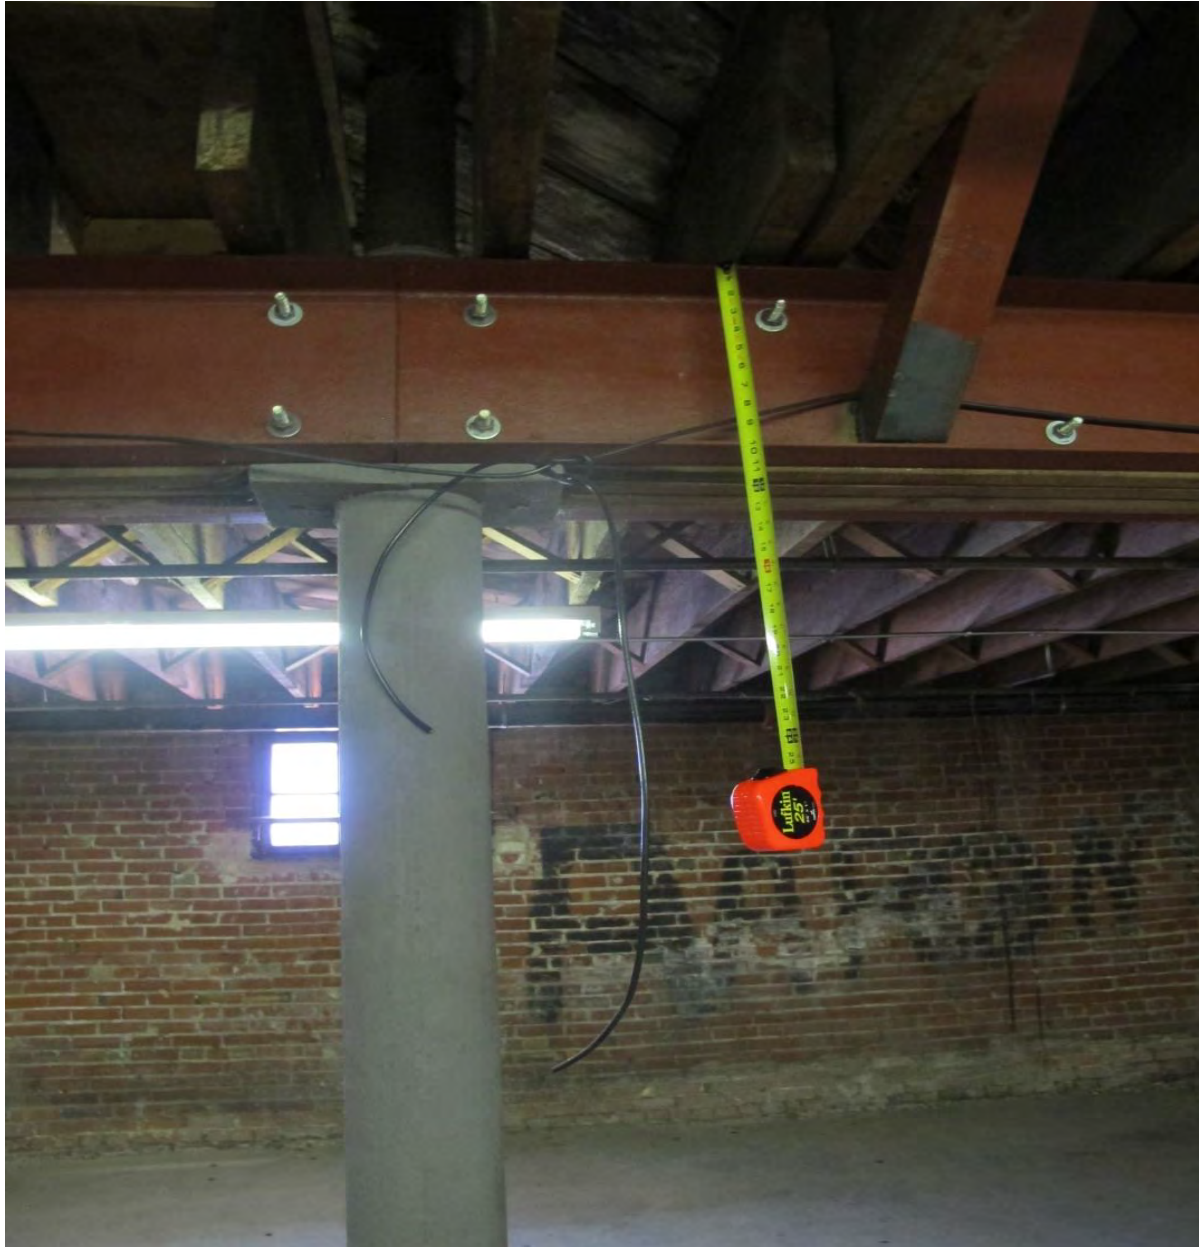
**Photo 27:** An example of a reinforced, original, multi-ply wood girder with two channel sections through bolted.

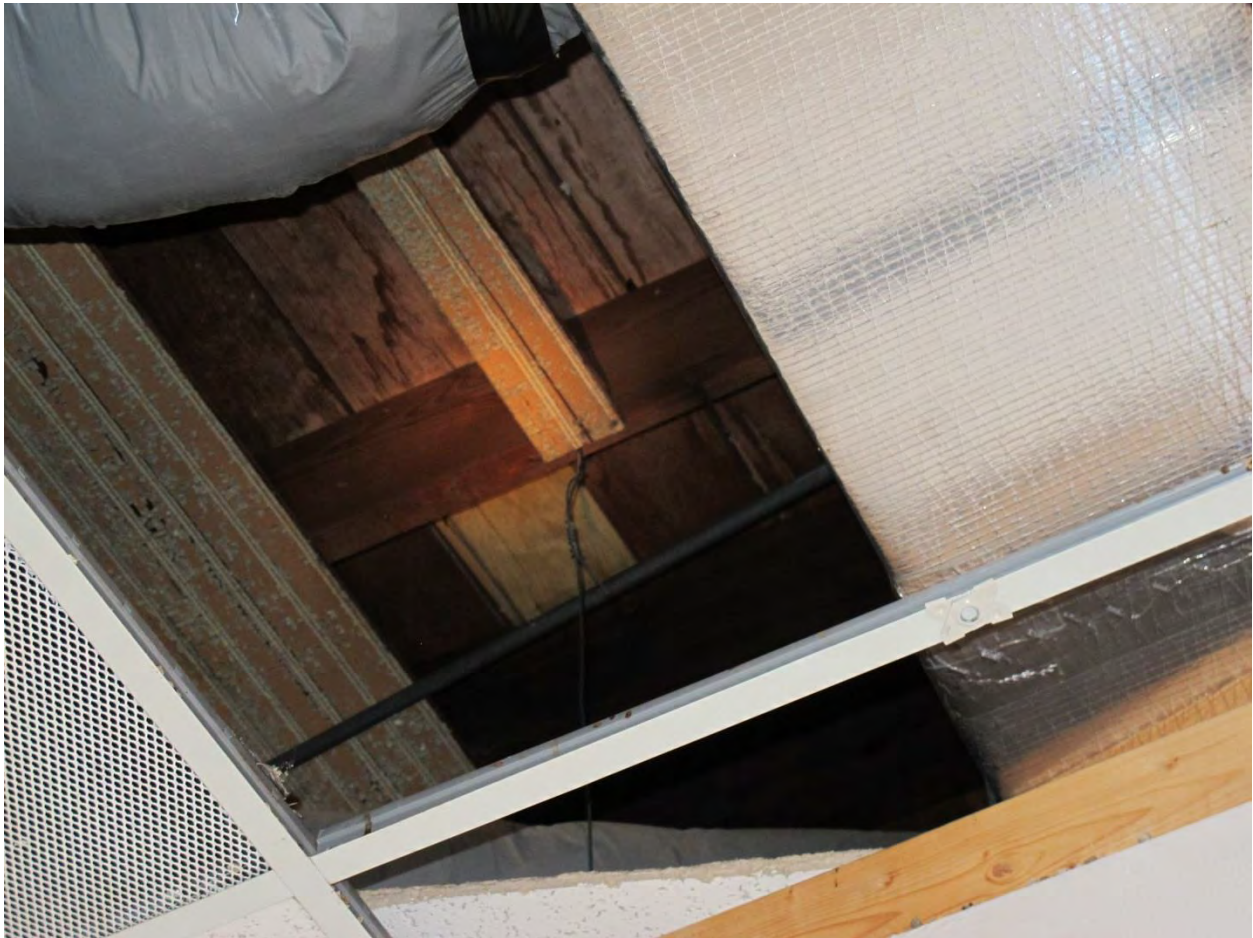
**Photo 29:** Looking at the roof framing through an opening in the ceiling of an office in the southeast corner of the building. Note that there appears a bead-board type ceiling, which is presumed to be original.

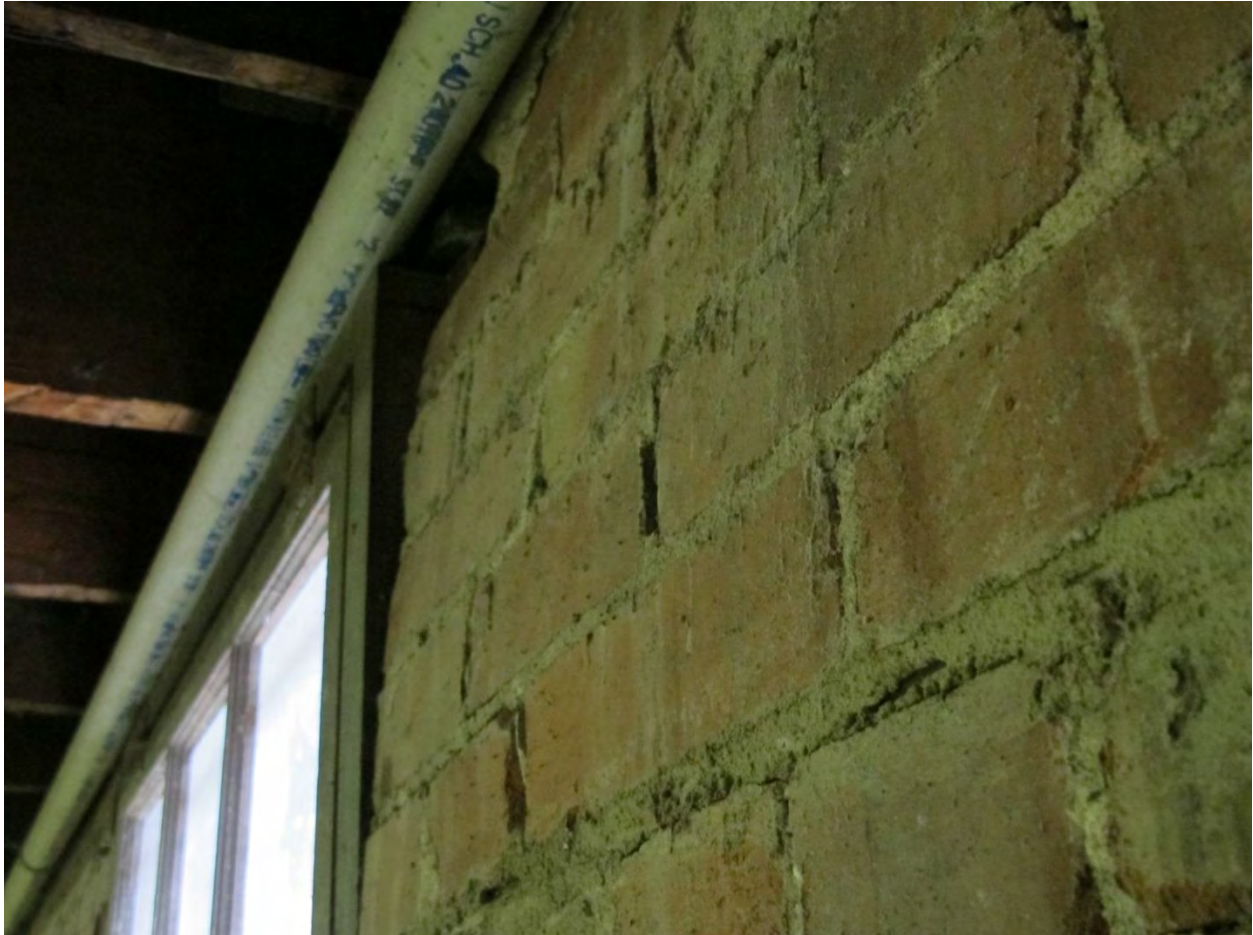
On the south elevation, it was observed that there is an inward displacement of the brick masonry in a range of 50 to 80 inches above the floor line and between the pass through area to the west elevation. Photos 30 through 34 depict this condition. The outward displacement or bulge was estimated to be about 1 inch, which is significant. This displacement is occurring in about the same part of the elevation where there is some outward displacement at the exterior face as seen in Photo 9.

**Photo 32:** A view of the window jamb on the south elevation which shows the relative movement of the masonry at the inwardly displaced (bulged) masonry area.

The extent of the masonry distress at the portion of the south elevation basement wall must be ascertained and a remedial course of action must be developed as part of the preservation process. If the existing basement will be infilled, then a concrete protective wall against the masonry foundation wall should be installed, after any masonry remediation, to further preserve the original construction above.
