## HISTORIC AND DESIGN REVIEW COMMISSION

### Agenda Item No: 23

**HDRC CASE NO:** 2015-288  
**ADDRESS:** 239 / 241 / 243 CENTER  
**LEGAL DESCRIPTION:** NCB 580 BLK 11 LOT 17 (SUNSET CENTER STREET SUBD) 2012-NEW ACCT PER SPLIT PER PLAT 9621/133-135 FILED 3/11/2011  
**ZONING:** D, H, HE  
**CITY COUNCIL DIST.:** 2  
**DISTRICT:** St. Paul Square Historic District  
**LANDMARK:** Guenther, Colin Building  
**APPLICANT:** Pam Carpenter/Seventh Generation Design  
**OWNER:** Zachry Realty  
**TYPE OF WORK:** Demolition and new construction of multi-family building  
**REQUEST:**

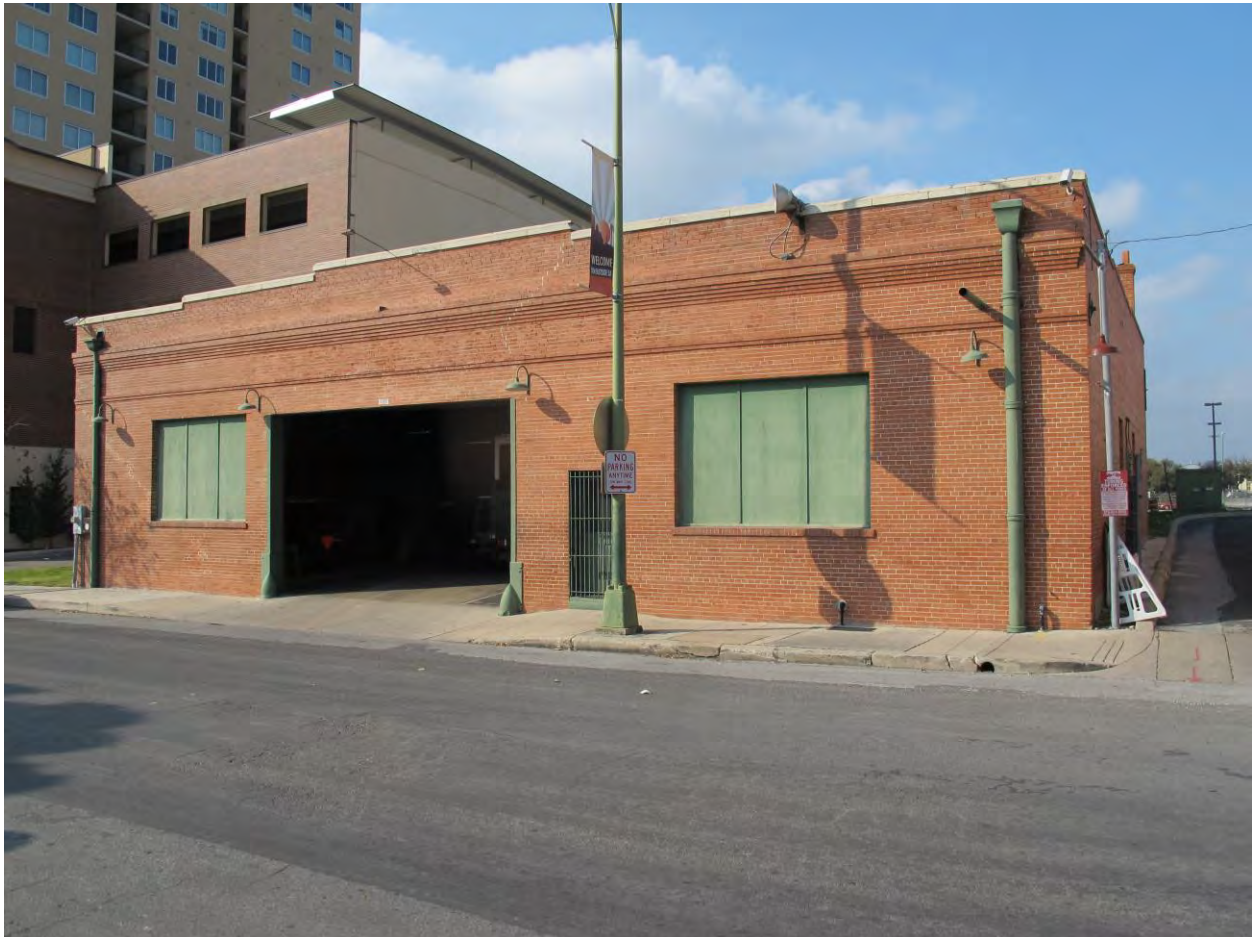
This elevation is the main or street elevation for the building (Photo 1). There is an entry way for vehicular access to the interior, and the windows were boarded as can be seen in the photo.

In general, the masonry was in an acceptable level of repair, but there is some cracking along the elevation near the roof line.

**Photo 1:** Looking at the south elevation of 241 Center Street. The entry door for vehicular access is open, and the building is actively in use as a storage facility.

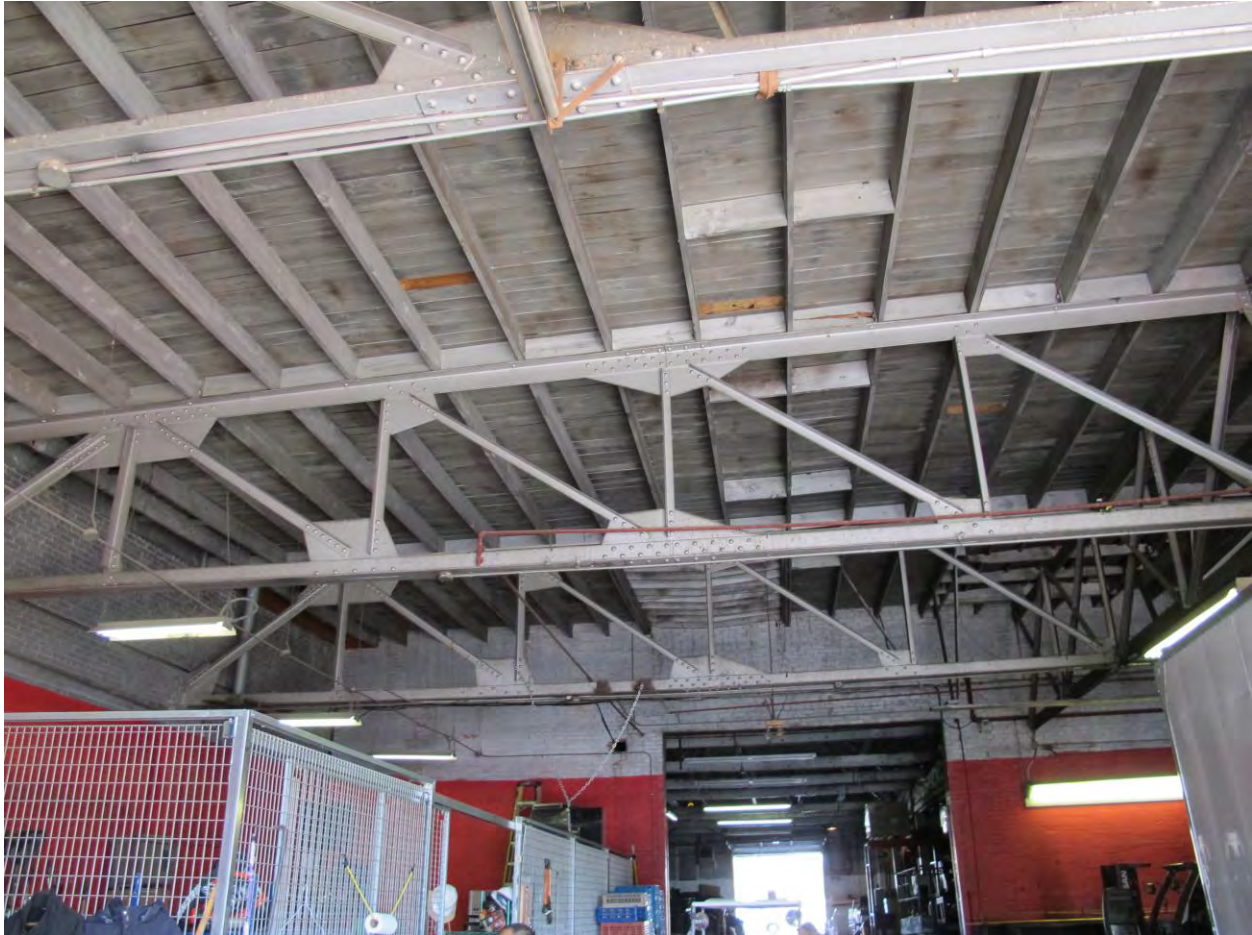
The three steel roof trusses in the front section of the building were observed from grade. The trusses are a modified Warren type truss constructed primarily with steel angles and connected with rivets and gusset plates. The steel trusses appeared to be sound and functional. There was some cracking in the masonry noted above the bearing points, which may have been caused by corrosion of the embedded end vertical of truss structure or movement of the truss. Regardless, the extent of the cracking at the bearing points appeared to be significant.

**Photo 4:** Looking north from the entry at the south elevation with the steel trusses, timber purlins and wood decking in view.

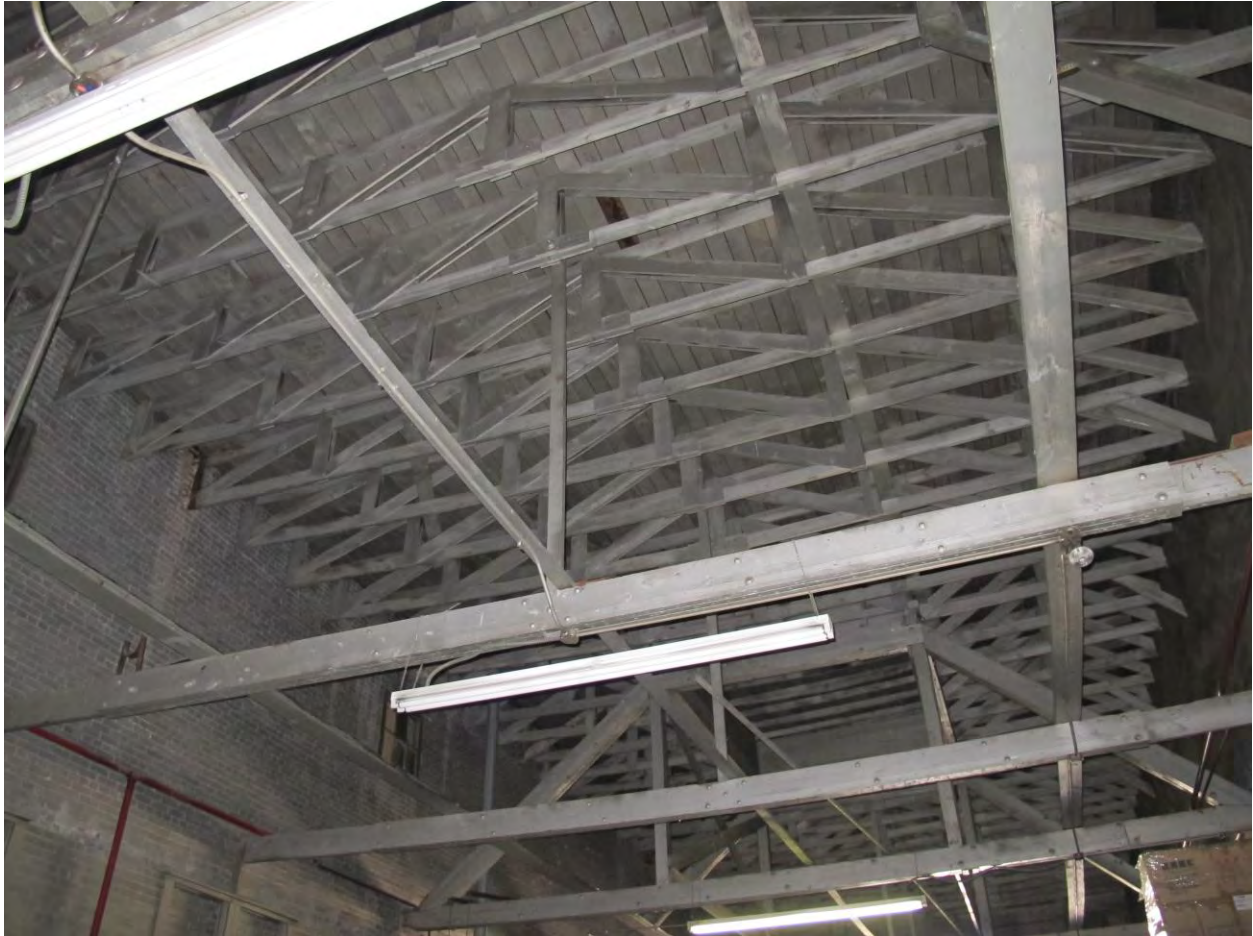
**Photo 5:** Looking at the roof trusses in the north portion of the building with suspended timber framing for an unknown purpose. The wall in view is the west elevation.

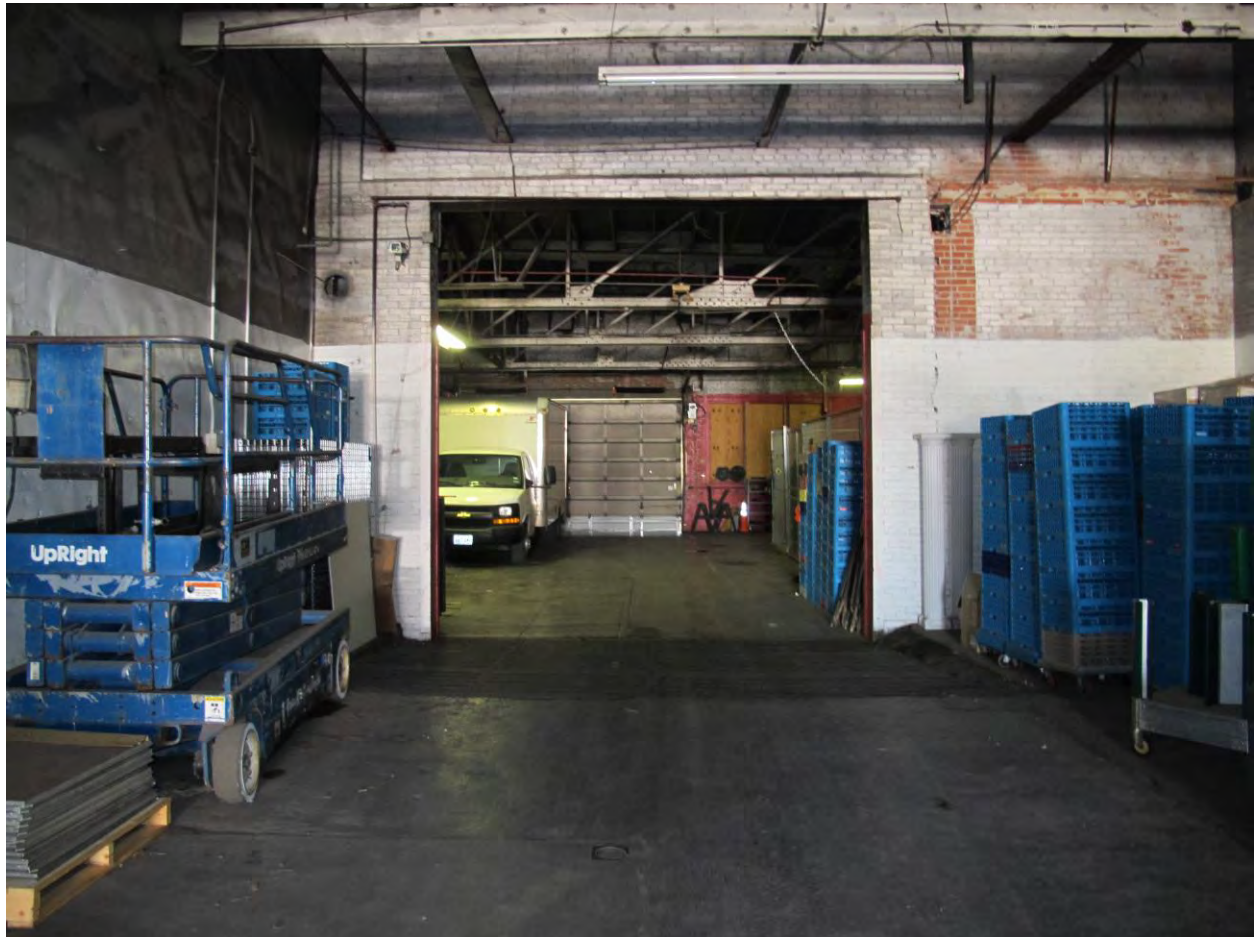
**Photo 6:** A view of an opening in the interior masonry wall which separates the two sections of the building. To the left of the lift is the interior bearing wall which supports the timber roof trusses.

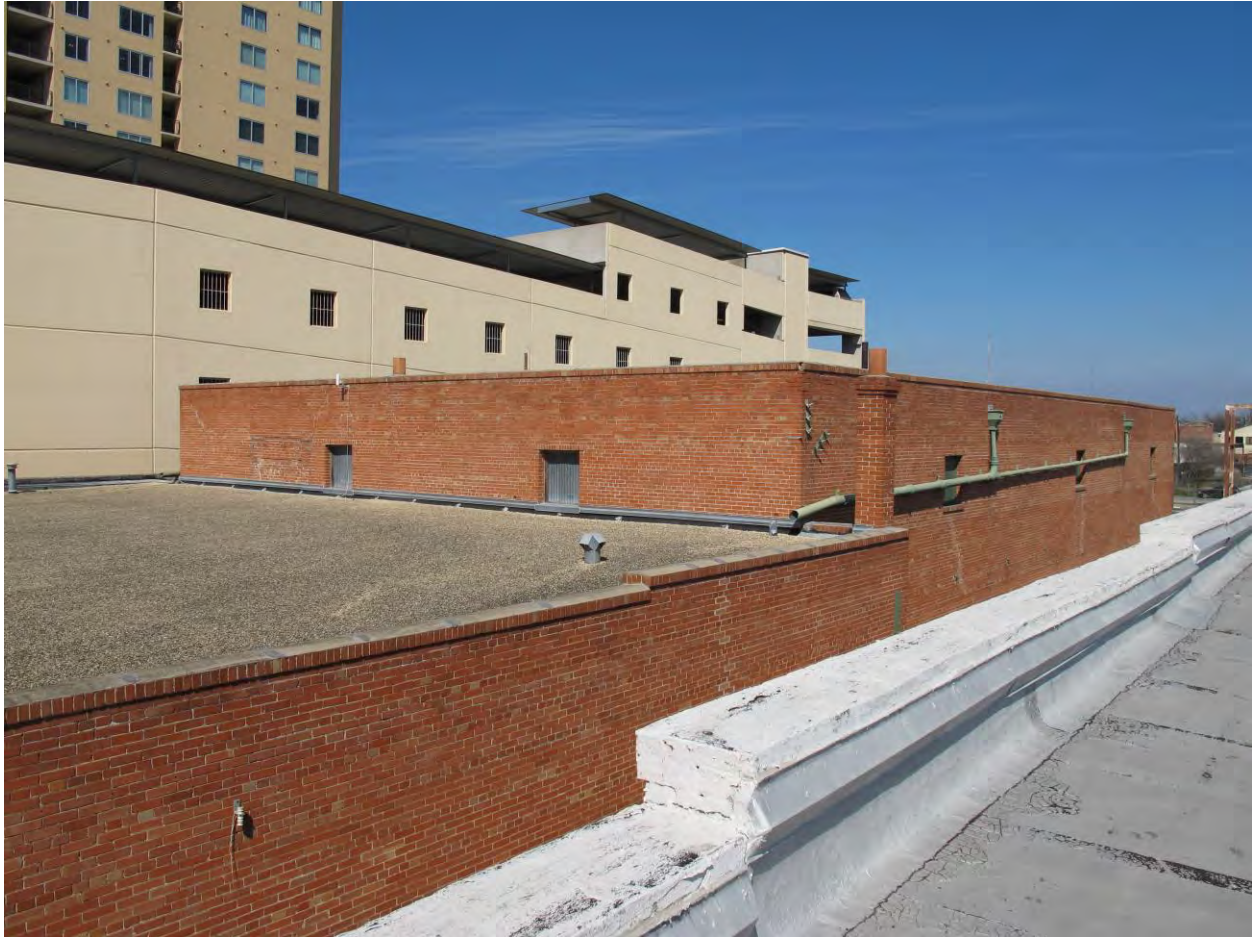
The roof was not accessed for any direct observation. Photo 7, taken from the adjacent roof of the 243 Center Street building, shows the roof of the front portion of the building.

**Photo 7:** A view from the roof of 243 Center Street looking at the low roof of 241 Center Street and the high roof beyond in the north portion of the building.
