HISTORIC AND DESIGN REVIEW COMMISSION

HDRC CASE NO: 2016-266
ADDRESS: 458 FURR DR
LEGAL DESCRIPTION: NCB 6696 BLK 5 LOT 22 W 25 FT OF 23 E 25 FT OF 21
ZONING: R6 H
CITY COUNCIL DIST.: 7
DISTRICT: Monticello Park Historic District
APPLICANT: Eduardo Garcia
OWNER: David & Lydia Lerma
TYPE OF WORK: Window replacement
REQUEST:

WINDOW
SCHEDULES

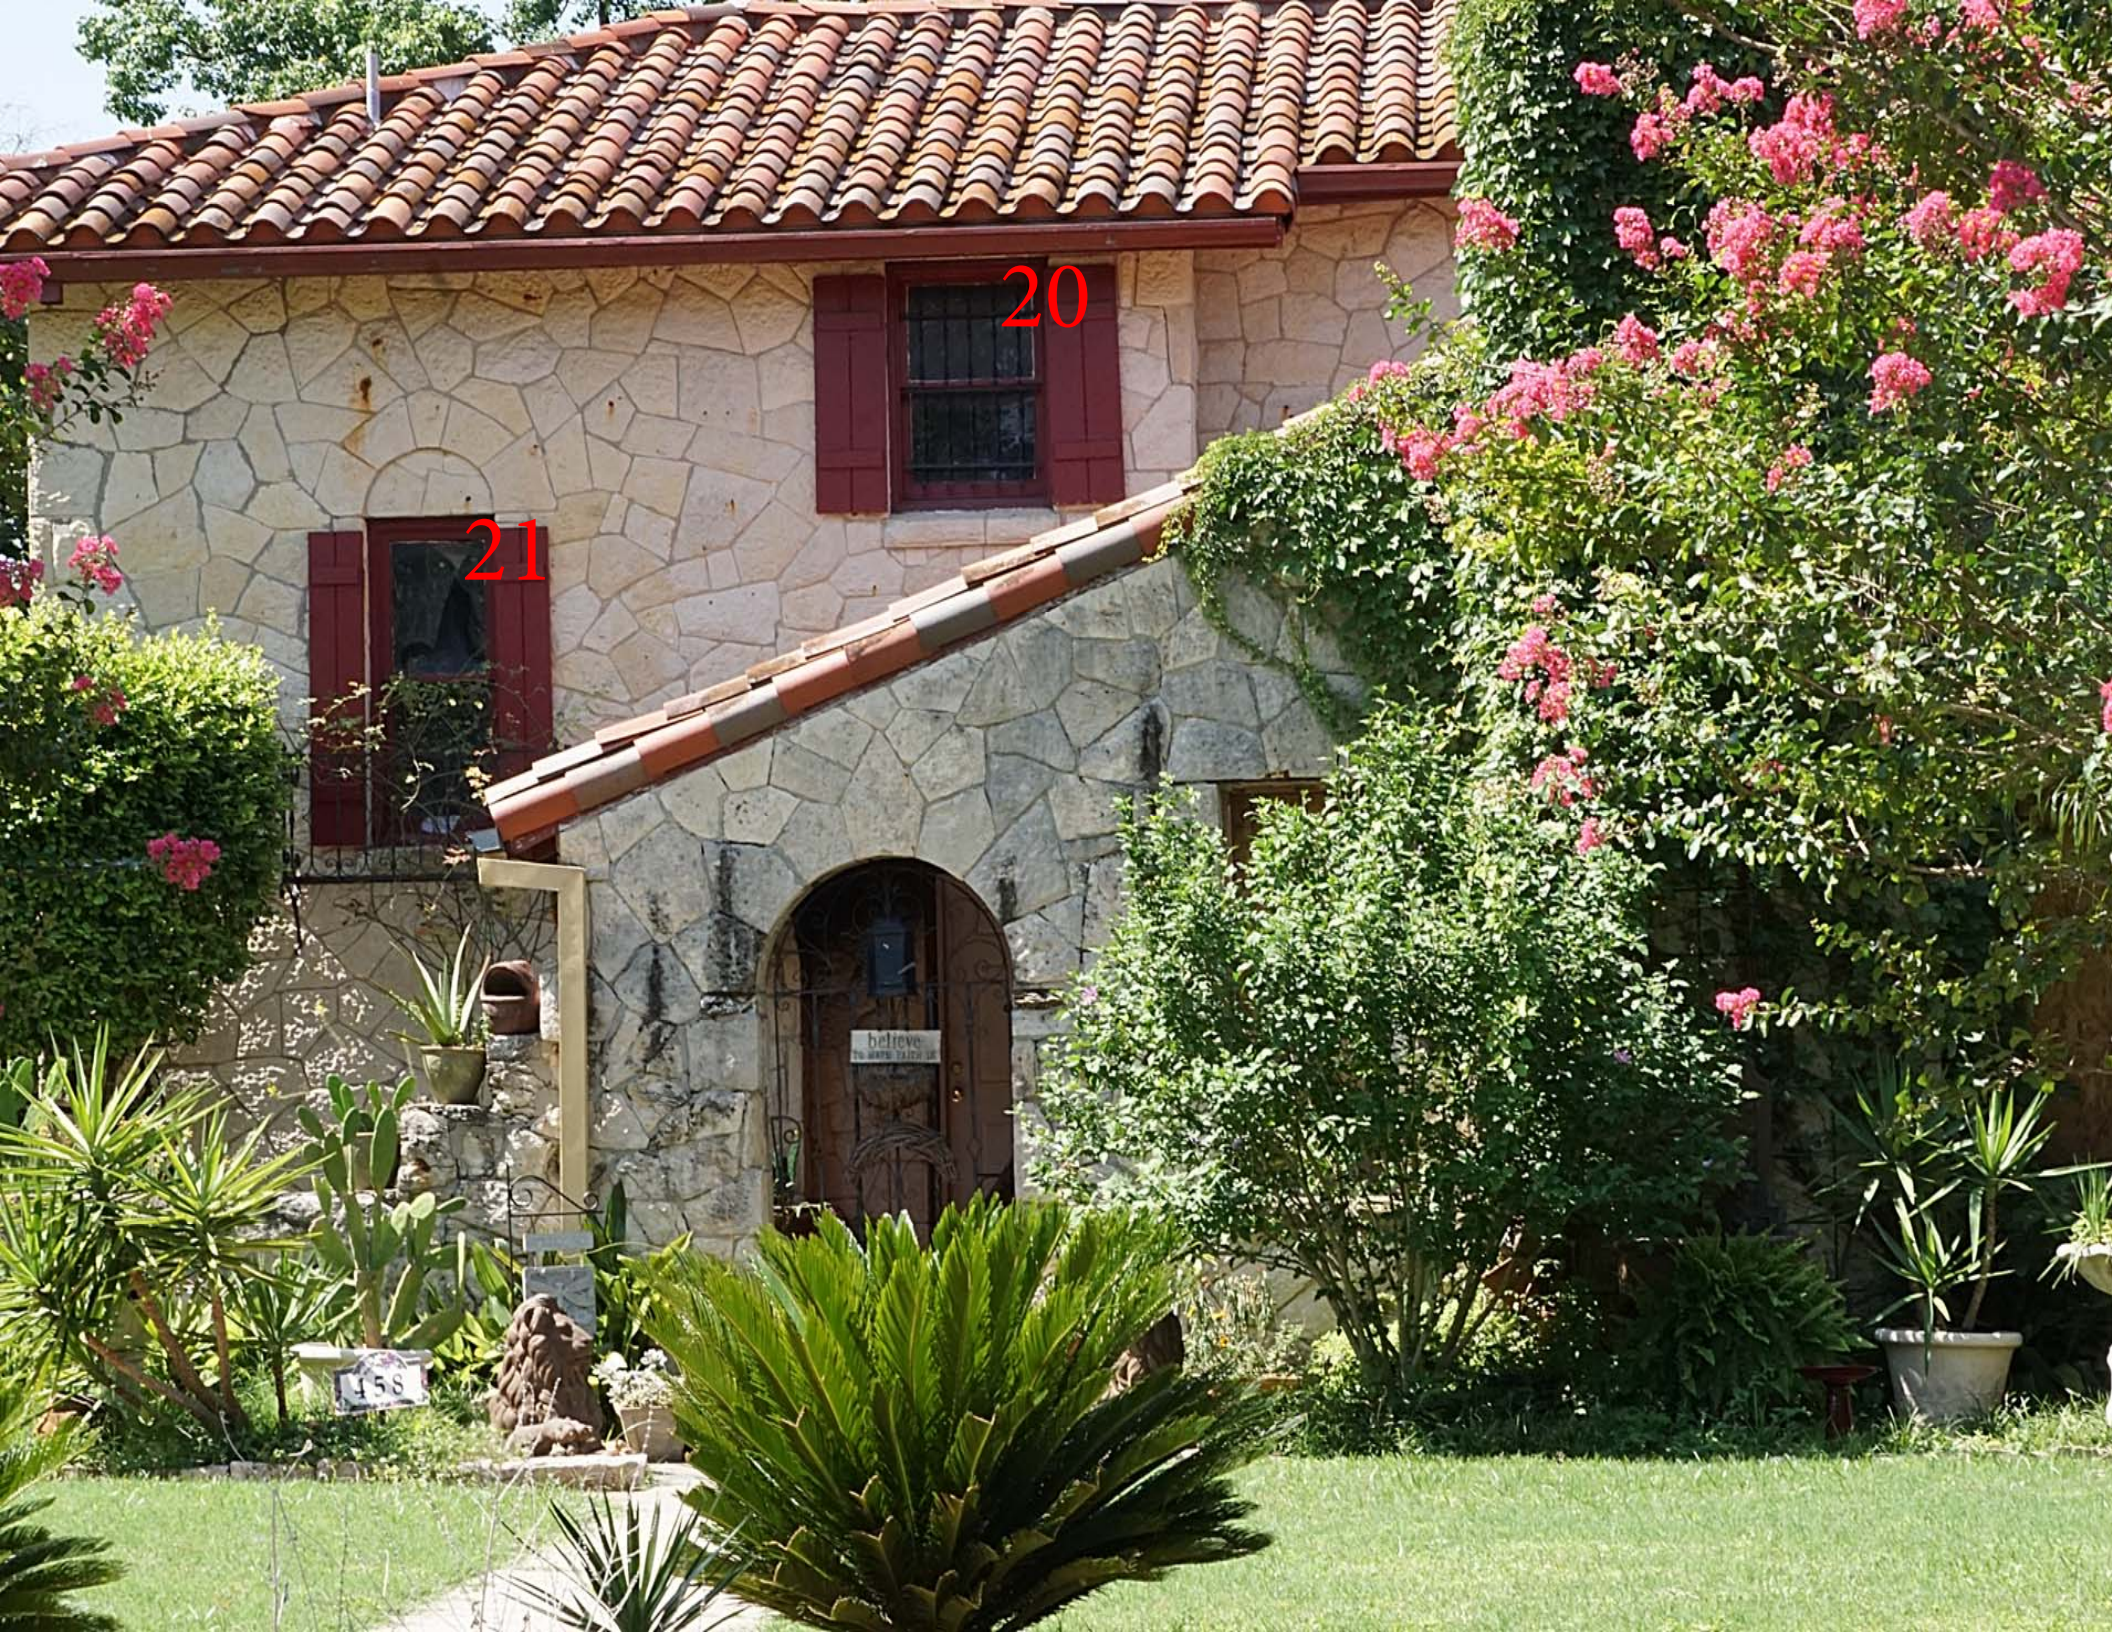
20

20. Deteriorated over 50% - wood one over one

21. Deteriorated over 50% - wood one over one

1. That the applicant repair 16 of the 27 windows with in-kind materials.
2. That the applicant replace 11 of the 27 windows with in-kind materials, type, configuration, form, appearance, and detail.

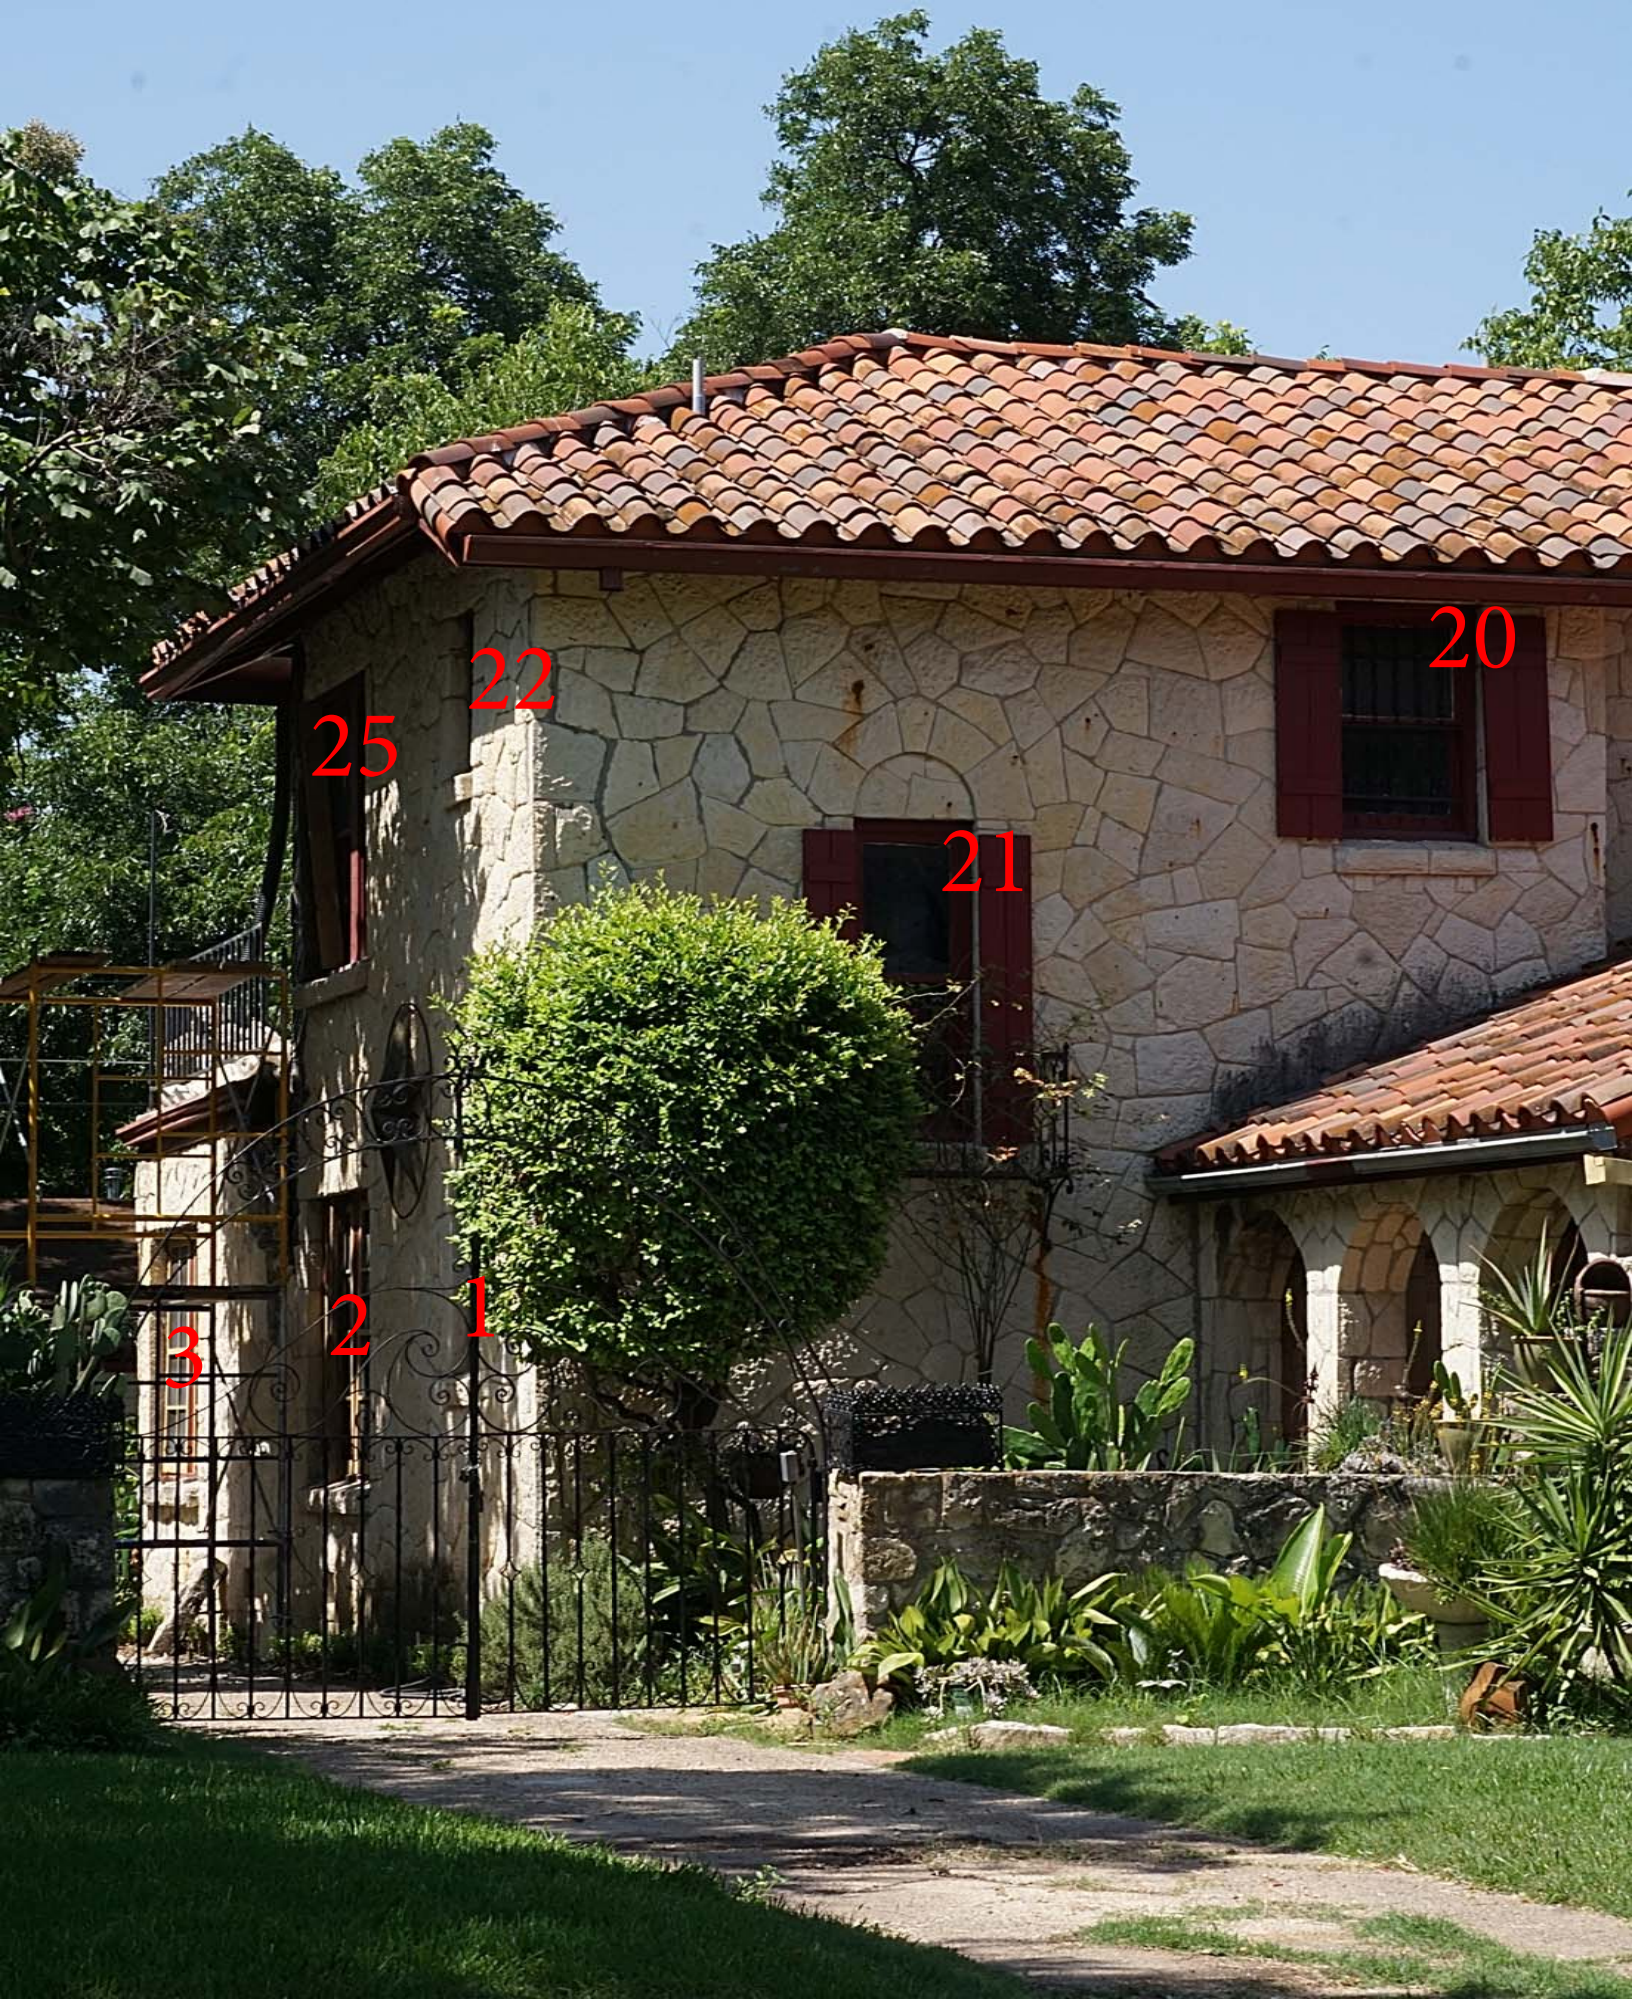
25

22. Repairable - wood one over one

25. Repairable - wood one over one triple hung

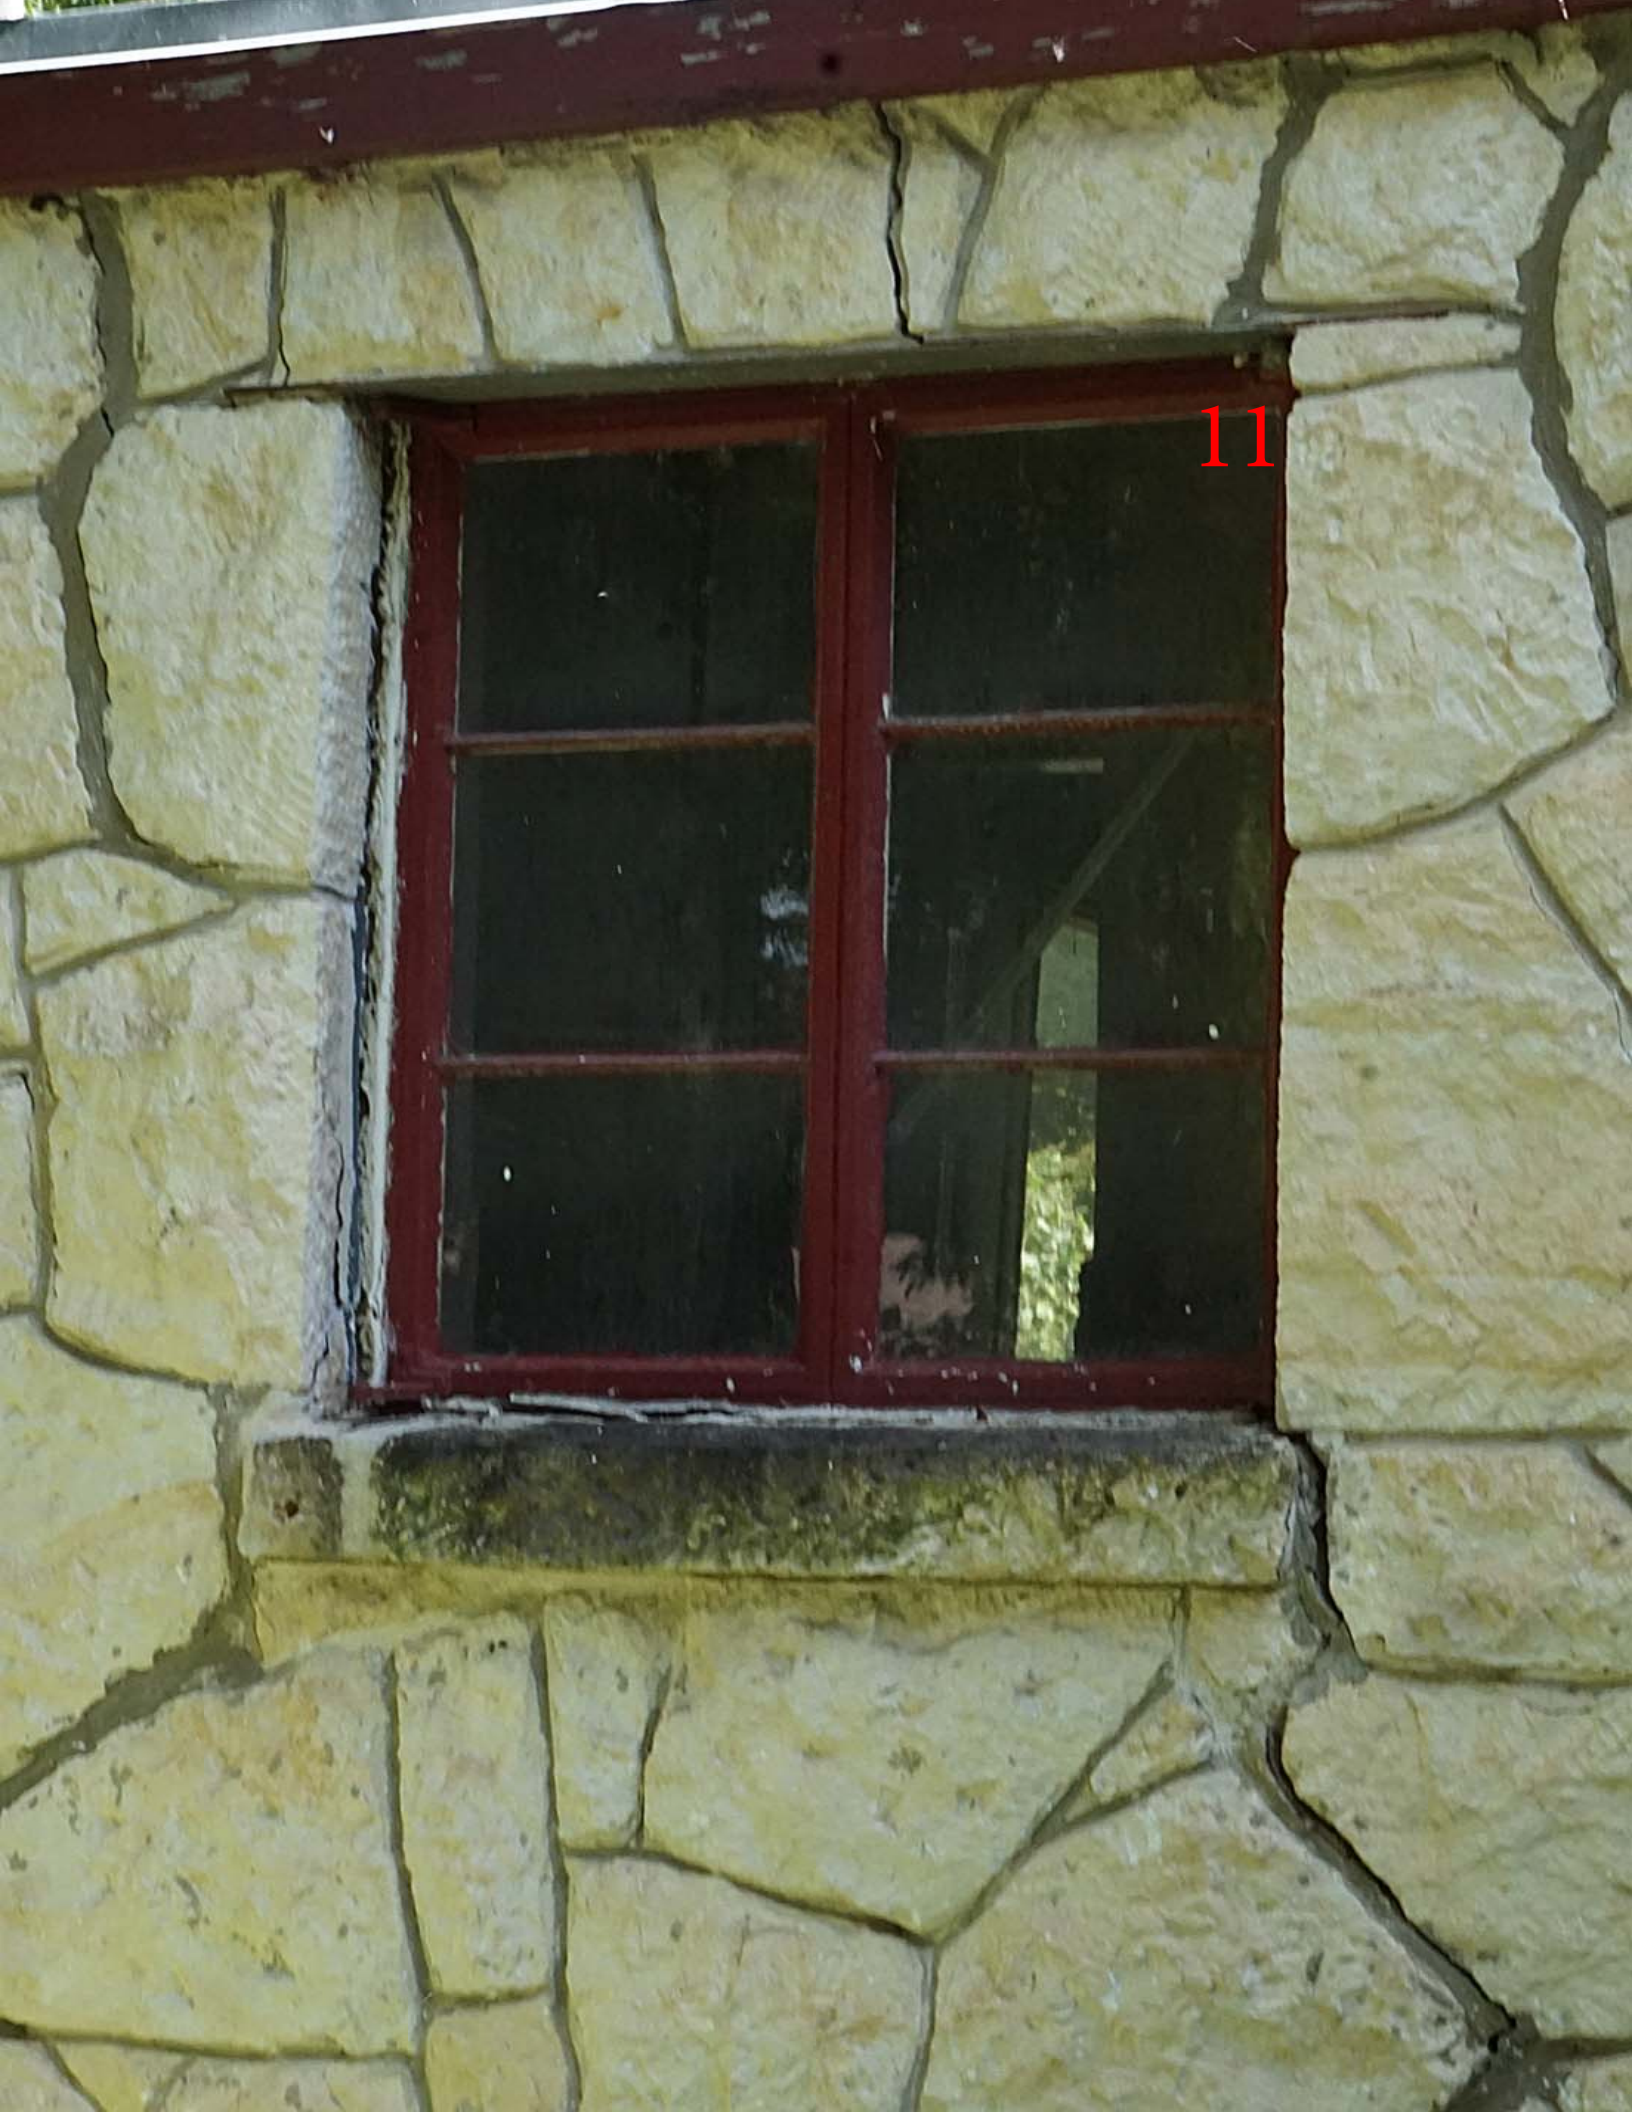
12

13. Repairable - wood 4 x 4 divided light with center casement

14. Repairable - wood divided light with center casement
