HISTORIC AND DESIGN REVIEW COMMISSION

HDRC CASE NO: 2016-319
ADDRESS: 1300 GUADALUPE ST
LEGAL DESCRIPTION: NCB 2444 BLK 1 LOT 19 AND 20
ZONING: C3 HL
CITY COUNCIL DIST.: 5
LANDMARK: Null
APPLICANT: Debra Dockery
OWNER: Guadalupe Cultural Arts Center
TYPE OF WORK: Window and door replacement
REQUEST:

GUADALUPE CULTURAL ARTS CENTER FORMER PROGRESO PHARMACY RENOVATION

CITY OF SAN ANTONIO GUADALUPE CULTURAL ARTS CENTER RENOVATION

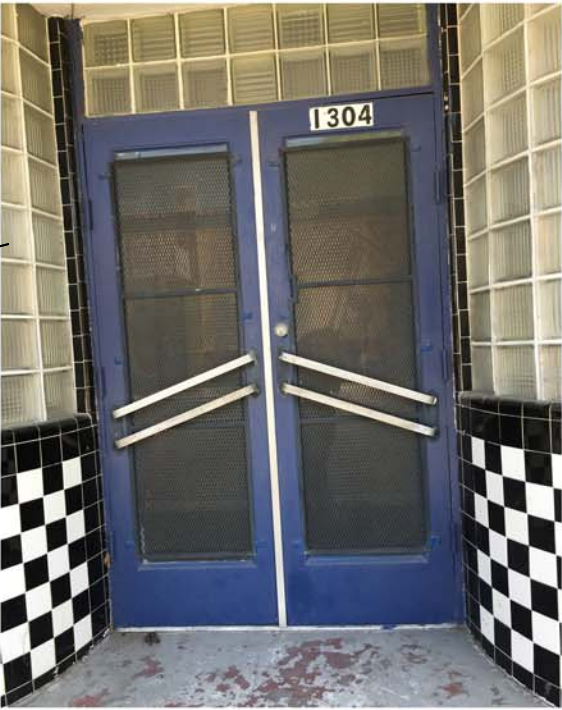
DOOR 103 IS AN ALUMINUM AND GLASS DOOR. THIS DOOR HAS A 2'-4" CLEAR OPENING AND DOES NOT MEET EMERGENCY EGRESS OR ADA. IT IS PROPOSED TO REPLACE THE DOOR WITH A SINGLE 3'-0" WIDE DOOR AND SIDELIGHT, BUT IN SAME MATERIAL AND DOOR CONFIGURATION AS EXISTING.

103 - DOOR IS UNDERSIZED FOR EMERGENCY EGRESS

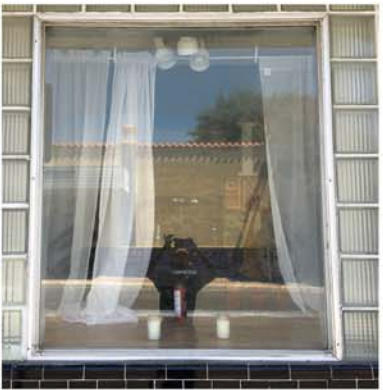
B - WINDOW HAS BEEN REPLACED WITH PLEXIGLAS

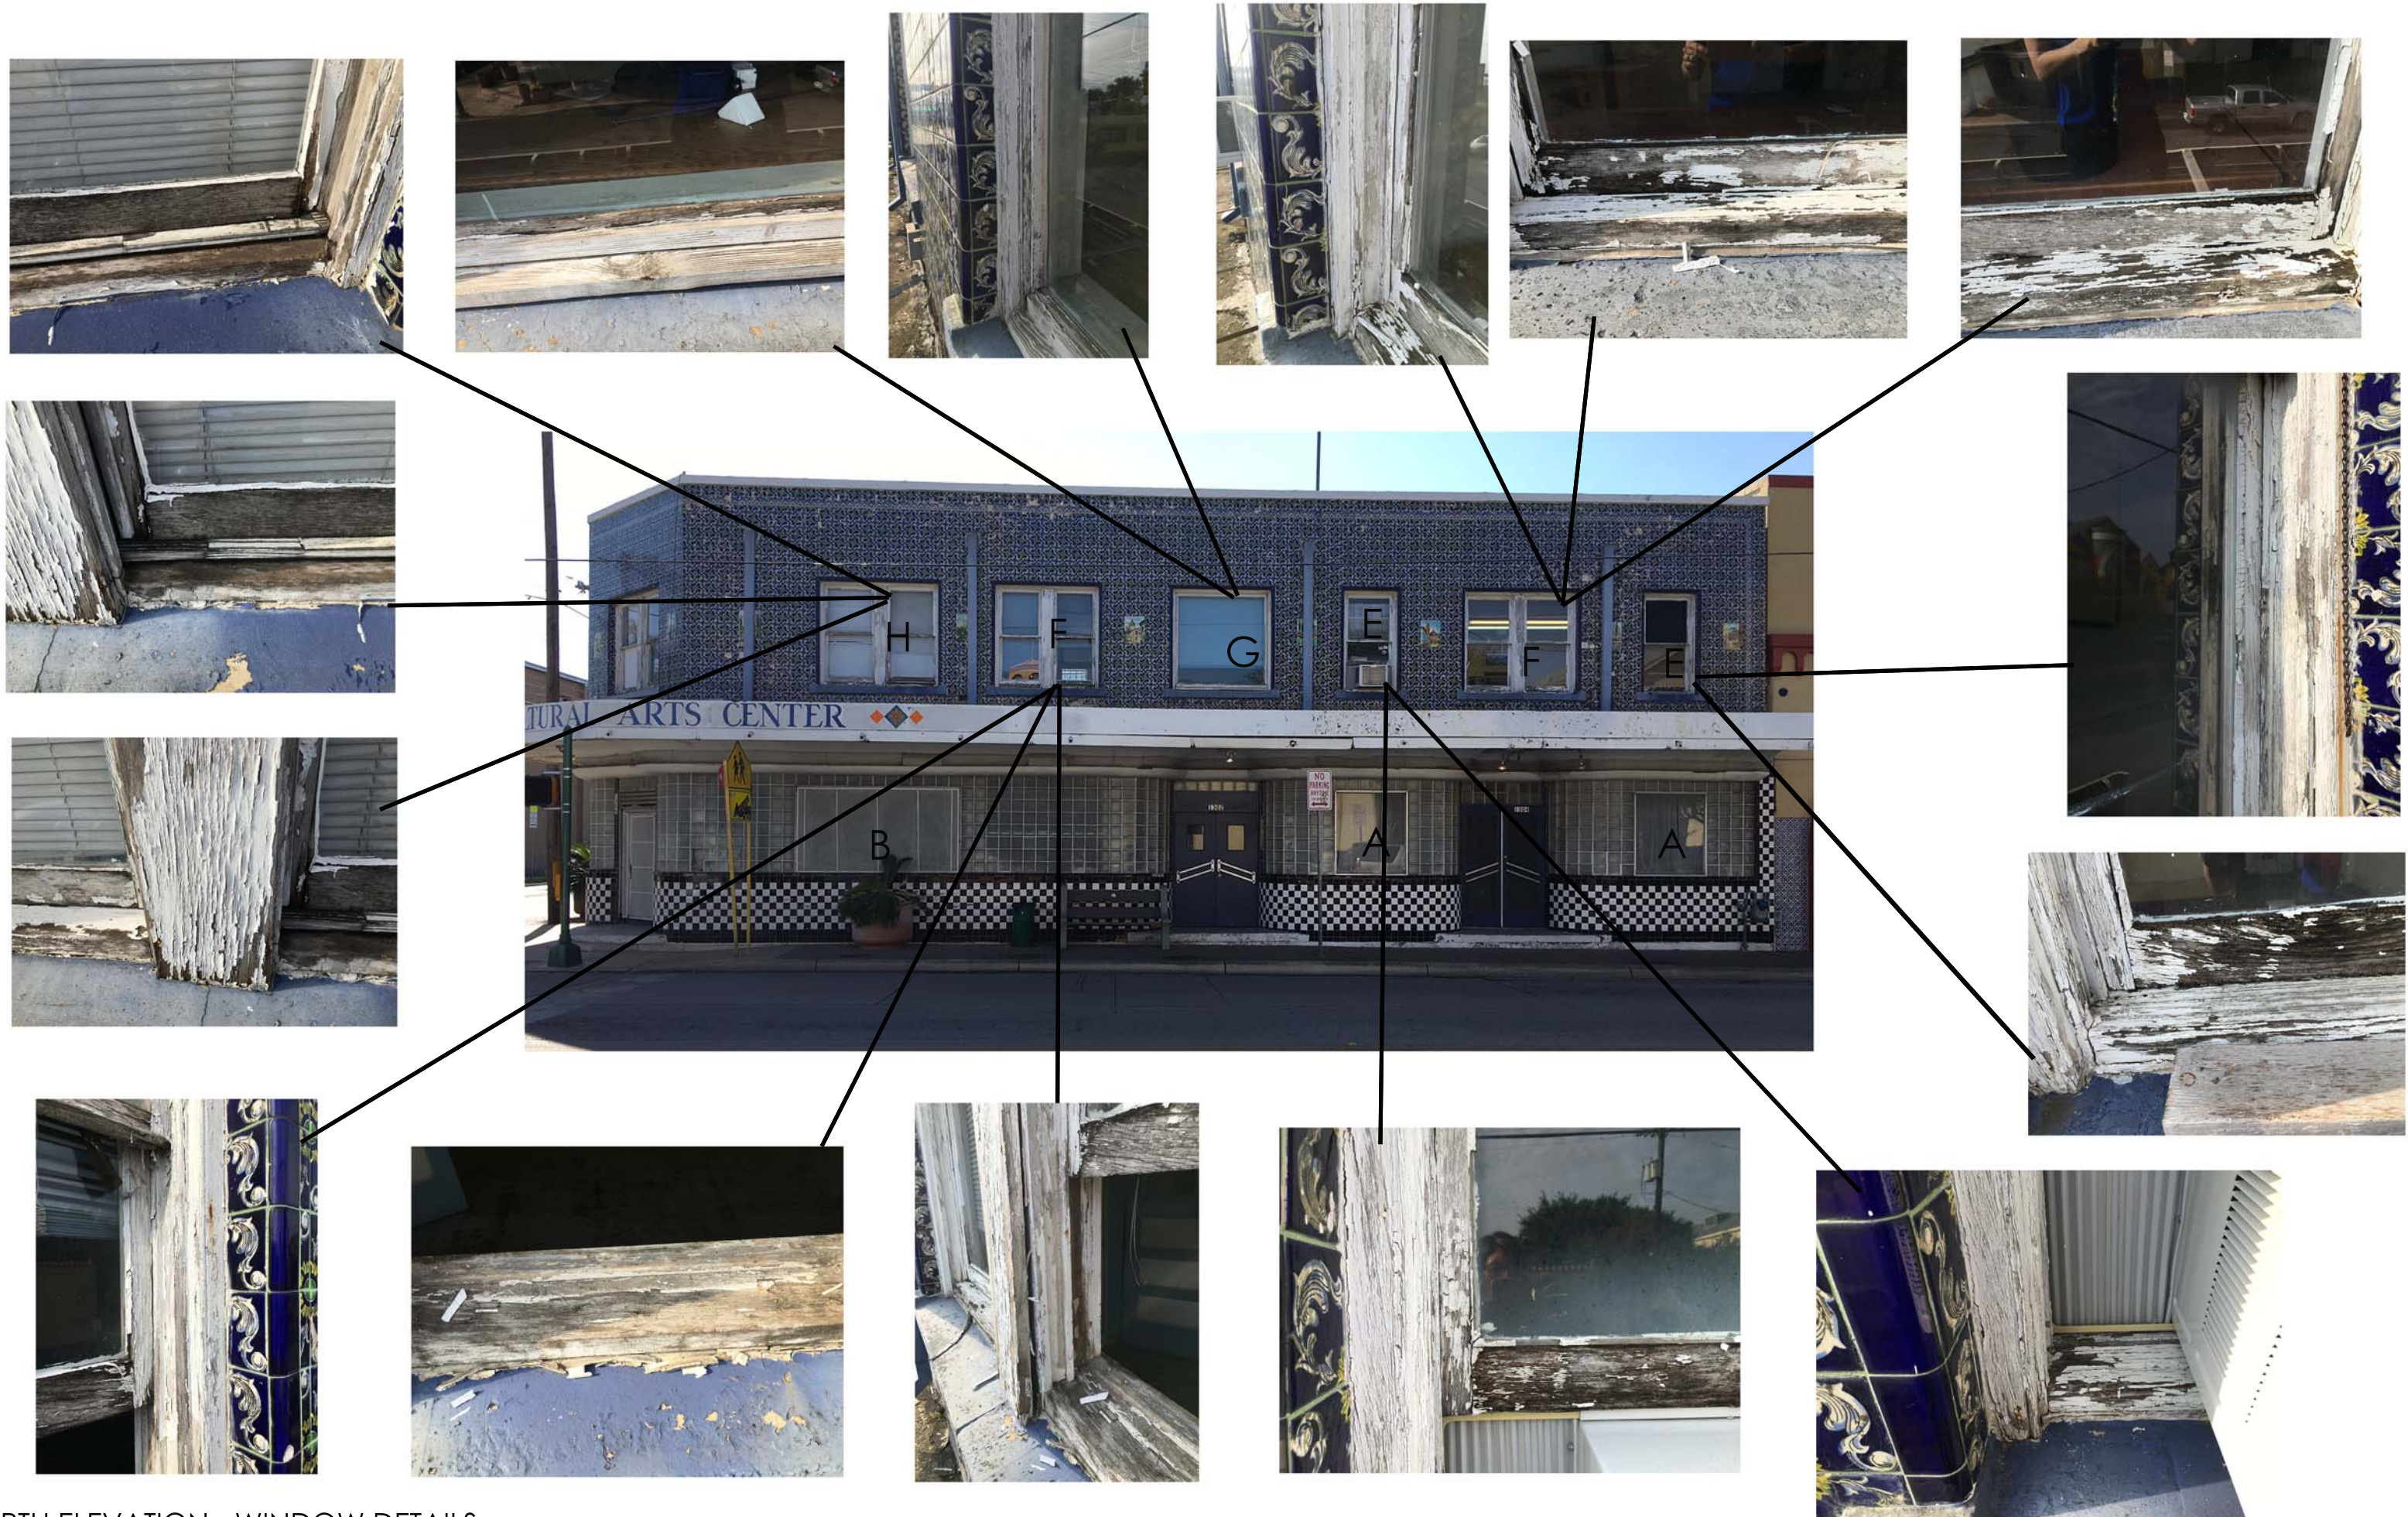
NORTH ELEVATION - WINDOWS & DOORS
SEE SHEET A3.1 FOR WINDOW SCHEDULE

ALL WINDOWS ON THE SECOND FLOOR NORTH ELEVATION ARE CONSTRUCTED OF WOOD. ALL OF THE WINDOWS HAVE WOOD ROT, AND ARE LEAKING WATER WHEN IT RAINS. THE GLASS DOES NOT MEET THE ENERGY CODE FOR AN AIR CONDITIONED SPACE. IT IS PROPOSED TO REPLACE THE WINDOWS WITH WOOD TO MATCH THE EXISTING/ HISTORIC PROFILE CONDITION.

ALL WINDOWS ON THE FIRST FLOOR NORTH ELEVATION ARE ALUMINUM. SEVERAL OF THESE WINDOWS HAVE BEEN REPLAED WITH PLEXIGLAS. THE GLASS OR PLEXIGLASS DOES NOT MEET THE ENERGY CODE FOR AN AIR CONDITIONED SPACE.IT IS PROPOSED TO REPLACE THE WINDOWS WITH ALUMINUM AND GLASS TO MATCH THE EXISTING/ HISTORIC PROFILE CONDITION.

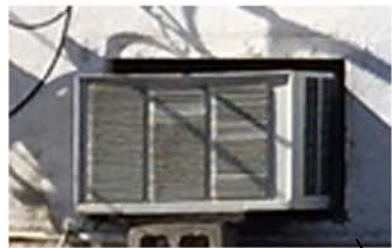
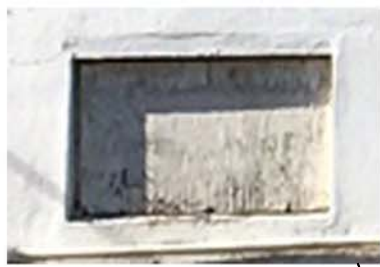
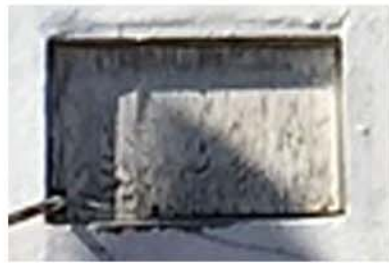
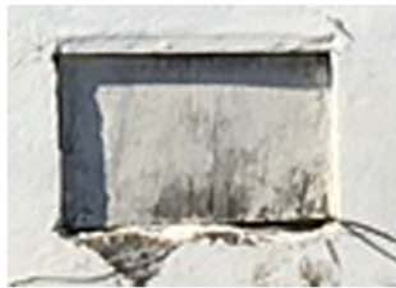
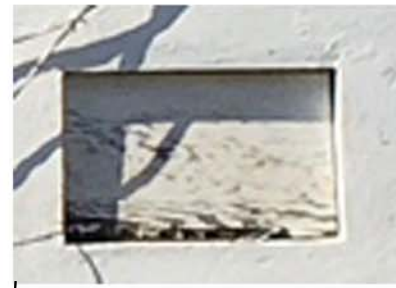
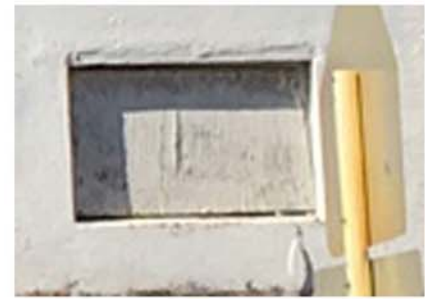
NORTH-EAST ELEVATION - WINDOWS, WINDOW DETAILS, & DOORS
SEE SHEET A3.1 FOR WINDOW SCHEDULE

ALL WINDOWS LABELED D APPEAR TO HAVE BEEN AN OPERABLE WOOD AWNING WINDOW. CURRENTLY THERE IS NO WINDOW AND THE OPENING IS BOARDED WITH PLYWOOD. IT IS PROPOSED TO RELACE THIS OPENING WITH A WOOD FIXED WINDOW.

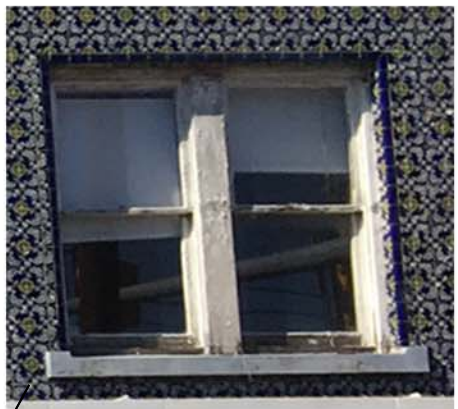
WINDOW H HAS WOOD ROT, AND LEAKS WHEN RAINING. THE CURRENT GLASS DOES NOT MEET THE ENERGY CODE FOR CONDITIONED SPACES. IT IS PROPOSED TO REPLACE THE WINDOW WITH A WOOD WINDOW TO MATCH THE EXISTING/ HISTORIC PROFILE COINDITION.

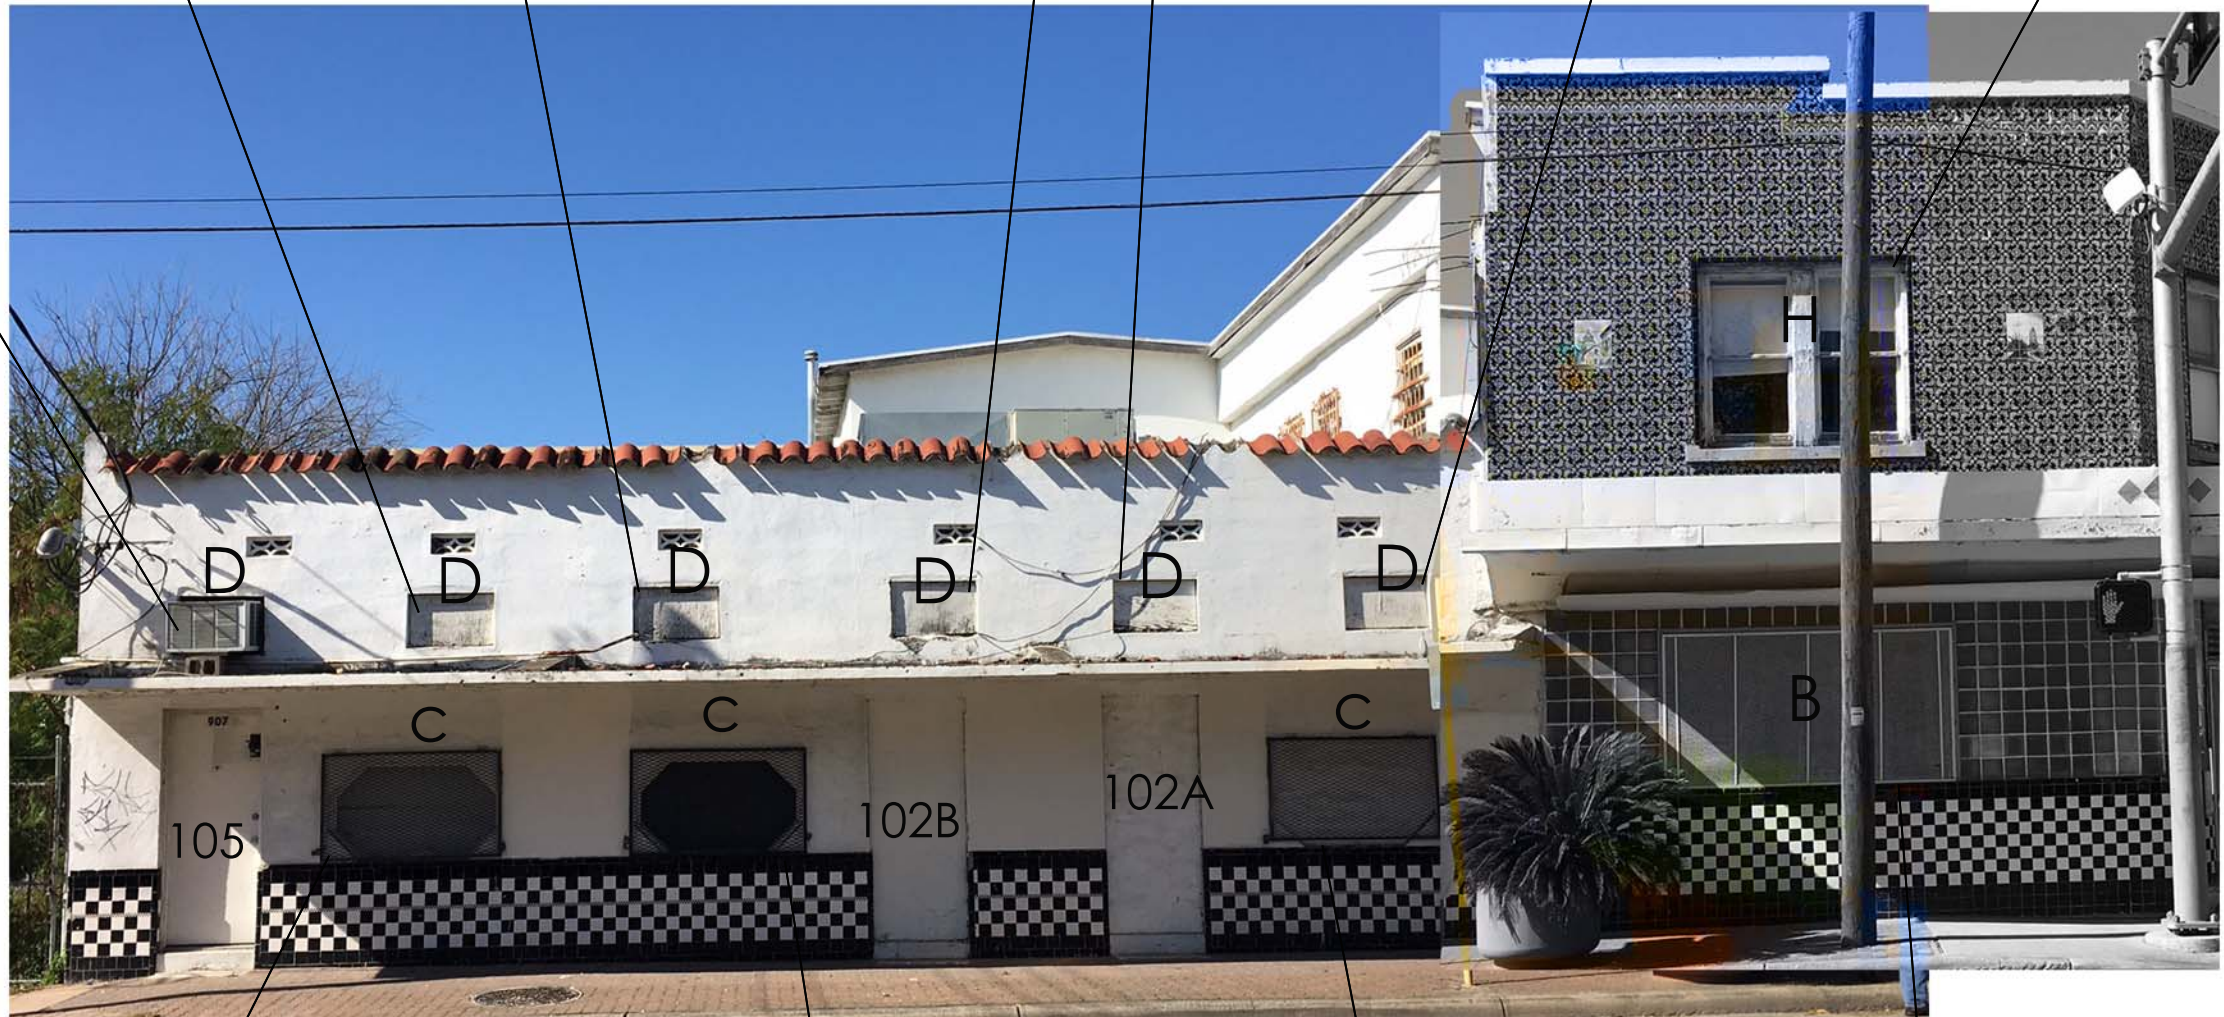
WINDOW B ON THE FIRST FLOOR IS ALUMINUM AND HAS BEEN REPLAED WITH PLEXIGLAS. THE PLEXIGLASS DOES NOT MEET THE ENERGY CODE FOR AN AIR CONDITIONED SPACE. THIS WINDOW HAS A STEEL GUARD COVERING THE WINDOW. IT IS PROPOSED TO REMOVED THE STEEL GUARD AND REPLACE THE WINDOW WITH ALUMINUM TO MATCH THE EXISINTG/ HISTORIC PROFILE CONDITION.

WINDOWS C ARE WOOD. ONE WINDOW HAS BEEN BOARDED WITH PLYWOOD, ONE WINDOW HAS BEEN REMOVED AND PLASTERED OVER. ALL THREE WINDOWS HAVE BEEN COVERED WITH STEEL GUARDS. IT IS PROPOSED TO REMOVED THE STEEL GUARDS, AND REPLACE THE WINDOWS WITH WOOD AND GLASS TO MATCH THE HISTORIC CONDITION

DOORS 102A AND 102 B HAVE BEEN REMOVED AND BOARDED WITH PLYWOOD. IT IS PROPOSED TO REPLACE WITH HOLLOW METAL DOORS.

DOOR 107 IS A WOOD DOOR IN BAD CONDITION. IT IS PROPOSED TO REPLACE WITH A HOLLOW METAL DOOR.

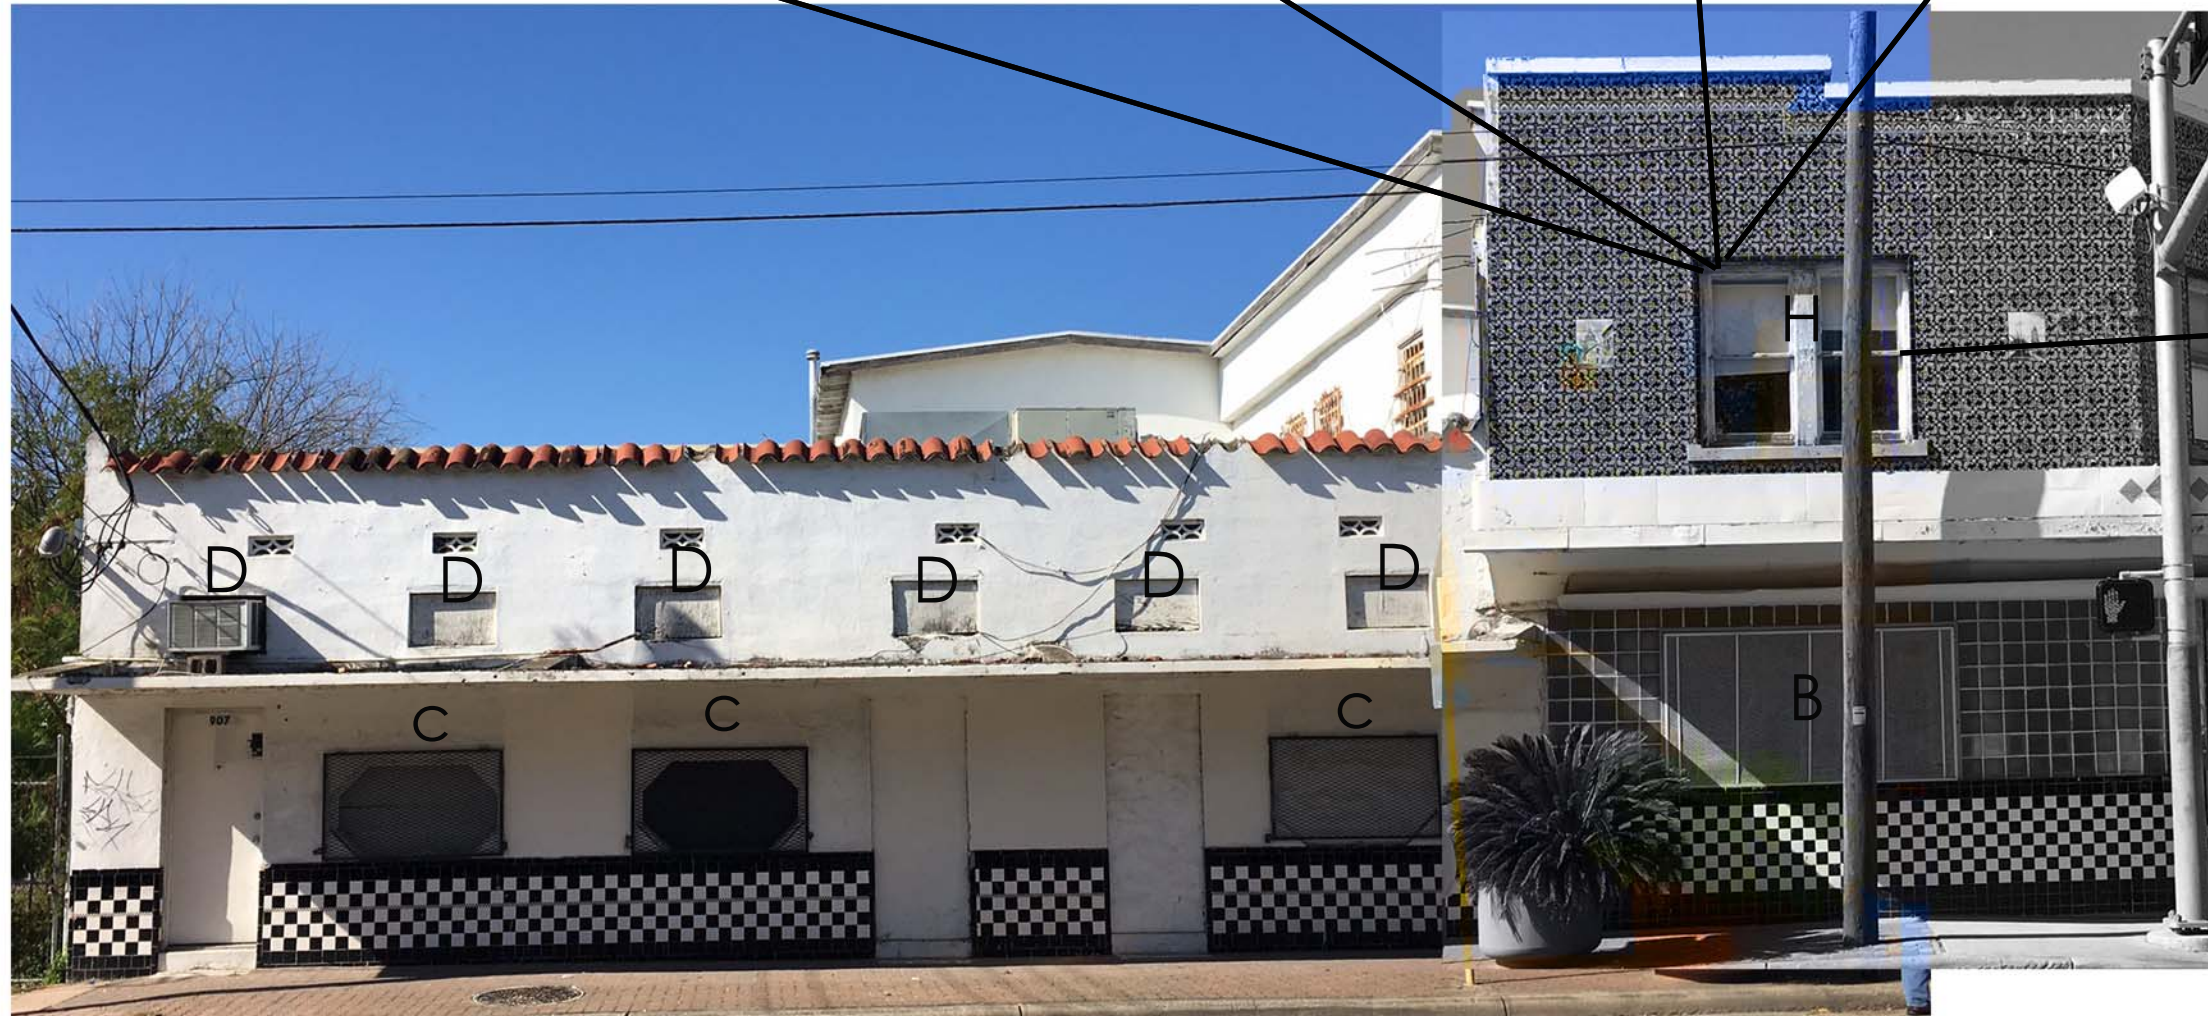
EAST ELEVATION - WINDOWS & DOORS
SEE SHEET A3.1 FOR WINDOW SCHEDULE

C- WINDOW IS BOARDED WITH PLYWOOD

C- WINDOW HAS BEEN REPLACED WITH PELXIGLASS

B- WINDOW HAS BEEN REPLACED WITH PLEXIGLASS

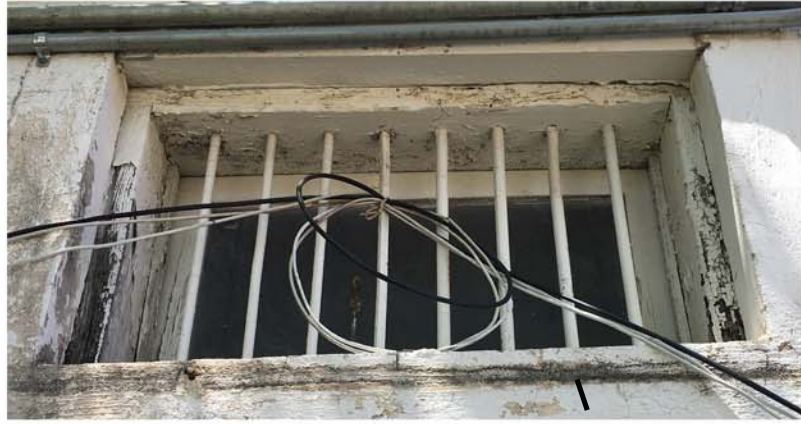
ALL D WINDOWS ARE WOOD AWNING WINDOW. THERE IS WOOD ROT ON BOTH OF THESE WINDOWS. STEEL BARS HAVE BEEN PLACE TO KEEP VANDALS OUT. IT IS PRPOSED TO REPLACE THESE WINDOWS WITH WOOD WINDOWS, AND REMOVE THE STEEL BARS.

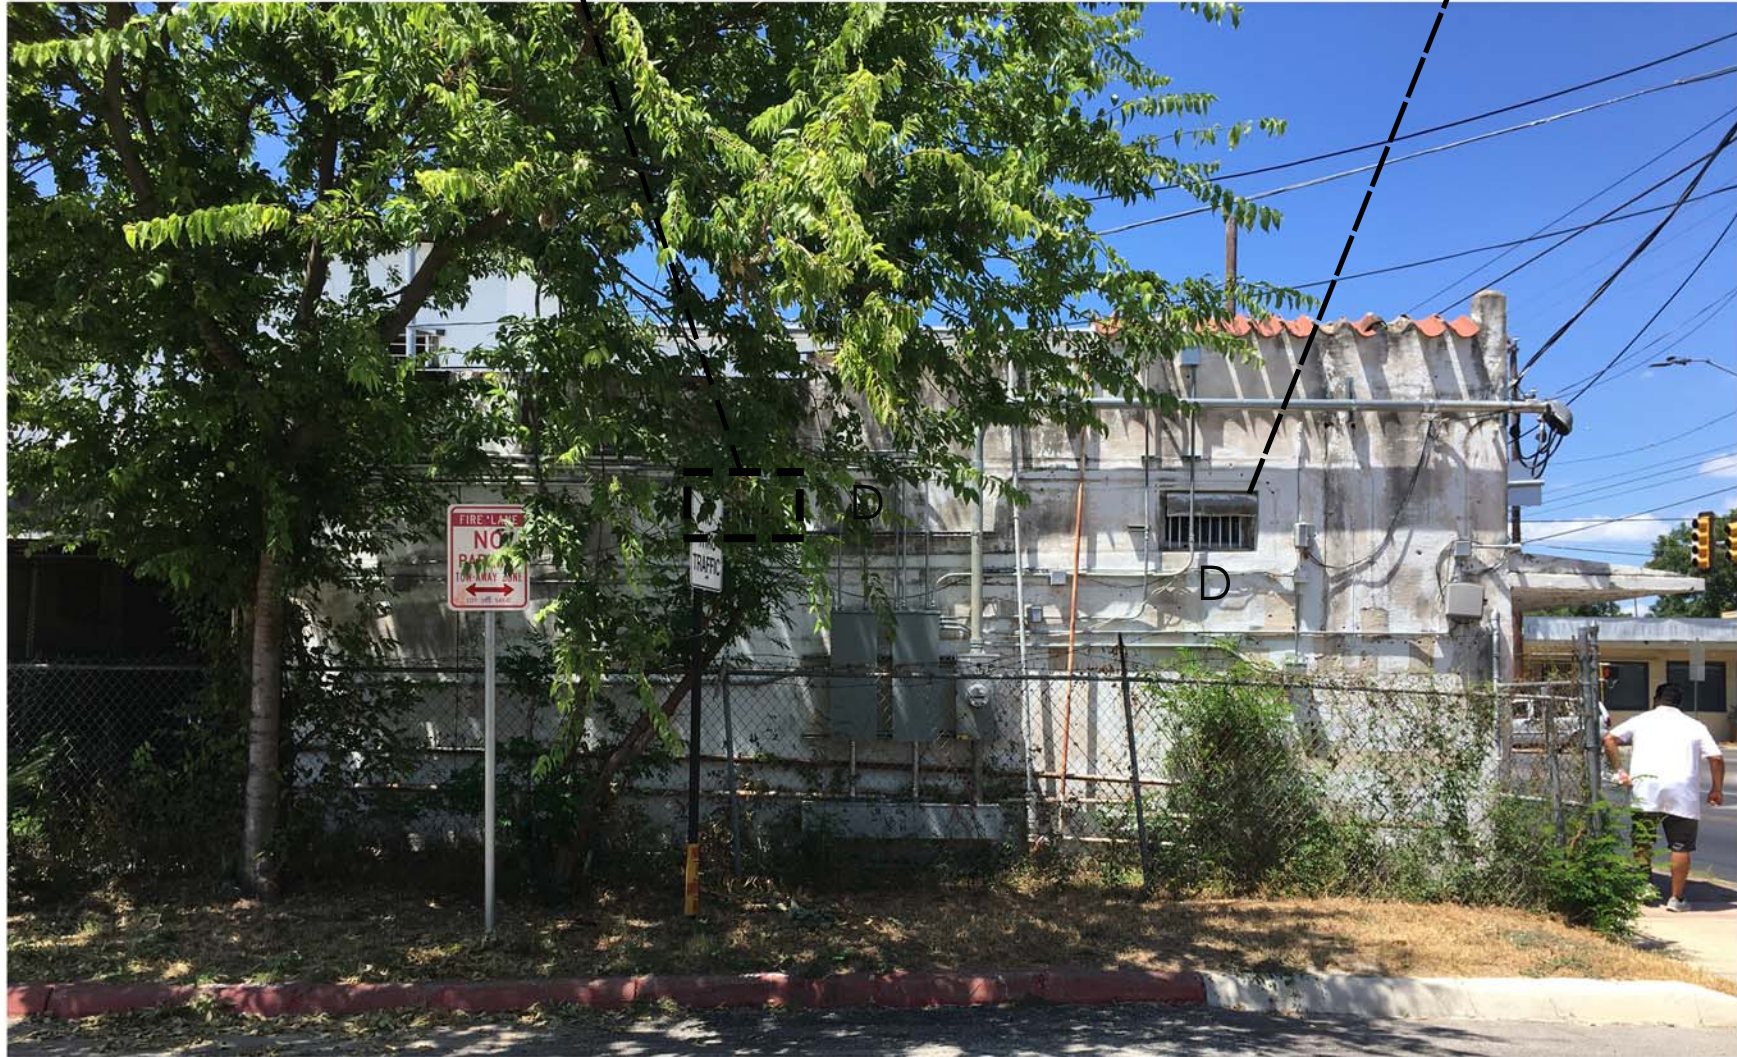
SOUTH ELEVATION - WINDOWS
SEE SHEET A3.1 FOR WINDOW SCHEDULE

WINDOWS K ARE WOOD FRAMED WINDOWS WHERE THE GLASS HAS BEEN BROKEN AND MUCH OF THE WOOD IS ROTTED OR BROKEN. THE OPENING HAS BEEN BOARDED WITH PLYWOOD AN STEEL GUARDS HAVE BEEN PLACED TO KEEP VANDALS OUT. IT IS PROPOSED TO REPLACE THE WINDOW WITH WOOD FRAMED WINDOWS TO MATCH EXISTING/ HISTORIC CONDITIONS AND TO REMOVE THE STEEL GUARDS.

WINDOW D APPEARS TO HAVE BEEN A WOOD AWNING WINDOW. STEEL GUARDS HAVE BEEN PLACED TO KEEP VANDALS OUT. IT IS PRPOSED TO REPLACE THIS WINDOW WITH A FIXED WINDOW TO MATCH EXISTING/ HISTORIC CONDITIONS AND TO REMOVE THE STEEL GUARDS.

DOOR 108 HAS BEEN REMOVED AND BOARDED WTIH PLYWOOD. IT IS PROPOSED TO REPLACE THIS DOOR OPENING WITH A HOLLOW METAL DOOR AND FRAME.

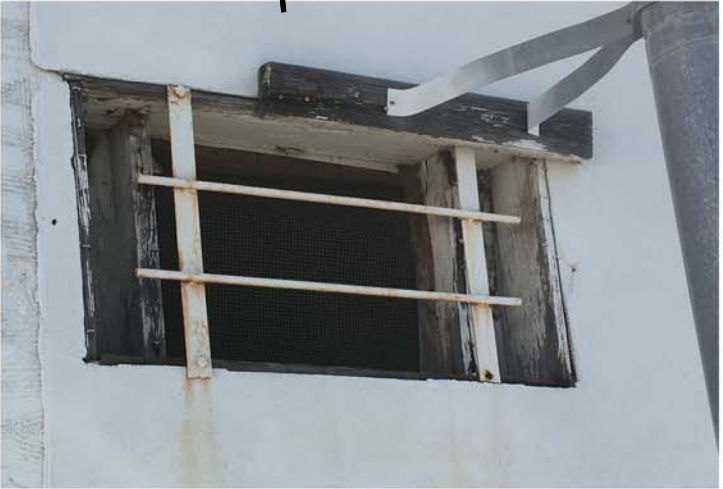
WINDOW D IS A WOOD AWNING WINDOW. THERE IS WOOD ROT AND THE WINDOW LEAKS WHEN IT RAINS. IT IS PROPOSED TO REPLACE THIS WINDOW WITH A FIXED WINDOW TO MATCH EXISTING/ HISTORIC PROFILE CONDITIONS.

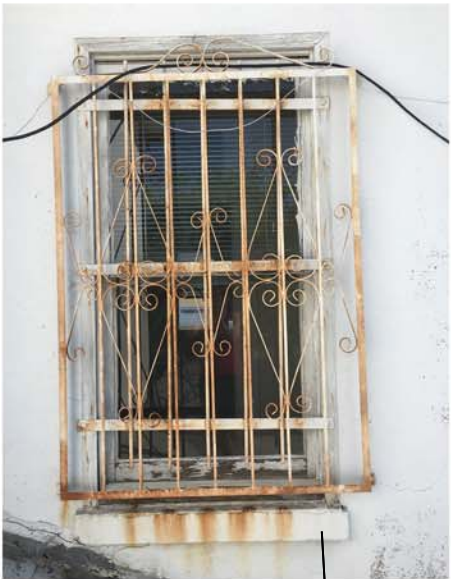
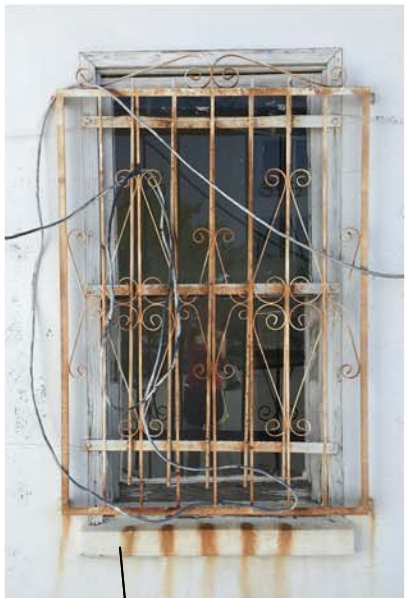
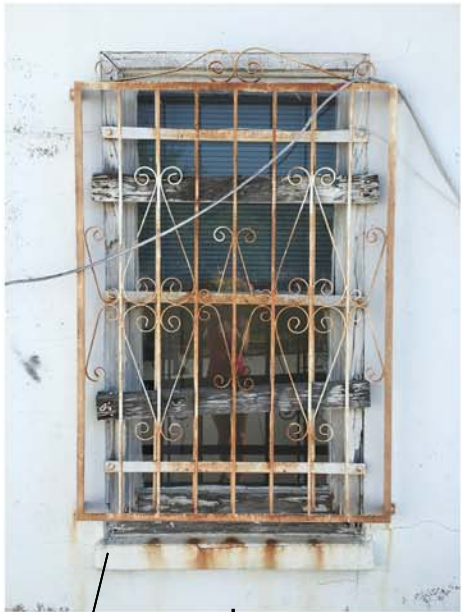
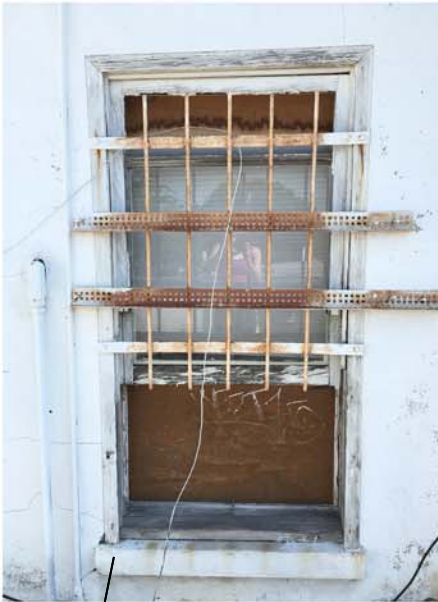
SOUTH ELEVATION - WINDOWS & DOORS ROOF LEVEL
SEE SHEET A3.1 FOR WINDOW SCHEDULE

WINDOWS J ARE WOOD FRAMED WINDOWS. THERE IS WOOD ROT AND THE WINDOW LEAKS WHEN IT RAINS. THE STEEL GUARDS HAVE BEEN PLACED OVER THE WINDOWS TO KEEP VANDAL OUT. IT IS PROPOSED TO REPLACE THE WINDOW WITH WOOD FRAMED WINDOWS TO MATCH EXISTING/ HISTORIC PROFILE CONDITIONS AND TO REMOVE THE STEEL GUARDS.
