HISTORIC AND DESIGN REVIEW COMMISSION

June 07, 2017

HDRC CASE NO: 2017-266
ADDRESS: 458 FURR DR
LEGAL DESCRIPTION: NCB 6696 BLK 5 LOT 22 W 25 FT OF 23 E 25 FT OF 21
ZONING: R-6 H
CITY COUNCIL DIST.: 7
DISTRICT: Monticello Park Historic District
APPLICANT: David and Lydia Lerma
OWNER: David and Lydia Lerma
TYPE OF WORK: Window replacement
REQUEST:

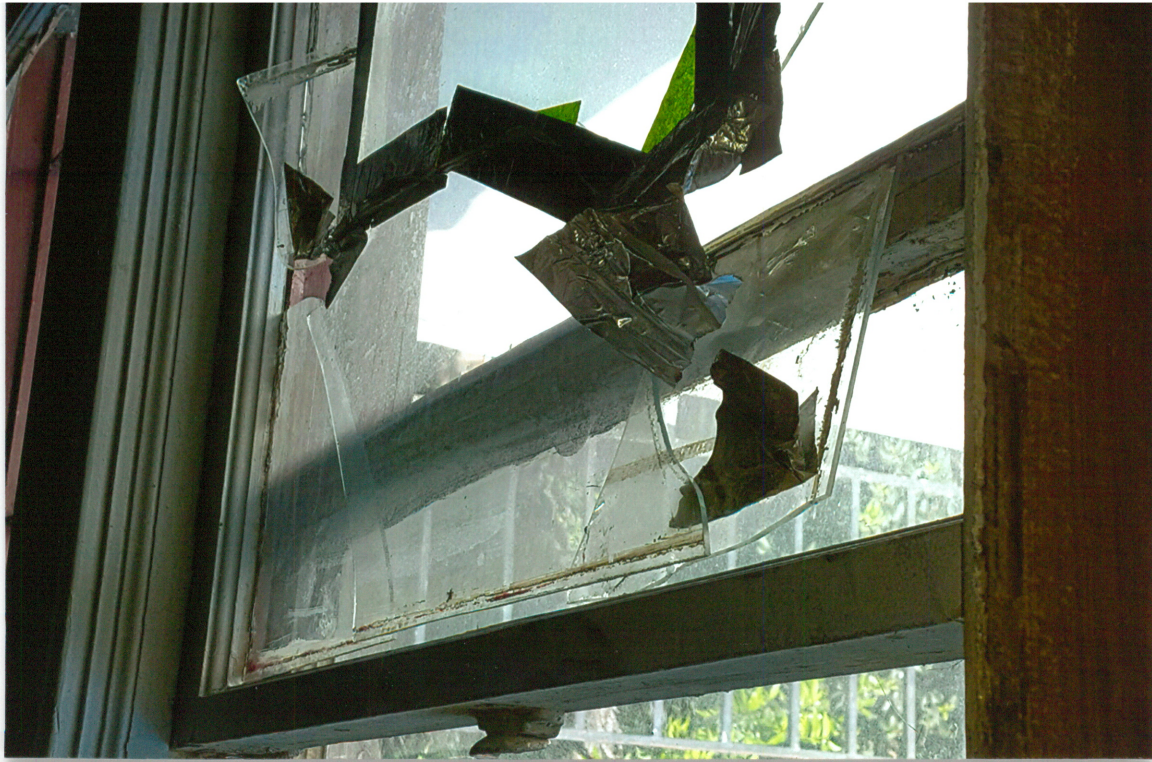
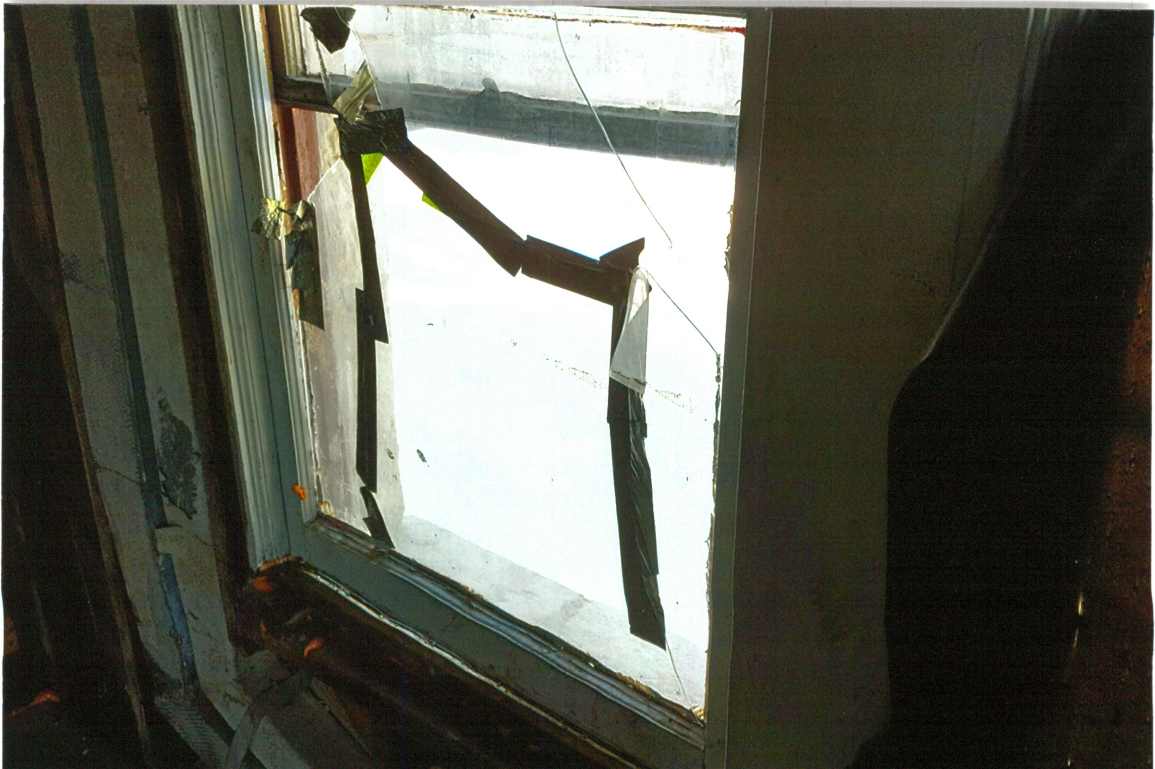
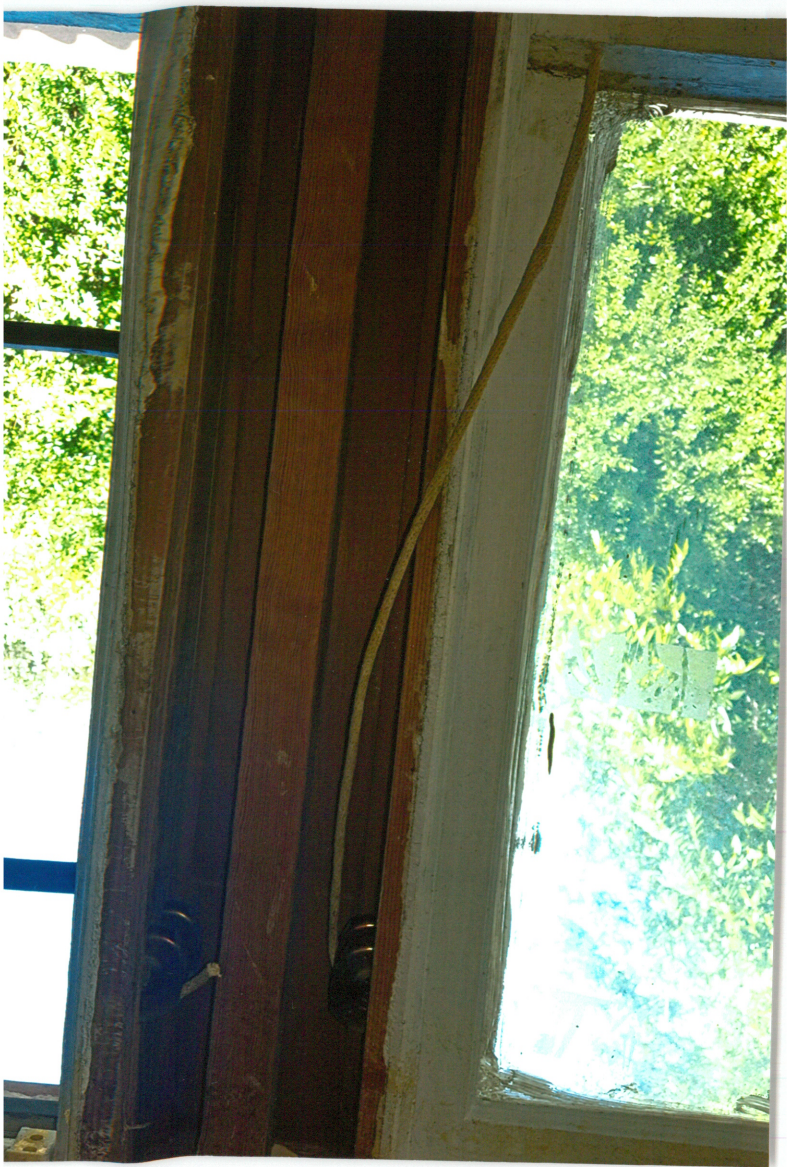
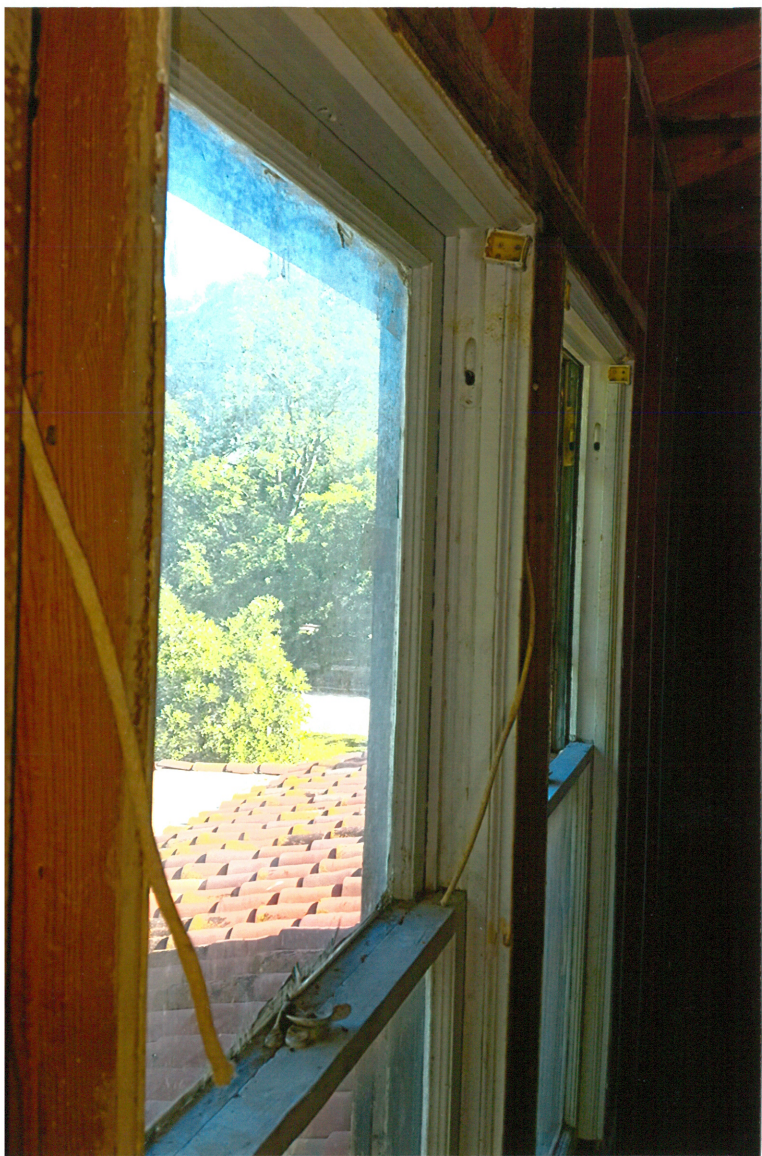
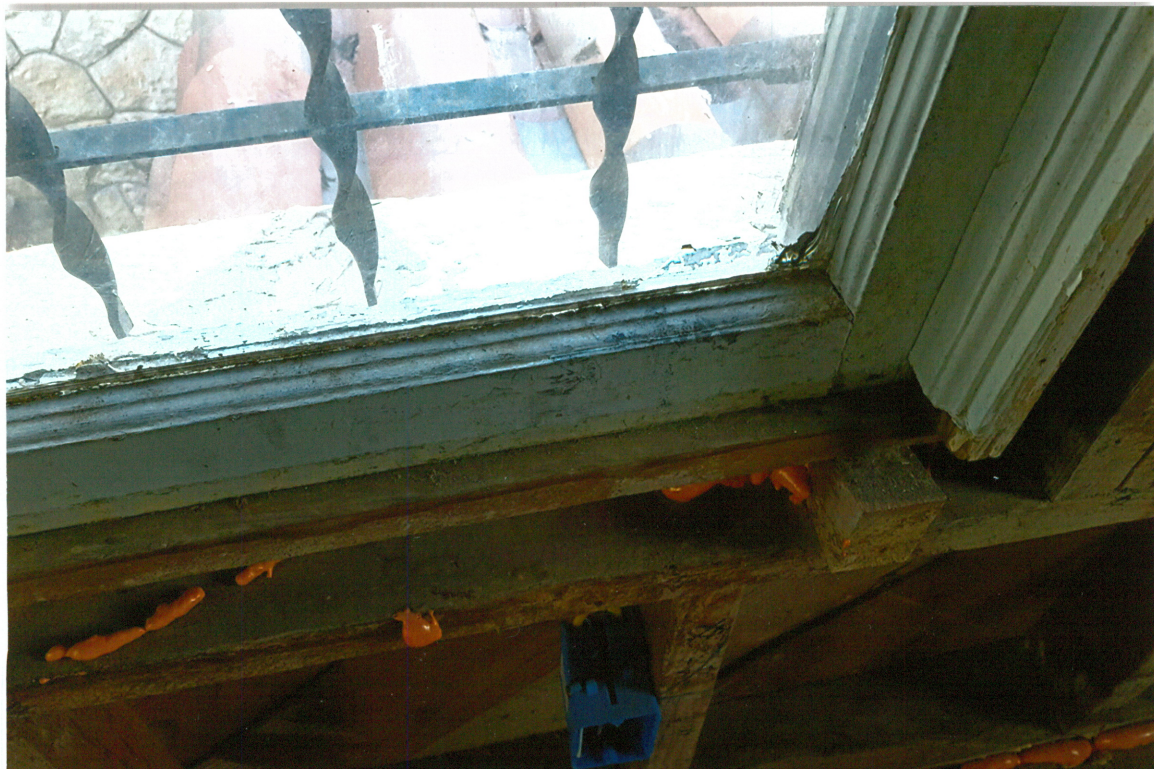
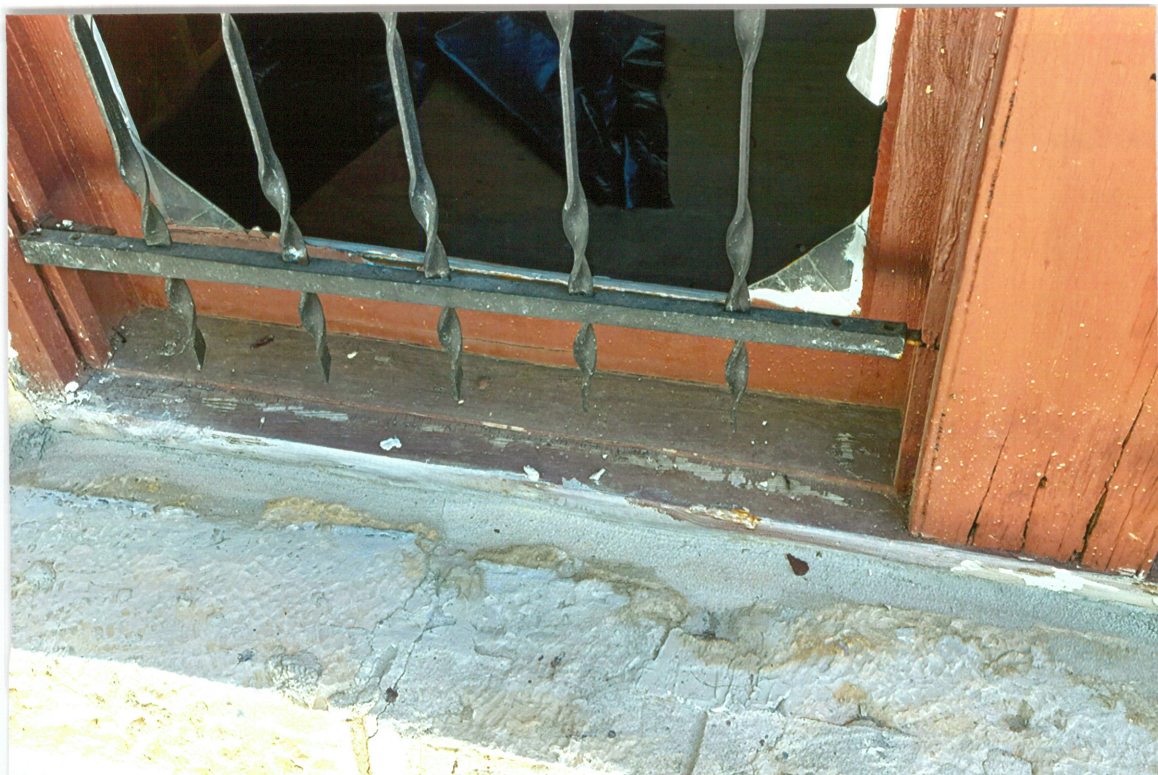
GAME / POOL ROOM

1. Three (3) windows located on the first level of the home in the game/pool room: are so dilapidated that the wood has deteriorated to the point that they are falling apart, and there is no way of salvaging them as they are unsound.
