HISTORIC AND DESIGN REVIEW COMMISSION

HDRC CASE NO: 2017-420
ADDRESS: 2136 W SUMMIT
LEGAL DESCRIPTION: NCB 6826 BLK 0 LOT 9&10
ZONING: R-6 H
CITY COUNCIL DIST.: 7
DISTRICT: Monticello Park Historic District
APPLICANT: Gary Perkins
OWNER: Gary Perkins
TYPE OF WORK: Reconstruct porte-cochere
REQUEST:

HDRC Application for 2136 W Summit Av, 78201

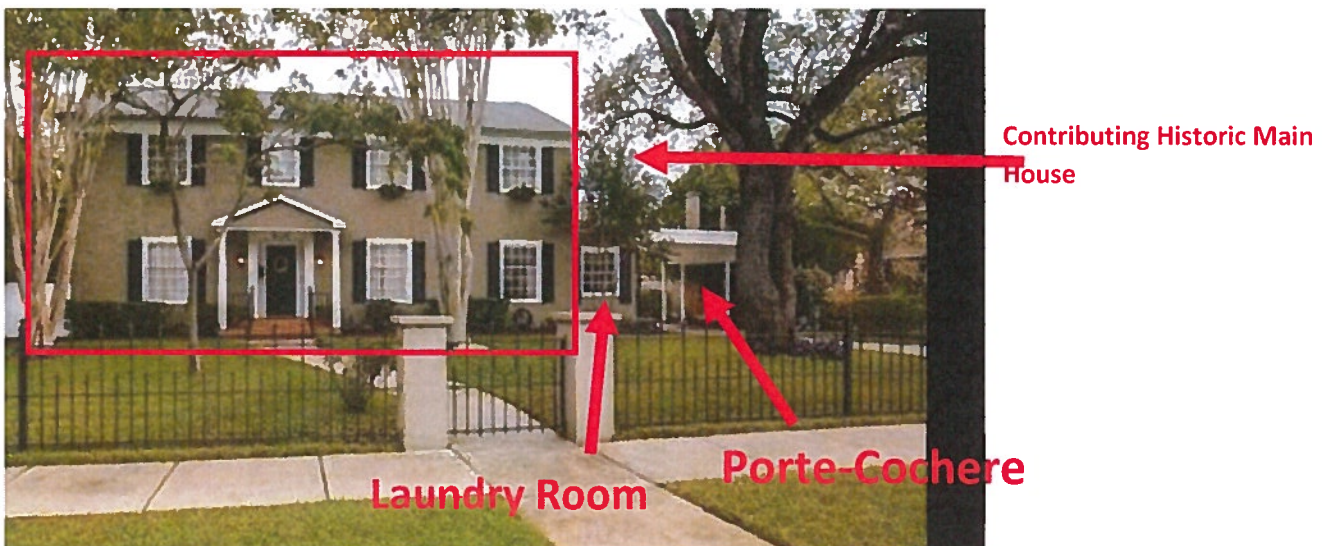
View from top

After 6 months, we discovered that water is leaking through the cracks of the tile and damaging the cross beams. Every 6 months we have sealed the tile. The terrace gets 8-9 hours of full sun every day and the sealer doesn't hold on to the clay tile.

It has come to a point where the cross beam has suffered rot and is now bending and cracks in the tile are becoming bigger.

Replace cross beam above laundry room with LVL (going from original house to supporting beams - XX ft). Paint white.

Replace all cross beams with 16-inch separation.

Replace upper floor decking with pressure treated cedar
