HISTORIC AND DESIGN REVIEW COMMISSION

HDRC CASE NO: 2017-387
ADDRESS: 815 N HACKBERRY ST
LEGAL DESCRIPTION: NCB 538 BLK 22 LOT N 66.3 FT OF 14 & N 66.3 FT OF E 9.52 FT OF 13
ZONING: R-5 H
CITY COUNCIL DIST.: 2
DISTRICT: Dignowity Hill Historic District
APPLICANT: Eduardo Martinez
OWNER: Eduardo Martinez
TYPE OF WORK: Historic Tax Certification
REQUEST:

Hook and Ladder Inspections

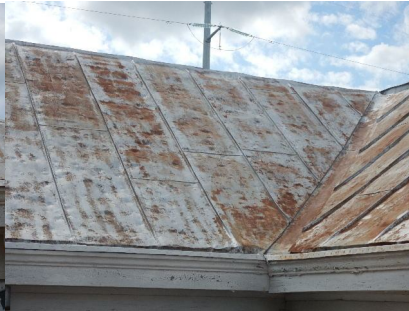
Rust and dents to metal roofing

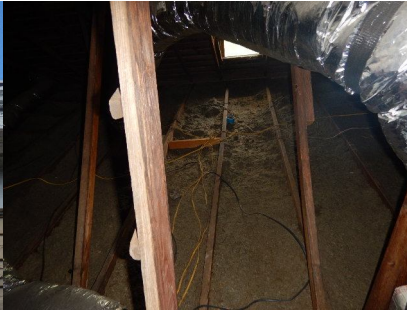
Opening to attic

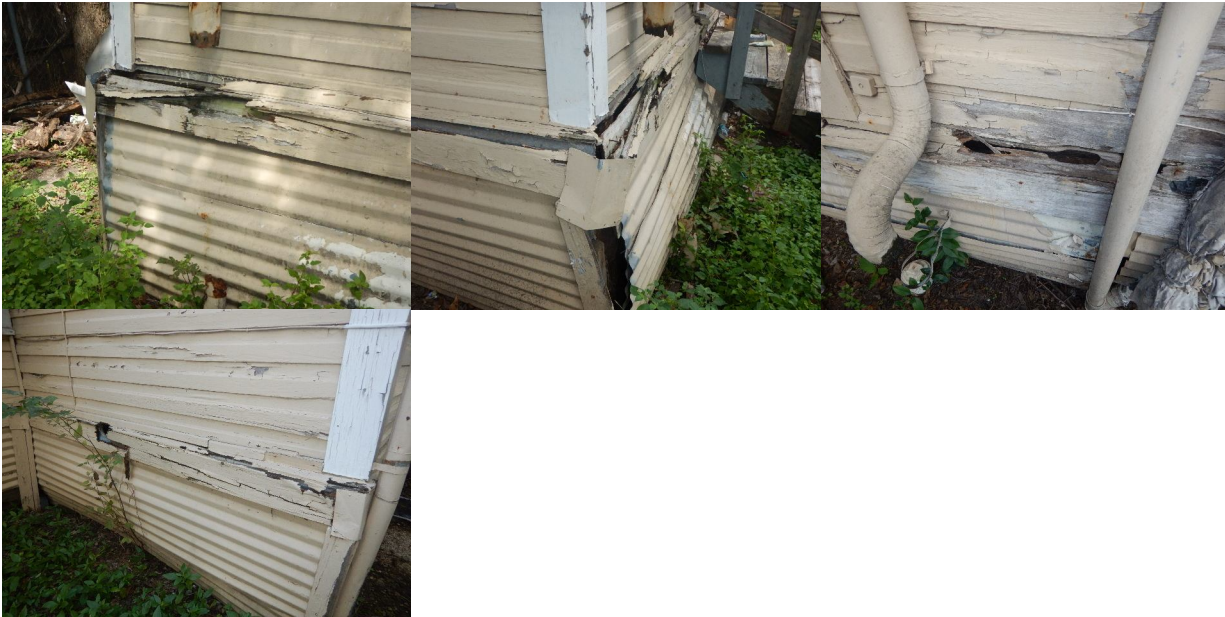
☒ Water stains / damage☒ Small cracks☐ Large cracks☐ Weepholes missing / blocked☒ Rotted / exposed wood☐ Previous repairs noted☒ Paint chipping☒ Damage to trim, door, siding

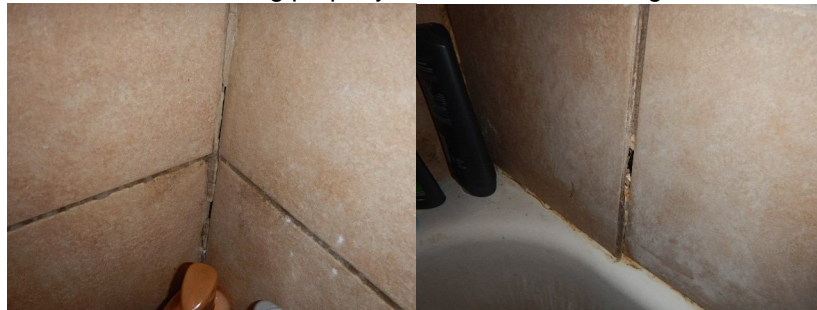
☐ Drain leak ☐ Slow drain ☐ Faucet leak ☐ Faucet/knob missing
☐ Faucet/knob damaged ☐ Head leak ☐ Pan leak
☐ Door not closing properly ☐ Water damage ☒ Grout/caulk missing
