HISTORIC AND DESIGN REVIEW COMMISSION

February 07, 2018

HDRC CASE NO: 2018-043
ADDRESS: 722 MASON ST
LEGAL DESCRIPTION: NCB 1276 BLK 8 LOT 6
ZONING: R-5, H
CITY COUNCIL DIST.: 2
DISTRICT: Government Hill Historic District
APPLICANT: Jesse Amado
OWNER: Jesse Amado
TYPE OF WORK: Install window in existing dormer
APPLICATION RECEIVED: January 18, 2018
60-DAY REVIEW: March 17, 2018

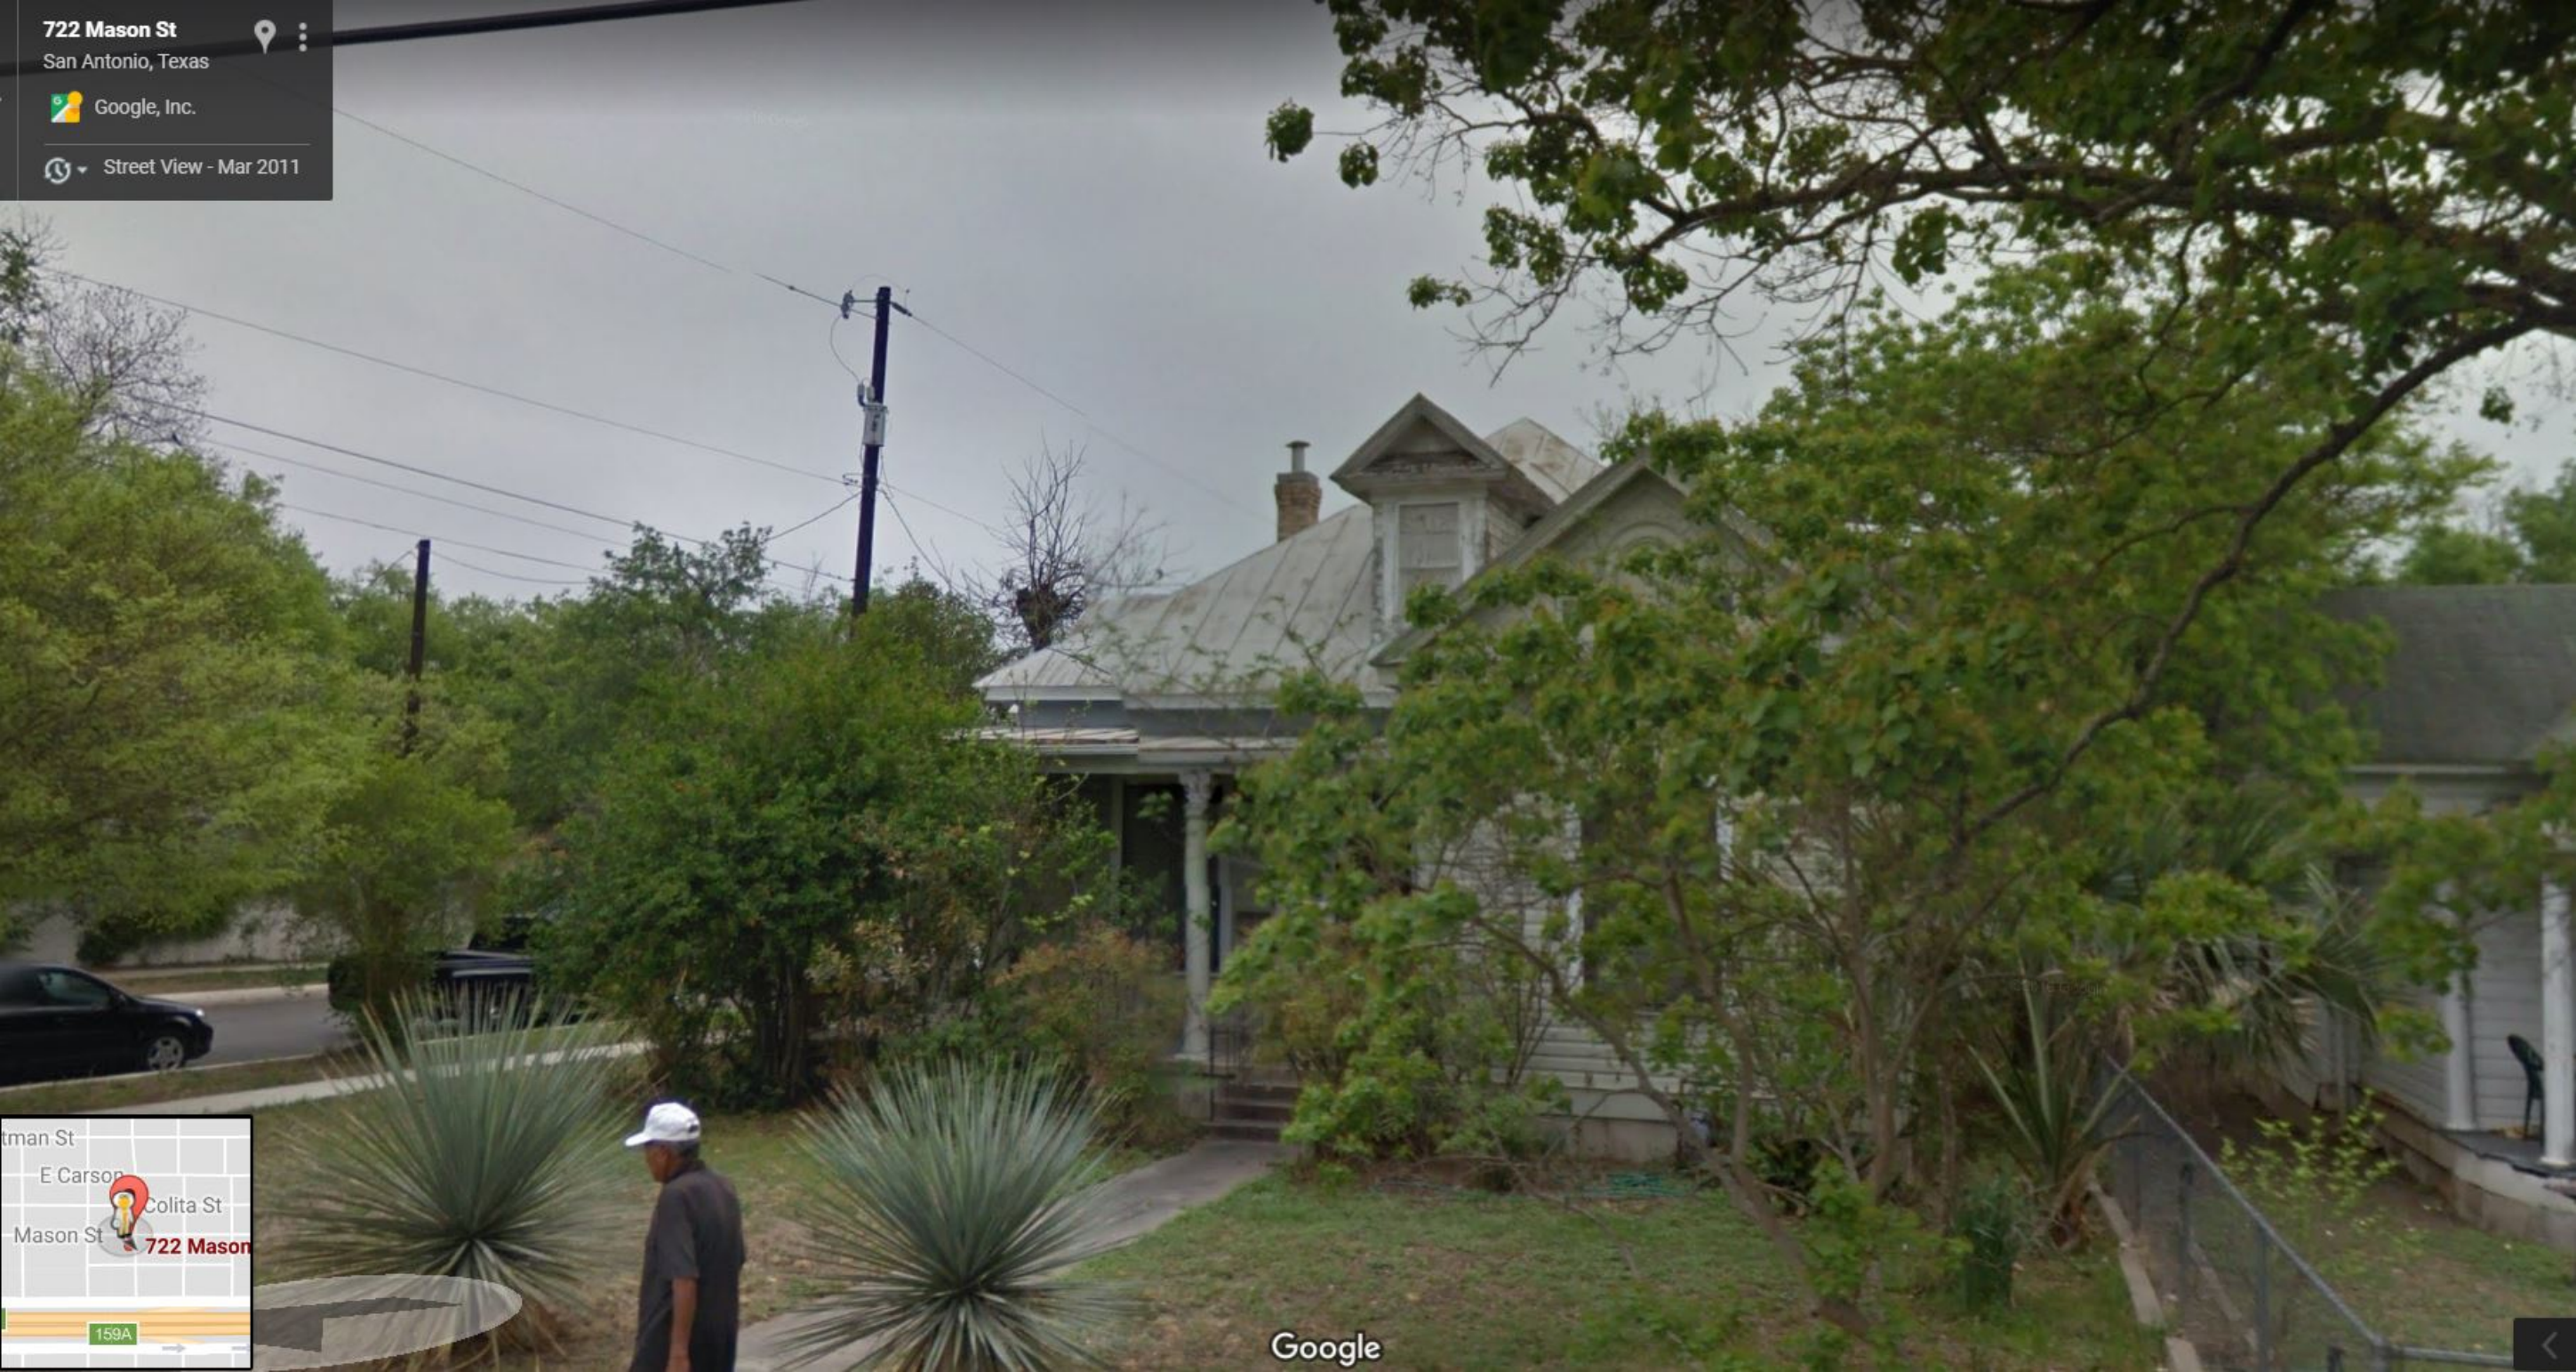
722 Mason St
San Antonio, Texas

- b. **DORMER** – The applicant has installed a single-light fixed window into the dormer prior to approval. Photographs show that the window opening had been boarded with plywood since at least 2008. The Guidelines for Windows 6.B.vii notes that non-historic incompatible windows should be replaced with windows that are typical of the architectural style of the building. Given that there is evidence that a window was not installed in the dormer for a number of years, staff finds that the installed fixed window is an improvement upon the previous plywood boarding. Staff also finds that a wood window screen comparable to the configuration of a double-hung window would be an appropriate to restore the character of the historic dormer.

Street View - May 2014

Staff recommends the approval to install a fixed window into the dormer window opening based on finding b with the stipulation that a wood window screen of a traditional configuration also be installed to minimize the visual impact of the new window.
