## HISTORIC AND DESIGN REVIEW COMMISSION

**HDRC CASE NO:** 2018-062  
**ADDRESS:** 222 W GUENTHER ST  
**LEGAL DESCRIPTION:** NCB 2973 BLK 5 LOT 1  
**ZONING:** RM-4,HS  
**CITY COUNCIL DIST.:** 1  
**DISTRICT:** Nathan Historic District  
**LANDMARK:** House  
**APPLICANT:** Robert Murray  
**OWNER:** Robert Murray  
**TYPE OF WORK:** Demolition of a rear accessory structure, Historic Tax Certification  
**APPLICATION RECEIVED:** January 11, 2018  
**60-DAY REVIEW:** March 12, 2018  
**REQUEST:**

**PROPERTY CONDITION INSPECTION:**  
**222 W. Guenther**  
**San Antonio, Texas 78204**

The property condition inspection of 222 W. Guenther, San Antonio, Texas, was performed at the request of Mr. Bob Murray. A representative of ATS Engineers conducted the site inspection on December 5, 2017.

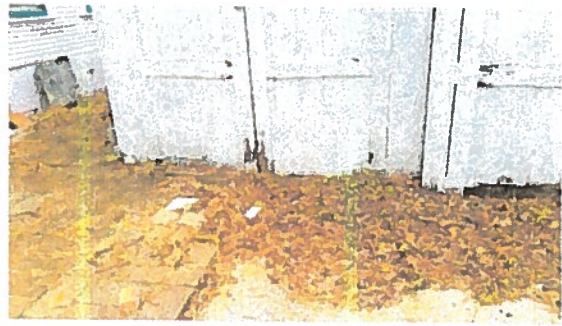
Photo 2

Photo 2: Shows side of extended wall and roof which is failing.

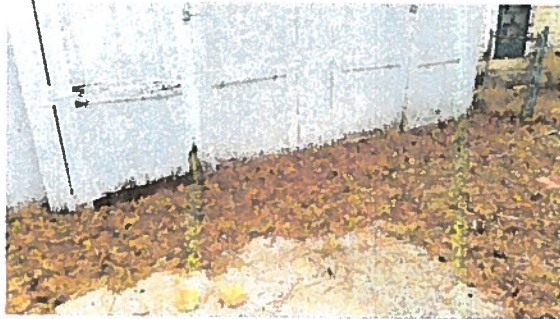
Photo 3 & 4: Because the structure has no slab or foundation, it sits on the ground and is lower than the surrounding yard. The bottom is completely rotted on sides and back.

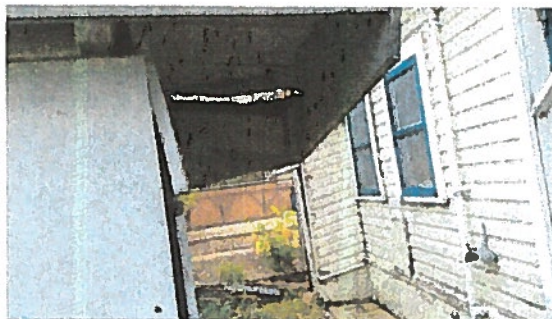
Photo 12 & 13: Because of lack of a foundation, the walls have sunk disproportionately. The back wall is approximately 6" out of level.
