HISTORIC AND DESIGN REVIEW COMMISSION

February 07, 2018

HDRC CASE NO: 2018-034
ADDRESS: 121 BUFORD
LEGAL DESCRIPTION: NCB 1369 BLK 6 LOT S 81.3 FT OF 5
ZONING: R-4, H
CITY COUNCIL DIST.: 2
DISTRICT: Dignowity Hill Historic District
APPLICANT: Ryan McWhirter/LUSH Greenscape Design
OWNER: Chris H. Williams Laura Lopez
TYPE OF WORK: Front yard site elements
APPLICATION RECEIVED: January 17, 2018
60-DAY REVIEW: March 16, 2018
REQUEST:

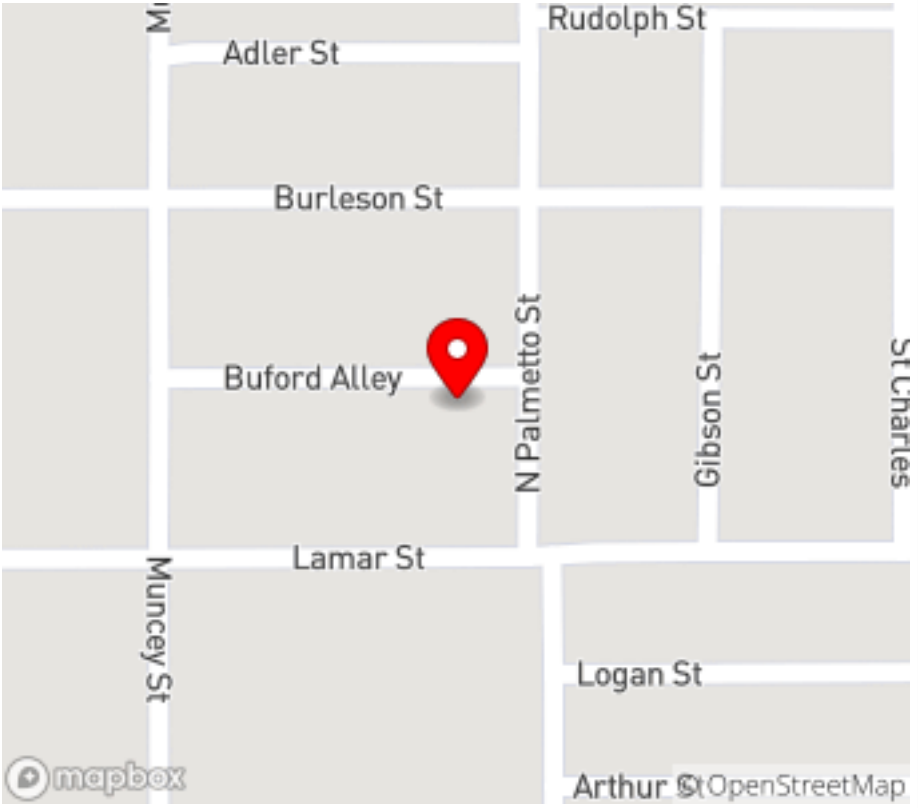
Date	01/12/2018
Time	10:47 AM (-6 GMT)
Present Staff	Huy Pham, Edward Hall
Present Individuals	Homeowner, Contractor(s)
Present Companies	Lush (fence)
Types of Work Observed	Site Elements
Amount of Work Completed	75%
Description of work	Initiated installation of rear and front yard fence with steel posts and wood pickets, and completed constructed of decorative CMU wall in front yard.

Violation Type	No Certificate of Appropriateness (Code 35-451a), Beyond scope of Certificate of Appropriateness (Code 35-451h)
----------------	---

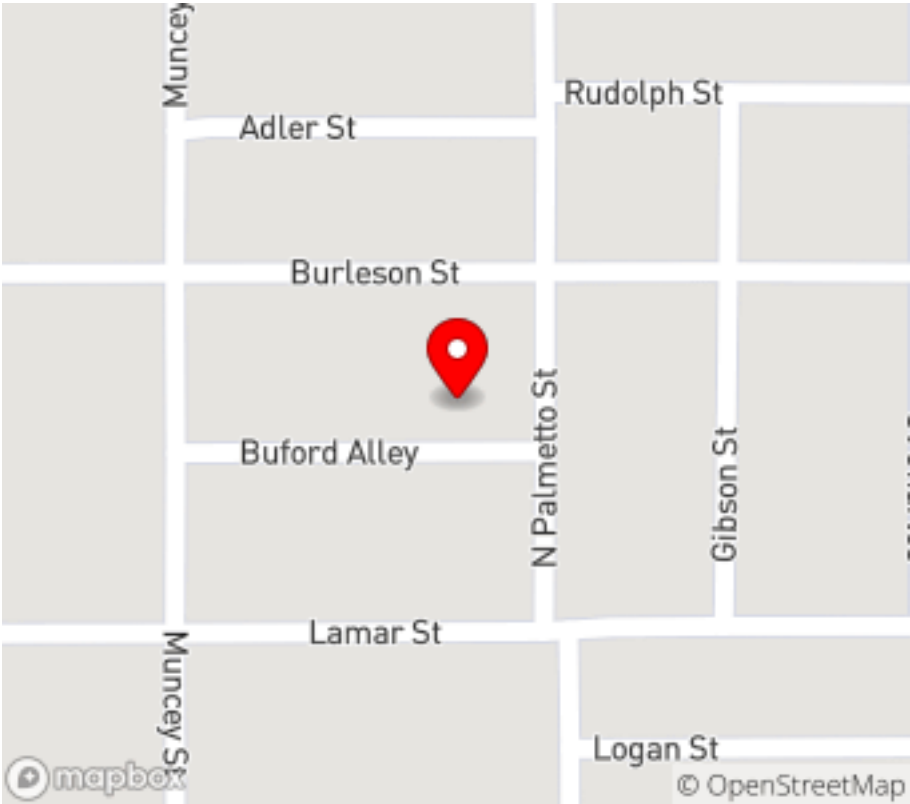
Date	01/23/2018
Time	10:46 AM (-6 GMT)
Present Staff	Huy Pham, Edward Hall
Present Individuals	Contractor(s), Crew member(s)
Present Companies	LUSH Landscaping
Types of Work Observed	Site Elements
Amount of Work Completed	75%
Description of work	Continued work without approval for front yard modifications including concrete pavers, metal planters, and site work.

Violation Type	No Certificate of Appropriateness (Code 35-451a), Beyond scope of Certificate of Appropriateness (Code 35-451h)
OHP Action	Spoke with contractor(s) and/or crew, posted "Stop Work Notice"
Deadline to contact office	01/23/2018
