## HISTORIC AND DESIGN REVIEW COMMISSION

September 19, 2018

**HDRC CASE NO:** 2018-462  
**ADDRESS:** 201 E HUISACHE AVE  
**LEGAL DESCRIPTION:** NCB 3085 BLK 1 LOT 23  
**ZONING:** MF-33, H  
**CITY COUNCIL DIST.:** 1  
**DISTRICT:** Monte Vista Historic District  
**APPLICANT:** Patrick Christensen  
**OWNER:** SA Huisache Investors LLC  
**TYPE OF WORK:** Window/door replacement  
**APPLICATION RECEIVED:** August 31, 2018  
**60-DAY REVIEW:** October 30, 2018  
**REQUEST:**

The applicant is requesting a Certificate of Appropriateness for approval to replace wood windows and doors with aluminum windows and doors.

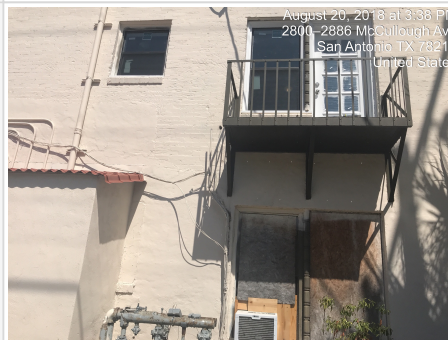
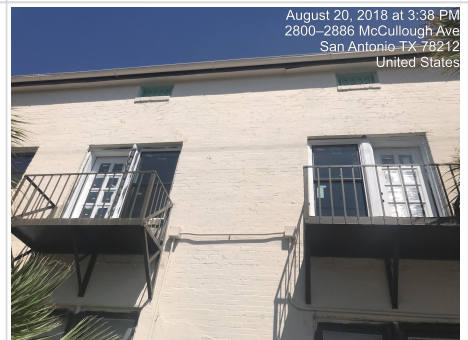
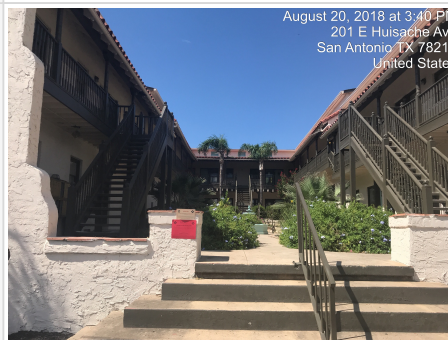
On a site visit conducted on August 20, 2018, staff found that approximately twenty windows and some doors have been replaced with aluminum windows and doors prior to the issuance of a Certificate of Appropriateness. The applicant submitted a request to be heard at an HDRC hearing on August 31, 2018. The \$500 post-work application fee has been paid.

Date	08/20/2018
Time	03:41 PM (-5 GMT)
Context	citizen report
Present Staff	Huy Pham
Present Individuals	None
Types of Work Observed	Exterior Maintenance and Alterations
Amount of Work Completed	75%
Description of work	Removal of over 20 wood windows and doors and installation of aluminum windows.

Staff does not recommend approval of window or door replacement based on finding d. Staff recommends repair of any remaining windows and doors.
