## HISTORIC AND DESIGN REVIEW COMMISSION

October 03, 2018

**HDRC CASE NO:** 2018-491  
**ADDRESS:** 1010 N HACKBERRY ST  
**LEGAL DESCRIPTION:** NCB 521 BLK 16 LOT S 52.53 FT OF N 100 FT OF 11 ARB 11D  
**ZONING:** IDZ, H  
**CITY COUNCIL DIST.:** 2  
**DISTRICT:** Dignowity Hill Historic District  
**APPLICANT:** Cory Johnson  
**OWNER:** Nicole Johnson  
**TYPE OF WORK:** Rear addition, window and door replacement, fenestration changes.  
**APPLICATION RECEIVED:** September 17, 2018  
**60-DAY REVIEW:** November 16, 2018  
**REQUEST:**

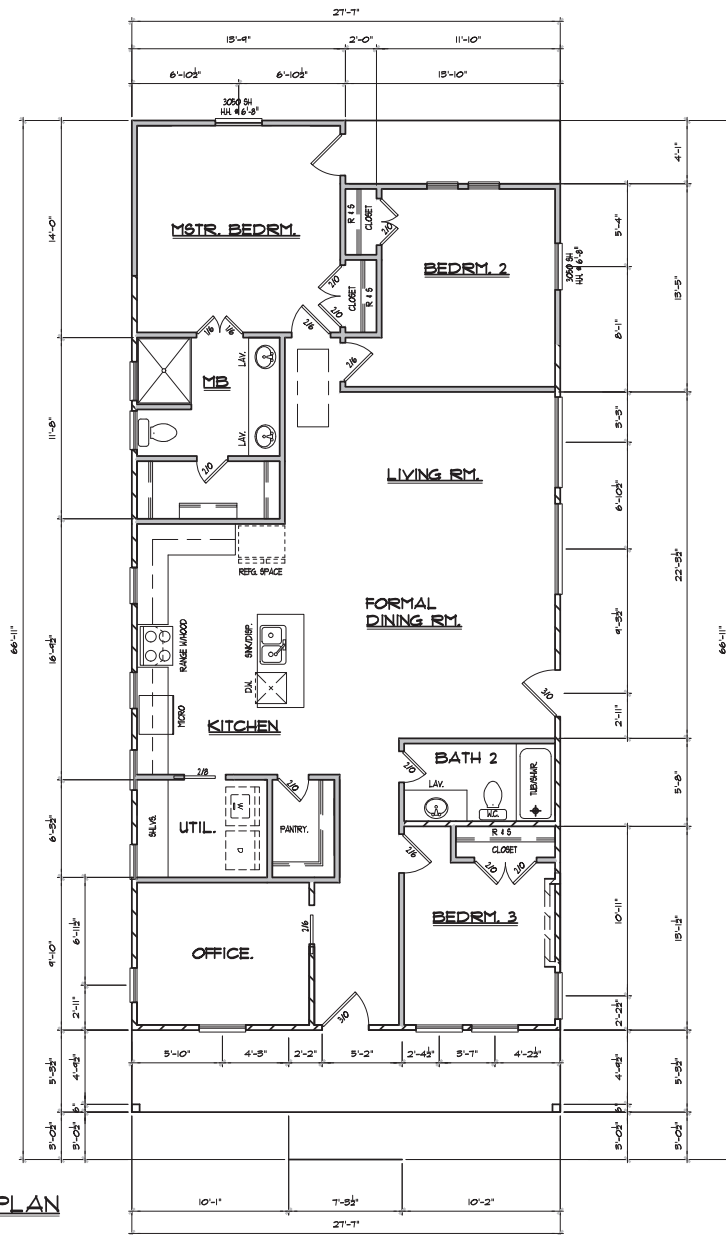
#### **WINDOWS DO NOT ALIGNED WITH OBSERVED ALTERATIONS, INCLUDING ONE WINDOW NOT DEPICTED OR REQUESTING TO BE REMOVED**

Staff comment: (1) The depicted roof form and fenestration does not match the modifications staff observed on site nor the applicants verbal description. (2) The set of arched casement windows are closer to the door, unless the applicant is proposing to relocate the windows (3) The rear gable features a centered set of two-over-two sash windows, unless the applicant is proposing to remove and relocate the windows.

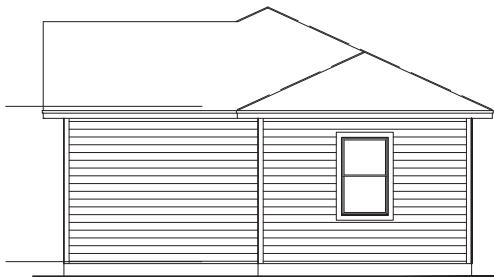
#### REAR ELEVATION

Staff comment: (1) The depicted fenestration does not match the modifications staff observed on site nor the applicants verbal description. (2) The front gable features two individual one-over-one wood windows, unless the applicant is proposing to remove one. (3) The intermediate wall features two picture windows and a covered sash window, unless the applicant is proposing to remove all three window openings. (4) The rear gable features a set of one-over-one wood windows, unless the applicant is proposing to remove those windows.
