HISTORIC AND DESIGN REVIEW COMMISSION

December 19, 2018

HDRC CASE NO: 2018-462
ADDRESS: 201 E HUISACHE AVE
LEGAL DESCRIPTION: NCB 3085 BLK 1 LOT 23
ZONING: MF-33
CITY COUNCIL DIST.: 1
DISTRICT: Monte Vista Historic District
APPLICANT: Patrick Christensen
OWNER: SA Huisache Investors LLC
TYPE OF WORK: Window replacement
APPLICATION RECEIVED: November 20, 2018
60-DAY REVIEW: January 19, 2018
REQUEST:

Investigation Report

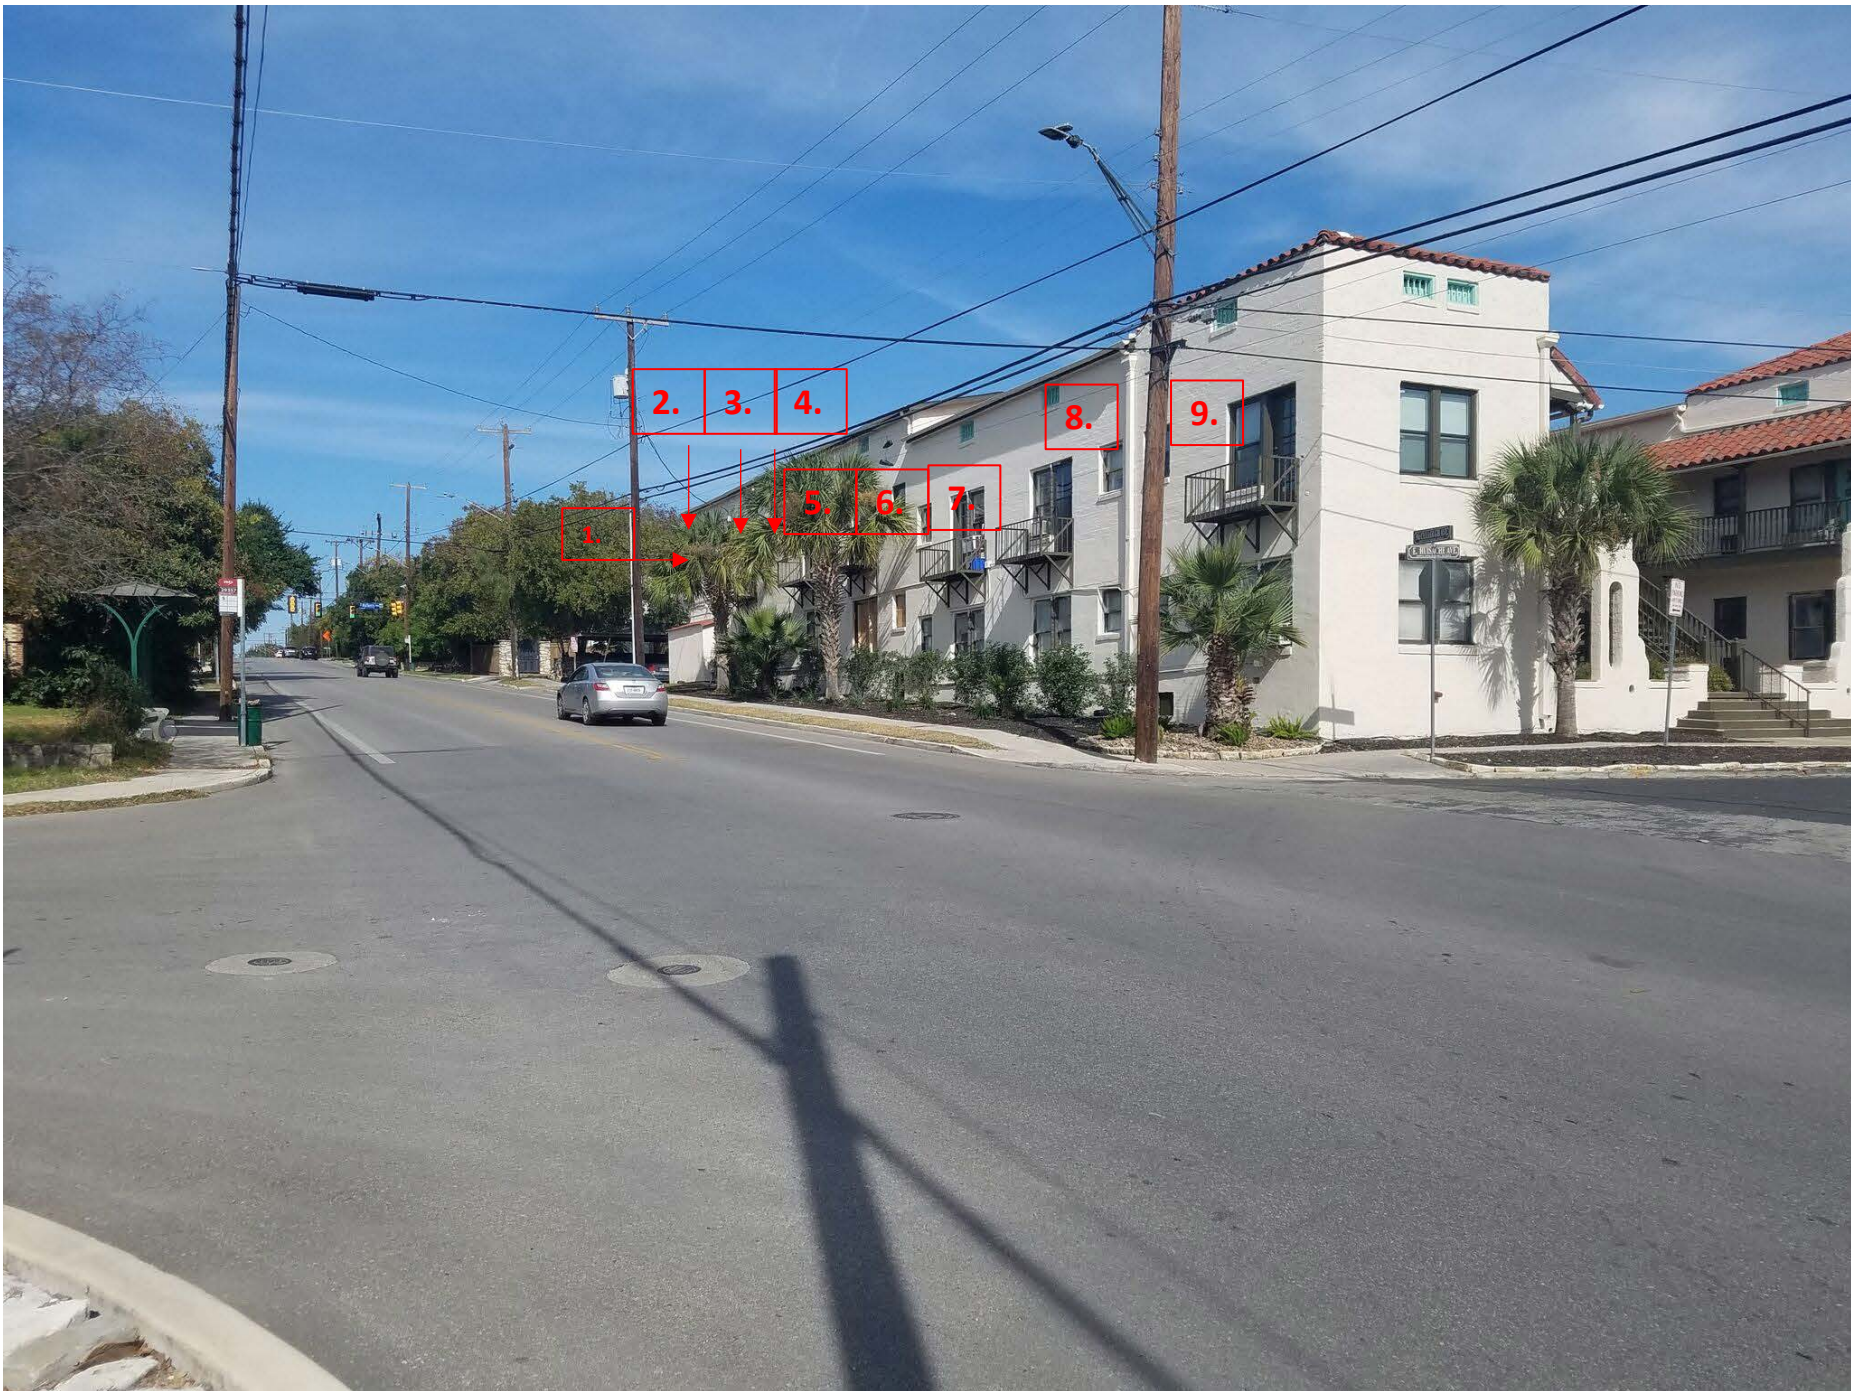
201 E. Huisache

The following photos are existing window conditions:
