HISTORIC AND DESIGN REVIEW COMMISSION

HDRC CASE NO: 2018-616
ADDRESS: 1405 S FLORES ST
LEGAL DESCRIPTION: NCB 1009 BLK LOT 40B
ZONING: I-1,HS
CITY COUNCIL DIST.: 1
LANDMARK: SAP Cleaners & Dyers
APPLICANT: Kris Feldmann
OWNER: HB Properties I, LLC
TYPE OF WORK: Rehabilitation, exterior modifications, signage, storefront restoration, window replacement, roofing
APPLICATION RECEIVED: December 05, 2018
60-DAY REVIEW:
REQUEST:

Antiques Warehouse Lofts
November 30, 2018

HDRC SUBMITTAL | 2018.11.30
1405 S. FLORES, SAN ANTONIO TX, 78204

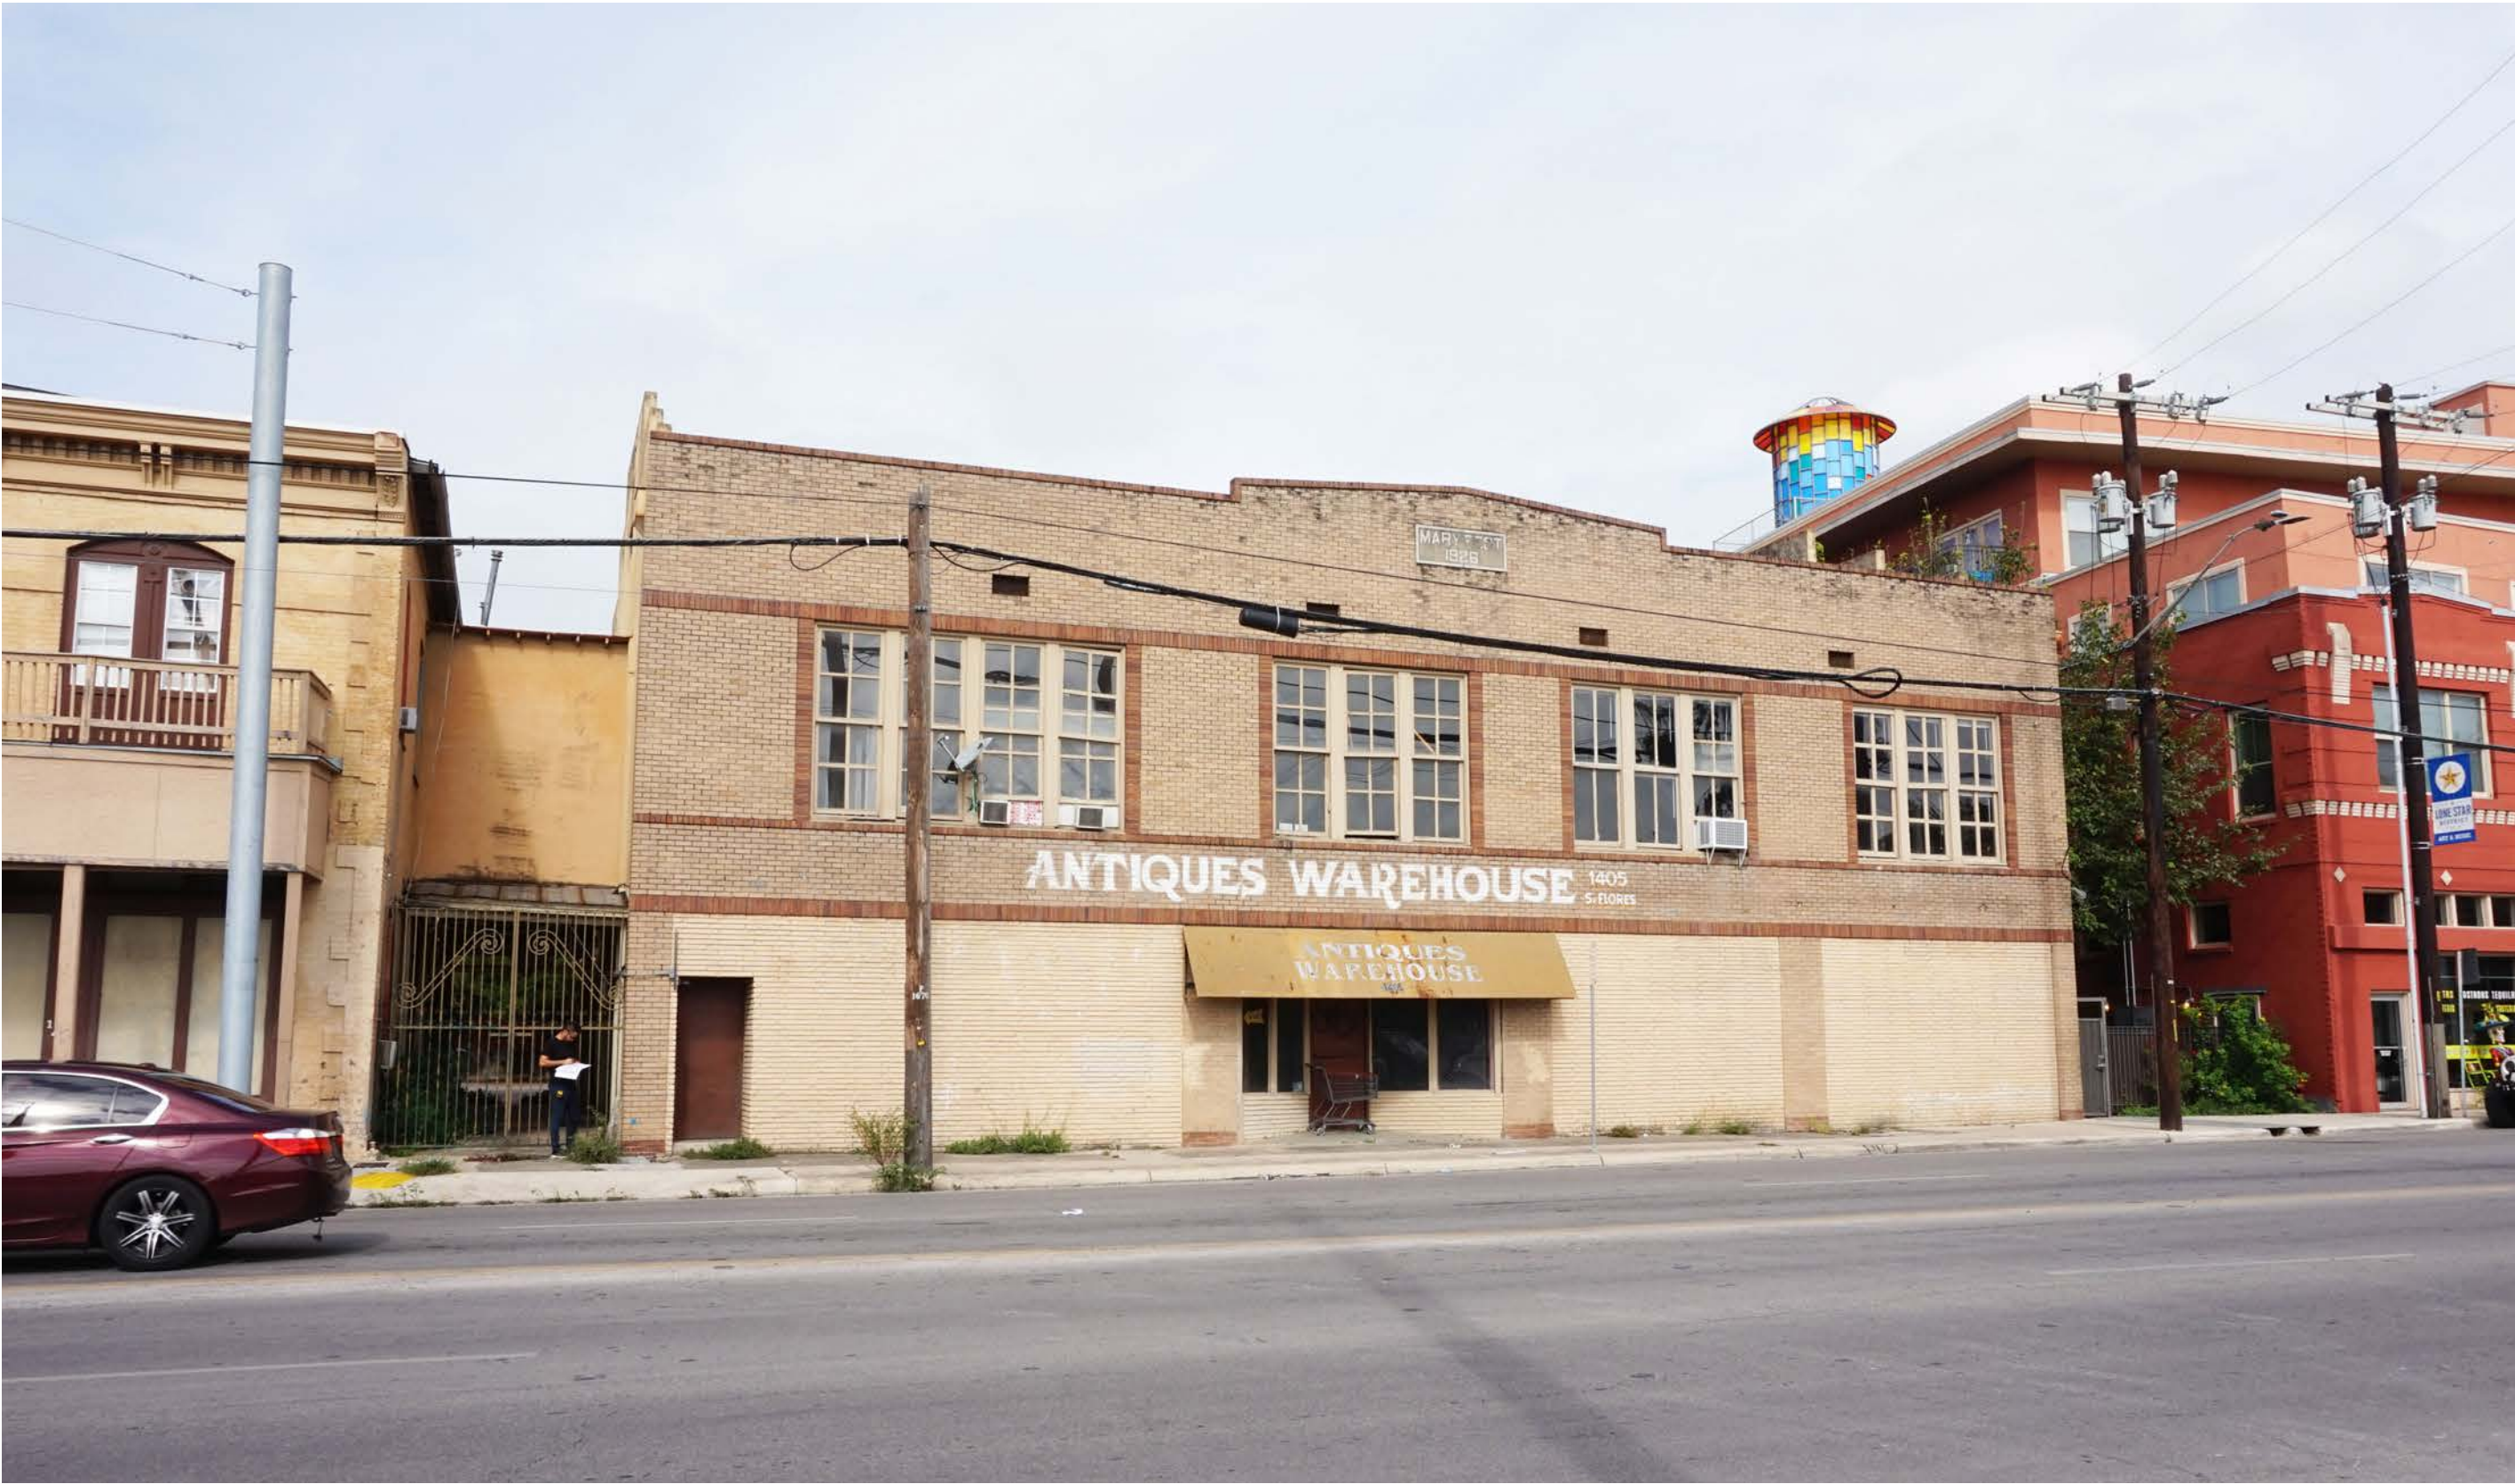
EAST ELEVATION - EXISTING DETAILS

EXISTING EXTERIOR CONDITION - EAST (STREET) ELEVATION

① DETERIORATING SINGLE PANE WOOD FRAMED WINDOWS - TO BE REPLACED (REF. WINDOW SPEC EXHIBIT)

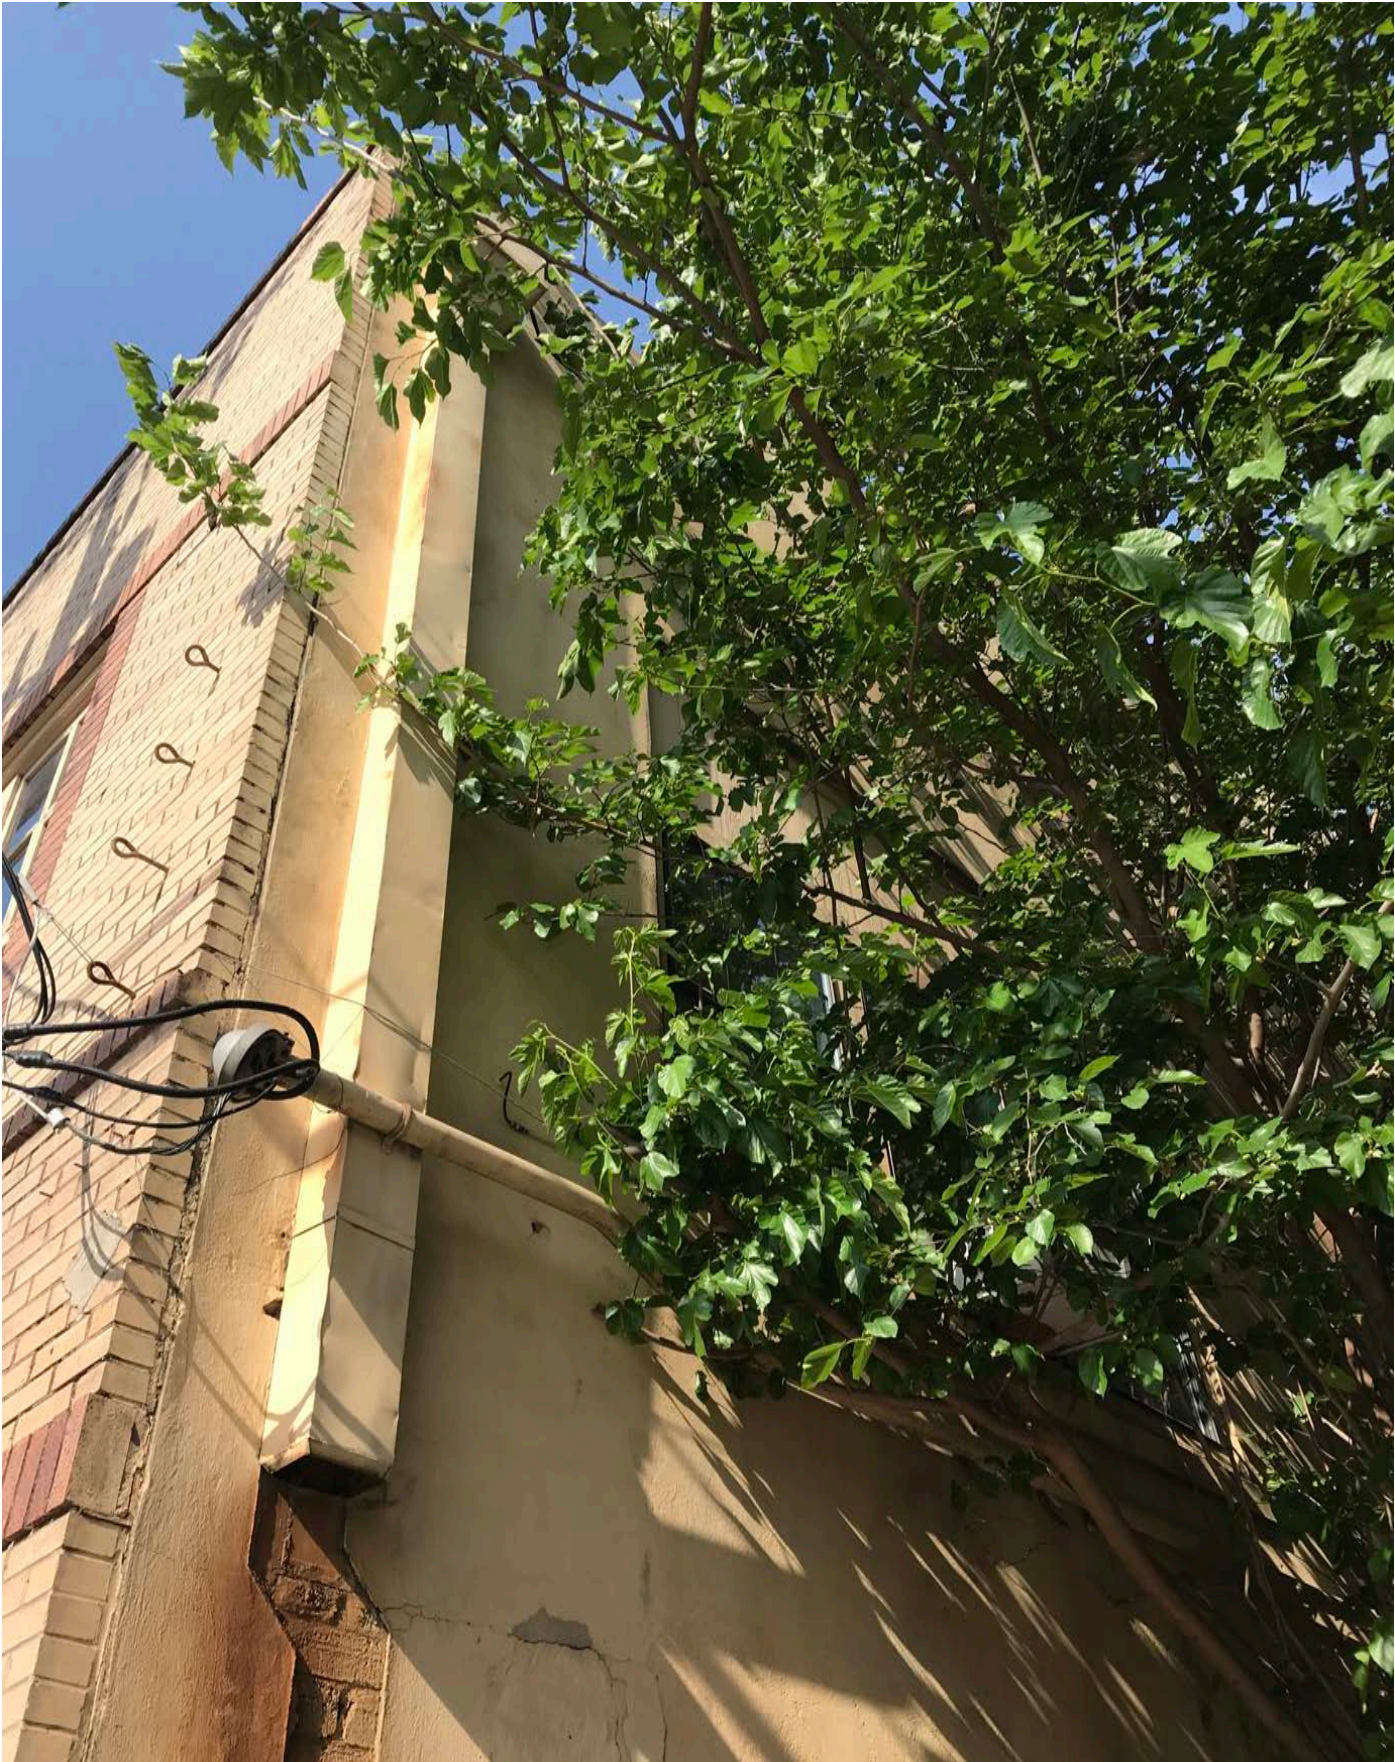
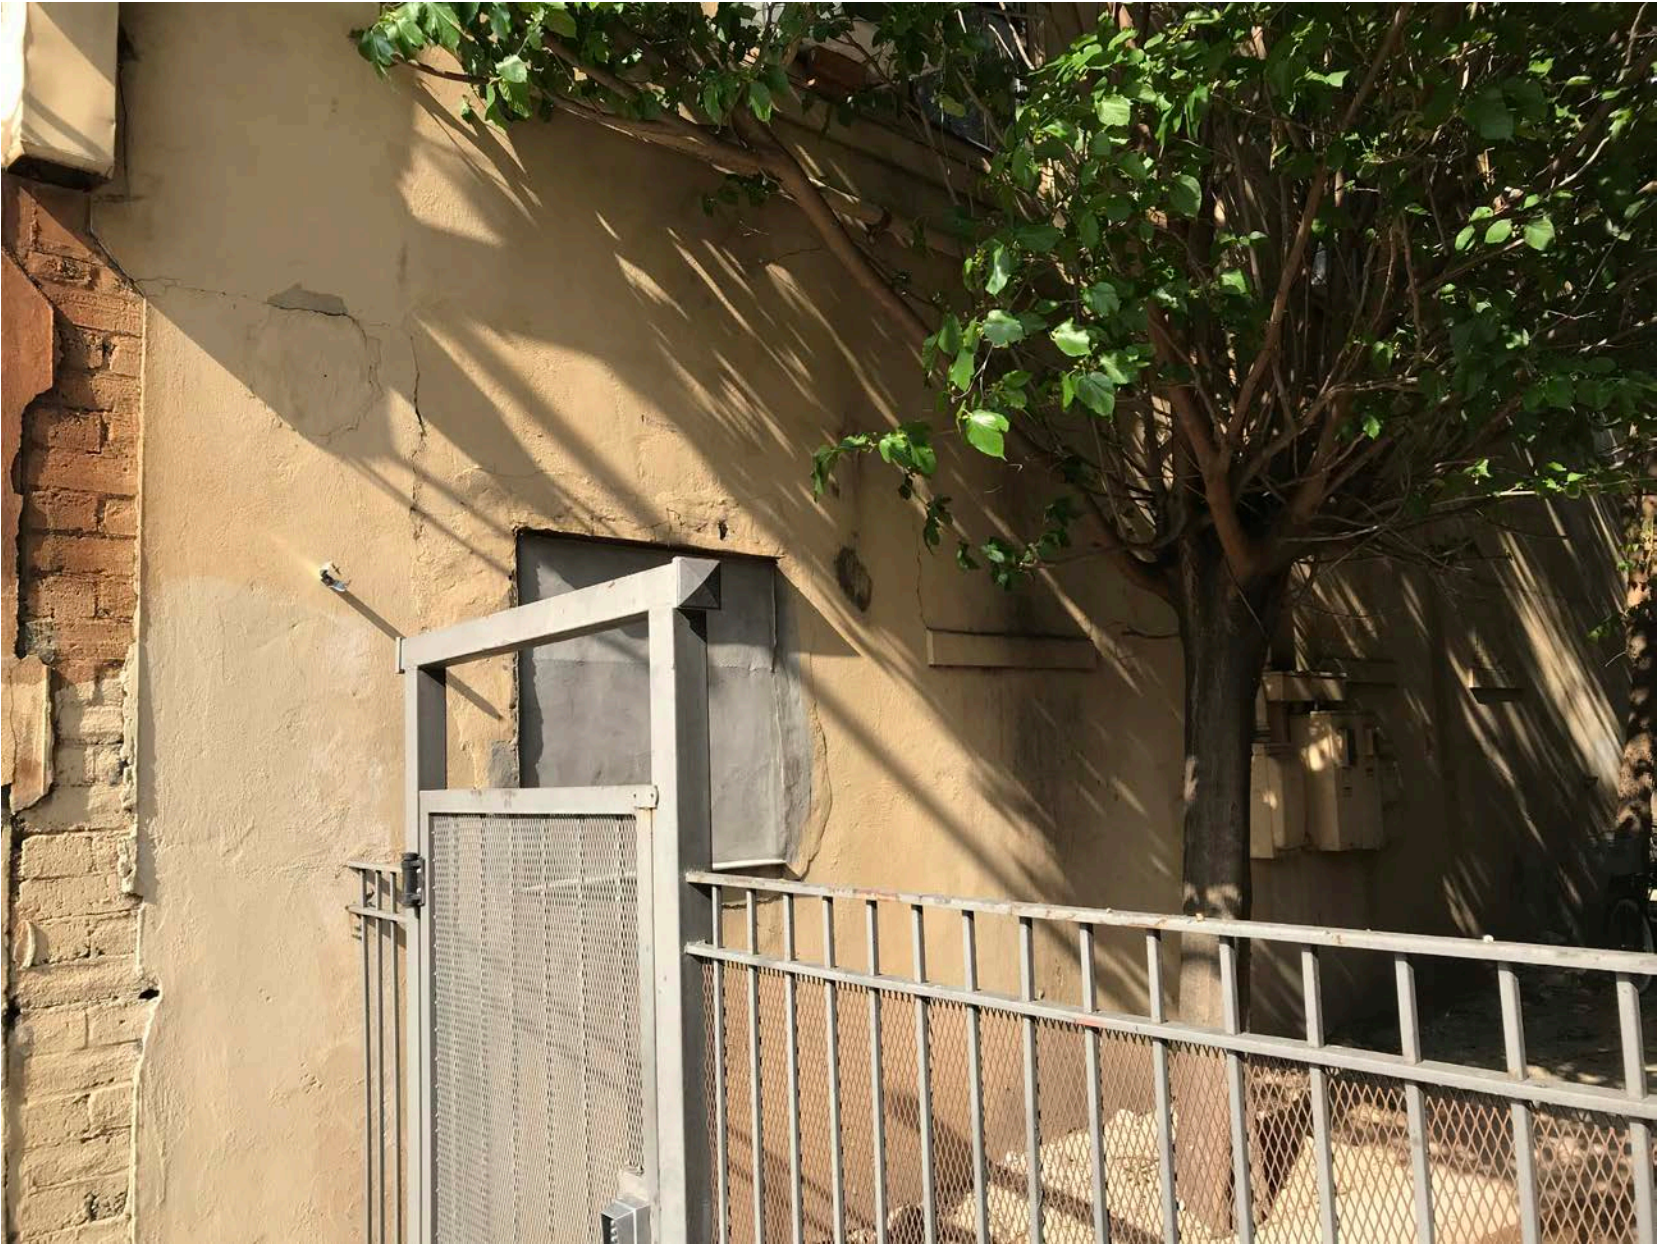
EXISTING EXTERIOR CONDITION - NORTH ELEVATION (SHARED ALLEY WITH STEEL HOUSE LOFTS)

- ① DETERIORATING SINGLE PANE WOOD FRAMED WINDOWS - TO BE REPLACED (REF. WINDOW SPEC EXHIBIT)
- ② AREA FOR PROPOSED LOFT ENTRY STOREFRONT

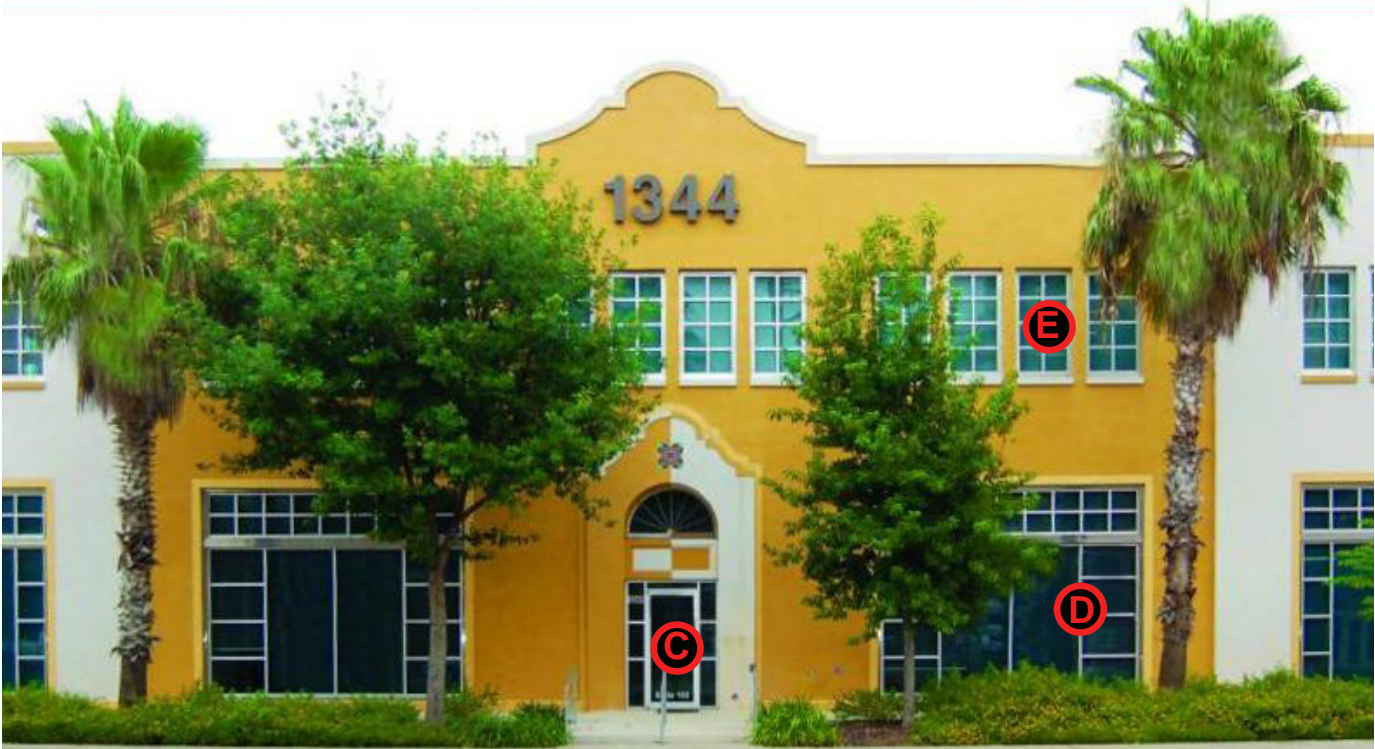
C EXHITBIT C
NON-HISTORIC ALUMINUM
STOREFRONT ON EXISTING
OPENING

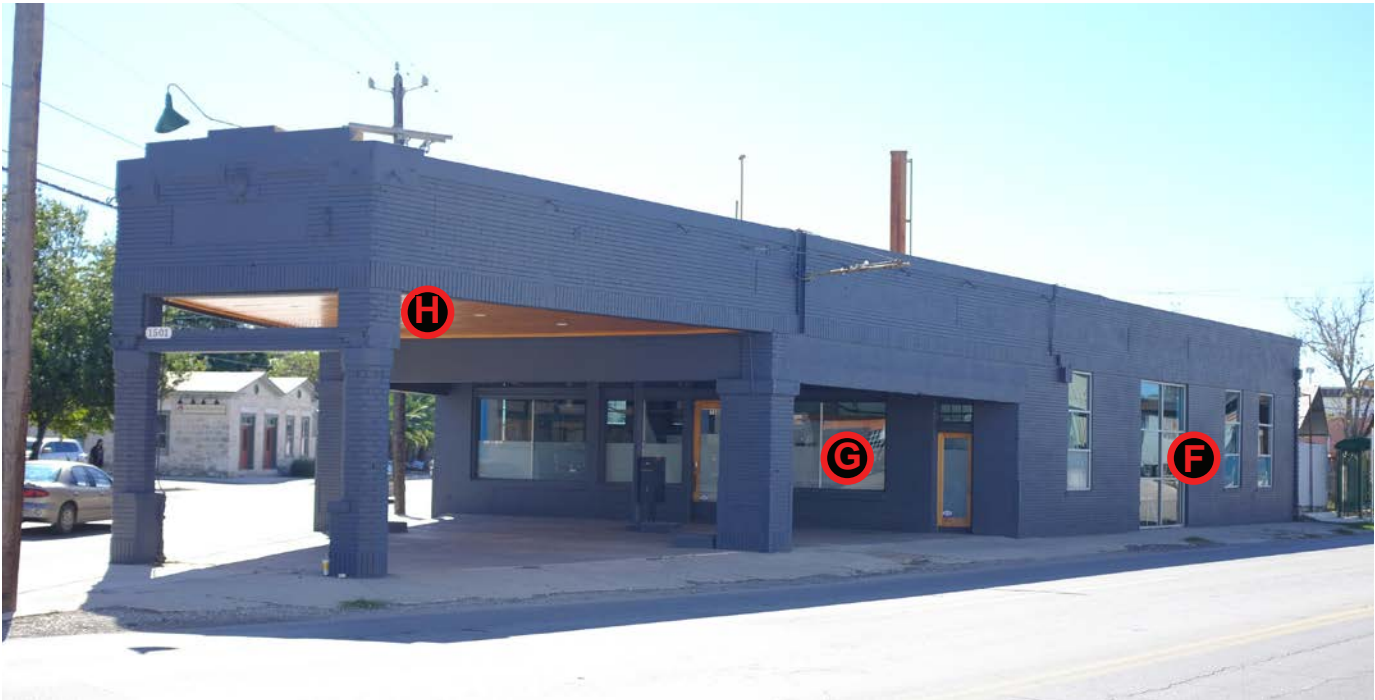
F EXHITBIT F
PAINTED BRICK FACADE AND
NON- HISTORIC ALUMINUM
STOREFRONT ON EXISTING
OPENINGS
