HISTORIC AND DESIGN REVIEW COMMISSION

December 19, 2018

HDRC CASE NO: 2018-622
ADDRESS: 914 LAMAR ST
LEGAL DESCRIPTION: NCB 1655 BLK C LOT 11
ZONING: R-5
CITY COUNCIL DIST.: 2
DISTRICT: Dignowity Hill Historic District
APPLICANT: Andrea Frias
OWNER: Juan and Oralia DeLeon
TYPE OF WORK: Front porch modifications
APPLICATION RECEIVED: December 05, 2018
60-DAY REVIEW: February 04, 2019
REQUEST:

The applicant is requesting a Certificate of Appropriateness for approval to replace Folk Victorian porch elements with square columns, cattle panel fencing, and 2x6 wood decking.

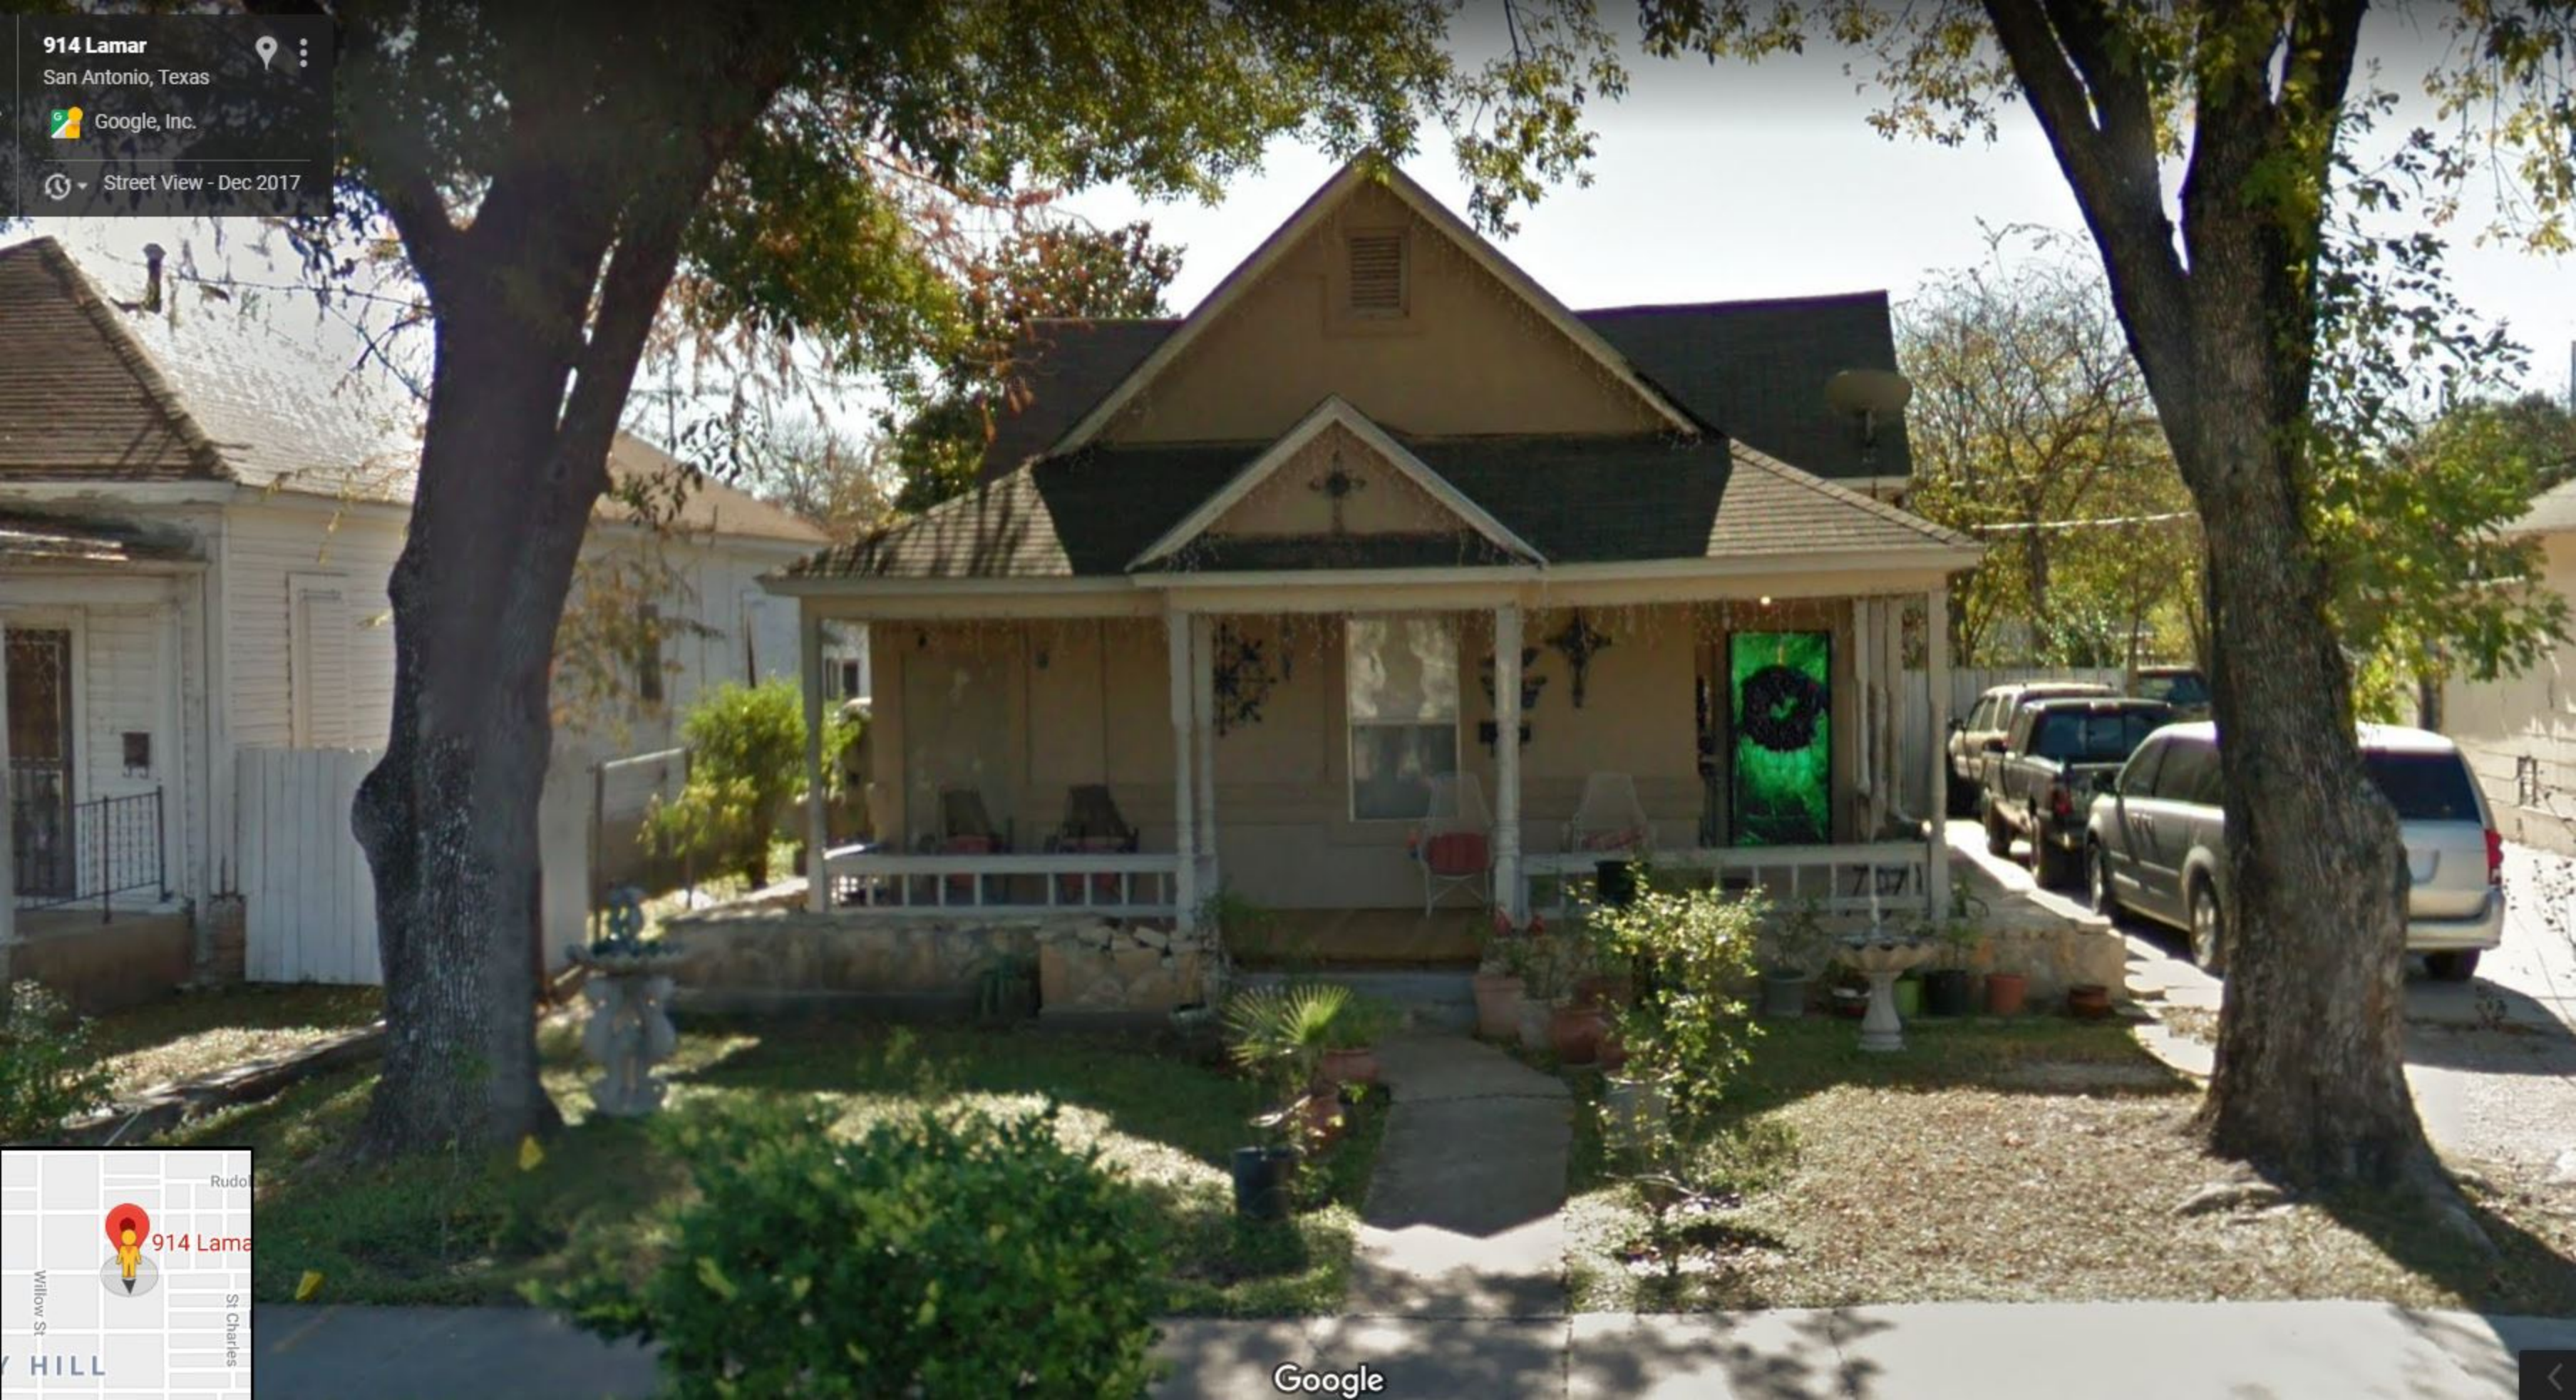
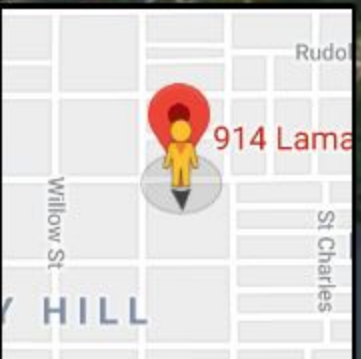
914 Lamar
San Antonio, Texas

Street View - Dec 2017

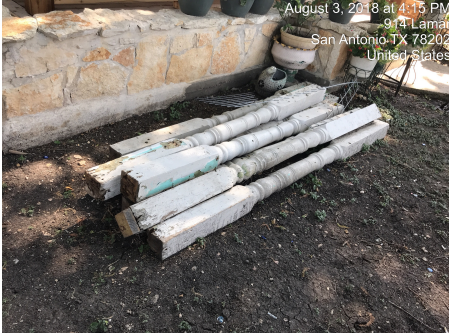
<p>August 3, 2018 at 4:13 PM 914 Lamar San Antonio, TX 78202 United States</p>

- b. On a site visit conducted on August 3, 2018, staff found that the front porch that once features Folk Victorian elements were replaced with cattle-panel fencing, square columns, and 2x6 wood decking. Staff advised that the original columns that were still on site be retained until the conclusion of an HDRC hearing. The applicant submitted the design as installed on December 5, 2018 and had notified staff that the original columns have been discarded. The \$500 post-work application fee has not been paid at this time.

Staff does not recommend approval of the porch modifications based on finding b and c. Staff recommends the reconstruction of the original porch configuration featuring:
