## HISTORIC AND DESIGN REVIEW COMMISSION

February 06, 2019

**HDRC CASE NO:** 2019-042  
**ADDRESS:** 125 W ASHBY PLACE  
**LEGAL DESCRIPTION:** NCB 1885 BLK LOT A1  
**ZONING:** R-6, H  
**CITY COUNCIL DIST.:** 1  
**DISTRICT:** Monte Vista Historic District  
**APPLICANT:** Craig Scott/CROSS  
**OWNER:** David and Alicia Garrett  
**TYPE OF WORK:** Basement window installation  
**APPLICATION RECEIVED:** January 22, 2019  
**60-DAY REVIEW:** March 21, 2019

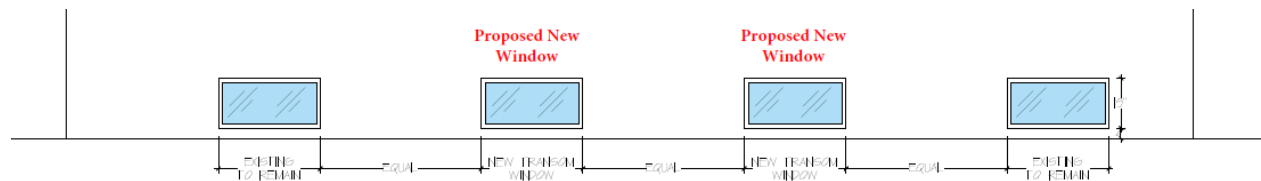
WEST EXTERIOR ELEVATION

- Homeowners would like to replace two existing windows with the same like and quality
- Create two additional window openings with the same original detail to the basement
- A total of four new awning windows would be installed
- Window Type: MARVIN Wood exterior, size RO 37 3/8" x 19 15/16"
- CROSS will carefully remove the basement exterior brick, to be re-used.

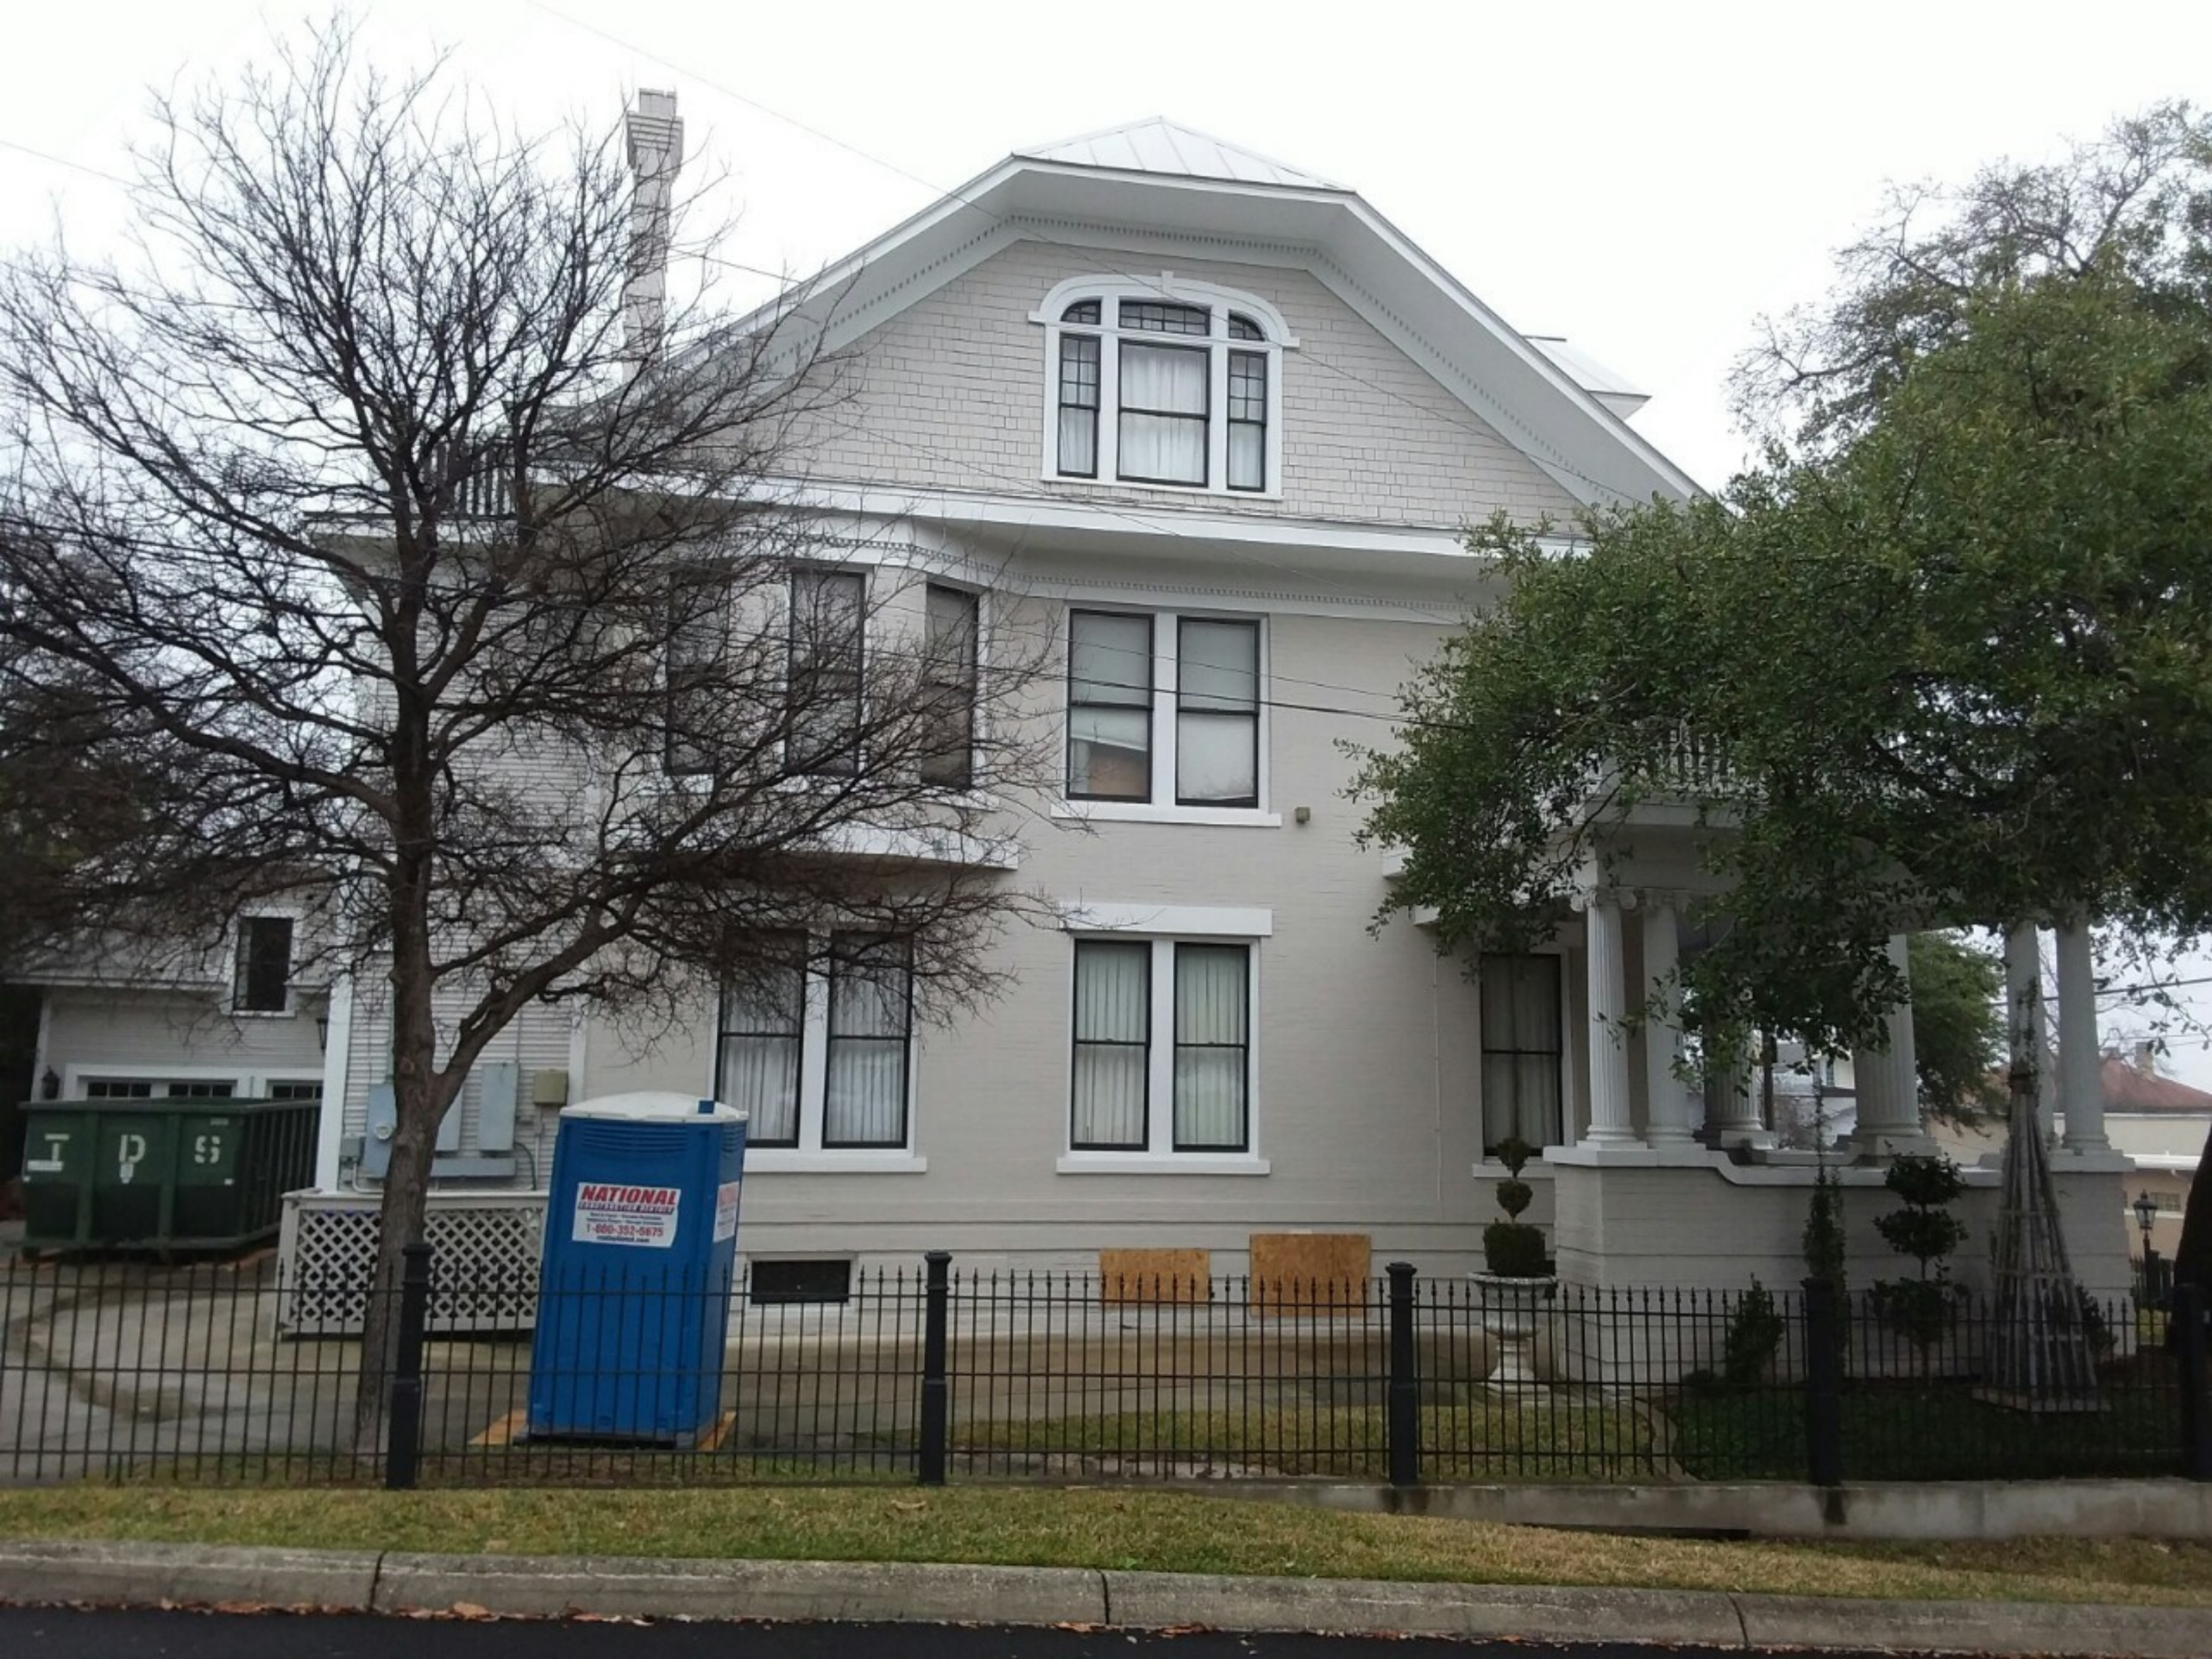
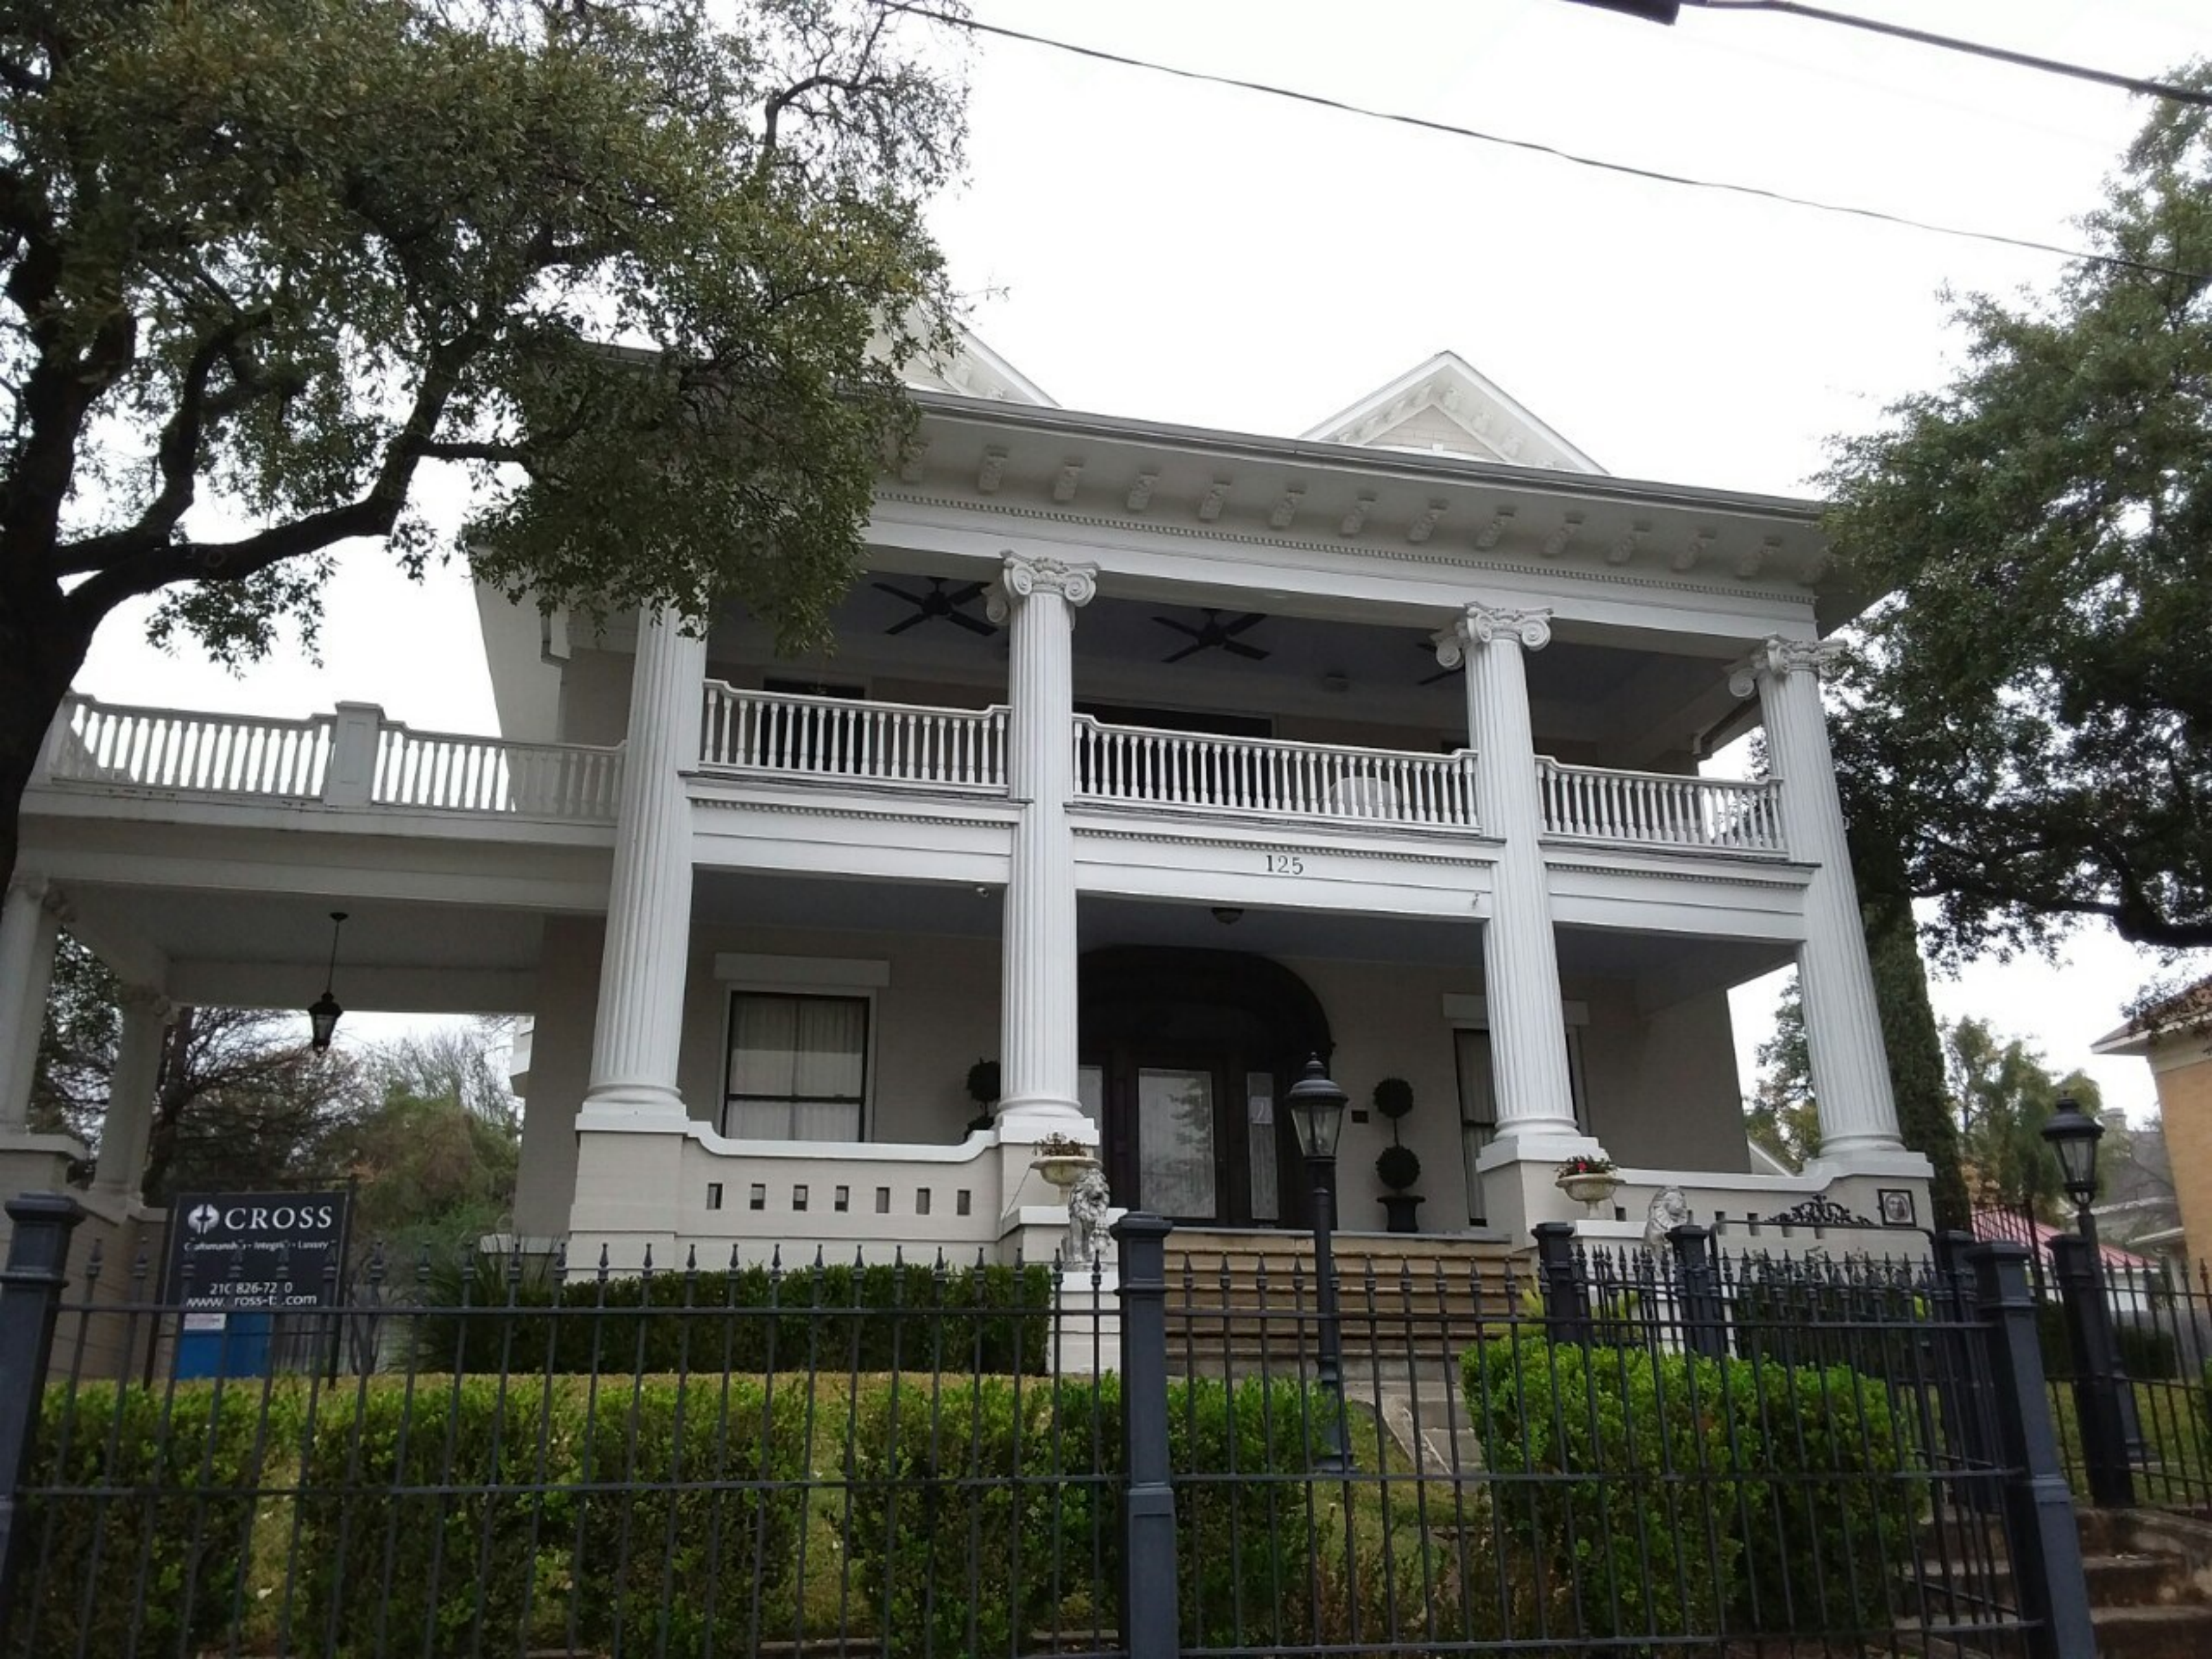
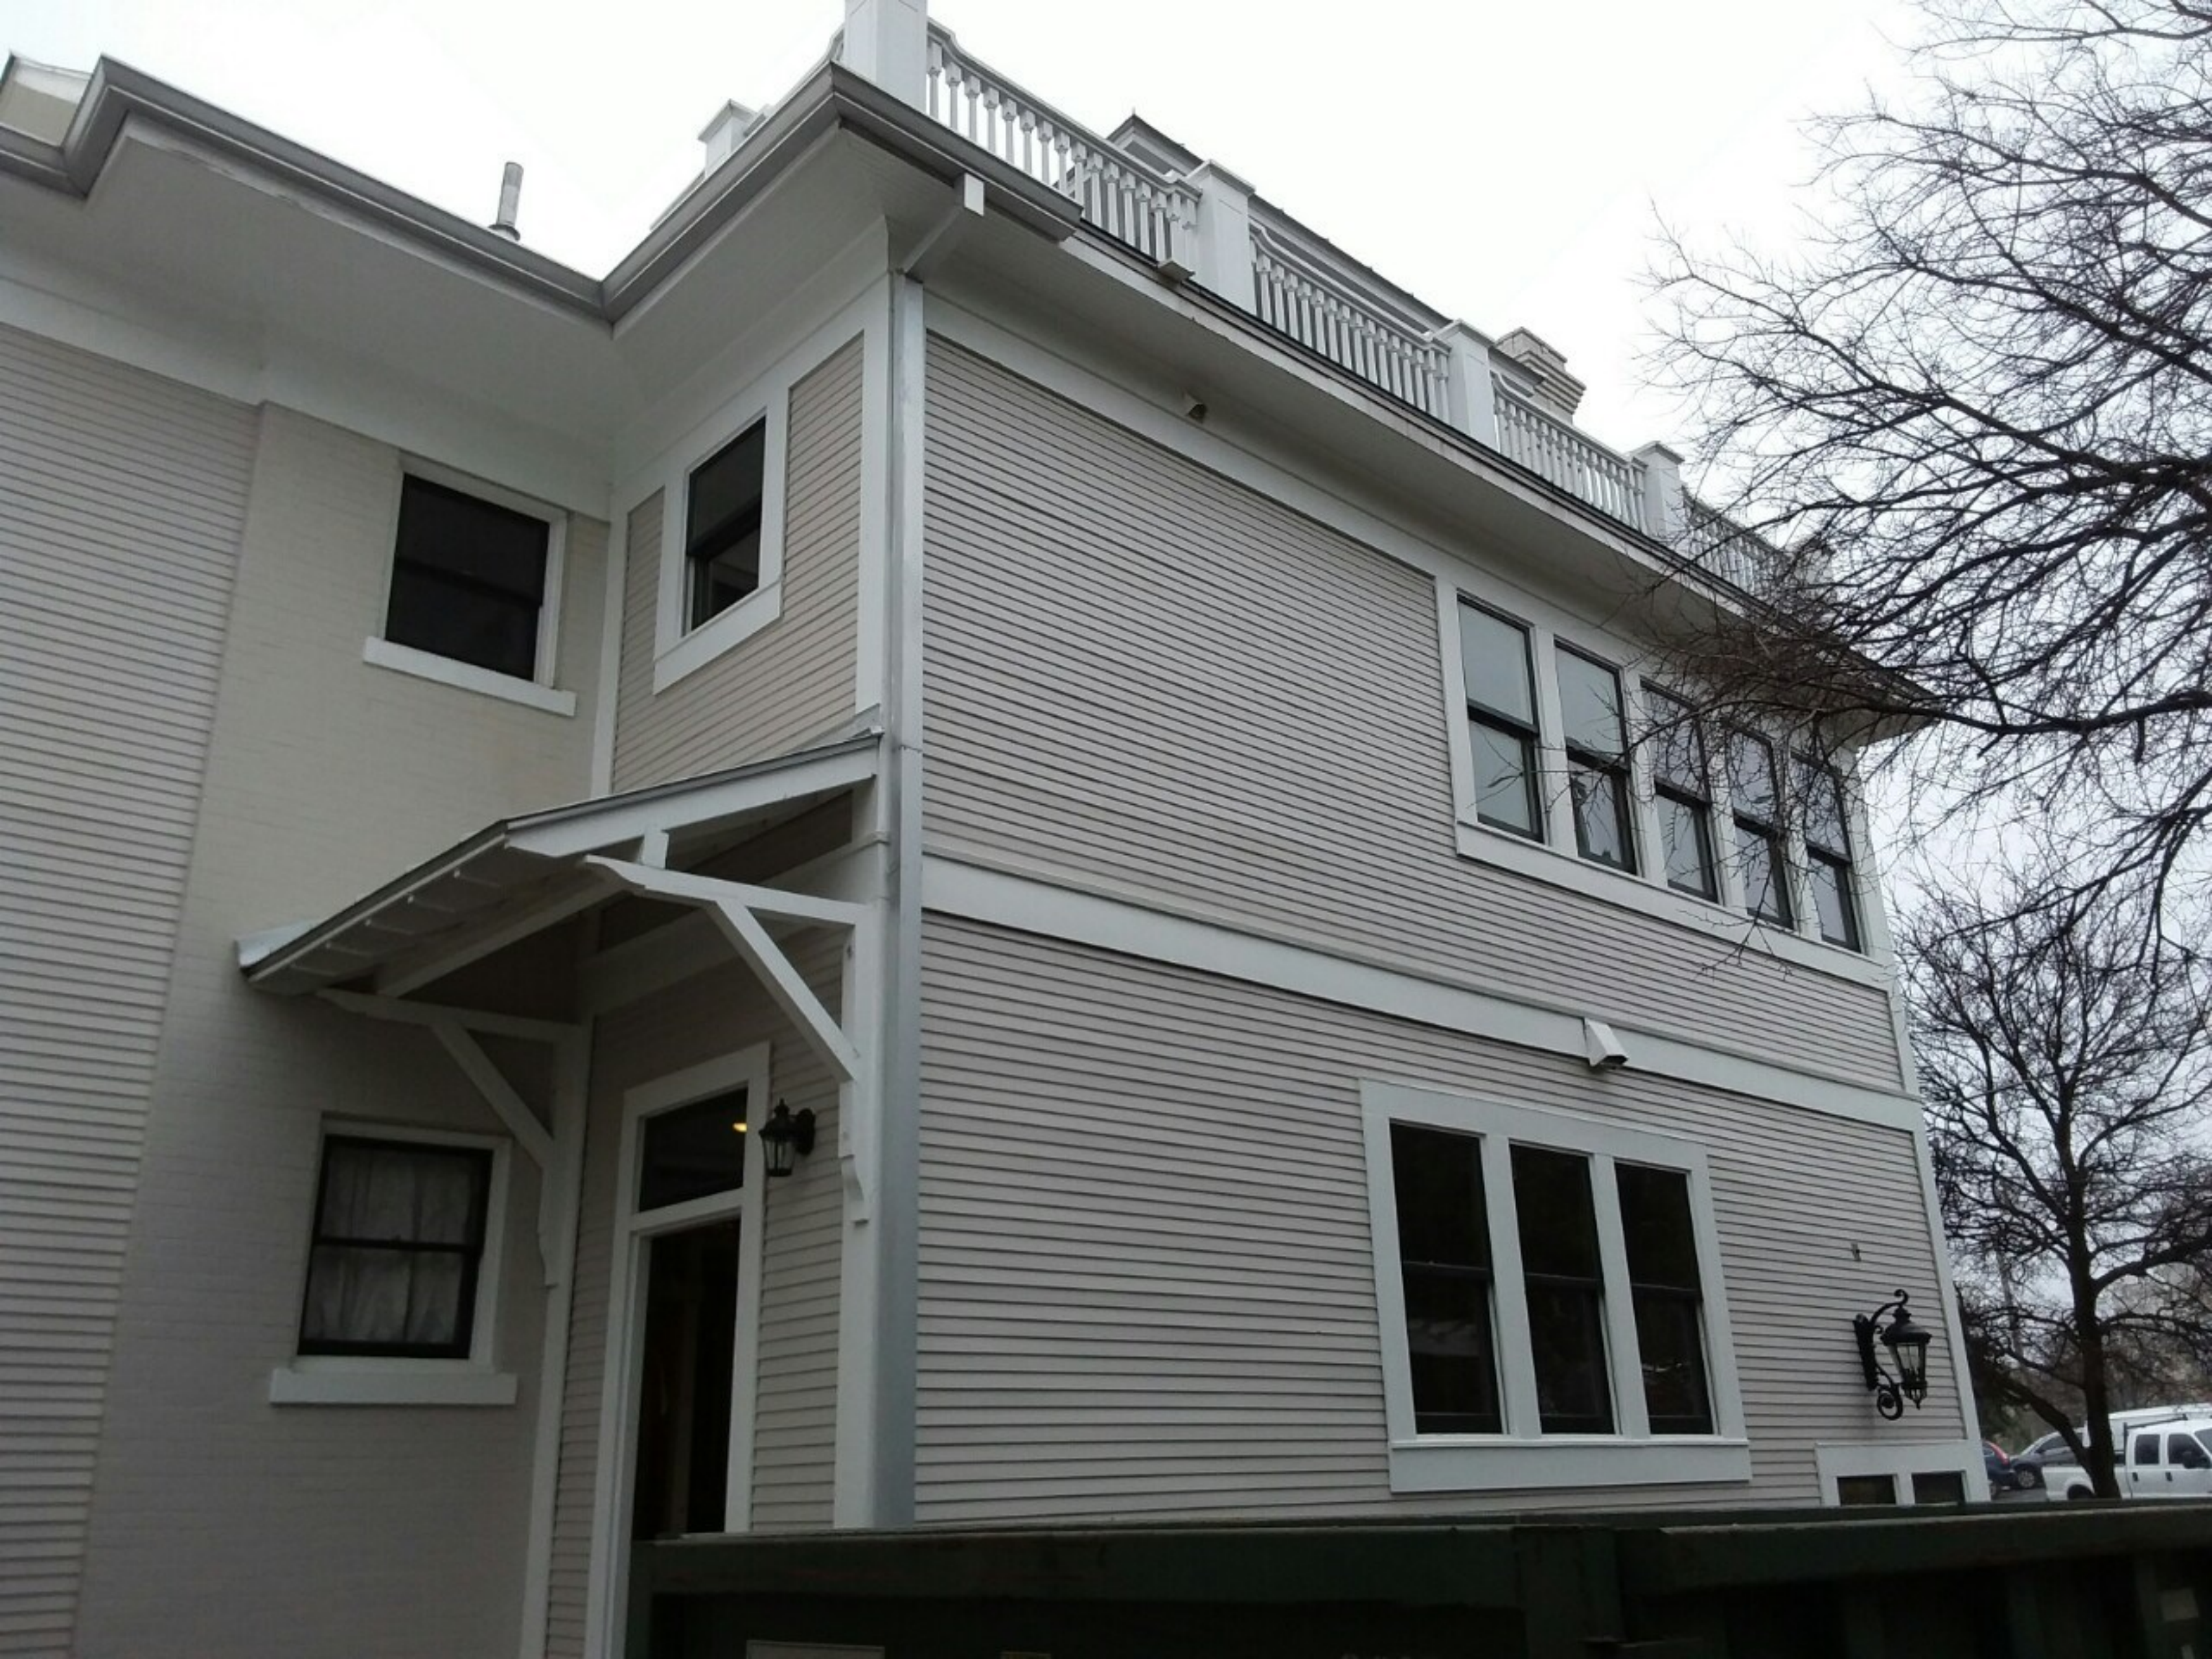
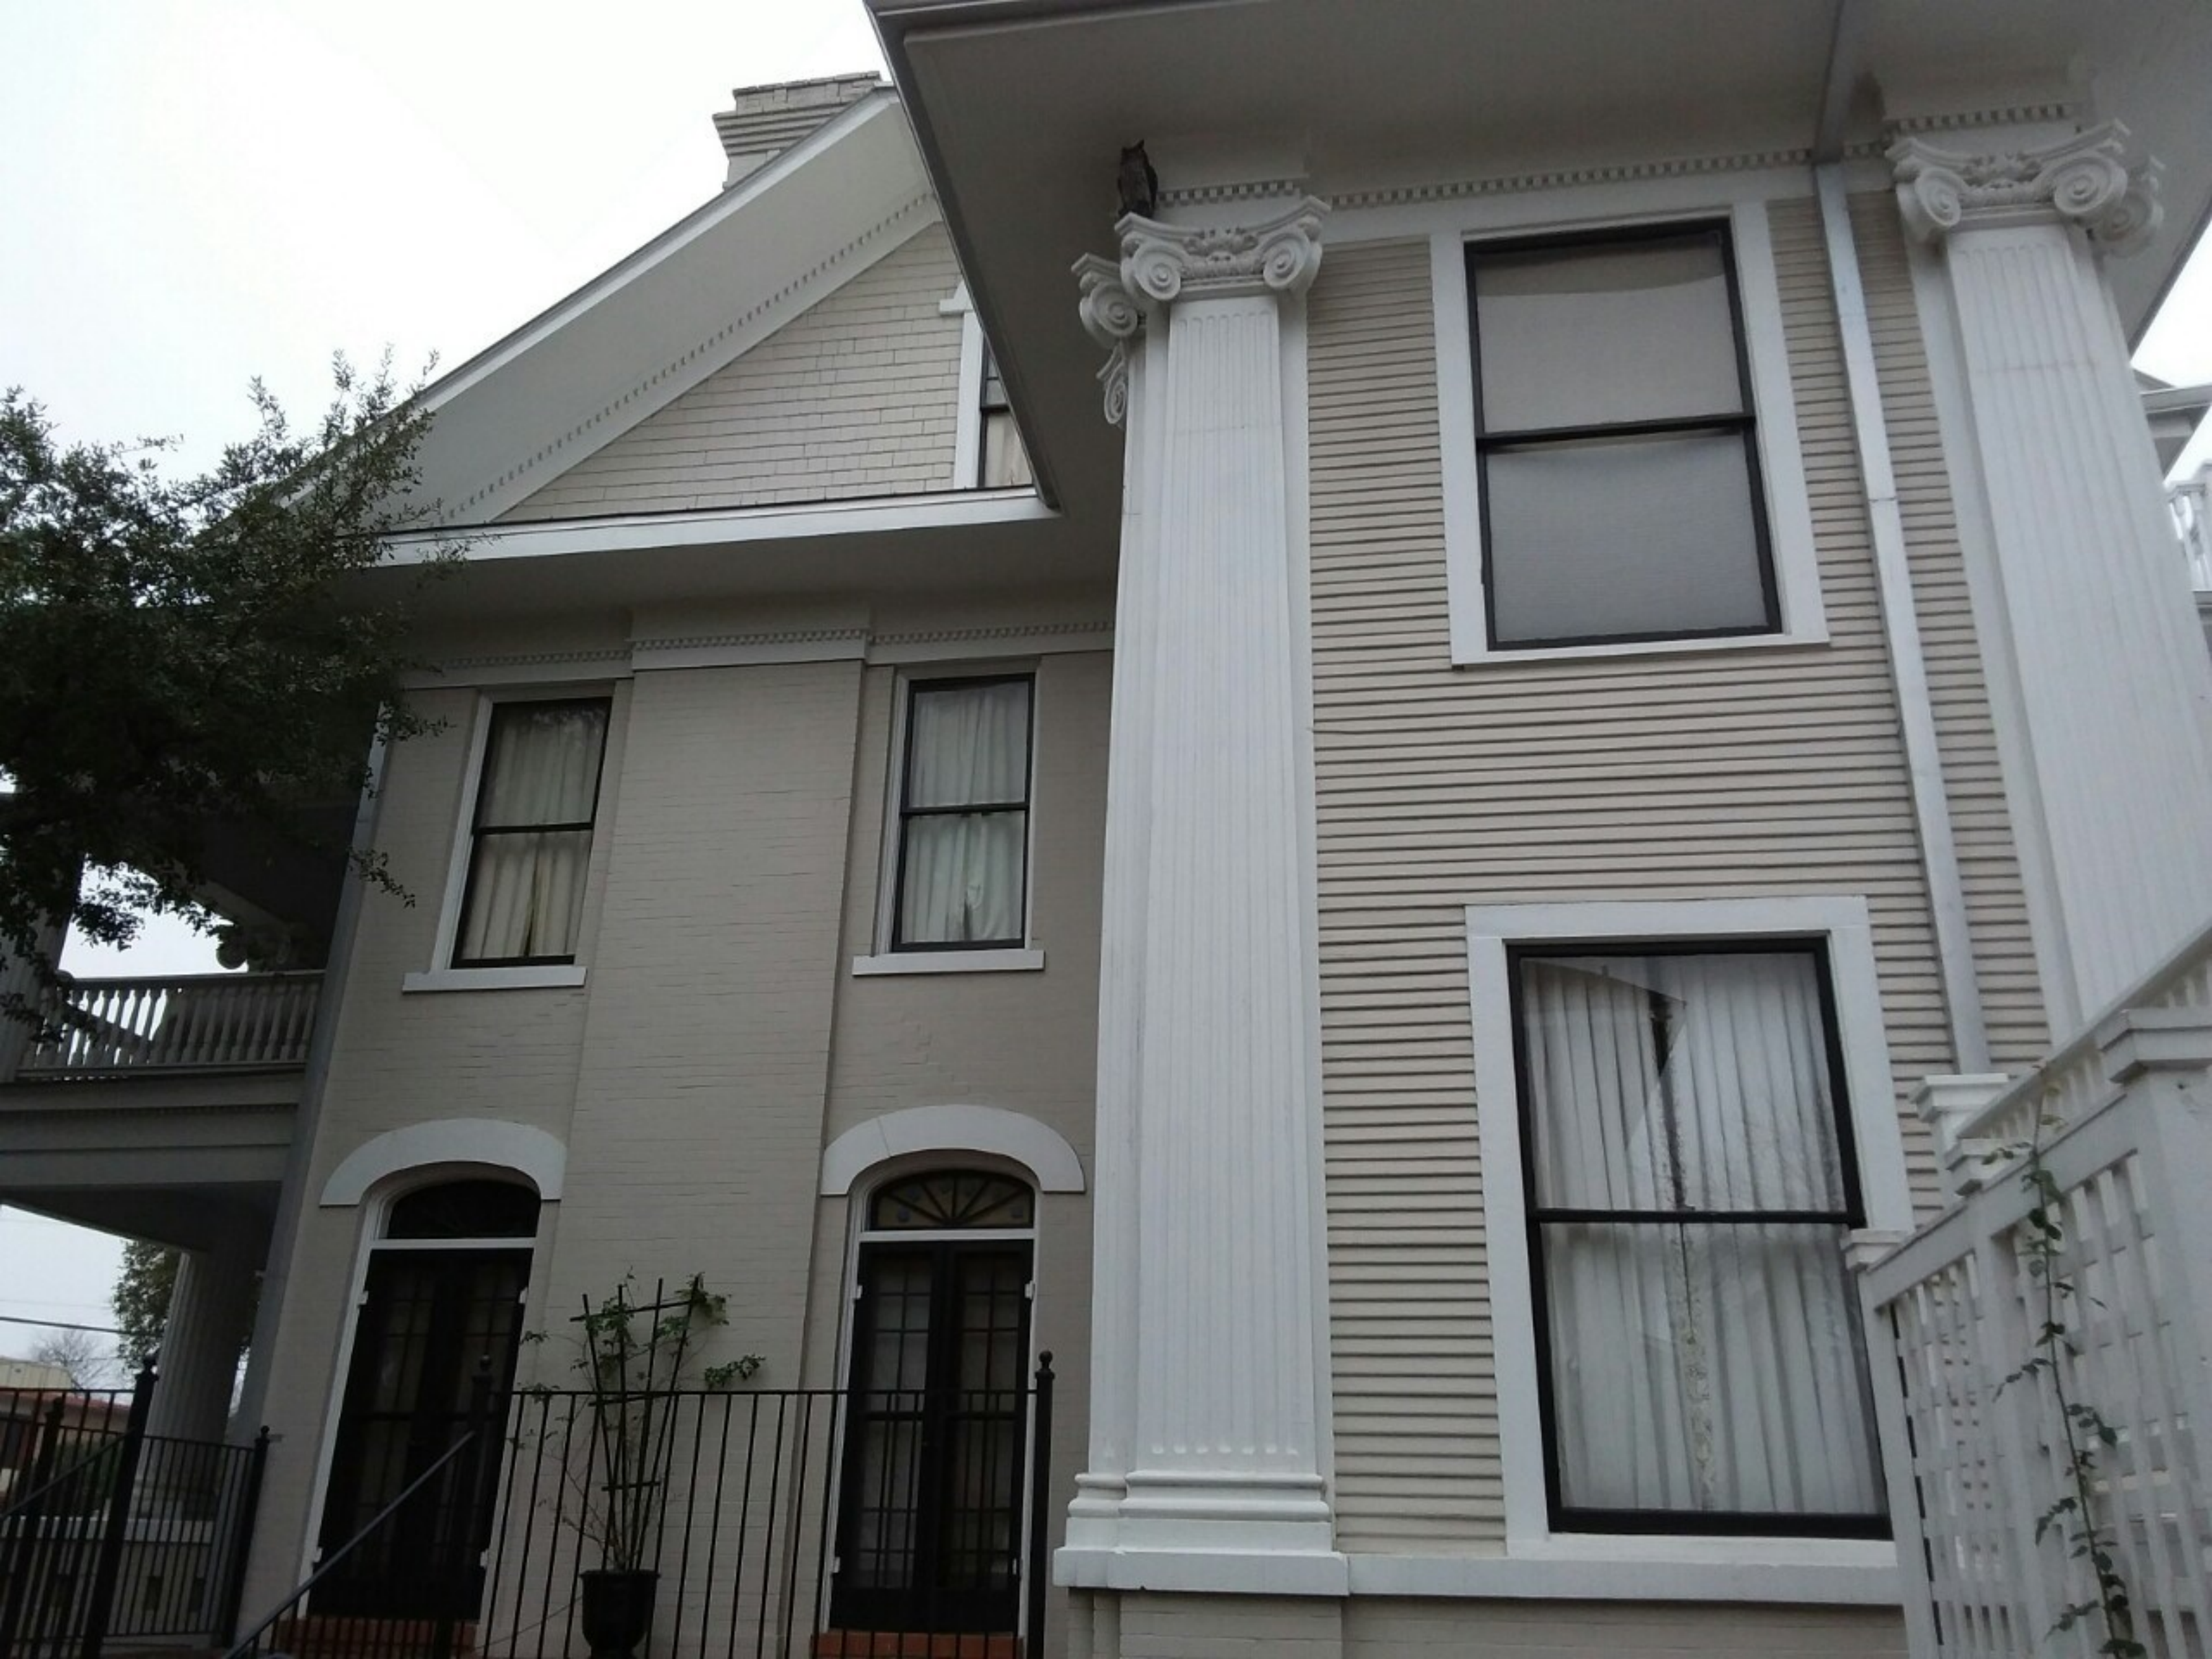
- b. VIOLATION – On a site visit conducted on January 9, 2019, staff found that masonry had been removed from the basement level skirting to install new window openings. After staff notified the contractors of the violation, they were cooperative towards compliance and submitted an application on January 22, 2019, to be heard at the next HDRC hearing.

- c. BASEMENT WINDOWS – The applicant has proposed to install two new transom windows to match the two existing transom windows at the basement level. Per the Guidelines for Exterior Modifications and Alterations 6.A.i., new window openings on the primary façade or visible from the public right-of-way and 6.B.iv., new windows are to match the historic or existing windows in terms of size, type, configuration, material, form, appearance, and detail when original windows are deteriorated beyond repair. Staff finds that the proposed new windows are constituent with the Guidelines as they are located on a side elevation at the basement level and match the existing windows in size, depth, material, and installed in an equidistant pattern. However, staff finds that the historic masonry removed from the new window openings should remain on site for reuse.

Date	01/09/2019
Time	03:04 PM (-6 GMT)
Context	citizen report
Present Staff	Huy Pham
Present Individuals	Contractor(s), Crew member(s)
Present Companies	Cross
Types of Work Observed	Exterior Maintenance and Alterations
Amount of Work Completed	50%
Description of work	Removal of basement level brick to initiate installation of two new windows.

Staff recommends approval based on finding c with the following stipulations:
