HISTORIC AND DESIGN REVIEW COMMISSION

February 06, 2019

HDRC CASE NO: 2018-462
ADDRESS: 201 E HUISACHE AVE
LEGAL DESCRIPTION: NCB 3085 BLK 1 LOT 23
ZONING: MF-33, H
CITY COUNCIL DIST.: 1
DISTRICT: Monte Vista Historic District
APPLICANT: Patrick Christensen
OWNER: SA Huisache Investors LLC
TYPE OF WORK: Window replacement
APPLICATION RECEIVED: January 16, 2019
60-DAY REVIEW: March 15, 2019
REQUEST:

The applicant is requesting a Certificate of Appropriateness for approval of a window master plan in response to the commission action at the HDRC hearing on August 19, 2018.

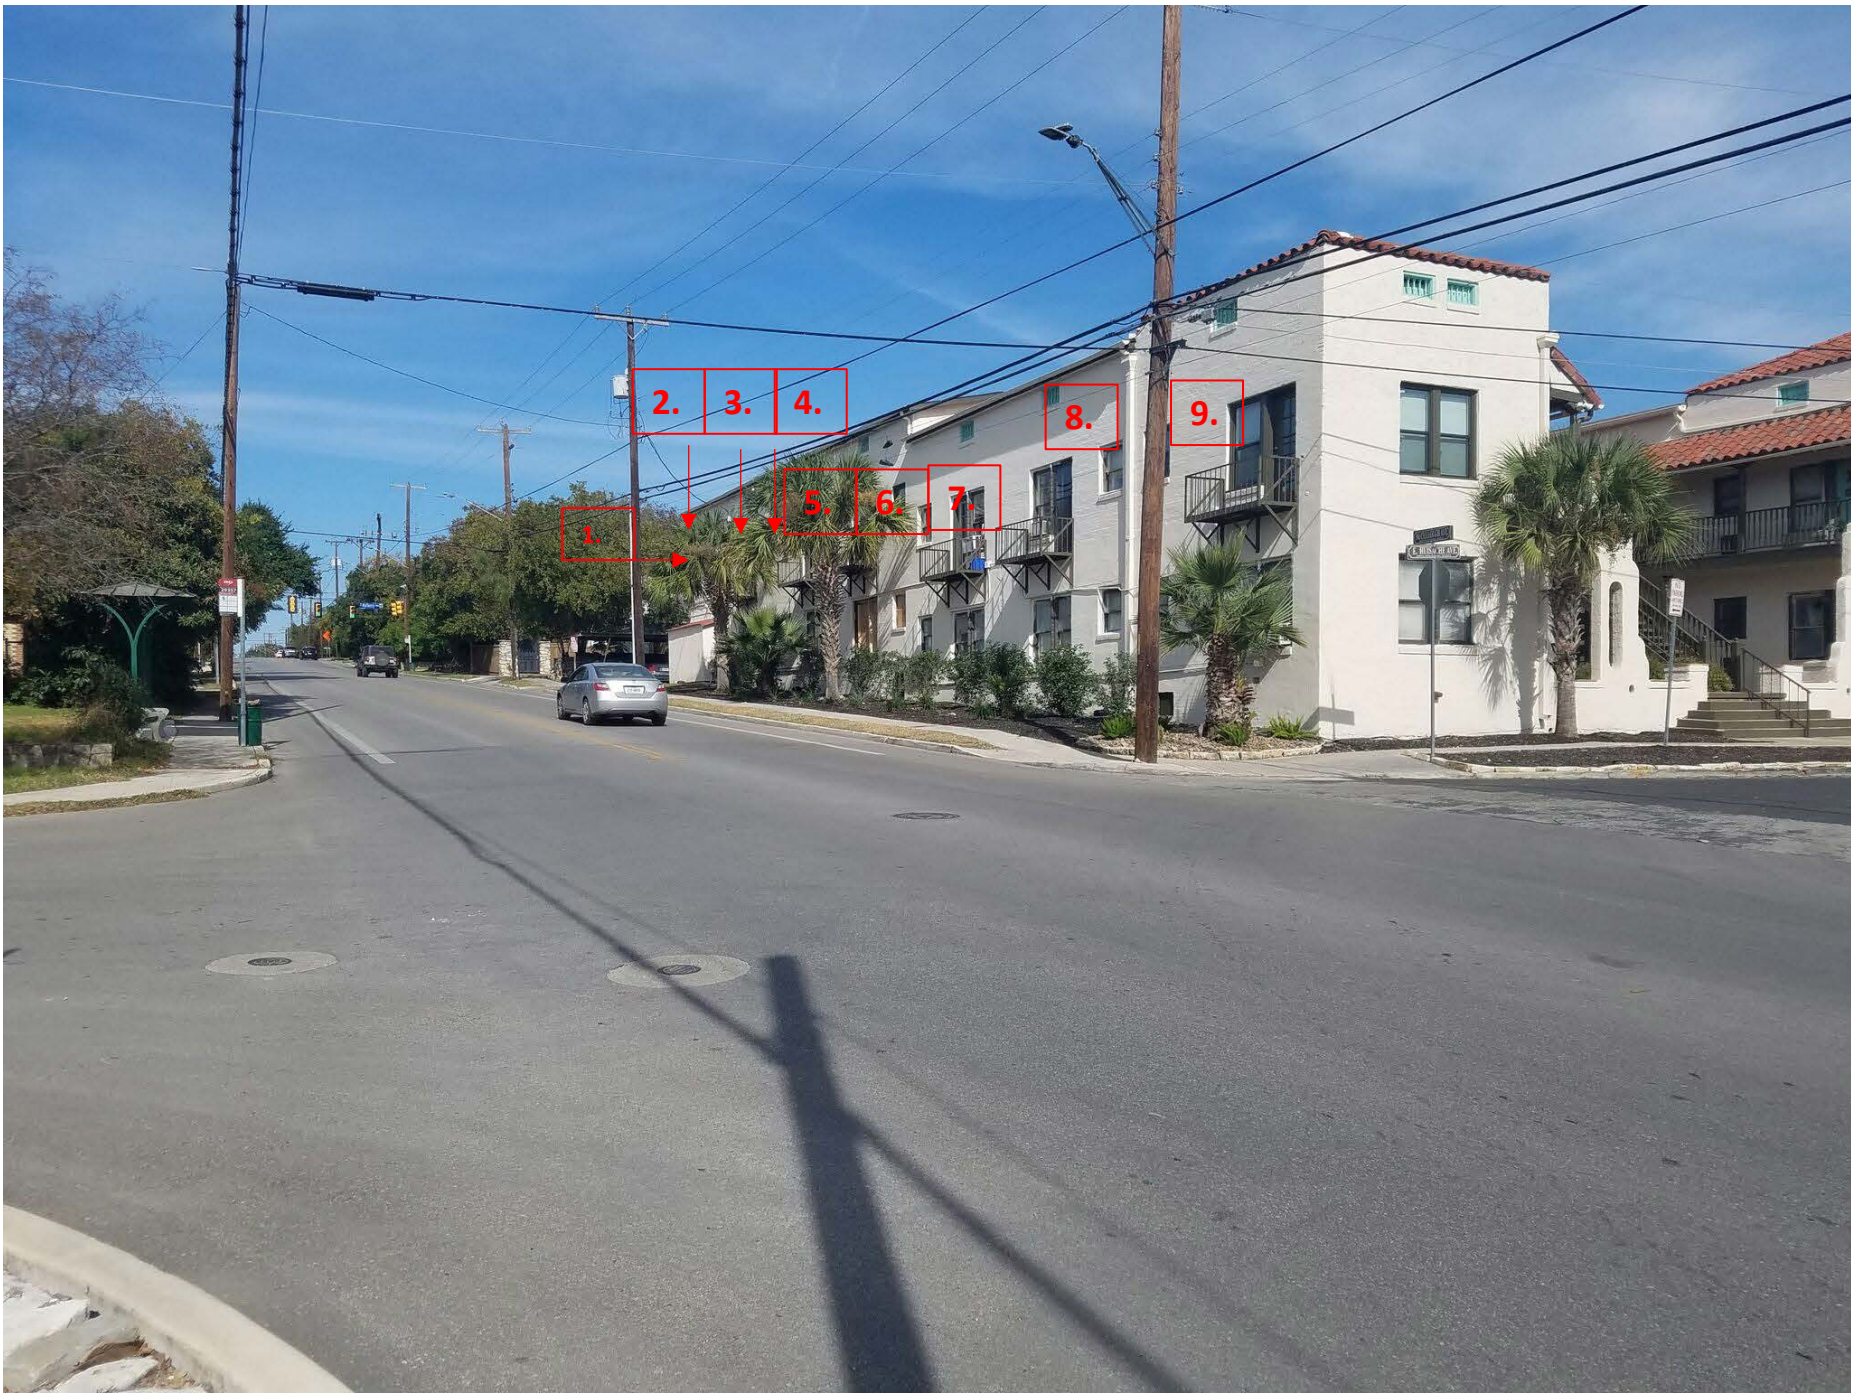
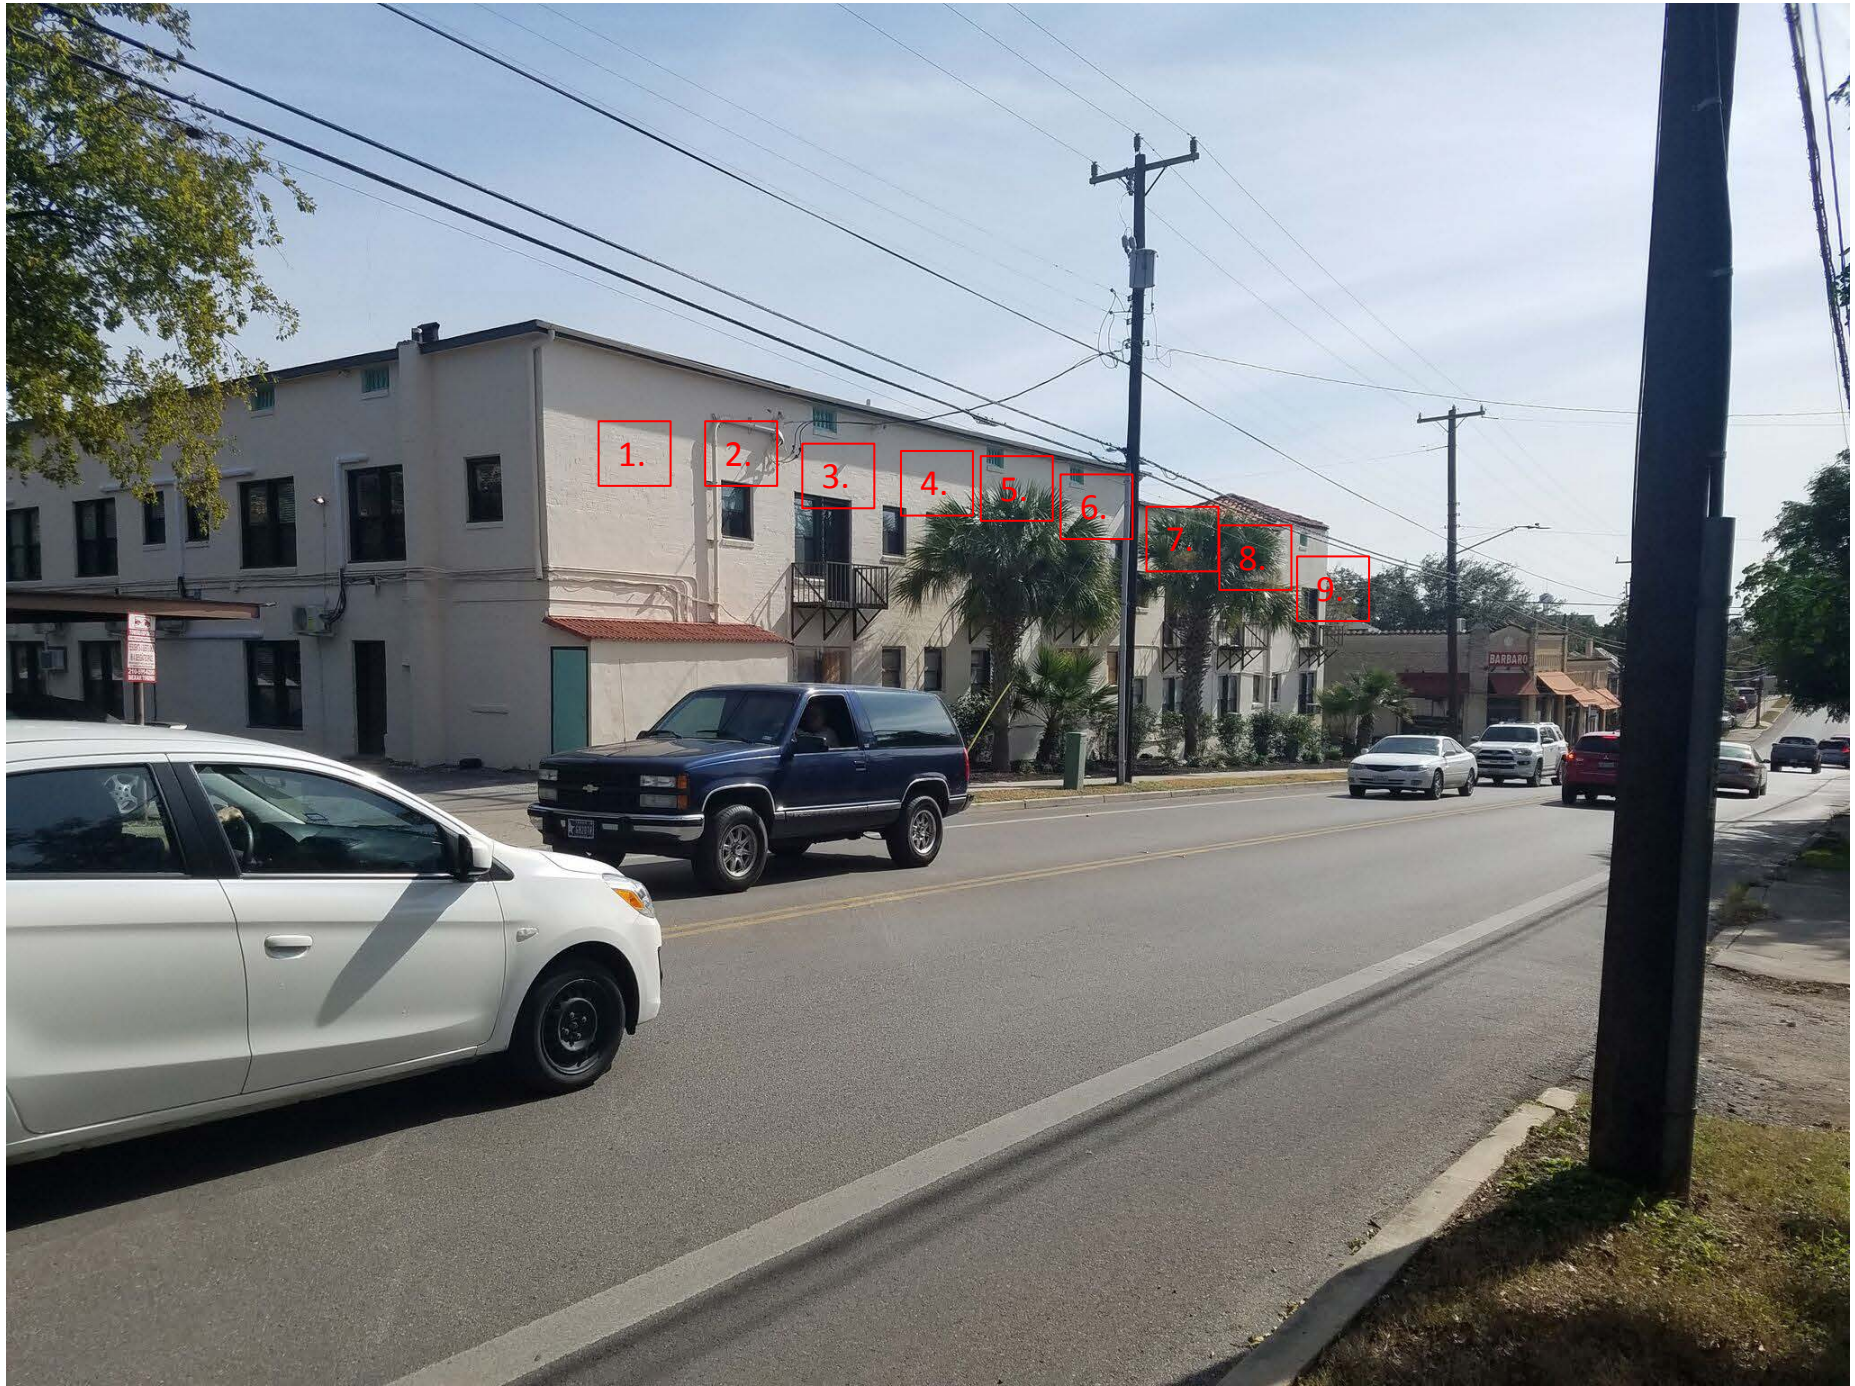
201 E. Huisache

The following photos are existing window conditions:

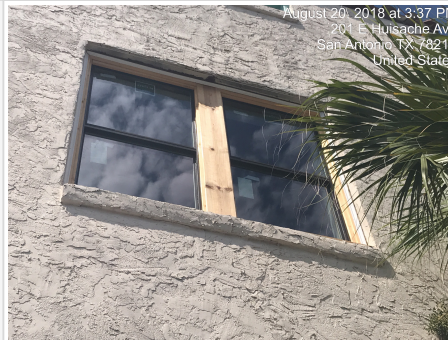
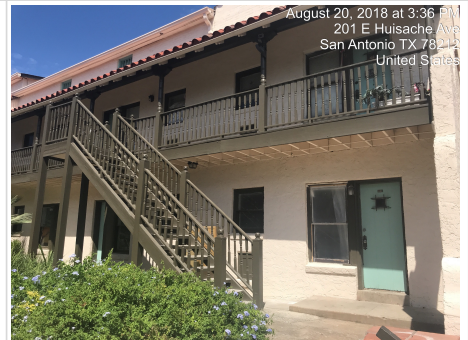
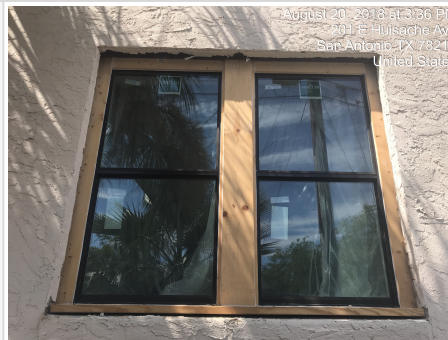
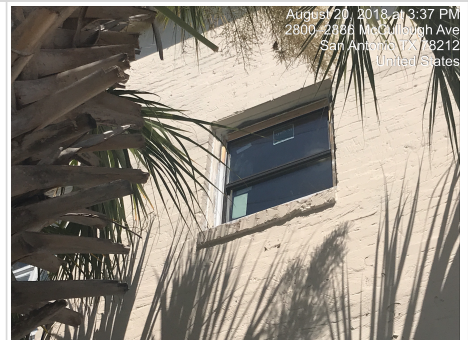
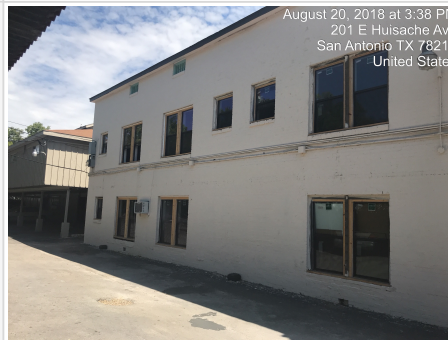
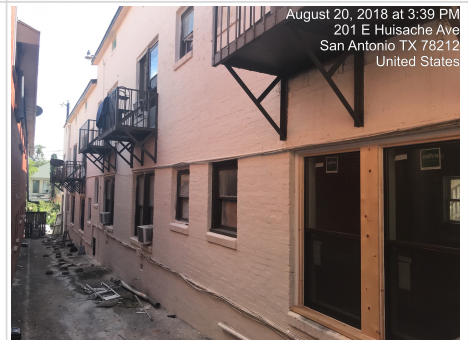
Investigation Report

Date	08/20/2018
Time	03:41 PM (-5 GMT)
Context	citizen report
Present Staff	Huy Pham
Present Individuals	None
Types of Work Observed	Exterior Maintenance and Alterations
Amount of Work Completed	75%
Description of work	Removal of over 20 wood windows and doors and installation of aluminum windows.

Violation Type	No Certificate of Appropriateness (Code 35-451a)
OHP Action	posted "Notice of Investigation", posted "Stop Work Notice"
Deadline to contact office	08/20/2018
