HISTORIC AND DESIGN REVIEW COMMISSION

February 06, 2019

HDRC CASE NO: 2019-024
ADDRESS: 1201 E CROCKETT ST
LEGAL DESCRIPTION: NCB 1373 BLK 1 LOT W 77.4 FT OF 9 & 10
ZONING: MF-33, H
CITY COUNCIL DIST.: 2
DISTRICT: Dignowity Hill Historic District
APPLICANT: Nate Manfred/French and Michigan
OWNER: Keith Jones/JT Renovations
TYPE OF WORK: Amendments to previously approved materials
APPLICATION RECEIVED: January 18, 2019
60-DAY REVIEW: March 17, 2019

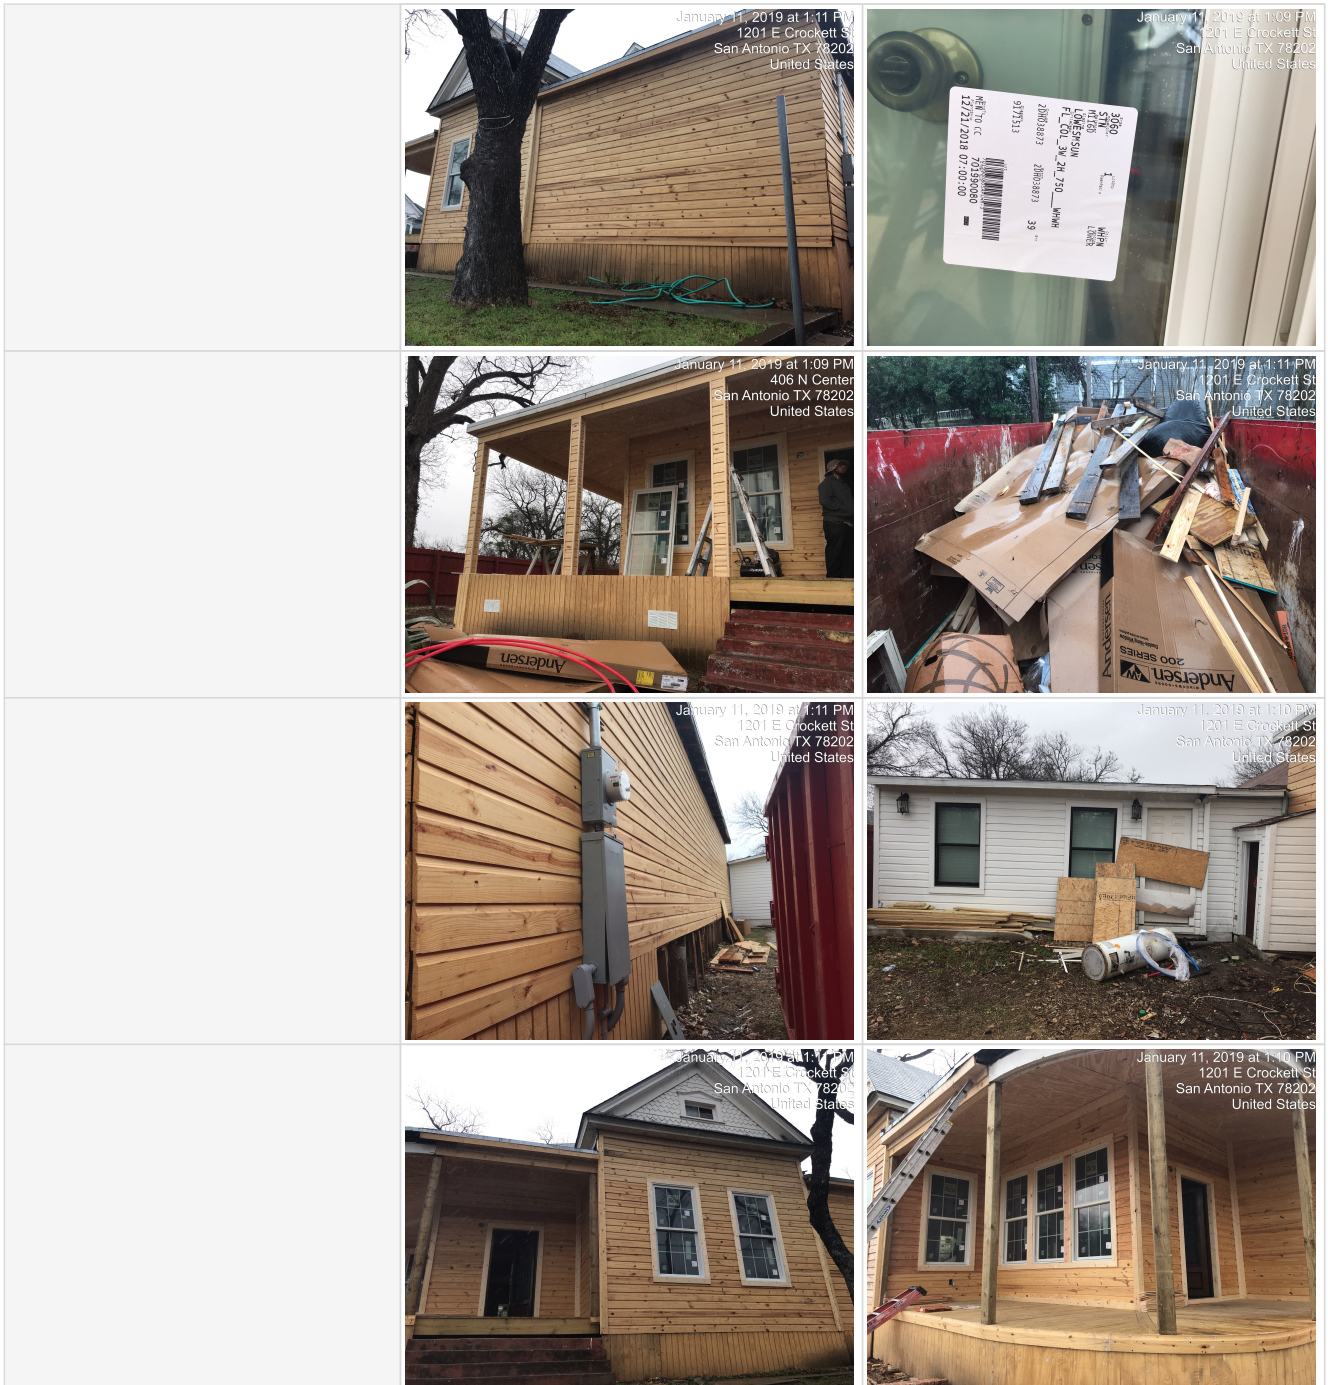
Investigation Report

Date	01/11/2019
Time	01:13 PM (-6 GMT)
Context	citizen report
Present Staff	Huy Pham
Present Individuals	Contractor(s), Crew member(s)
Present Companies	JT Renovations
Types of Work Observed	Exterior Maintenance and Alterations
Amount of Work Completed	50%
Description of work	Installation of vinyl windows, removal of window openings, installation of new skirting, replacement or modifications of existing Folk Victorian columns and spindle work.

Violation Type	No Certificate of Appropriateness (Code 35-451a), Beyond scope of Certificate of Appropriateness (Code 35-451h)
OHP Action	Spoke with property owner, Spoke with contractor(s) and/or crew
Deadline to contact office	01/11/2019
Will post-work application fee apply?	Yes
