HISTORIC AND DESIGN REVIEW COMMISSION

February 20, 2019

HDRC CASE NO: 2019-065
ADDRESS: 228 LAVACA ST
LEGAL DESCRIPTION: NCB 713 BLK 10 LOT E 3.7 OF N 95.1 OF 14, W 9 OF N 91.5 OF 15 & W 45.1 OF E 49.1 OF 15
ZONING: RM-4, H
CITY COUNCIL DIST.: 1
DISTRICT: Lavaca Historic District
APPLICANT: Clint Belew/LRRB Holdings LLC
OWNER: Clint Belew/LRRB Holdings LLC
TYPE OF WORK: Hardie skirting
APPLICATION RECEIVED: February 1, 2019
60-DAY REVIEW: April 1, 2019
REQUEST:

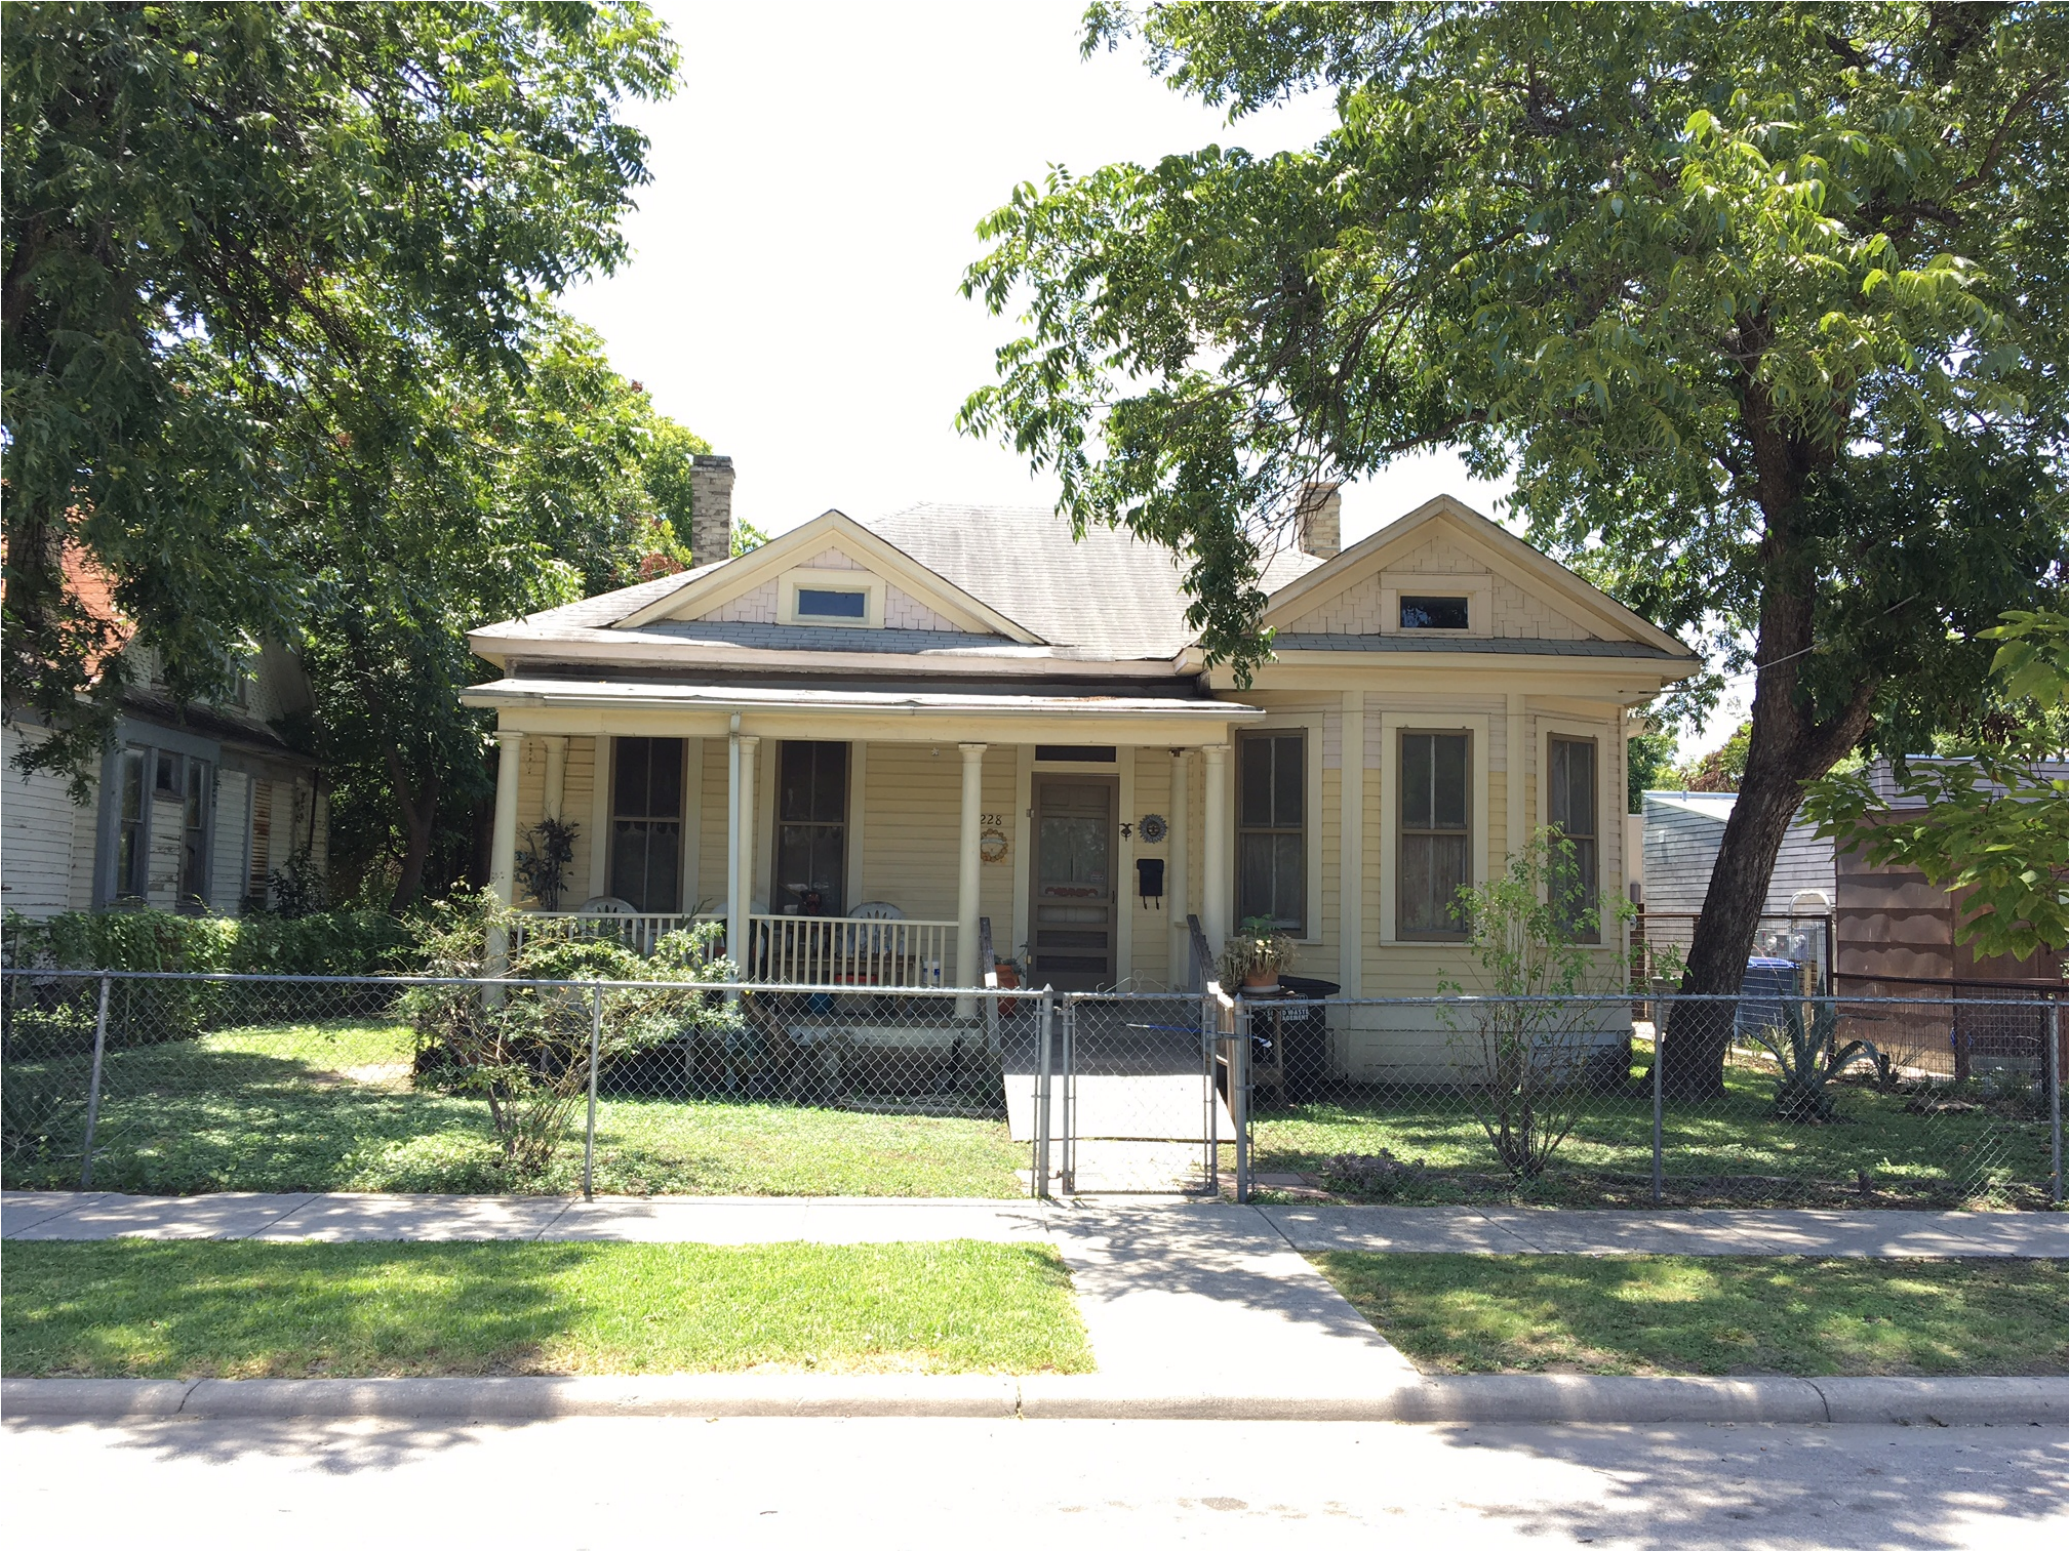
- c. VIOLATION – On site visit conducted on July 16, 2018, staff found that a side window was removed prior to approval and that the skirting on the foundation and porch was installed inconsistently with the scope of approval. The owner/applicant has restored the window and submitted an HDRC application to amend the detail regarding skirting on February 1, 2019, to be heard at the next HDRC hearing.

July 16, 2018 at 3:11 PM
224 Lavaca St
San Antonio TX 78210
United States

Staff does not recommended approval to amend previous approvals regarding skirting on the foundation and porch. Staff finds that the both elements should feature lap siding with 4 to 6 inch exposure with either smooth Hardie or wood.
