## HISTORIC AND DESIGN REVIEW COMMISSION

**HDRC CASE NO:** 2019-079  
**ADDRESS:** 112 LINDELL PLACE  
**LEGAL DESCRIPTION:** NCB 6204 BLK 5 LOT 1  
**ZONING:** MF-33, H, RIO-1  
**CITY COUNCIL DIST.:** 1  
**DISTRICT:** River Road Historic District  
**APPLICANT:** Jim Bailey/Alamo Architects  
**OWNER:** Asher Reilley  
**TYPE OF WORK:** Amendments to a previously approved design including the reconstruction of original walls  
**APPLICATION RECEIVED:** February 15, 2019  
**60-DAY REVIEW:** April 16, 2019  
**REQUEST:**

RE: Engineer's Opinion Statement  
**112 Lindell Place**  
San Antonio, TX

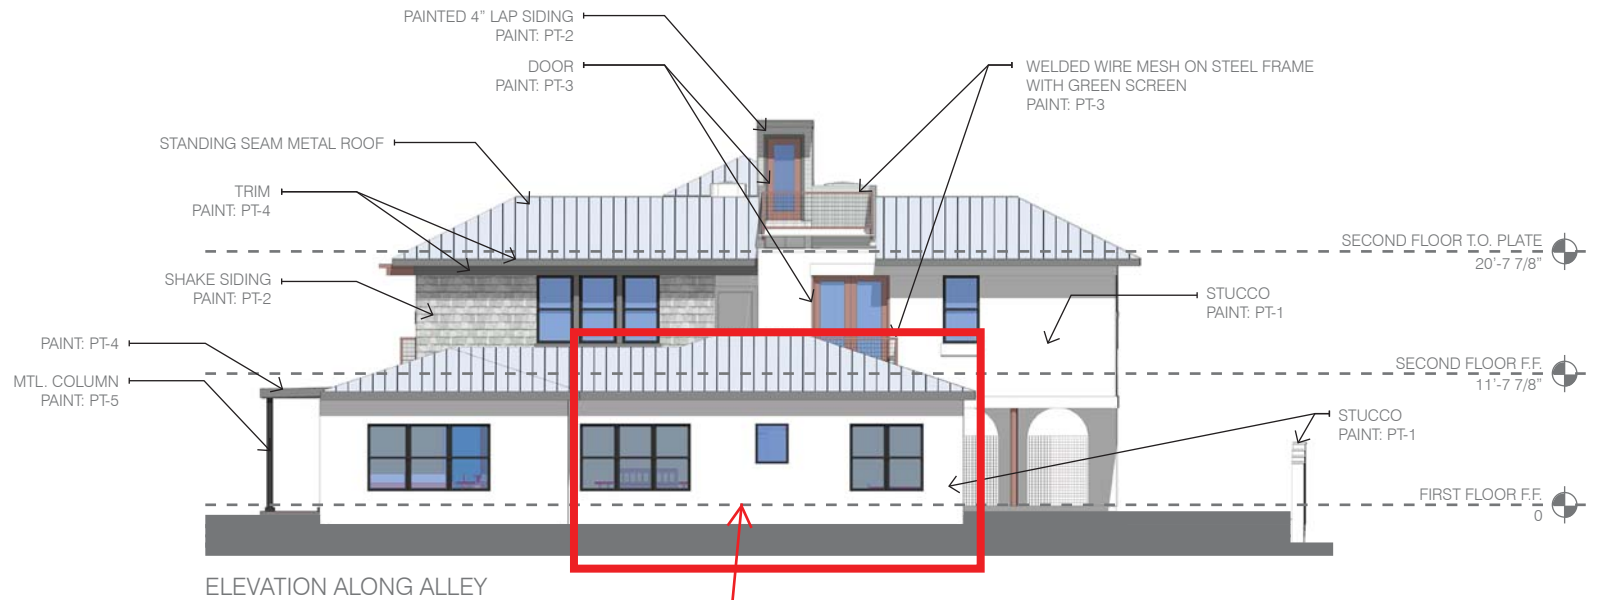
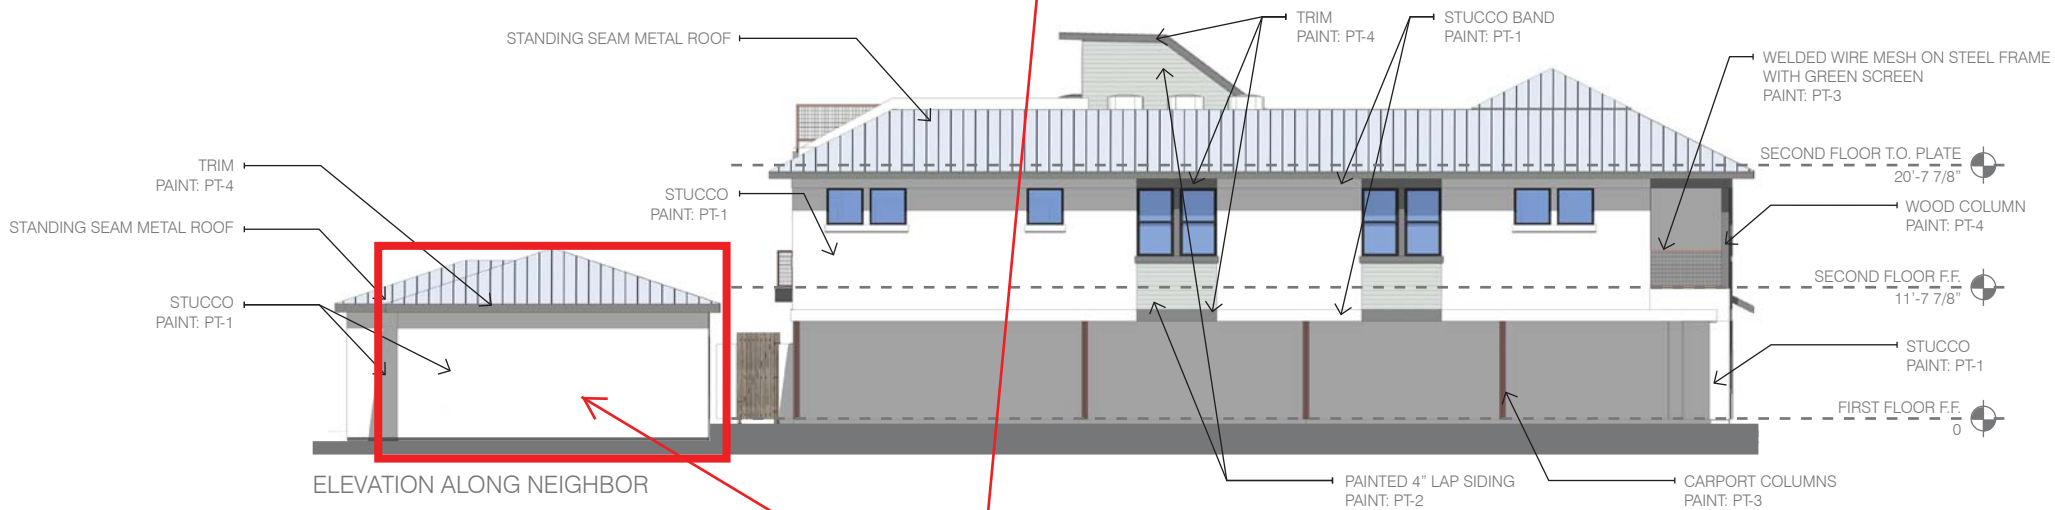
## ELEVATIONS

WALLS OF THE STANDALONE  
STRUCTURE TO BE REFURBISHED  
MASSING AND FORM OF THE  
EXISTING ELEVATIONS WILL BE  
MAINTAINED
