HISTORIC AND DESIGN REVIEW COMMISSION

March 06, 2019

HDRC CASE NO: 2019-078
ADDRESS: 124 GLORIETTA
LEGAL DESCRIPTION: NCB 576 BLK 15B LOT E 56.45 FT OF 5
ZONING: RM-4, H
CITY COUNCIL DIST.: 2
DISTRICT: Dignowity Hill Historic District
APPLICANT: Edward Casias
OWNER: Andres Casias
TYPE OF WORK: Window Replacement; removal of siding; side deck
APPLICATION RECEIVED: February 15, 2019
60-DAY REVIEW: April 14, 2019

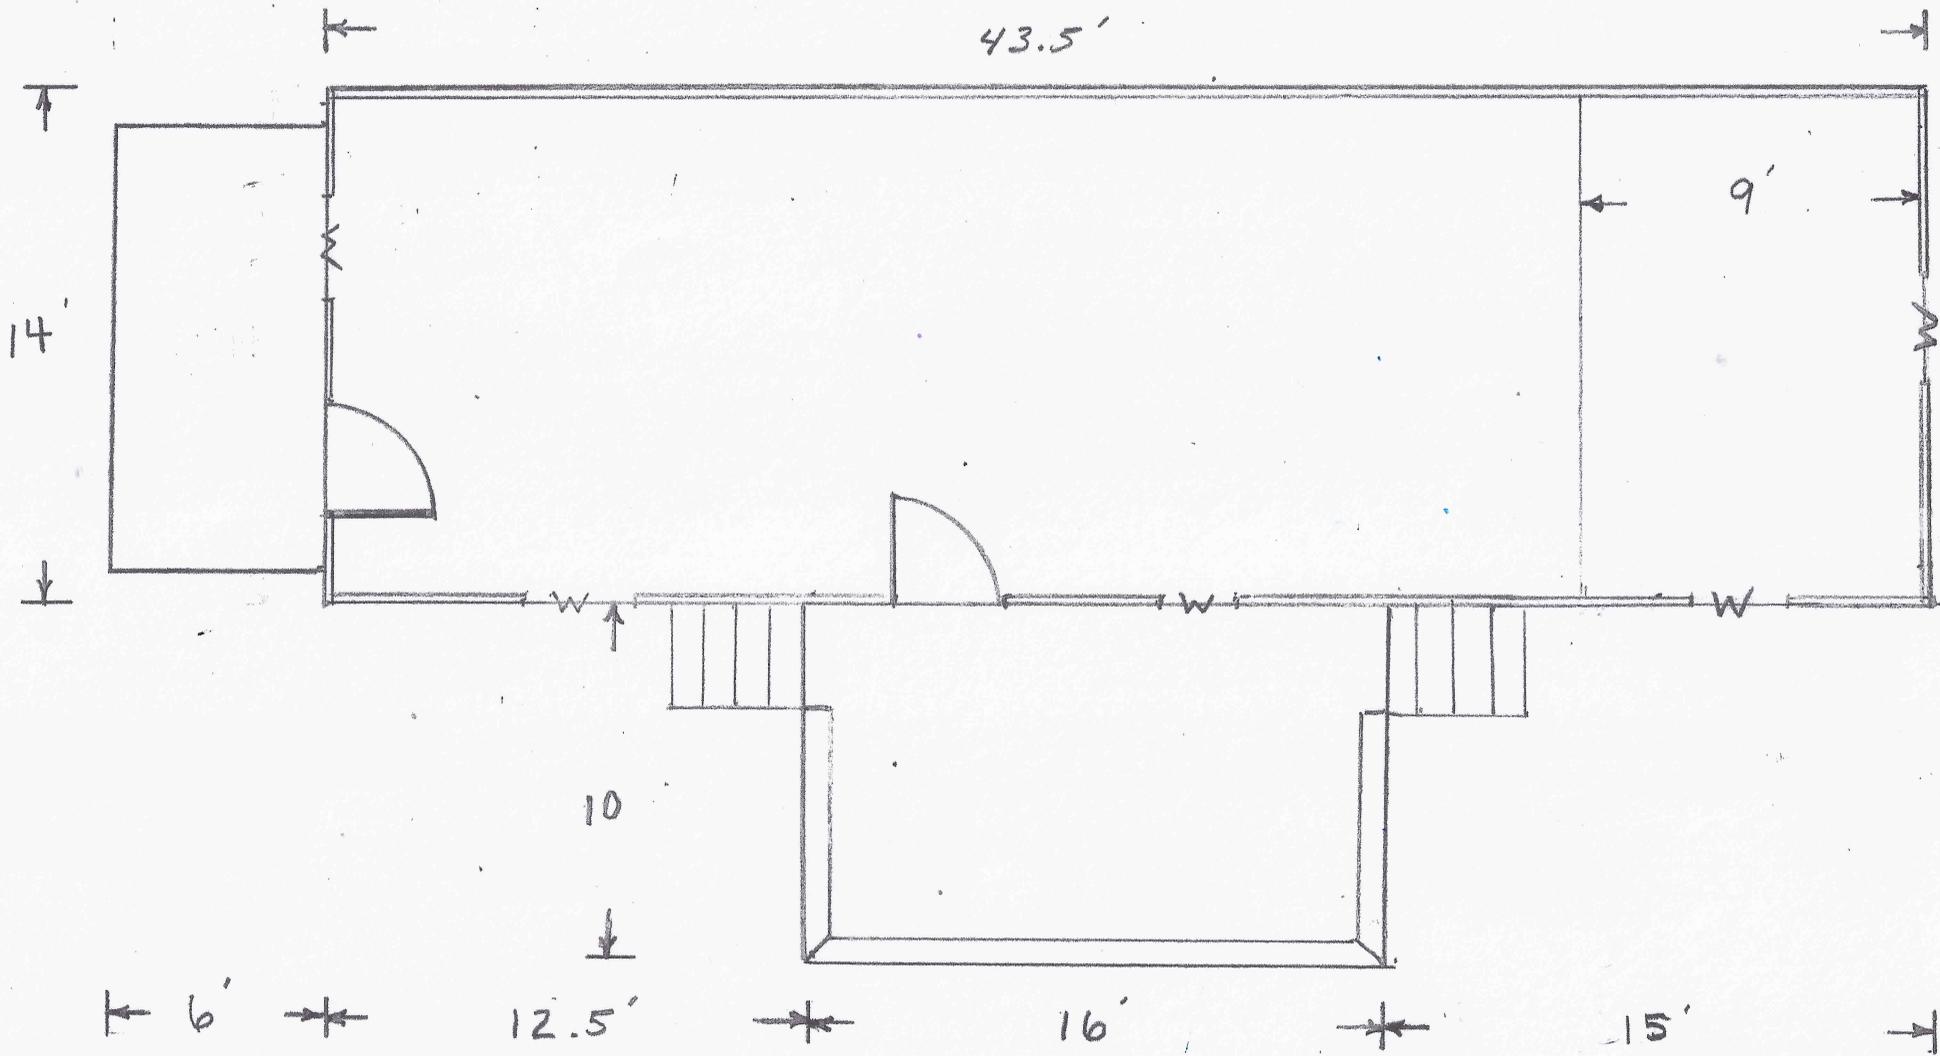
Proposed Work at 124 GLORIETTA

Remove wood lap siding to expose board and batten siding underneath.

Replace front door with metal clad wood door with glass 36"x80".

Replace front window with new wood window 36"x60".

Replace 3 west facing windows with 3 vinyl-clad wood frame windows (2)32"x54" and (1) 24"x36".

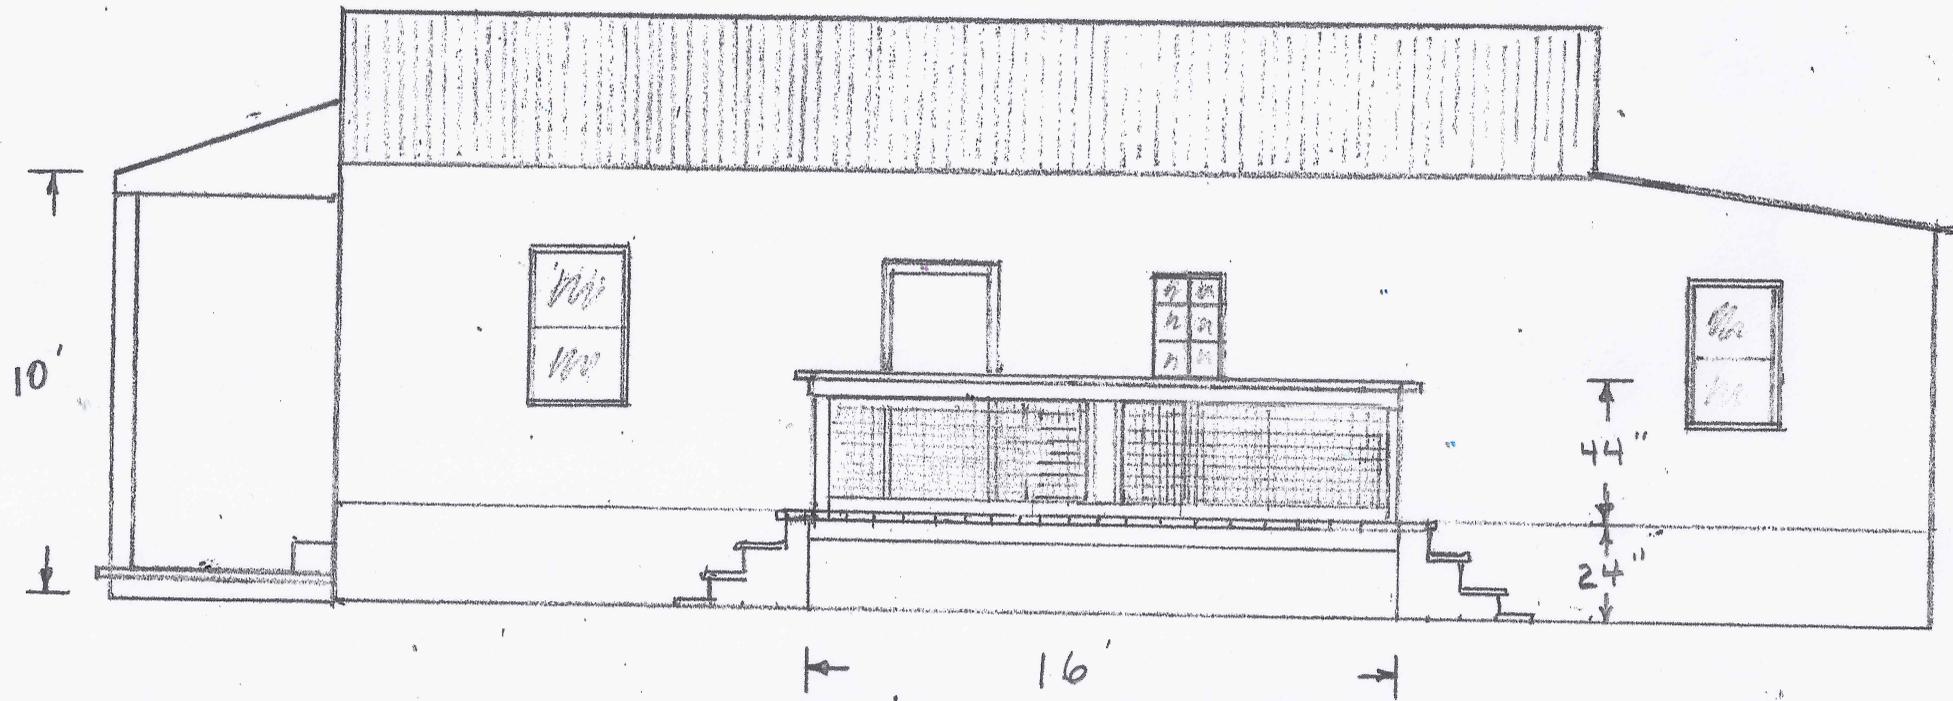
124 GLORIETTA

Install rear addition 9'x14' for water heater and storage; to replace water heater enclosure that has deteriorated beyond repair.

Install new board and batten siding around rear addition.

Replace 2 east facing windows deteriorated beyond repair with board and batten siding.

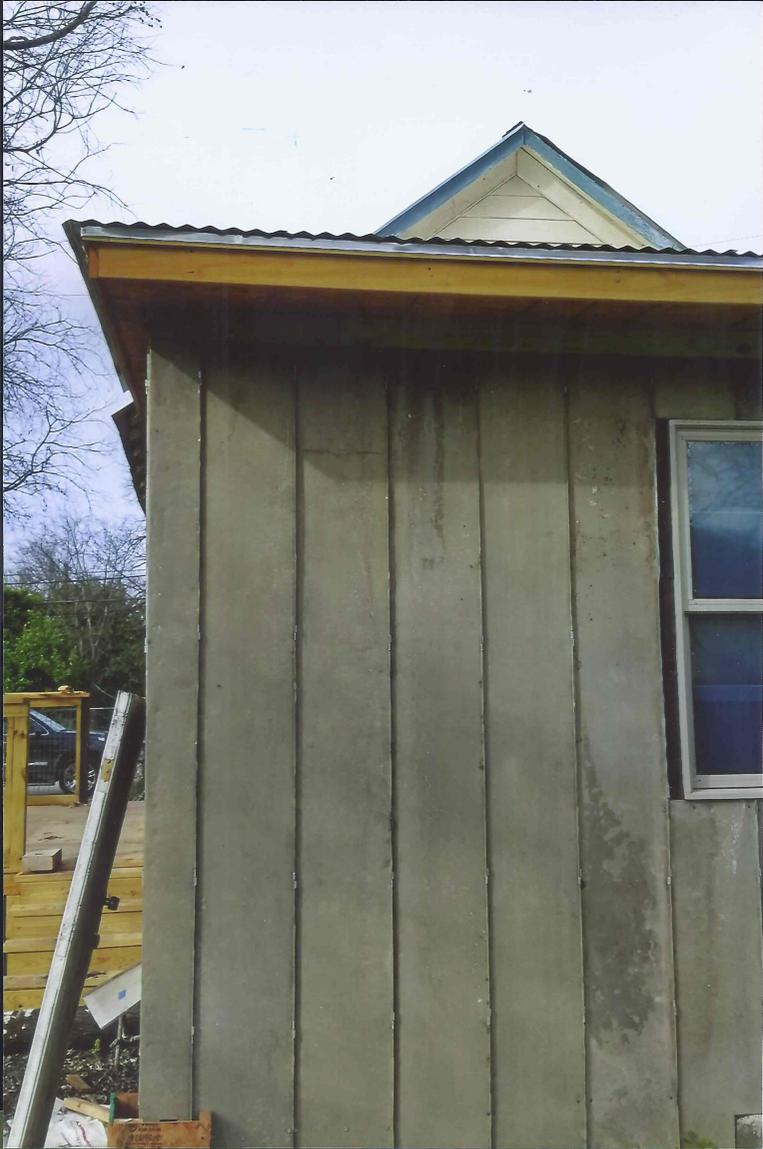
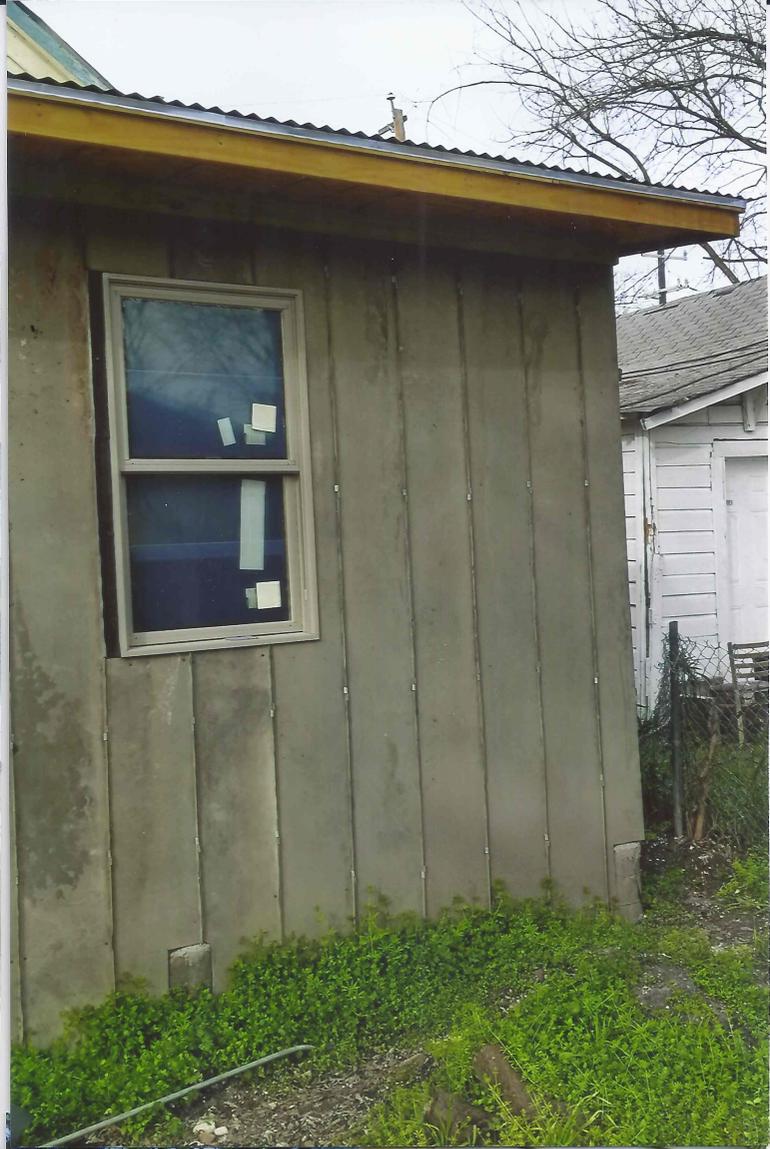
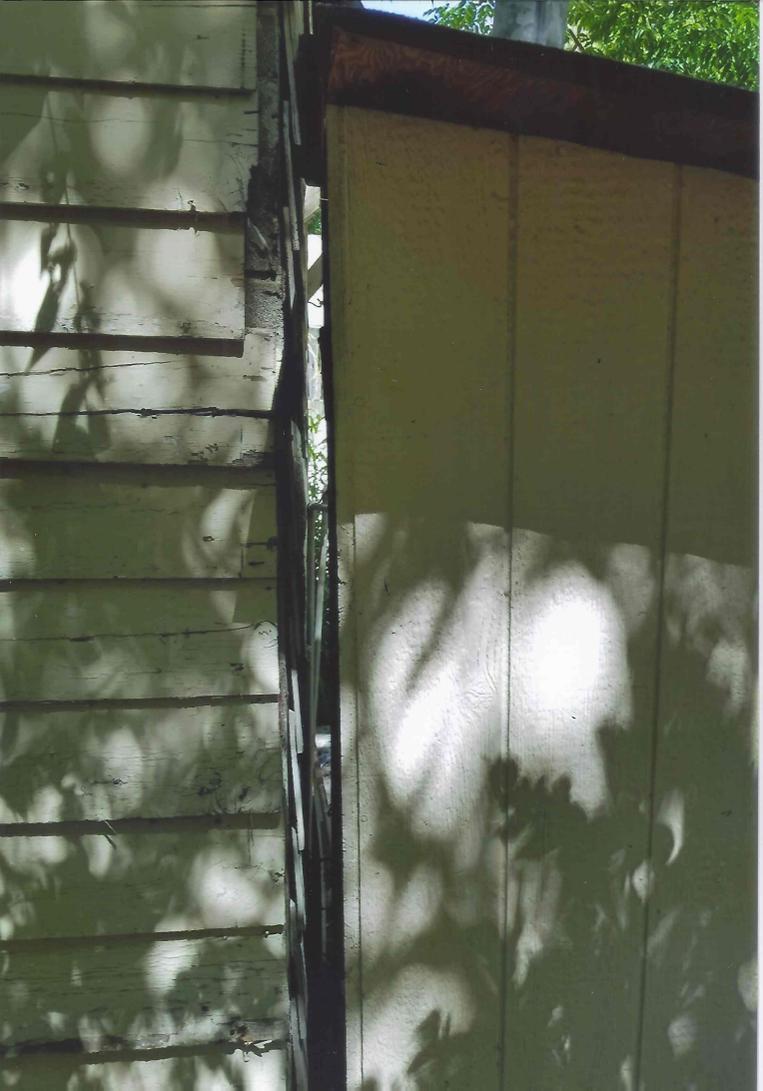
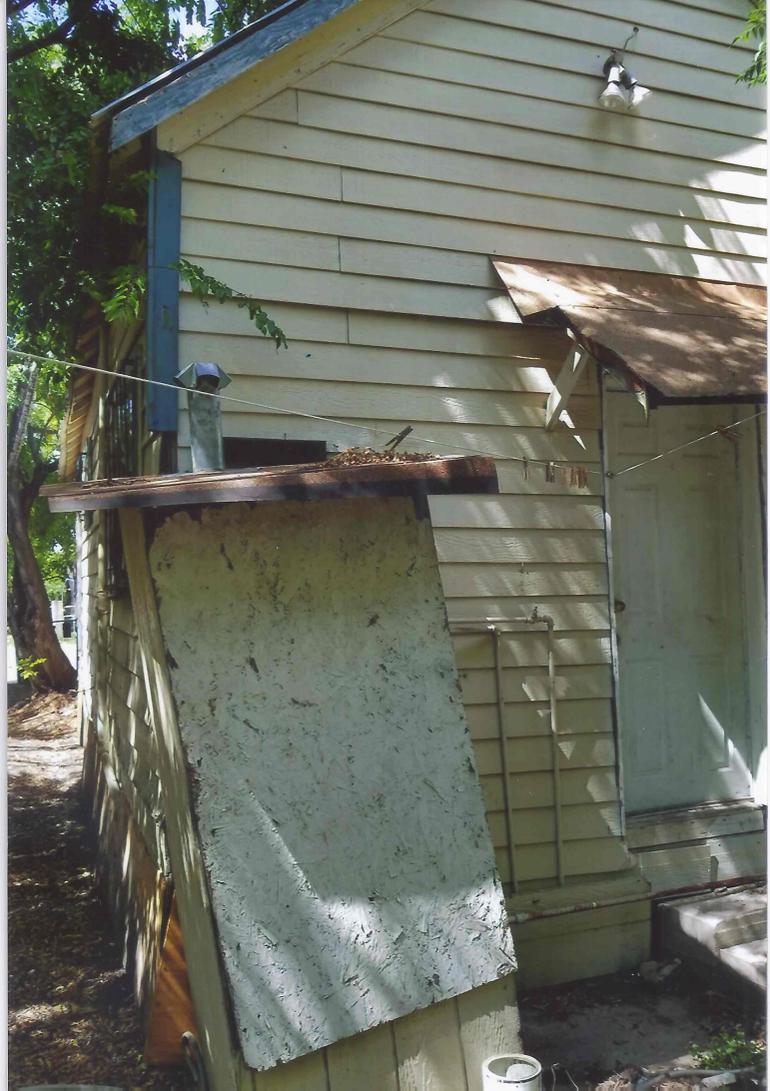
Date	02/01/2019
Time	12:00 PM (-6 GMT)
Context	drive-by
Present Staff	Huy Pham, Other
Present Individuals	None
Types of Work Observed	Exterior Maintenance and Alterations
Amount of Work Completed	75%
Description of work	Window replacement, door replacement, construction of a side deck, siding removal/repair.

Violation Type	No Certificate of Appropriateness (Code 35-451a)
OHP Action	posted "Notice of Investigation"
