HISTORIC AND DESIGN REVIEW COMMISSION

May 01, 2019

HDRC CASE NO: 2019-224
ADDRESS: 515 BURLESON ST
LEGAL DESCRIPTION: NCB 514 BLK 18 LOT 9
ZONING: R-6, H
CITY COUNCIL DIST.: 2
DISTRICT: Dignowity Hill Historic District
APPLICANT: Stephanie Padua/TexPro Painting and Renovations
OWNER: Patricia Gonzales
TYPE OF WORK: Window replacement, porch steps replacement, paint
APPLICATION RECEIVED: April 16, 2019
60-DAY REVIEW: June 15, 2019
CASE MANAGER: Huy Pham

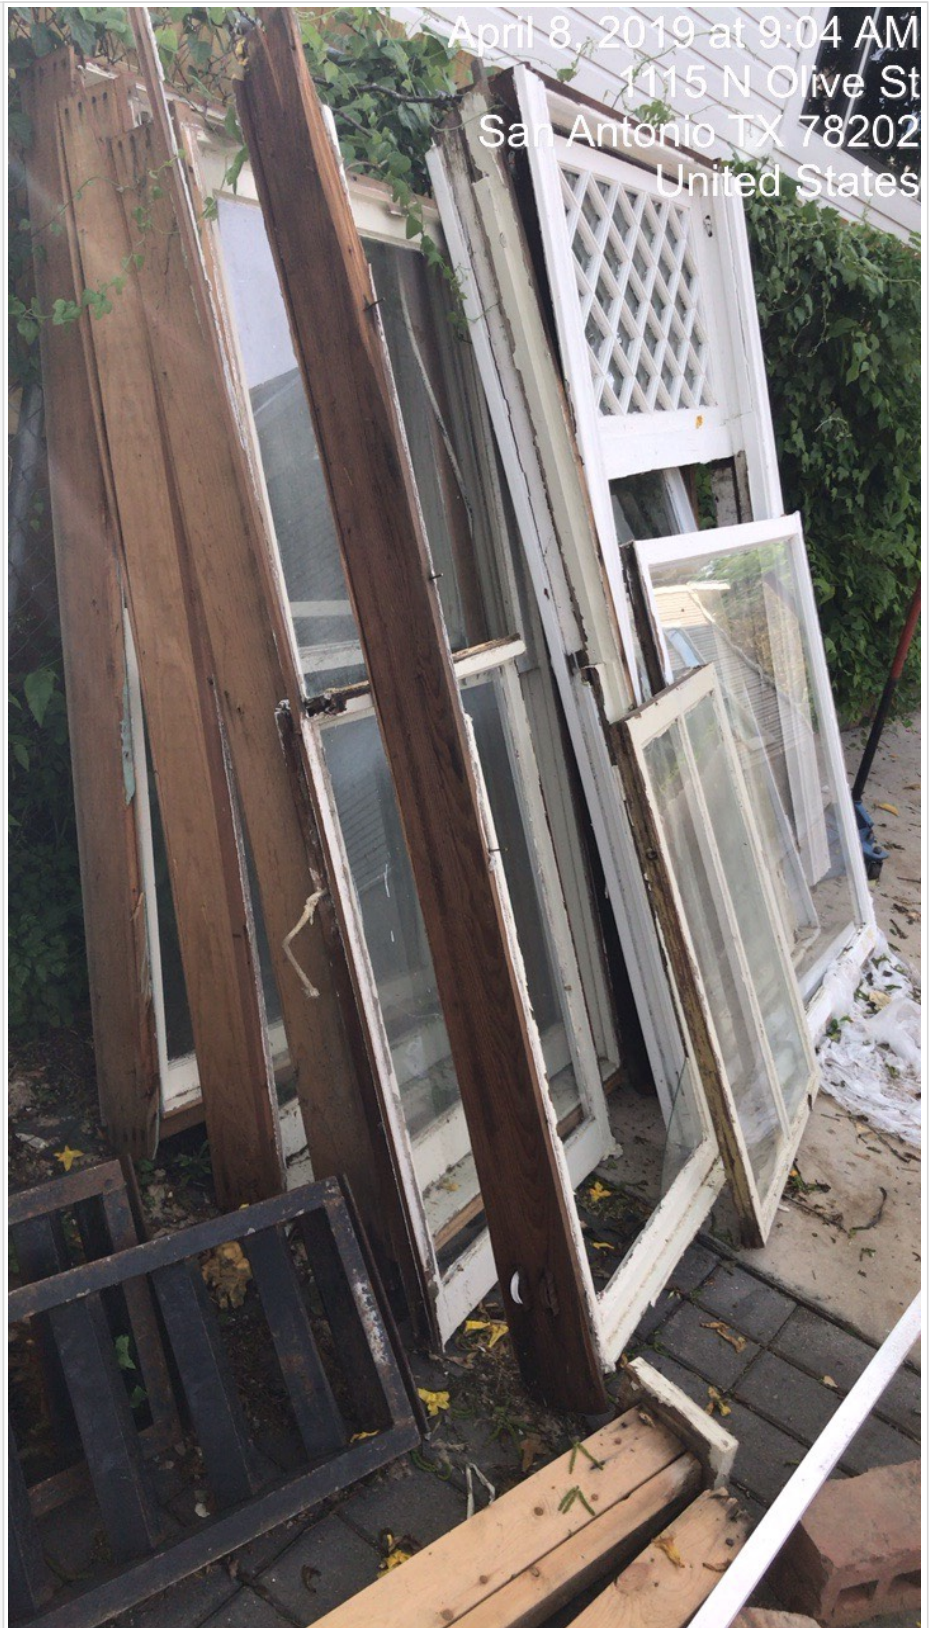
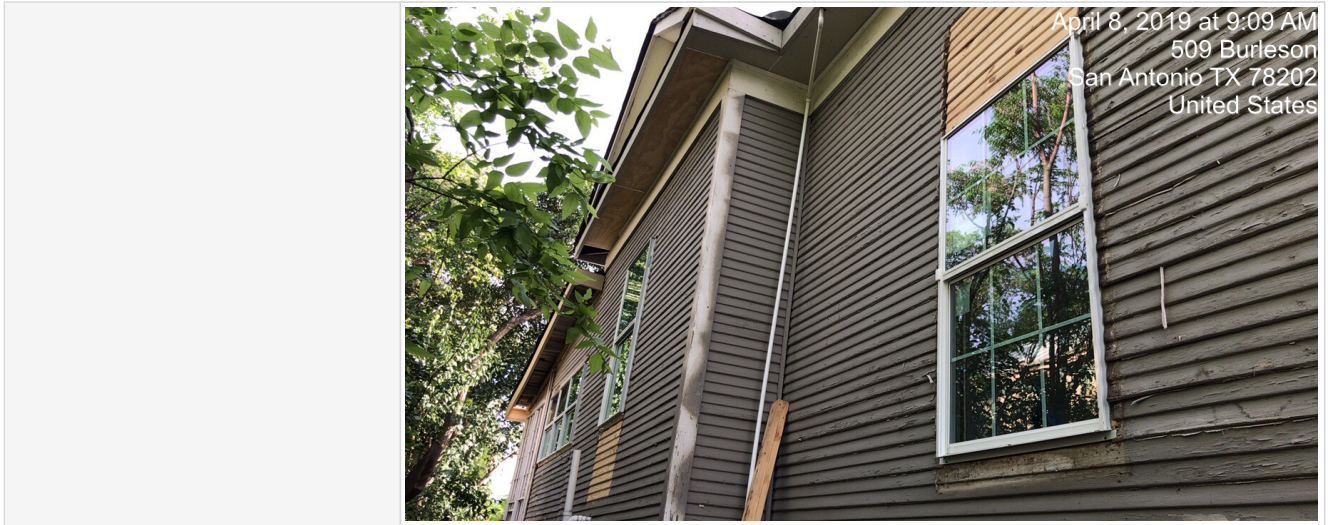
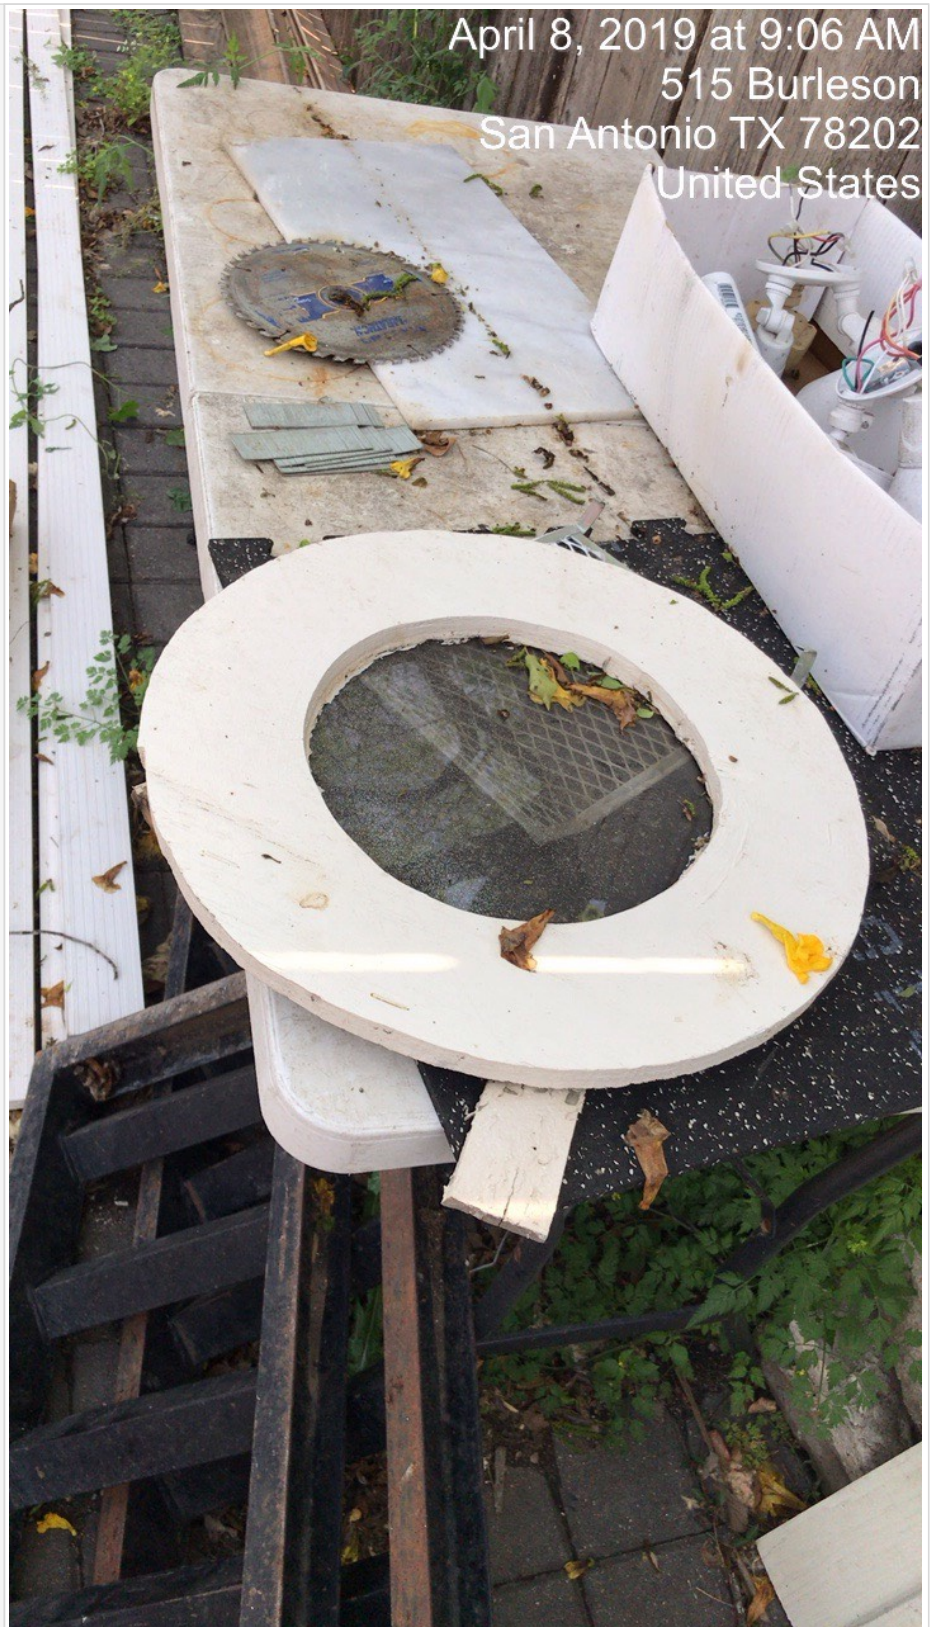
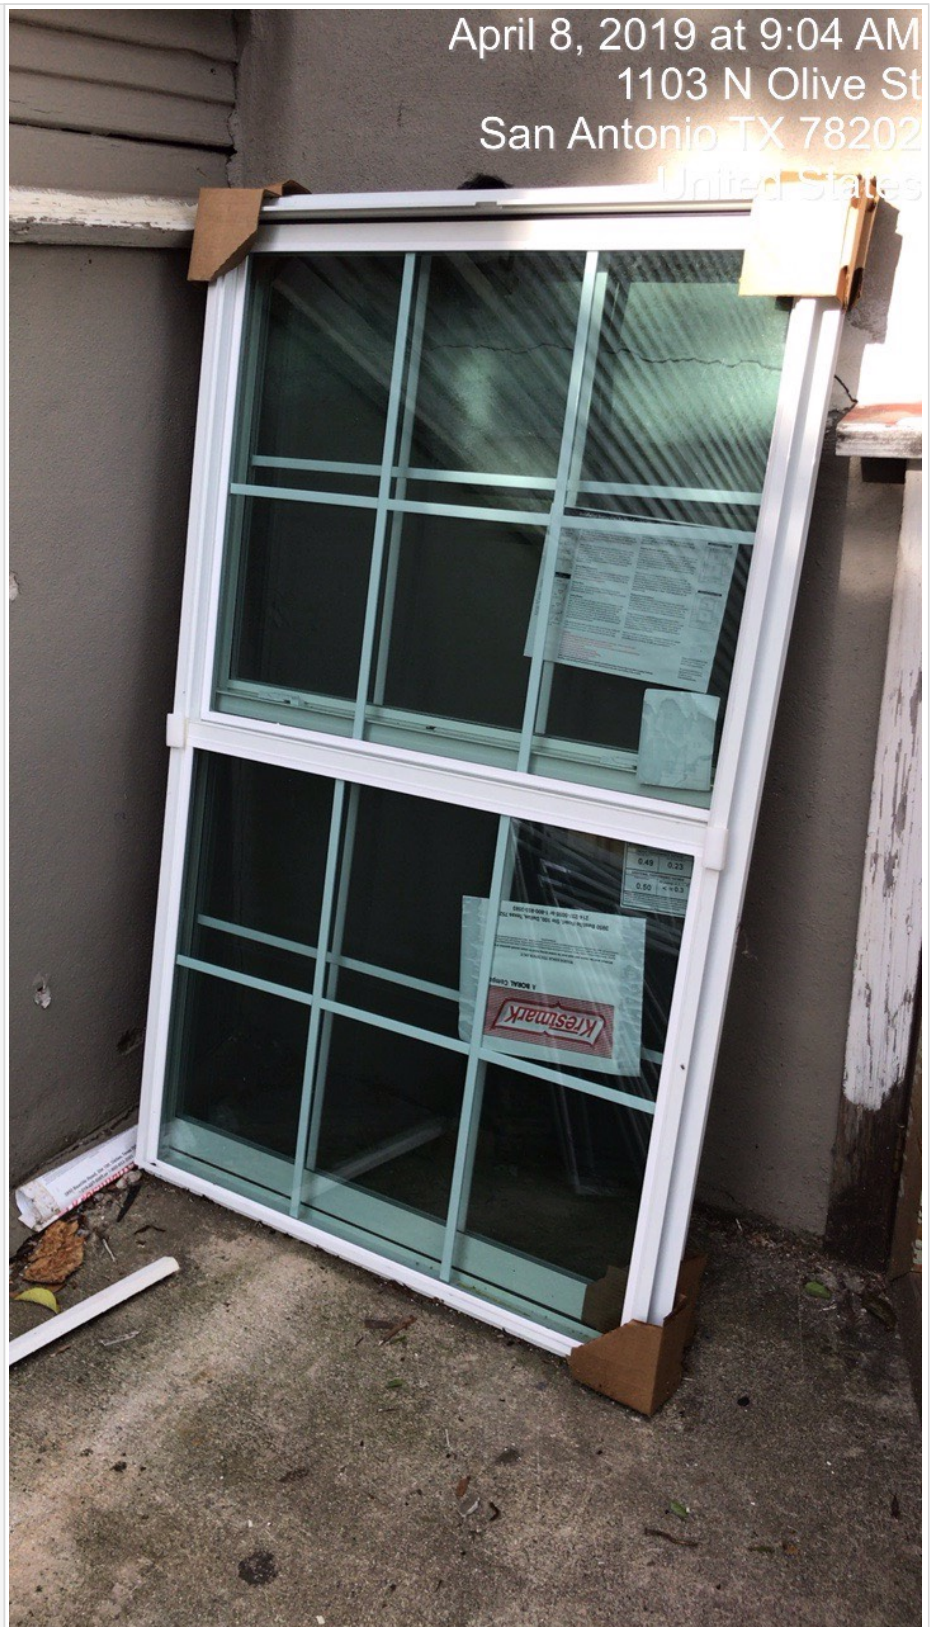
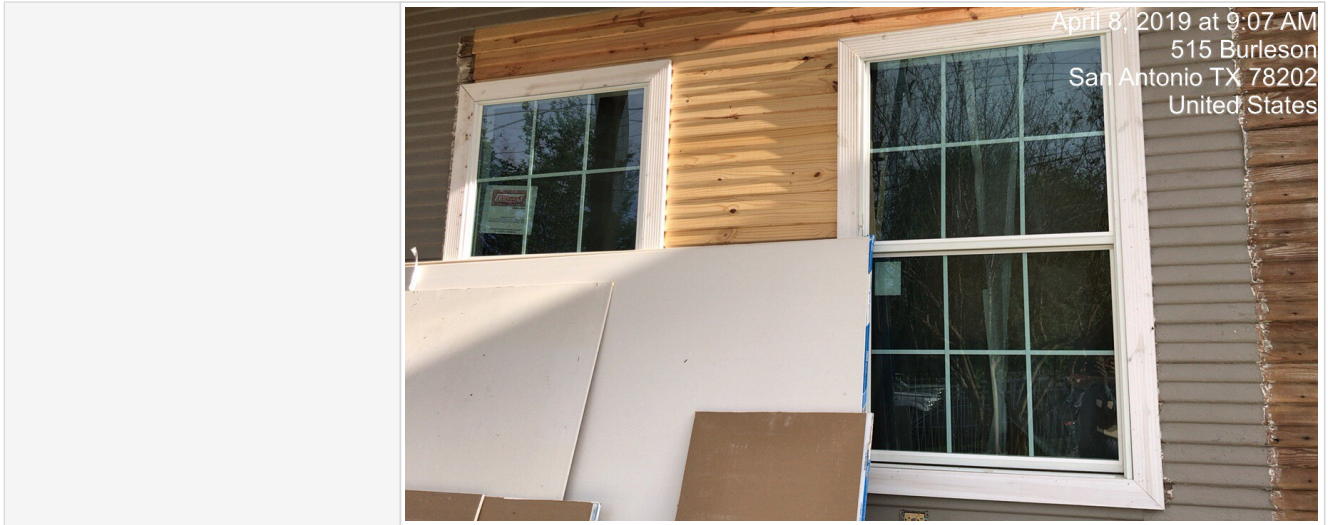
Photographs

Date	04/08/2019
Time	09:41 AM (-5 GMT)
Context	follow-up
Present Staff	Huy Pham
Present Individuals	Homeowner, Family/Tenant
Contractor/Realtor Companies	Jesus Hernandez (family member)
Types of Work Observed	Exterior Maintenance and Alterations
Amount of Work Completed	75%
Description of work	Replacement of original wood sash windows with vinyl window with faux divided lites and nailing strips. Removal of fluted wood pilaster. All original windows and pilaster are still on site.
Description of interaction	Staff met with Jesus Hernandez and two other family members (daughters of owner Patricia Gonzales) on sight. Staff took a photo of each original and replacement window. Staff explained the next steps towards compliance including HDRC, BOA, and municipal court. Staff also provided information on other resources including OHP's wood window workshop, NHSD, DHNA, and SACS. Jesus committed to submitting an application for the next available HDRC heading.

Violation Type	No Certificate of Appropriateness (Code 35-451a)
OHP Action	Spoke with neighbor/family/tenant
Other field notes	Post work fee will only apply if original windows are discarded or if the owner/applicant is non-compliant.
Will post-work application fee apply?	To be determined
