## HISTORIC AND DESIGN REVIEW COMMISSION

May 01, 2019

**HDRC CASE NO:** 2019-225  
**ADDRESS:** 314 MISSION ST  
**LEGAL DESCRIPTION:** NCB 944 BLK 1 LOT 31  
**ZONING:** RM-4  
**CITY COUNCIL DIST.:** 1  
**DISTRICT:** King William Historic District  
**APPLICANT:** Isabelle Robledo  
**OWNER:** Jose Robledo  
**TYPE OF WORK:** Front porch, door replacement, exterior modifications to addition  
**APPLICATION RECEIVED:** April 16, 2019  
**60-DAY REVIEW:** June 15, 2019  
**CASE MANAGER:** Huy Pham

# 314 Mission St

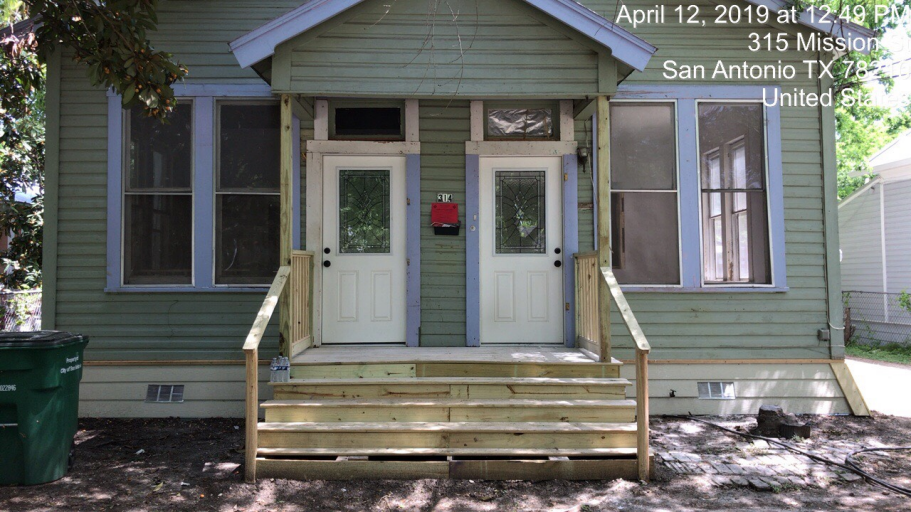
- b. **WORK WITHOUT APPROVAL:** On a site visit conducted on April 12, 2019, staff found that the front porch had been modified including replacement of the doors, decking and steps, columns, and new railing, as well as the installation of tapered skirting with Hardie board with faux wood grain texture and rear window removal. A previous applicant had received administrative approval for foundation repair with no changes to skirting in November 2018. The current applicant/owners have not been cooperative to providing additional photos or drawings to staff to prepare for the commission hearing.

Staff does not recommend skirting modifications or window removal based on finding d and e. Staff recommends removal the tapered skirting to expose the simply concrete slab, install smooth Hardie skirting without a taper or faux wood grain, or continuing the wood siding down to grade. All remaining unapproved items should be reversed.

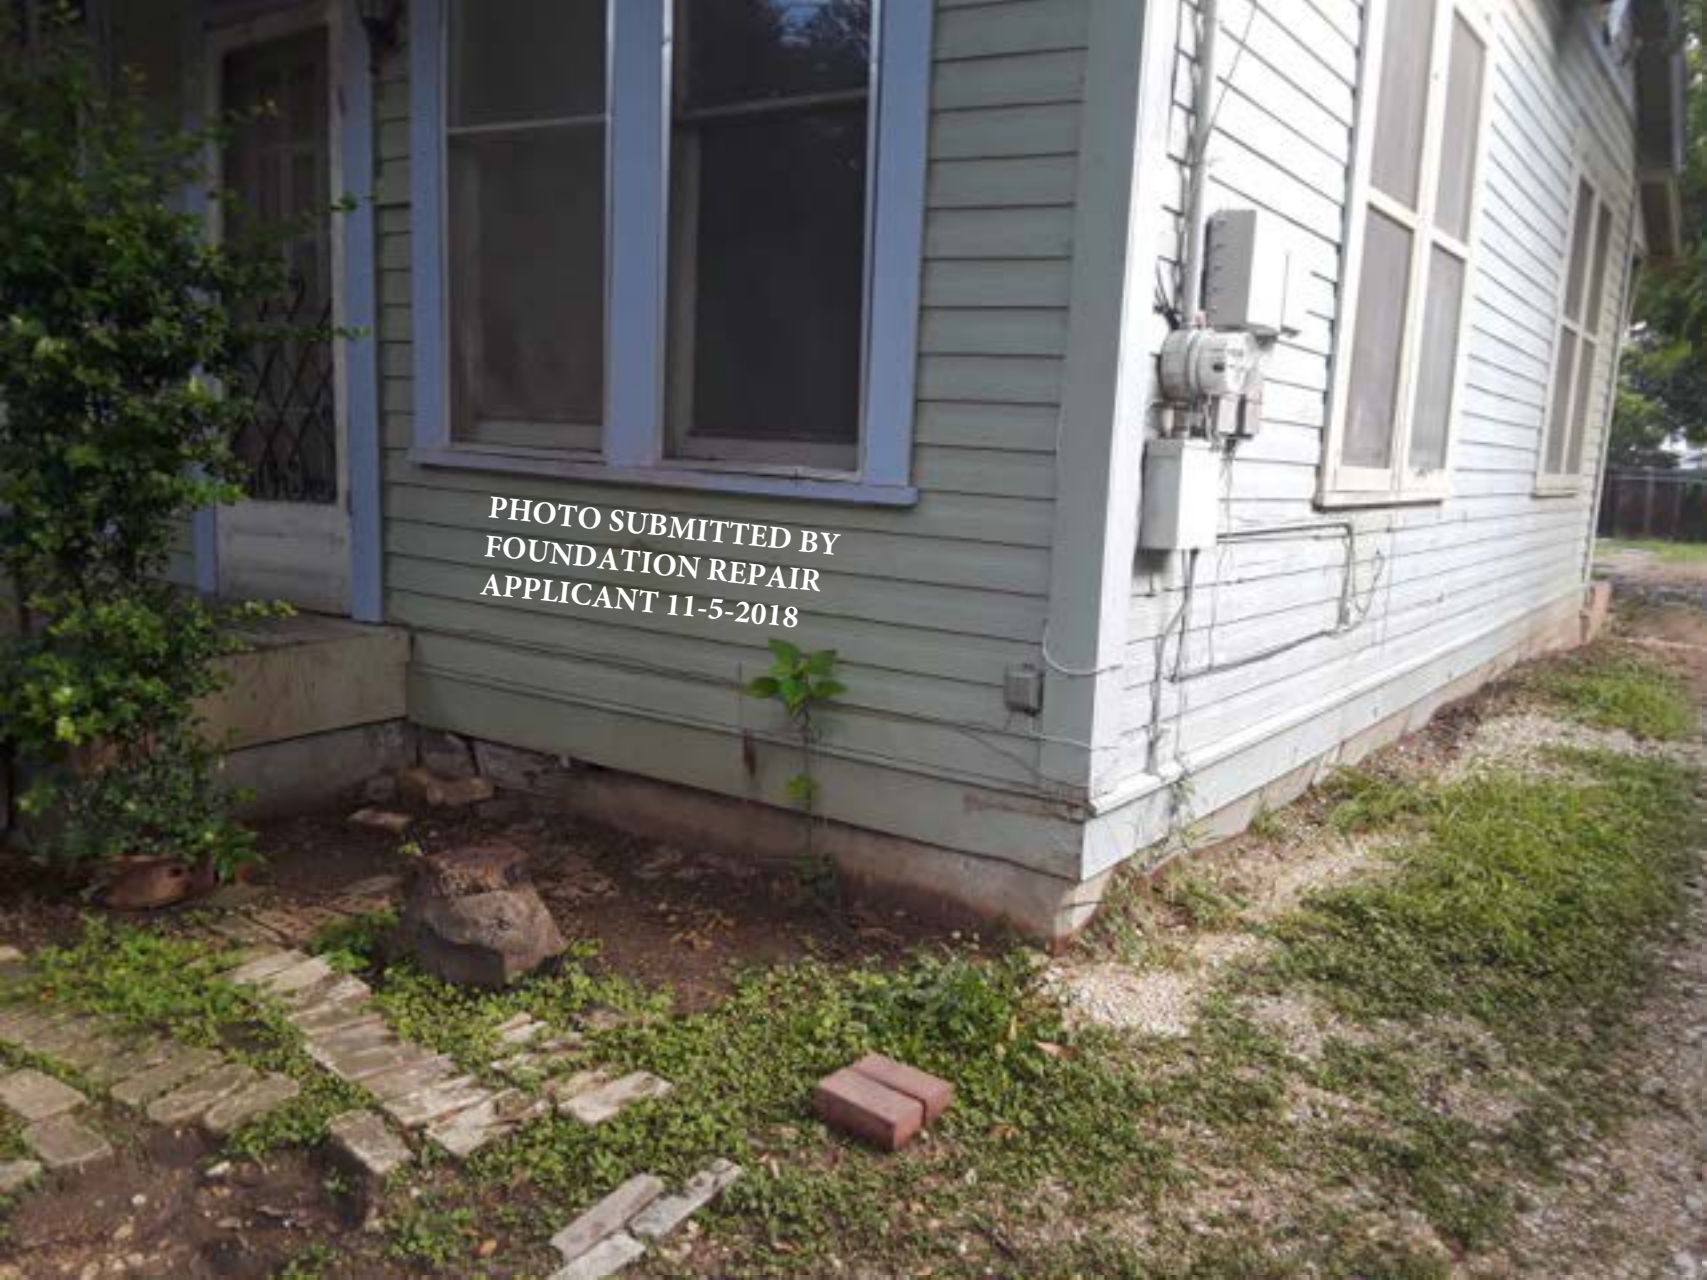
PHOTO SUBMITTED BY  
FOUNDATION REPAIR  
APPLICANT 11-5-2018

- d. **SKIRTING** – Prior to work without approval, the foundation featured exposed concrete slab with some portions covered with continuous aluminum panels. The applicant has proposed to install tapered skirting with Hardie siding with faux wood grain texture. The Guidelines 8.B. notes: ensure that features such as decorative vents and grilles and lattice panels are replaced in-kind when deteriorated beyond repair; when in-kind replacement is not possible, use features matching in size, material, and design; replacement skirting should consist of durable, proven materials, and should either match the existing siding or be applied to have minimal visual impact. Staff finds the proposed installation is inconsistent with the Guidelines. Appropriate solutions include: removal the tapered skirting to expose the simply concrete slab, install smooth Hardie skirting without a taper or faux wood grain, or continuing the wood siding down to grade.
