## HISTORIC AND DESIGN REVIEW COMMISSION

**HDRC CASE NO:** 2019-224  
**ADDRESS:** 515 BURLESON ST  
**LEGAL DESCRIPTION:** NCB 514 BLK 18 LOT 9  
**ZONING:** R-6, H  
**CITY COUNCIL DIST.:** 2  
**DISTRICT:** Dignowity Hill Historic District  
**APPLICANT:** Stephanie Padua/TexPro Painting and Renovations  
**OWNER:** Patricia Gonzales  
**TYPE OF WORK:** Window replacement, porch steps replacement, paint  
**APPLICATION RECEIVED:** April 16, 2019  
**60-DAY REVIEW:** June 15, 2019  
**CASE MANAGER:** Huy Pham

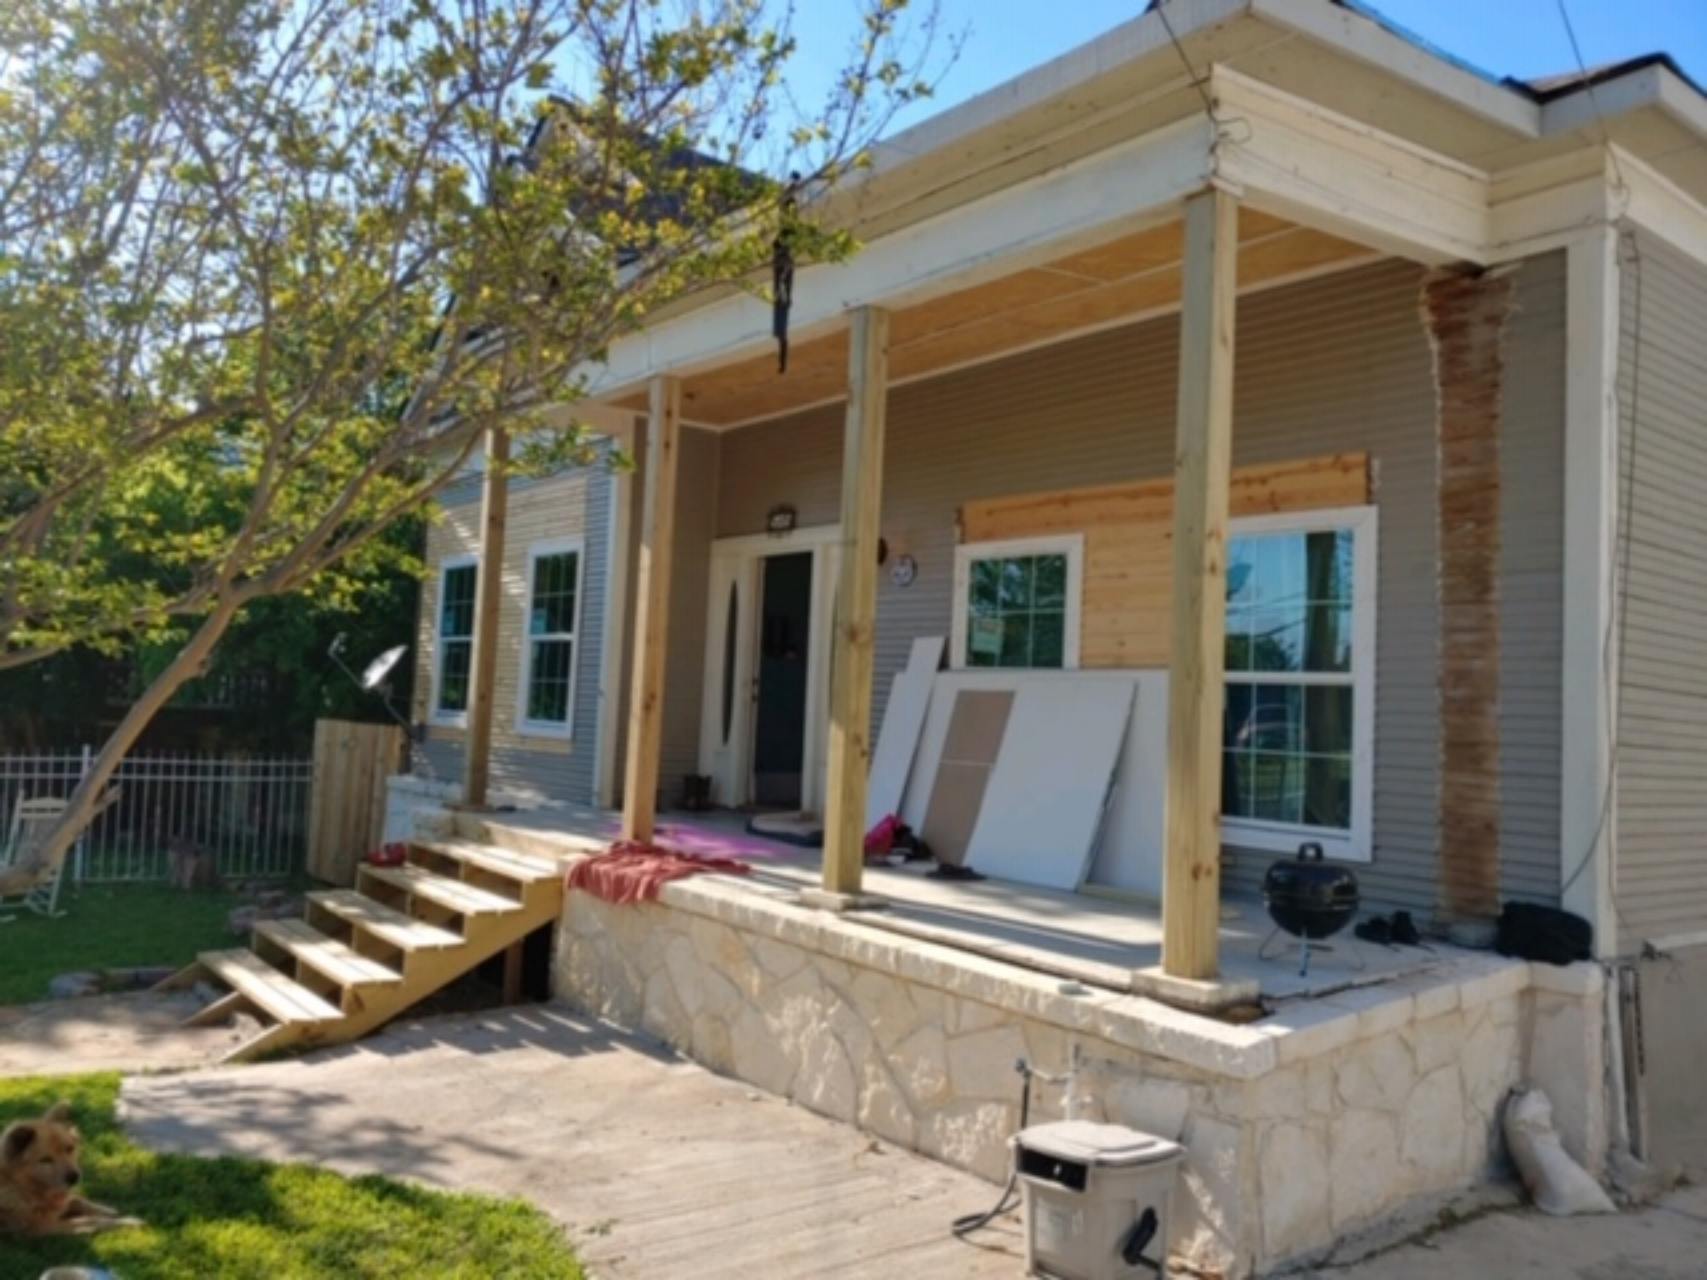
March 29, 2019 at 1:51 PM  
515 Burleson  
San Antonio TX 78202  
United States

WORK PRIOR TO APPROVAL – On a site visit conducted on March 29, 2019, staff found a number of windows have been removed and replaced with vinyl windows, the pilaster and porthole windows were removed, and areas of siding have been replaced in-kind. The applicant committed to restoring the pilaster and porthole windows to their original configuration and submitted a request for the remaining items on April 16, 2019 to be heard at the next HDRC hearing. Staff advise the applicant to store the original windows in a safe location until the conclusion of the commission hearing. A \$500 post-work application fee will be assessed based on the commission action and ability to restore the original windows if they have not been discarded or further damaged.

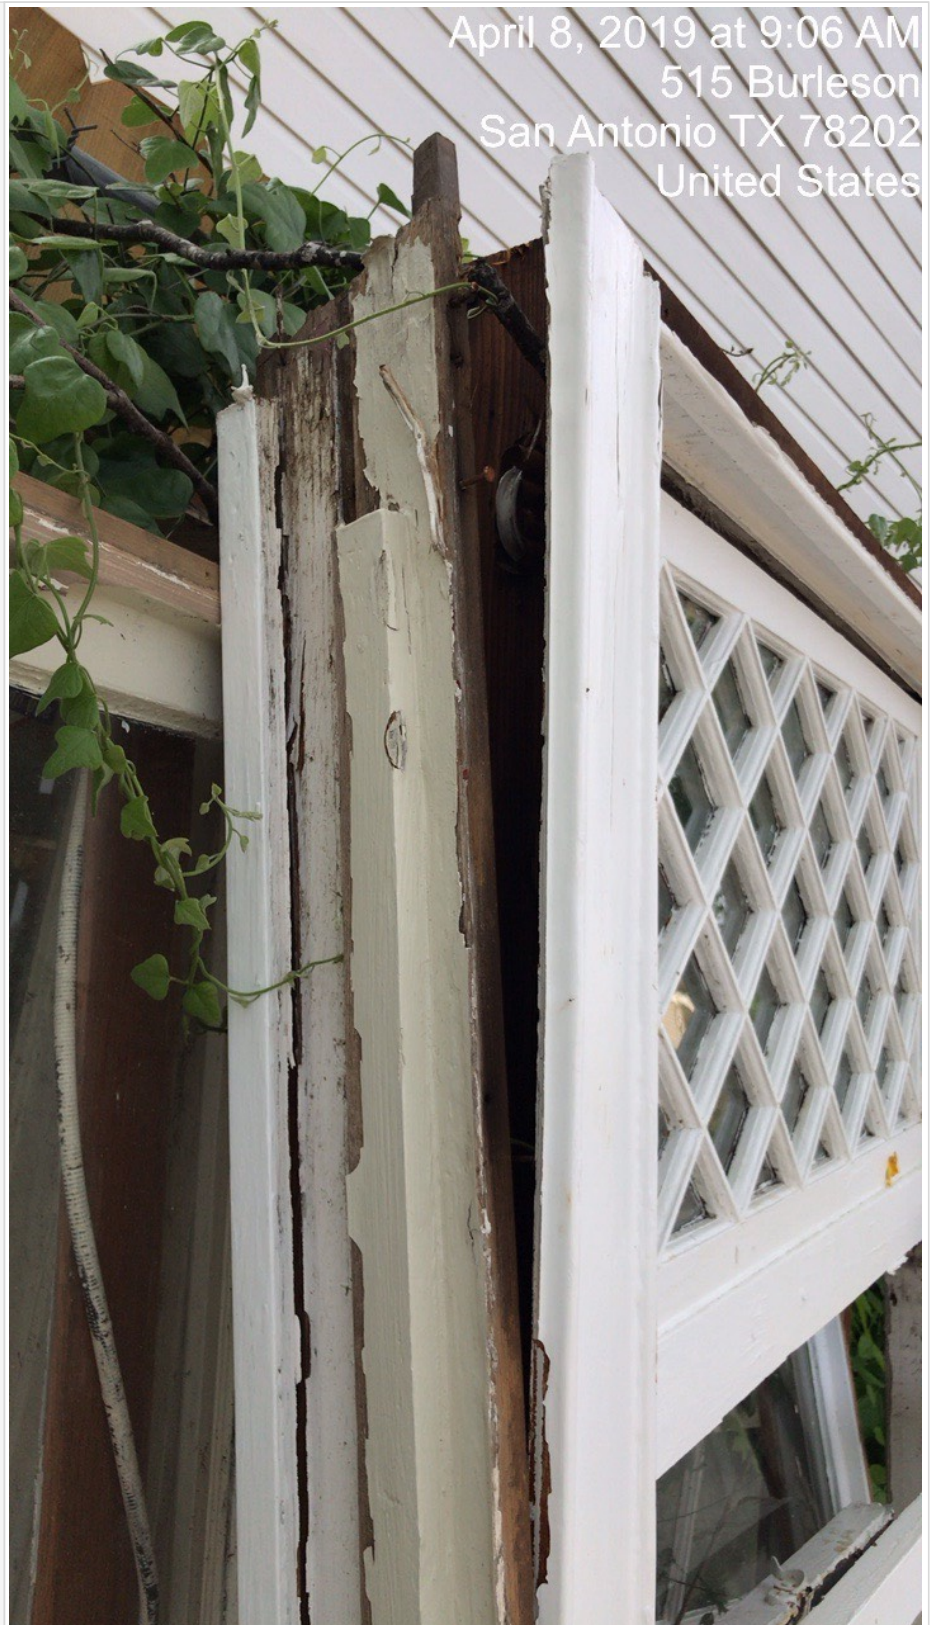
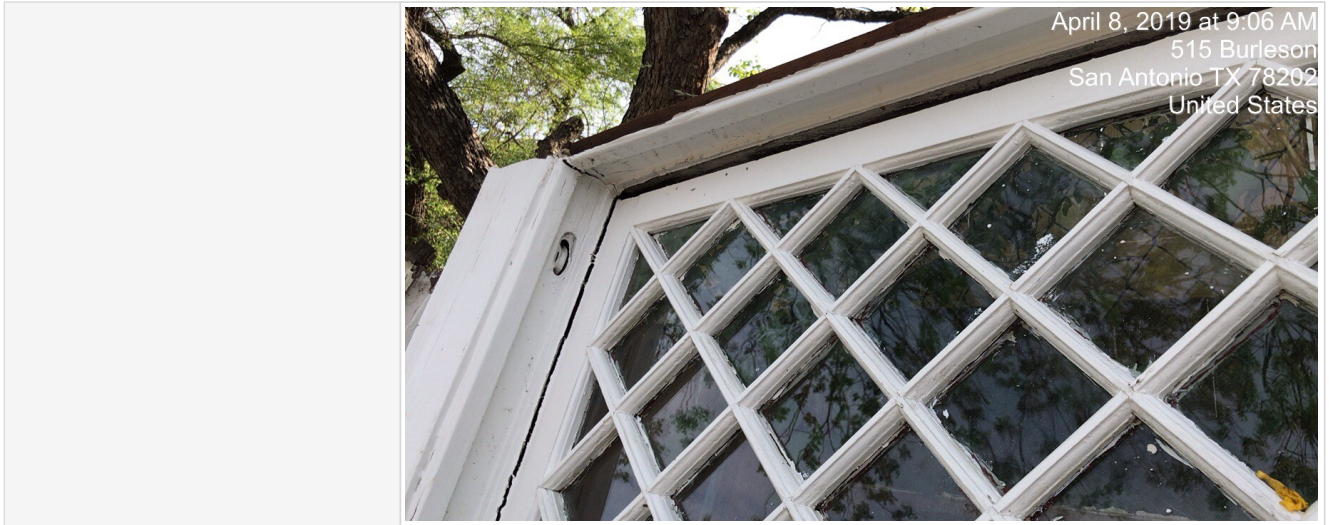
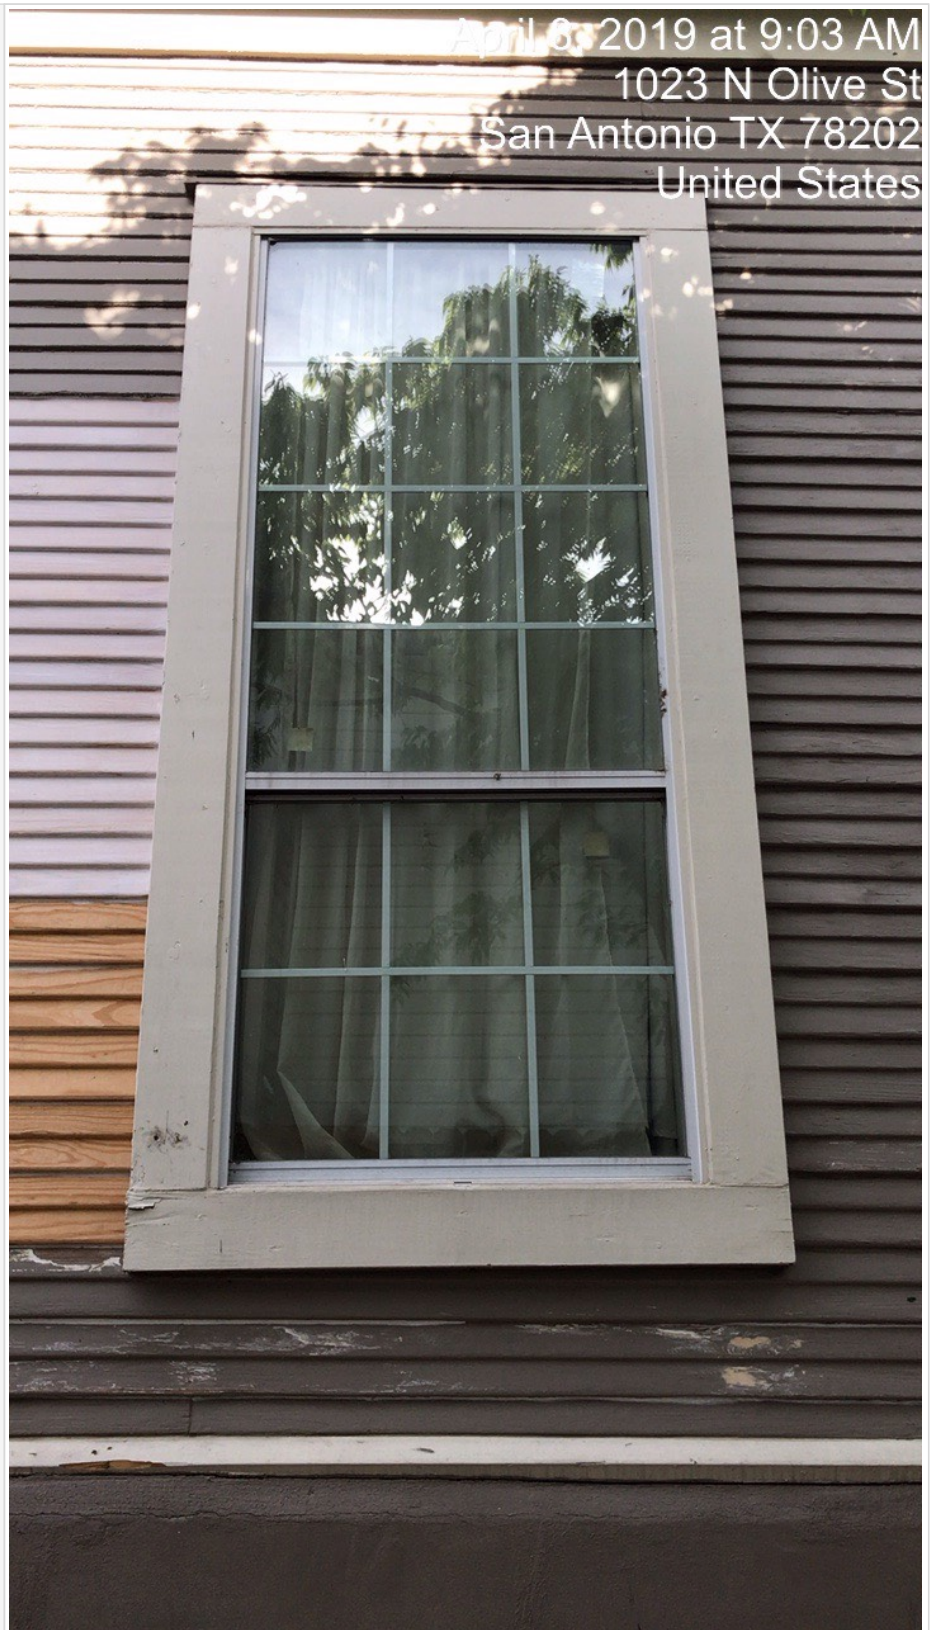
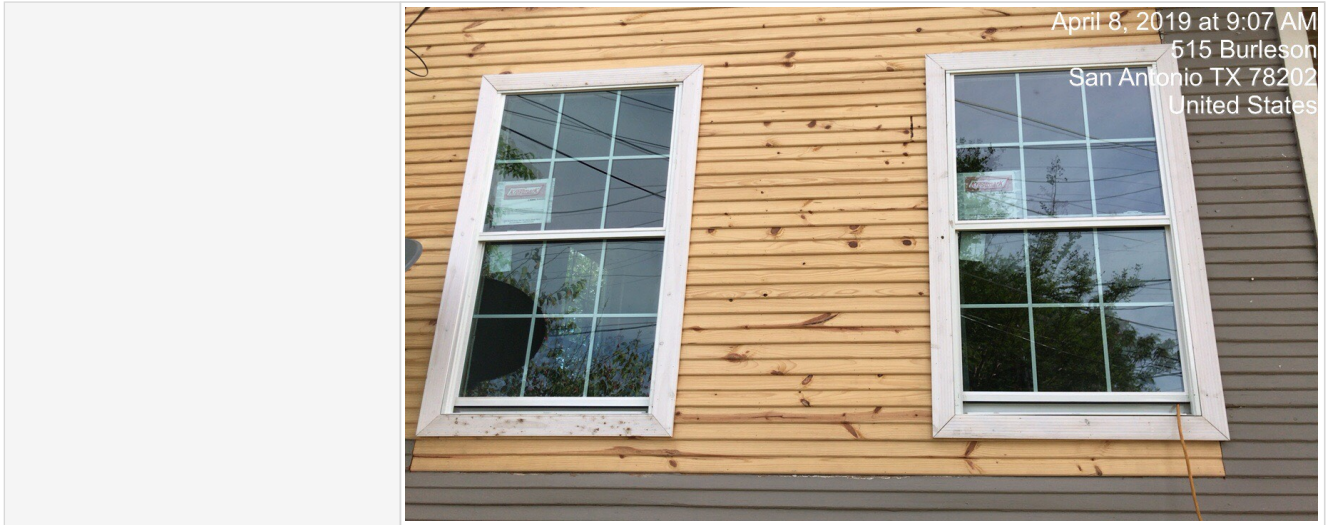
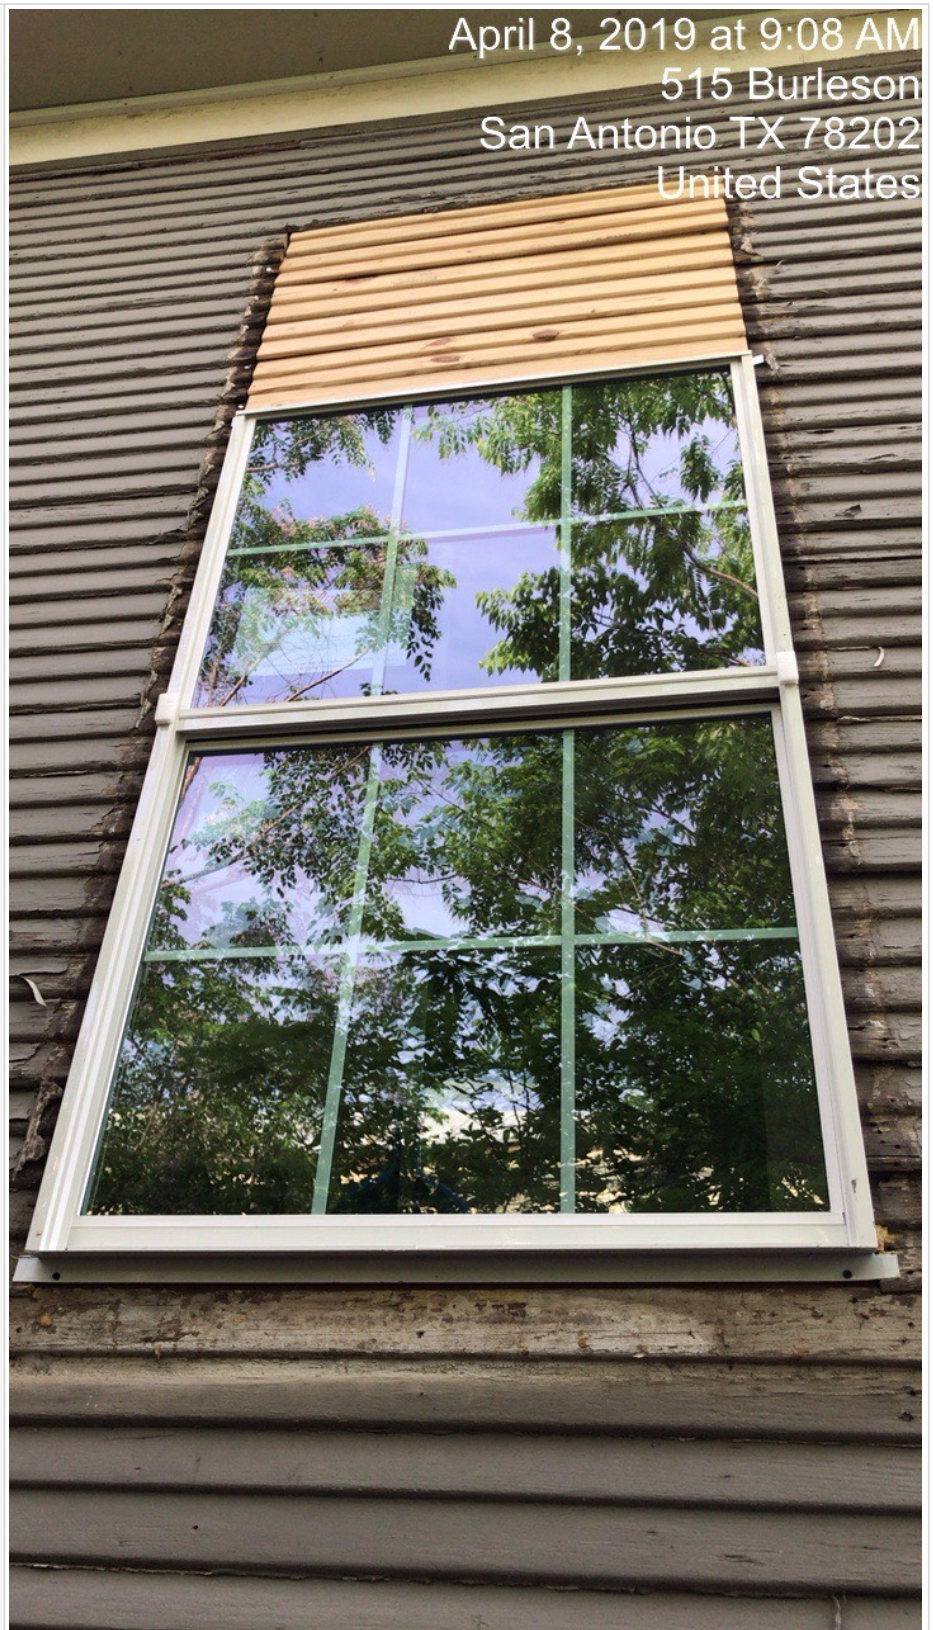
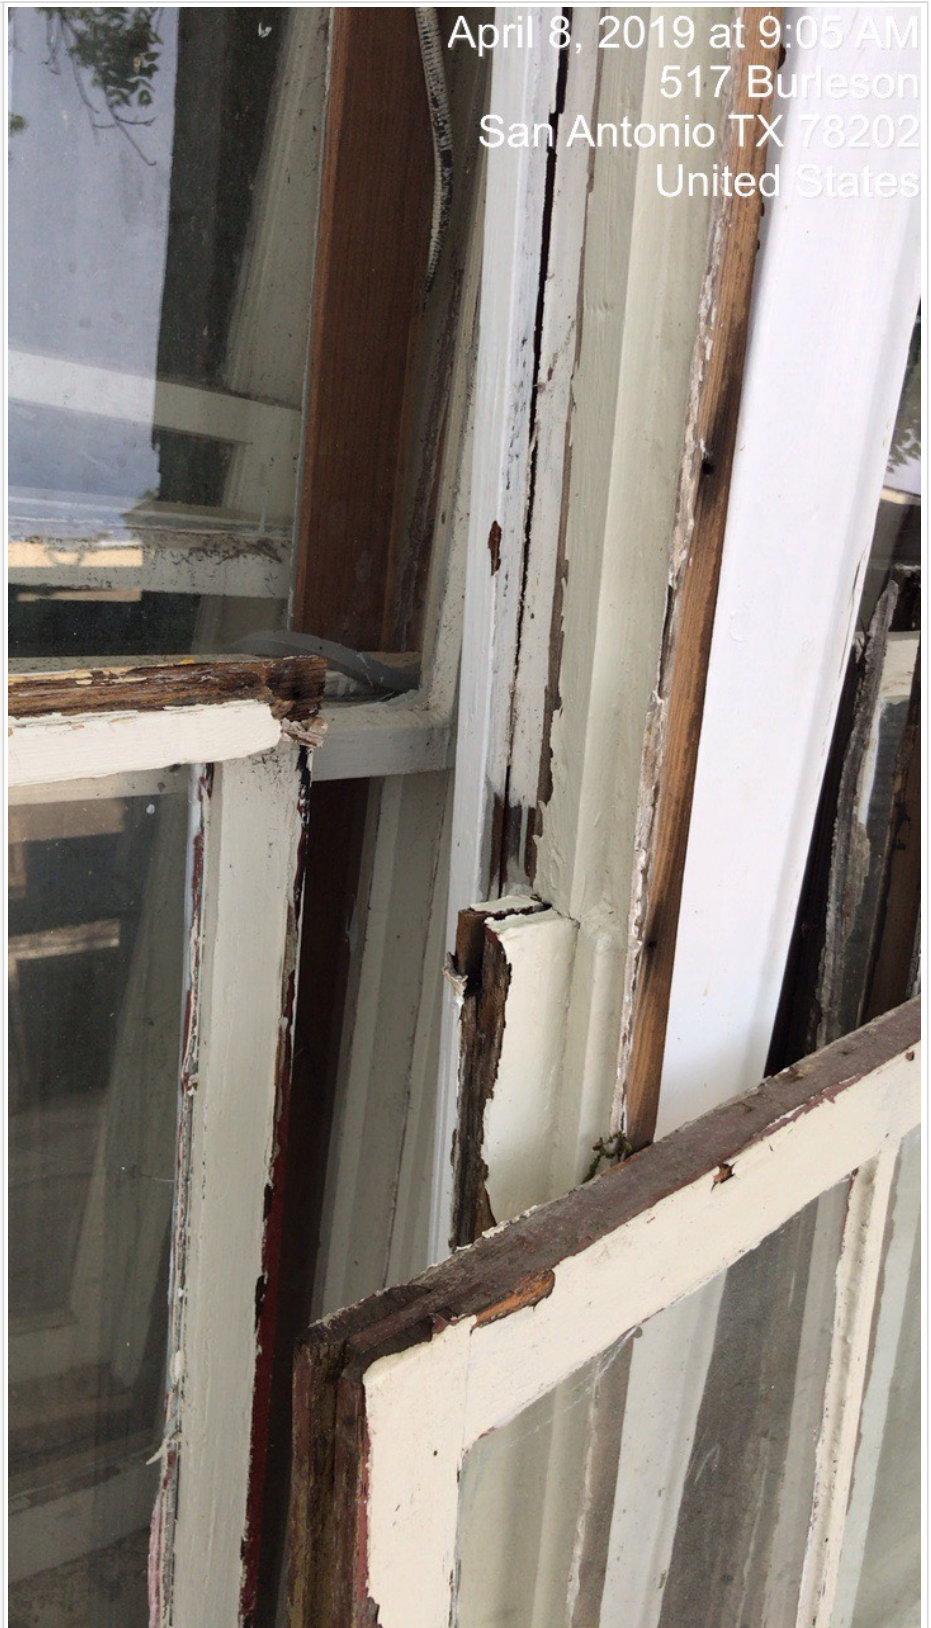
Date	03/29/2019
Time	01:47 PM (-5 GMT)
Context	drive-by
Present Staff	Huy Pham, Adam Rajper
Present Individuals	None
Types of Work Observed	Exterior Maintenance and Alterations
Amount of Work Completed	75%
Description of work	Window replacement on nearly all windows, front porch modifications to skirting and columns. Wood windows sashes are visible in the front yard and rear of driveway.
