## HISTORIC AND DESIGN REVIEW COMMISSION

**HDRC CASE NO:** 2019-224  
**ADDRESS:** 515 BURLESON ST  
**LEGAL DESCRIPTION:** NCB 514 BLK 18 LOT 9  
**ZONING:** R-6, H  
**CITY COUNCIL DIST.:** 2  
**DISTRICT:** Dignowity Hill Historic District  
**APPLICANT:** Stephanie Padua/TexPro Painting and Renovations  
**OWNER:** Patricia Gonzales  
**TYPE OF WORK:** Window replacement, porch steps replacement, paint  
**APPLICATION RECEIVED:** April 16, 2019  
**60-DAY REVIEW:** June 15, 2019  
**CASE MANAGER:** Huy Pham

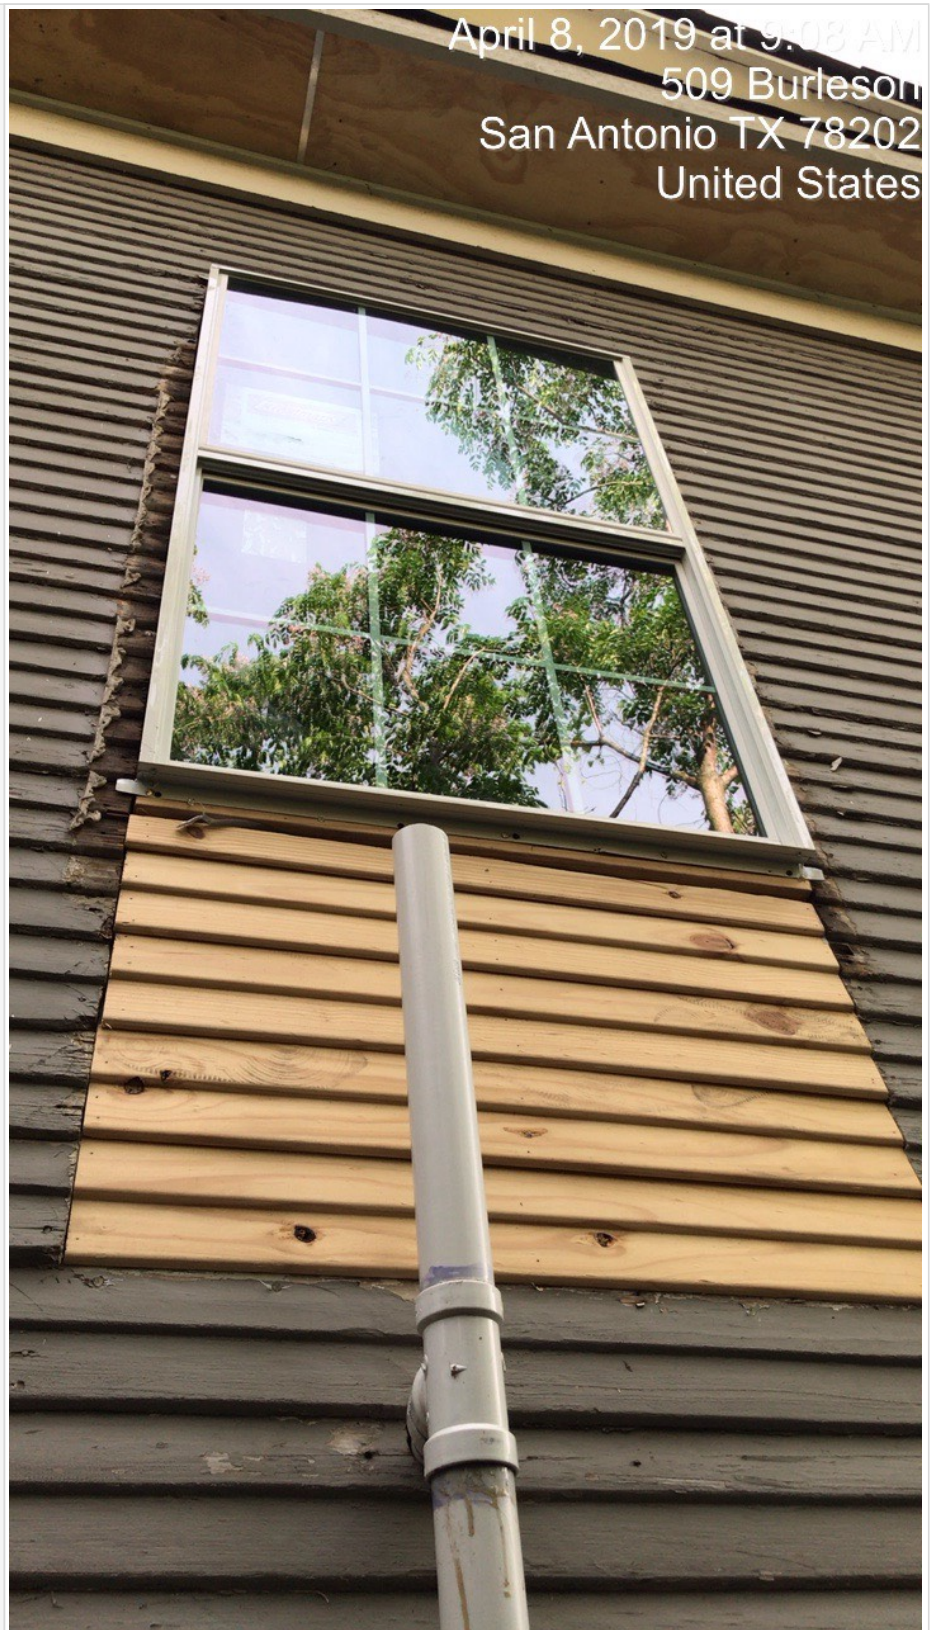
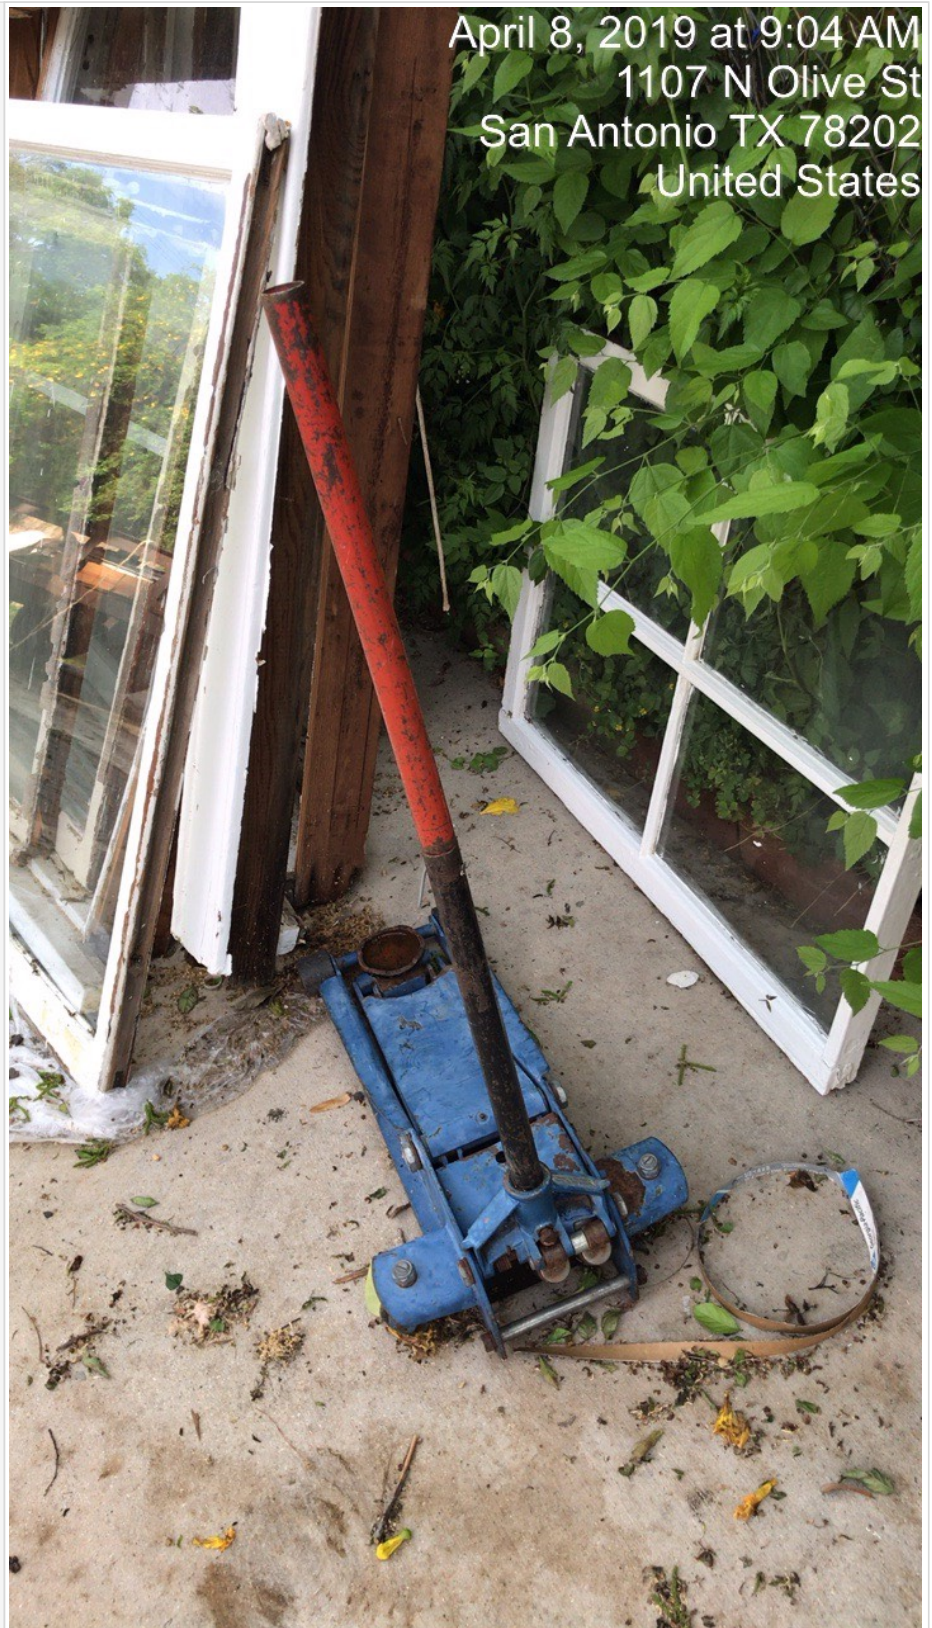
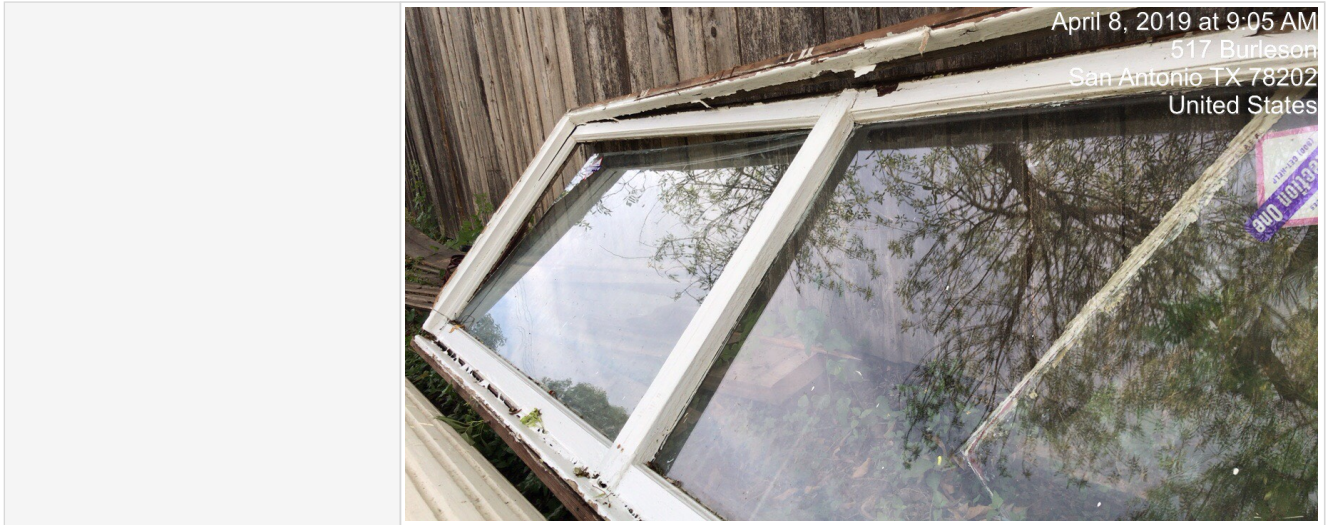
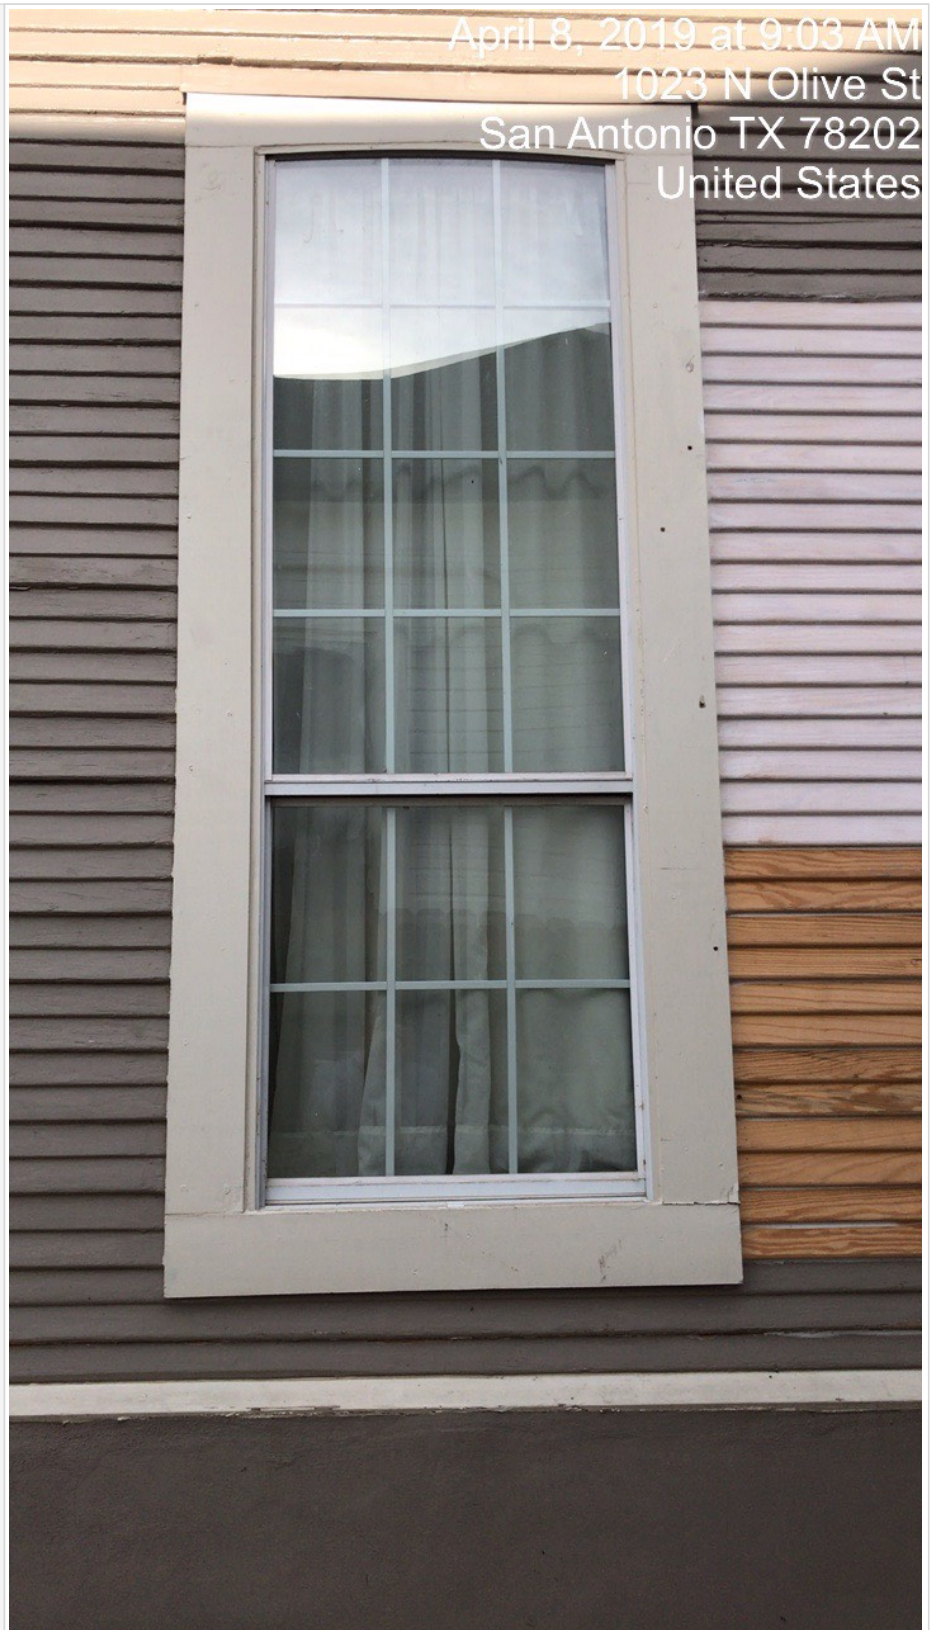
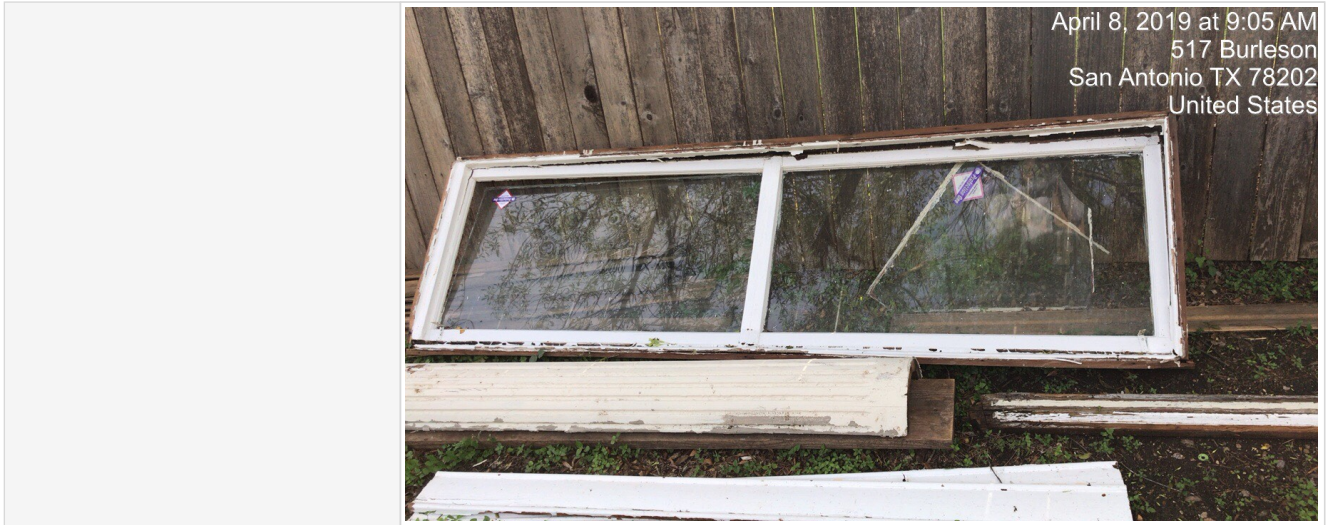
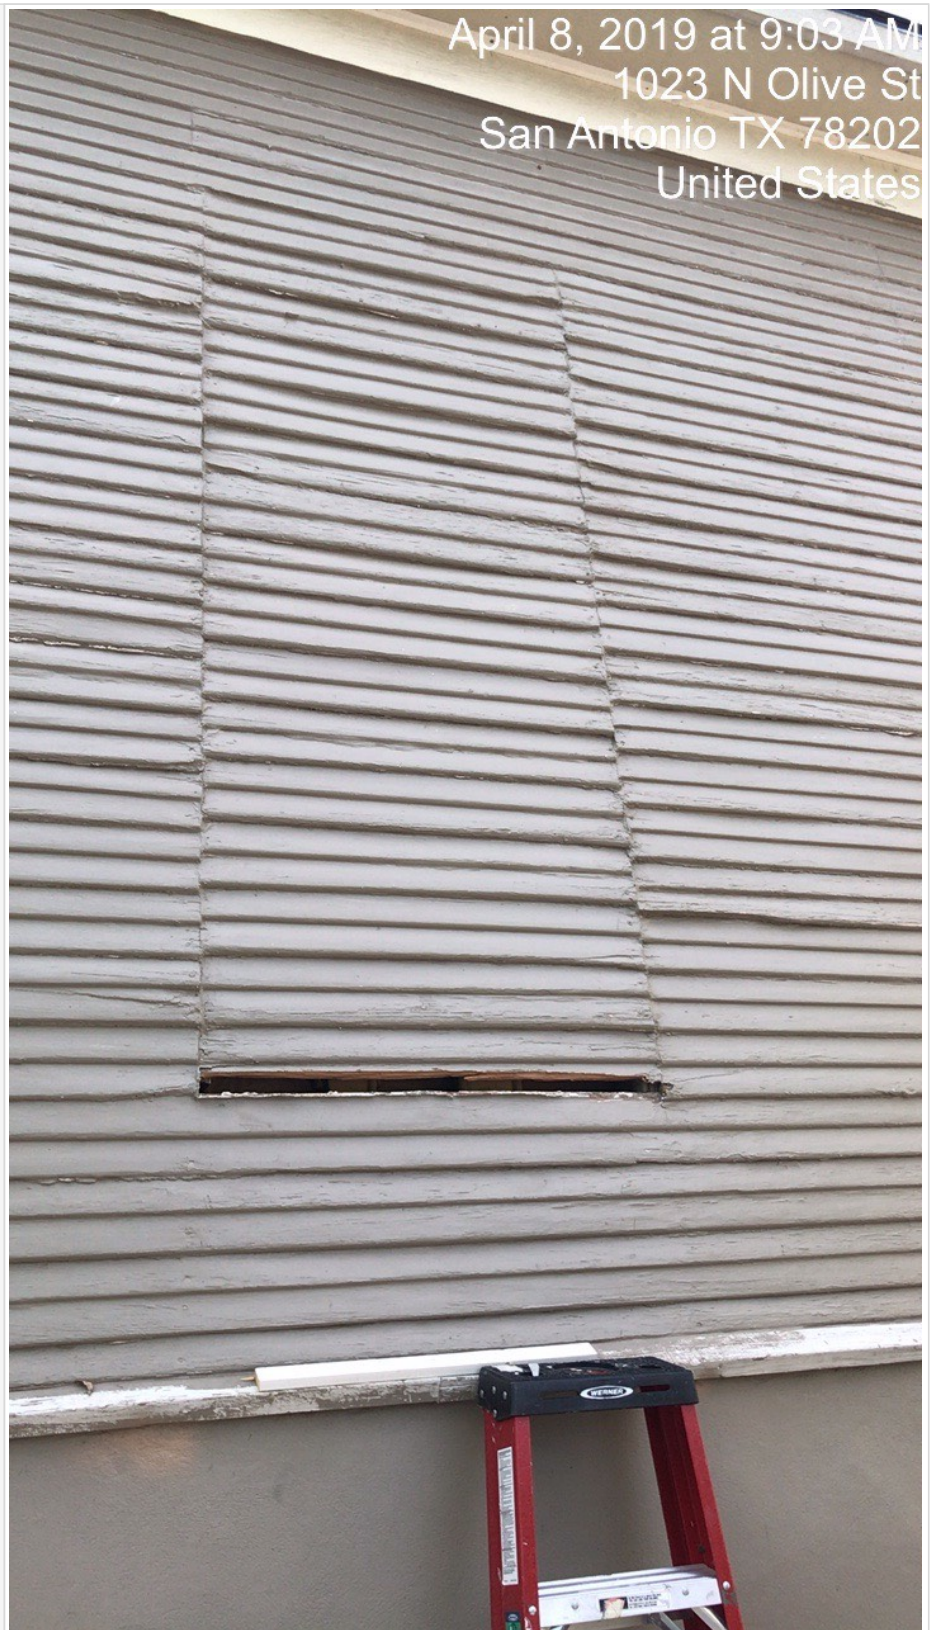
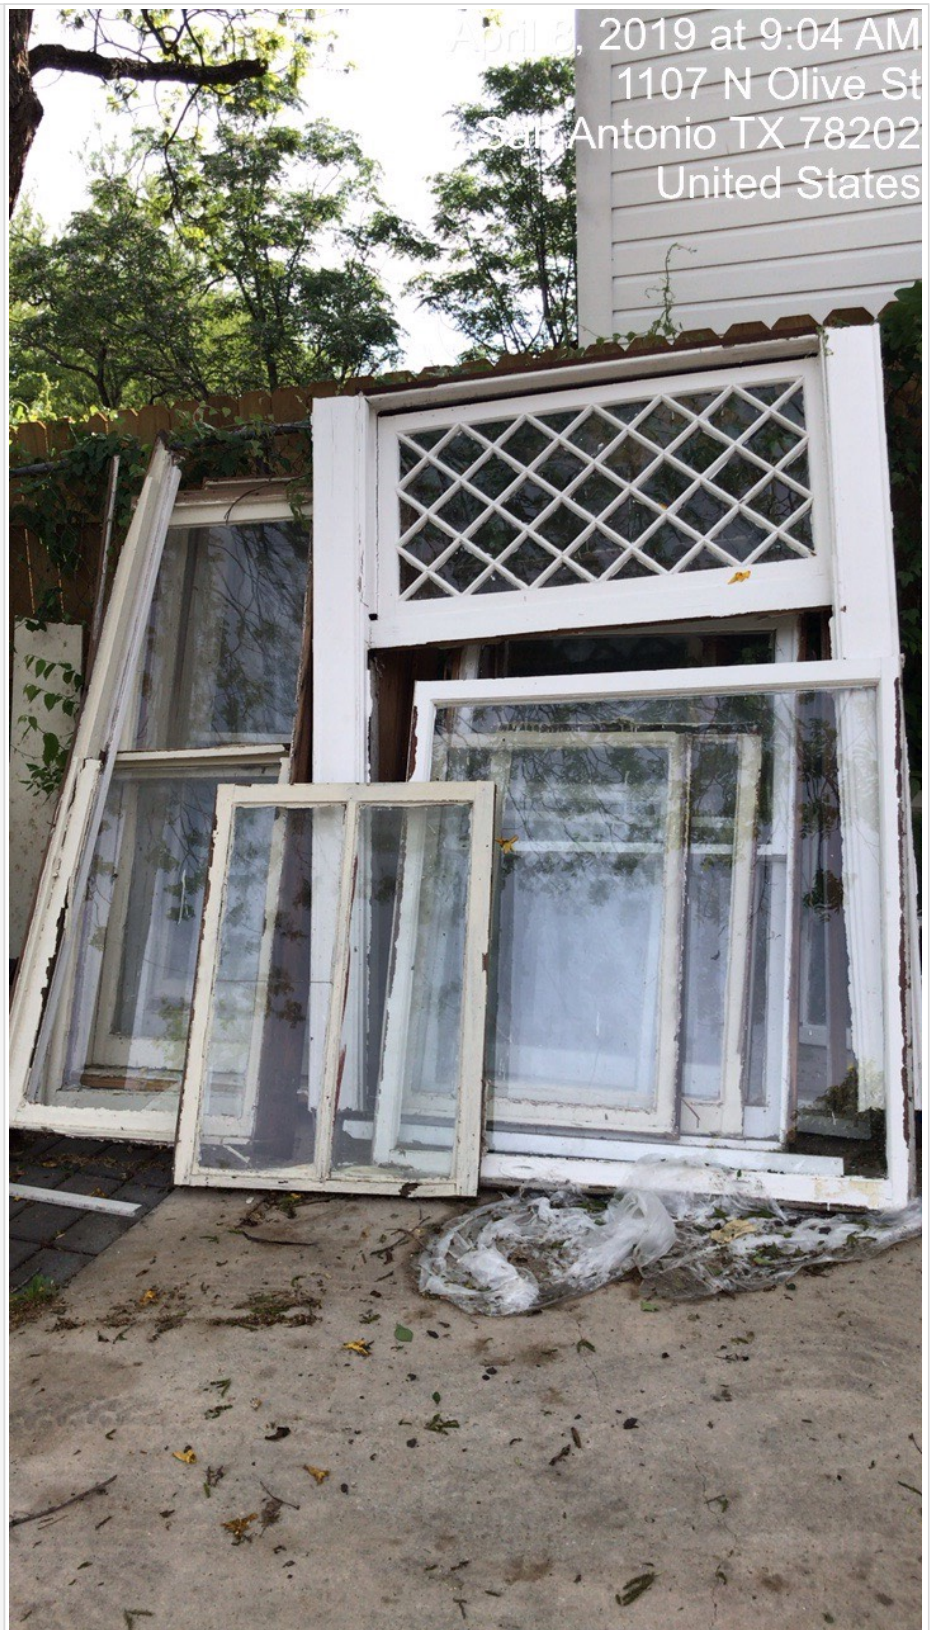
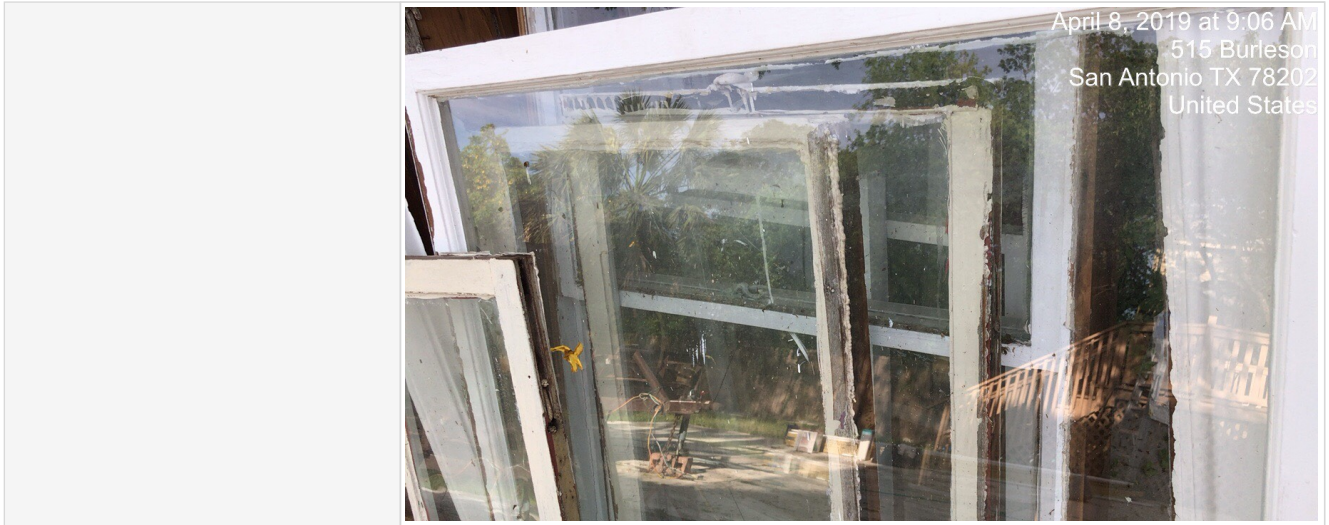
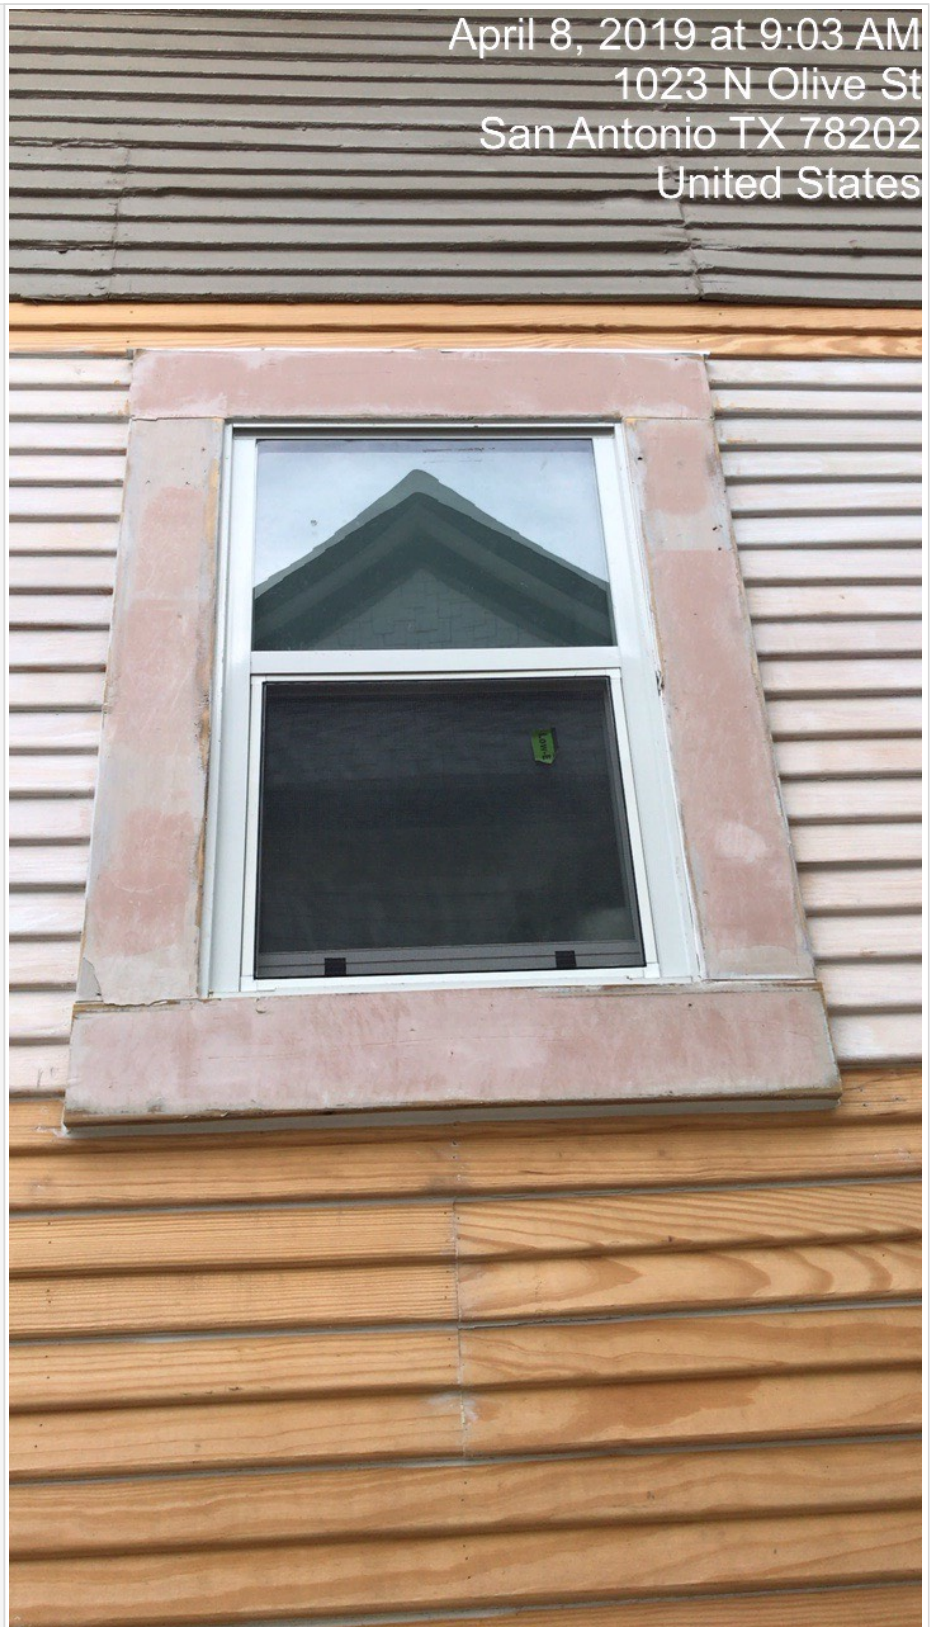
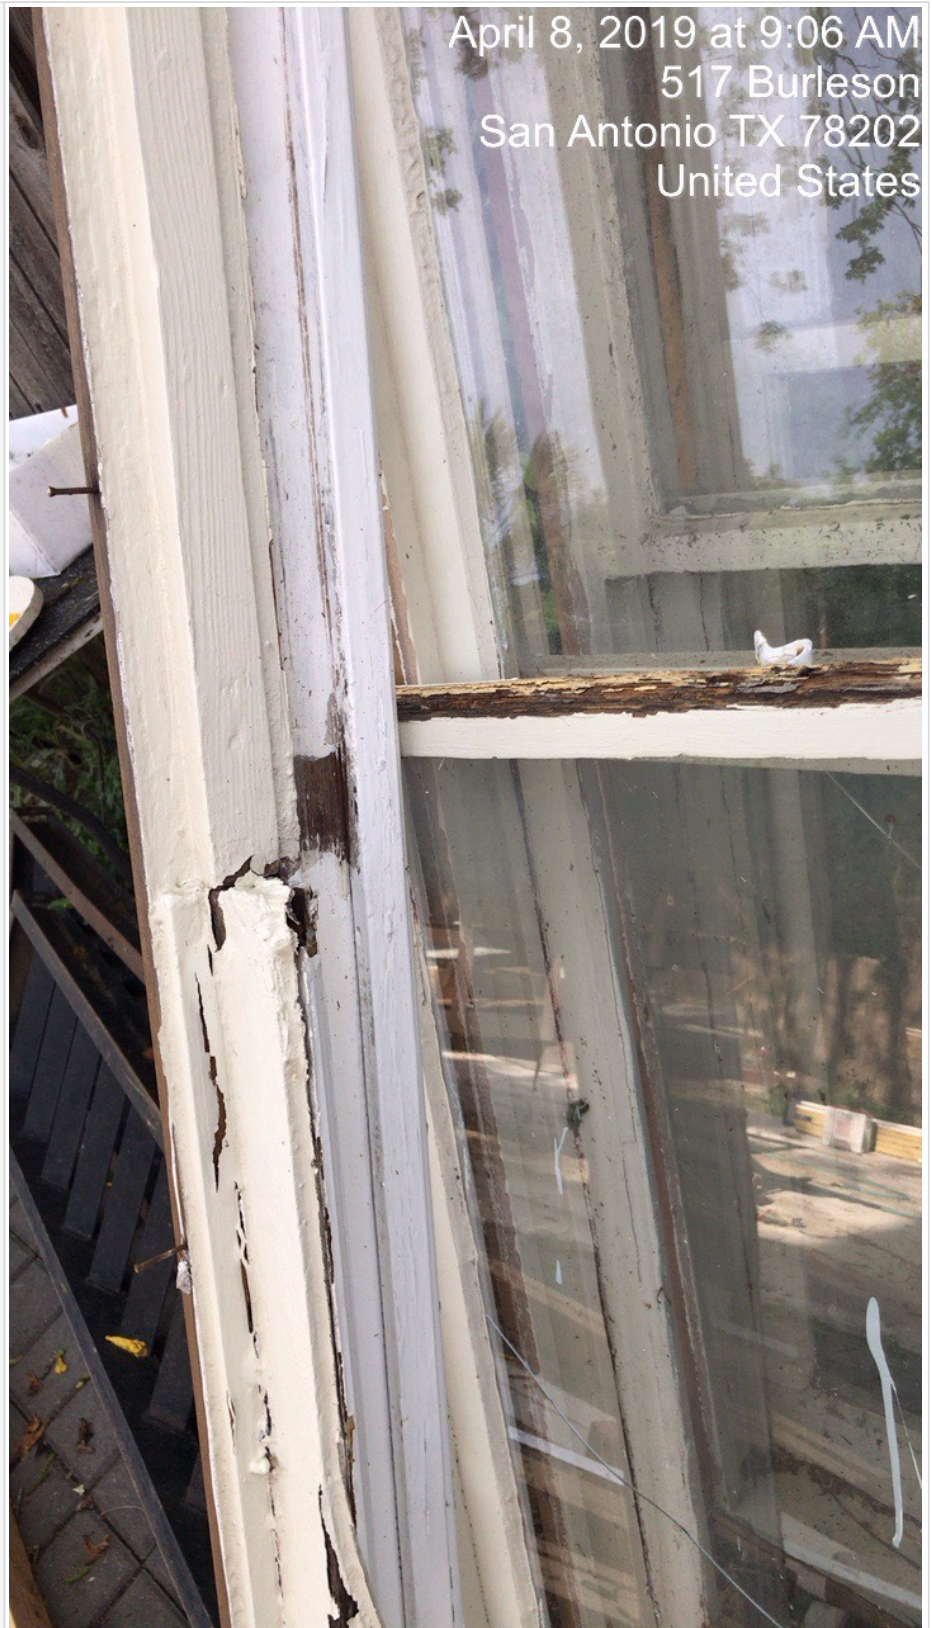
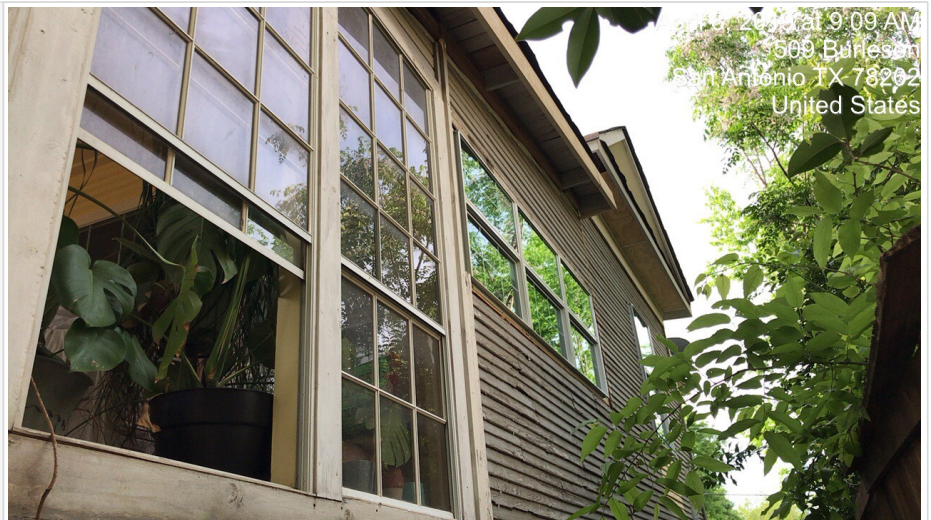
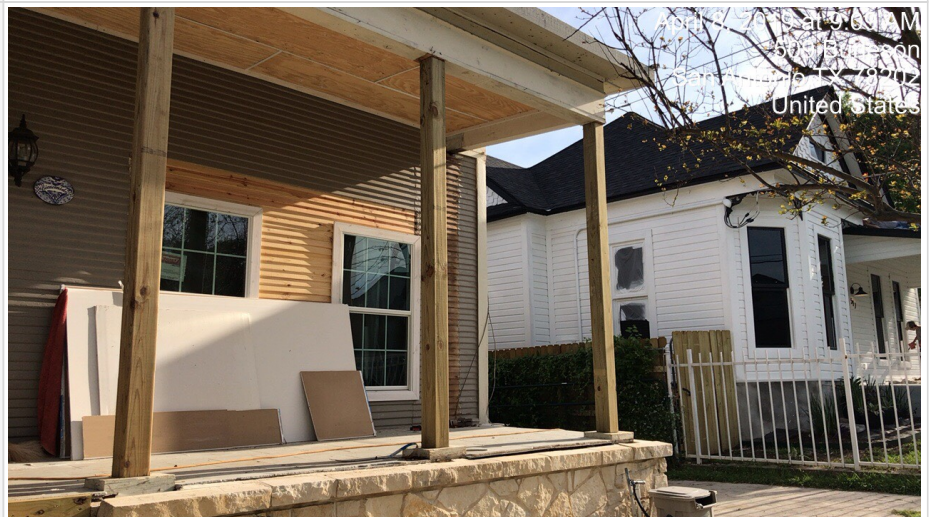
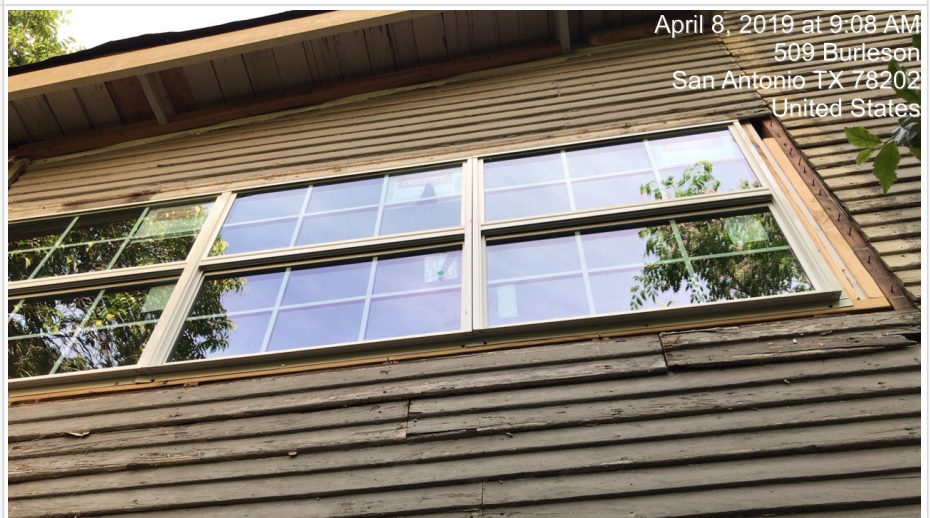
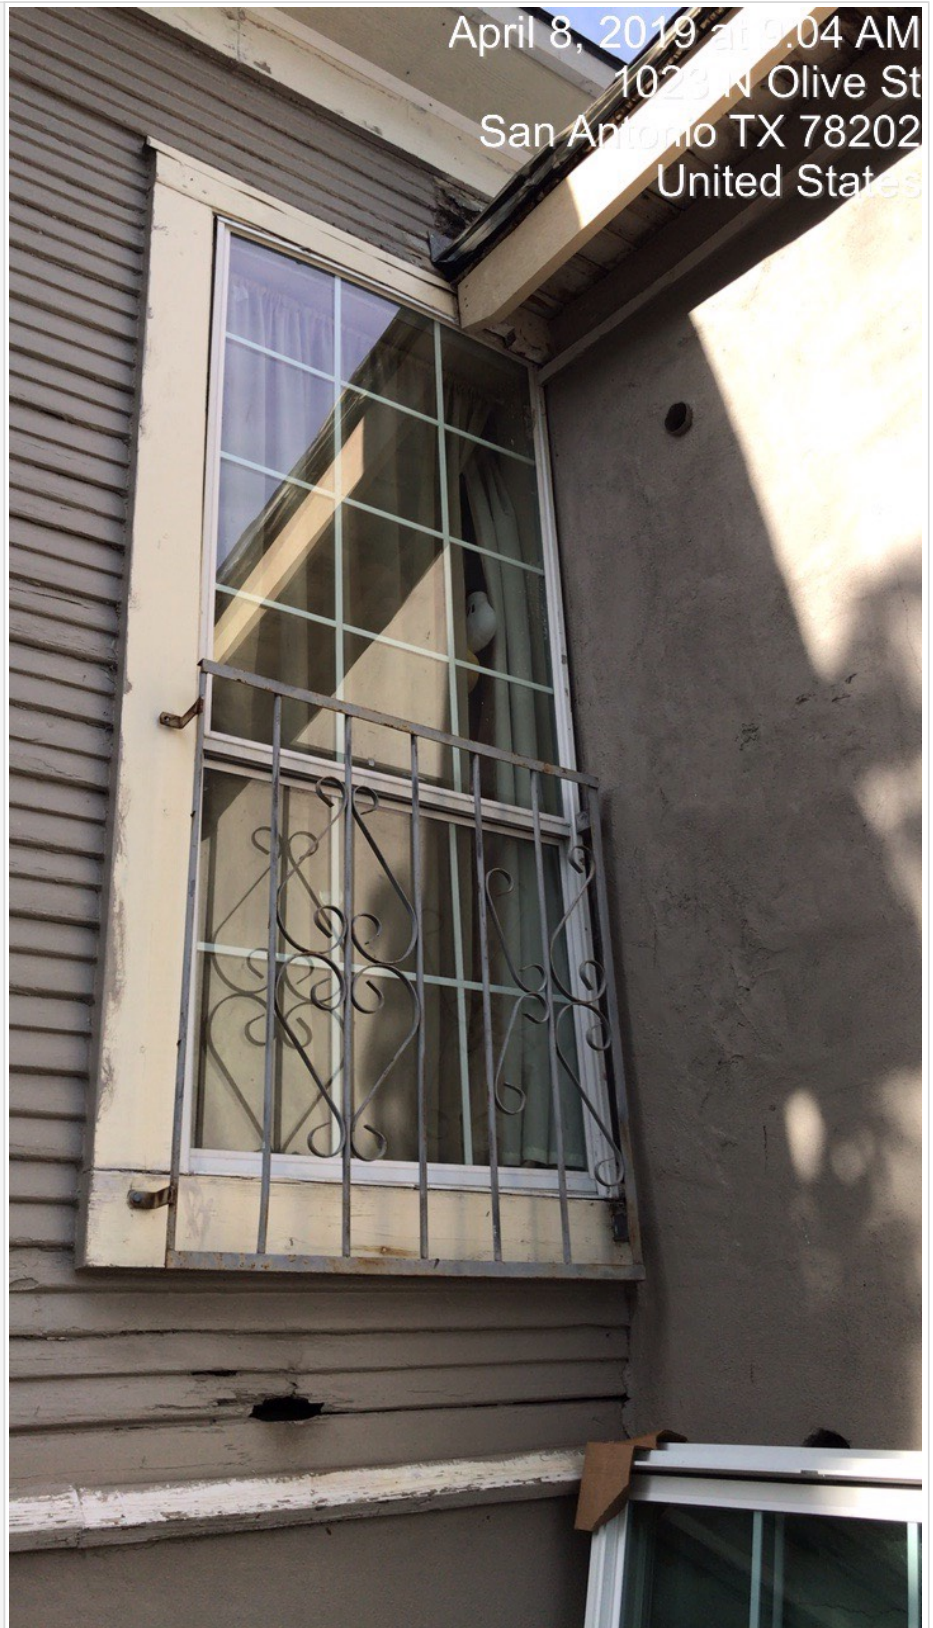
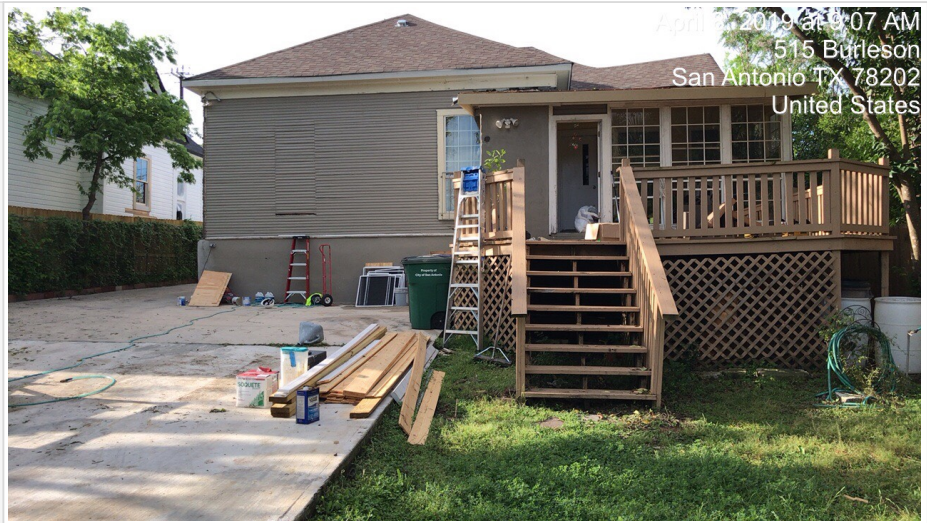
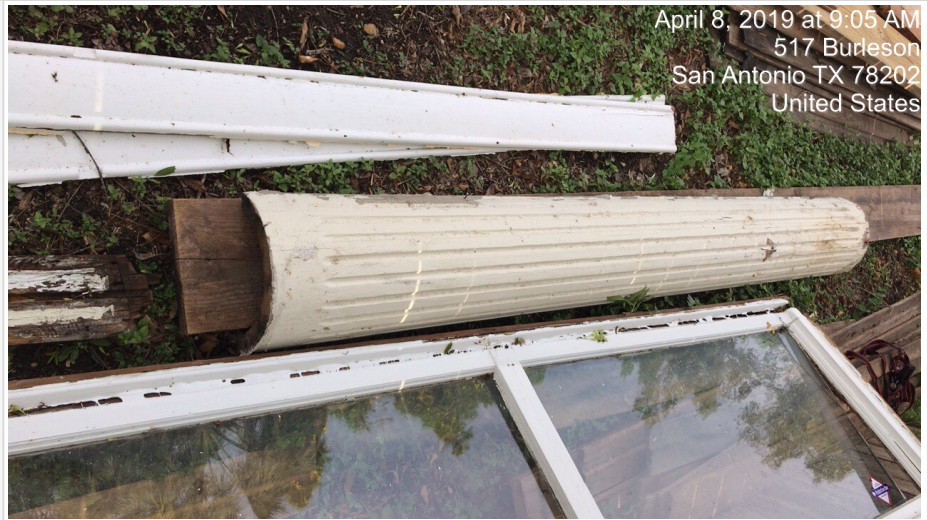
Date	04/08/2019
Time	09:41 AM (-5 GMT)
Context	follow-up
Present Staff	Huy Pham
Present Individuals	Homeowner, Family/Tenant
Contractor/Realtor Companies	Jesus Hernandez (family member)
Types of Work Observed	Exterior Maintenance and Alterations
Amount of Work Completed	75%
Description of work	Replacement of original wood sash windows with vinyl window with faux divided lites and nailing strips. Removal of fluted wood pilaster. All original windows and pilaster are still on site.
Description of interaction	Staff met with Jesus Hernandez and two other family members (daughters of owner Patricia Gonzales) on sight. Staff took a photo of each original and replacement window. Staff explained the next steps towards compliance including HDRC, BOA, and municipal court. Staff also provided information on other resources including OHP's wood window workshop, NHSD, DHNA, and SACS. Jesus committed to submitting an application for the next available HDRC heading.
