HISTORIC AND DESIGN REVIEW COMMISSION

June 19, 2019

HDRC CASE NO: 2019-321
ADDRESS: 523 CEDAR ST
LEGAL DESCRIPTION: NCB 2878 BLK 3 LOT 11
ZONING: RM-4, H
CITY COUNCIL DIST.: 1
DISTRICT: King William Historic District
APPLICANT: TREVINO EDUARDO R &
OWNER: TREVINO EDUARDO R &
TYPE OF WORK: Porch Replacement
APPLICATION RECEIVED: May 31, 2019
60-DAY REVIEW: August 18, 2019
CASE MANAGER: Huy Pham

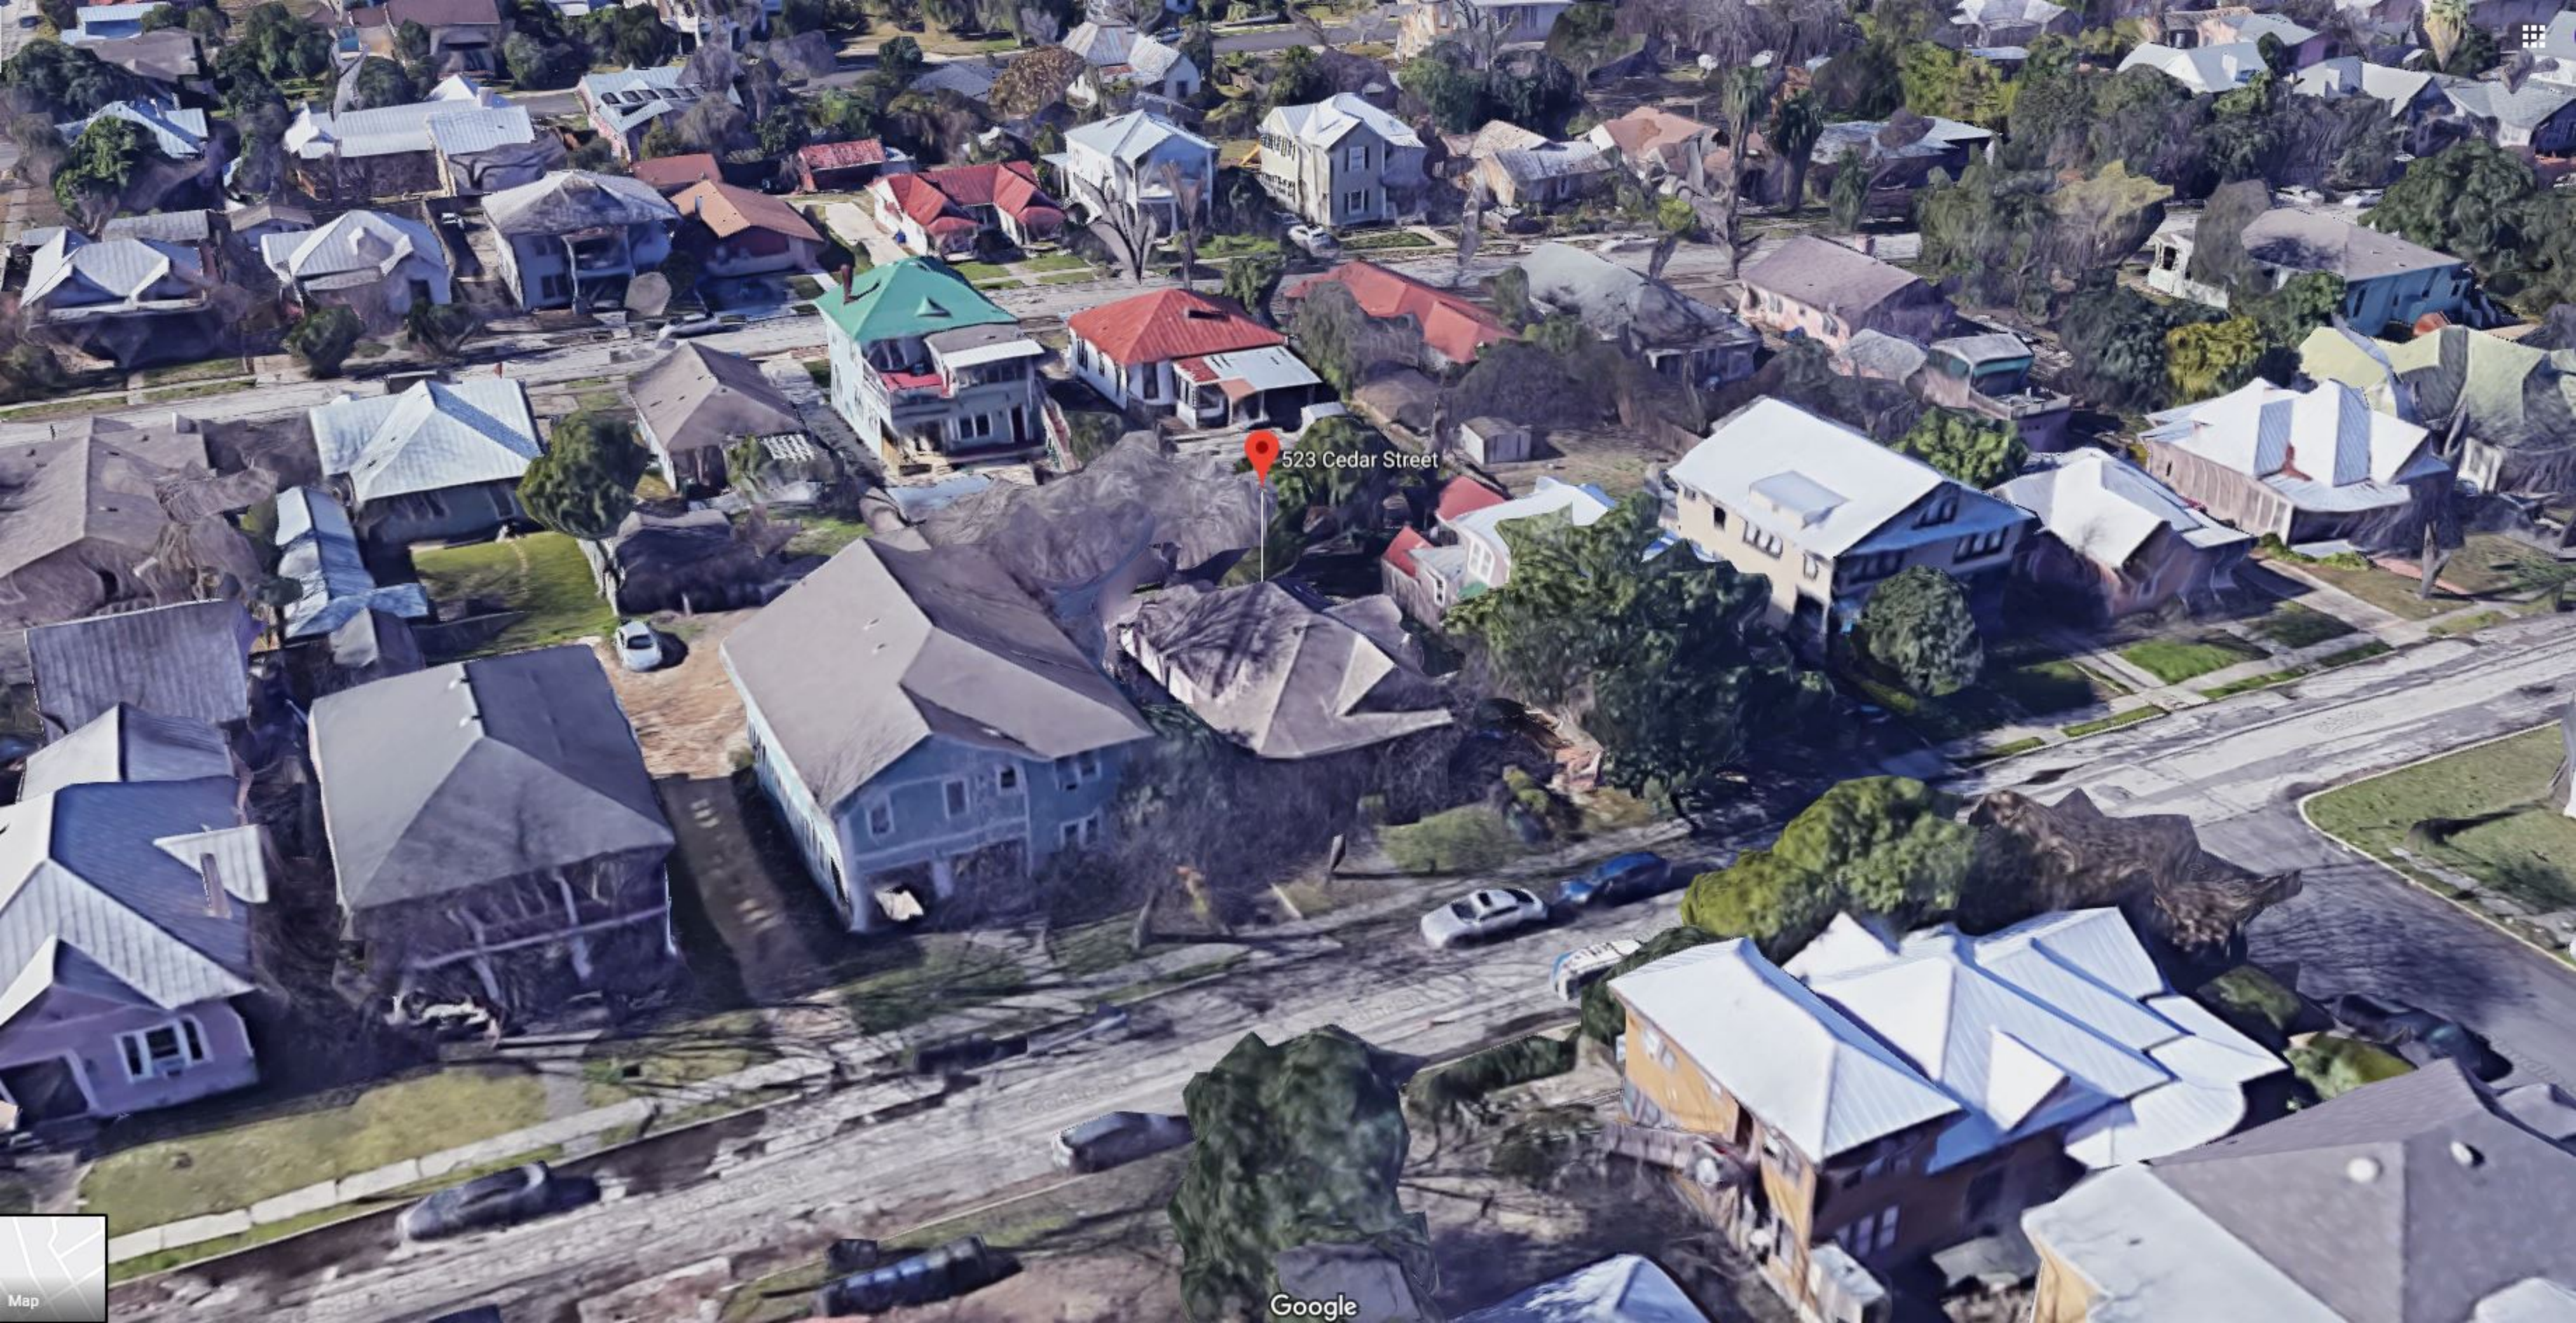
523 Cedar Street

- b. **COMPLIANCE** – On a site visit conducted on May 30, 2019, staff found that the front porch tongue-and-groove decking was replaced with 1x6 boards including the removal of some column capitals. The applicant submitted an application May 31, 2019, to be heard at the next available HDRC hearing.

Staff does not recommend approval based on finding b and c. In-kind replacement of 1x3 tongue-and-groove decking should be installed instead and the column capitals should be restored.
