HISTORIC AND DESIGN REVIEW COMMISSION

HDRC CASE NO: 2019-322

ADDRESS: 648 LEIGH ST

OWNER: DUNN LATASHA
TYPE OF WORK: Window replacement

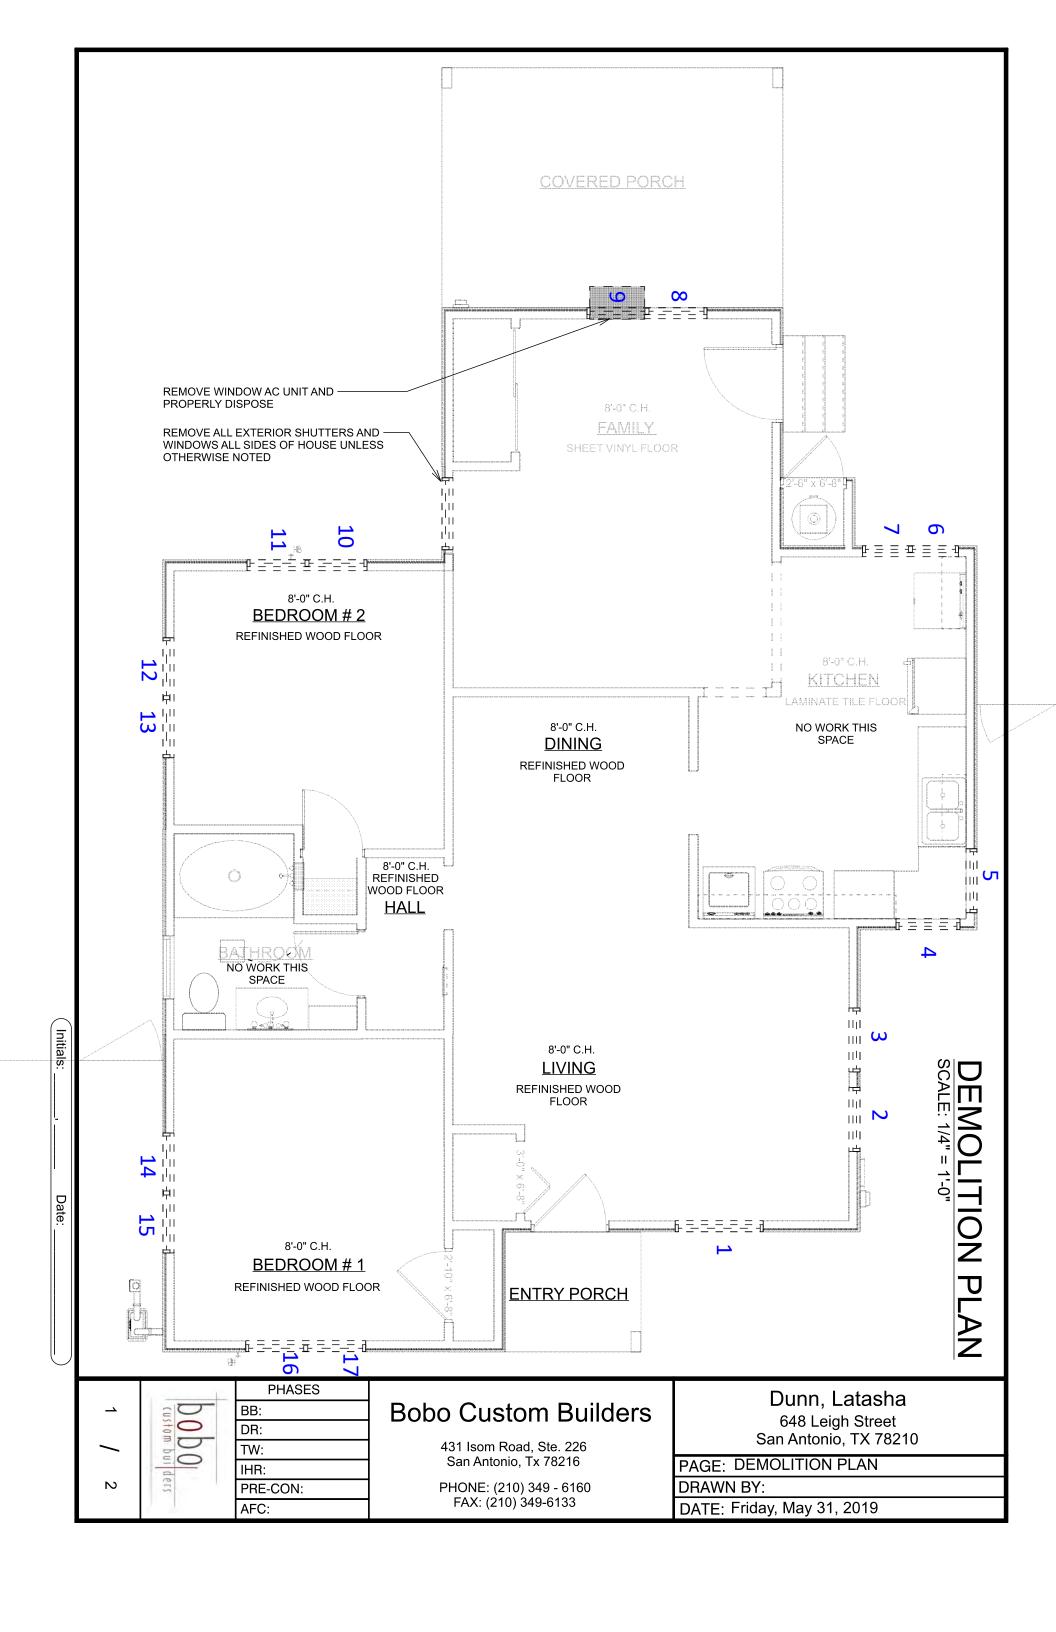
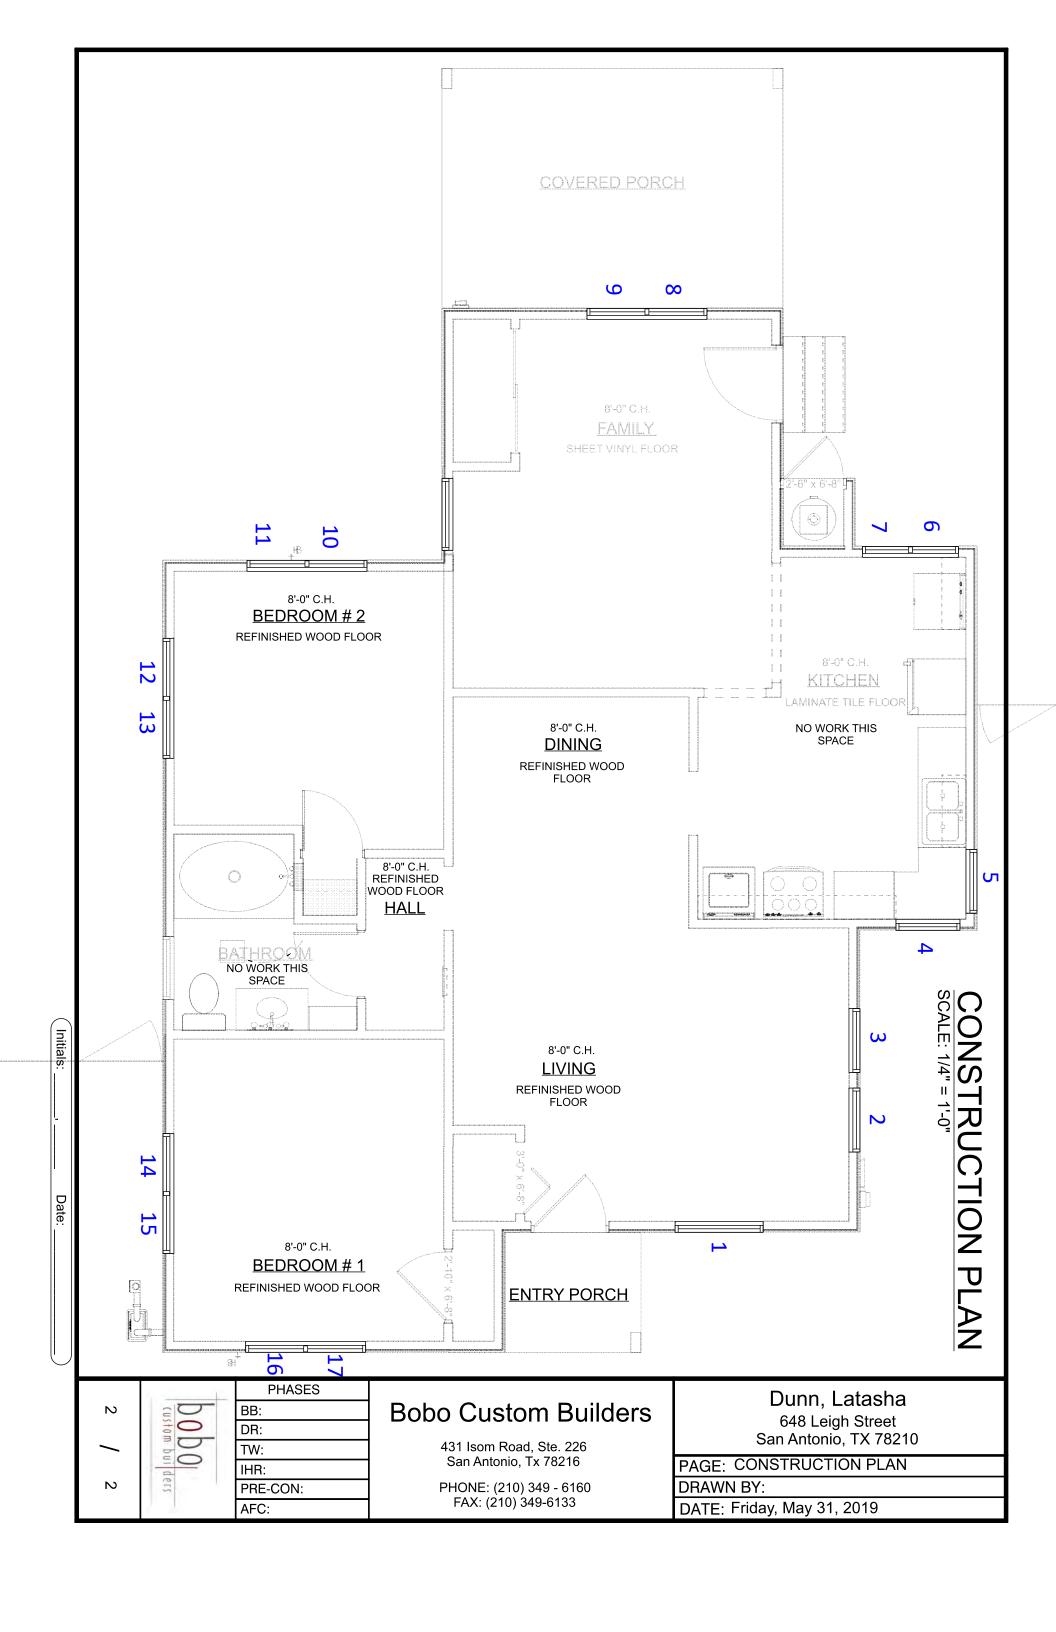
- b. EXISTING WINDOWS: CONDITON The applicant provided several photographs of the existing windows taken from outside the structures. Many of the windows feature exterior wood screens or louvers which have helped protect the window assemblies from ample sun exposure and other environmental factors. The applicant has noted that some of the windows are not operable, have broken or missing pulley cords, and are drafty. Based on the photographic evidence provided, staff finds that the windows are in good condition and are fully repairable.

Desc	ription of Window	•			General In	formation			Fra	me	Sash				Recommendation		
Number	Style	Width & Height	Material	Historic?	Paint Condition?	Square?	Operable?	Glazing Condition?	Weather Stripping?	Sill	Jamb	Sash Only Replacement?	Bottom Rail	Rails	Muntins	Meeting Rail	Total Value	Treatment
1	Double Hung	44" x 57 ¾"	Wood	Yes	Poor	Yes	No	N/A	Poor	1	1	No	2	1	No	1	6	
2	Double Hung	31 ¾" x 57 ¾"	Wood	Yes	Poor	Yes	No	N/A	Poor	1	1	No	2	1	No	1	6	
3	Double Hung	31 ¾" x 57 ¾"	Wood	Yes	Poor	Yes	No	N/A	Poor	1	1	No	2	1	No	1	6	
4	Double Hung	31 ¾" x 34"	Wood	Yes	Poor	Yes	No	N/A	Poor	1	1	No	2	1	No	1	6	
5	Double Hung	31 ¾" x 34"	Wood	Yes	Poor	Yes	No	N/A	Poor	1	1	No	2	1	No	1	6	
6	Double Hung	44" x 53 ¾"	Wood	Yes	Poor	Yes	No	N/A	Poor	1	1	No	2	1	No	1	6	
7	Double Hung	31 ¾" x 57 ½"	Wood	Yes	Poor	Yes	No	N/A	Poor	1	1	No	2	1	No	1	6	
8	Double Hung	31 ¾" x 57 ½"	Wood	Yes	Poor	Yes	No	N/A	Poor	1	1	No	2	1	No	1	6	
9	Double Hung	31 ¾" x 57 ½"	Wood	Yes	Poor	Yes	No	N/A	Poor	1	1	No	2	1	No	1	6

10	Double Hung	31 ¾" x 57 ½"	Wood	Yes	Poor	Yes	No	N/A	Poor	1	1	No	2	1	No	1	6	
11	Double Hung	31 ¾" x 57 ½"	Wood	Yes	Poor	Yes	No	N/A	Poor	1	1	No	2	1	No	1	6	
12	Double Hung	31 ¾" x 57 ½"	Wood	Yes	Poor	Yes	No	N/A	Poor	1	1	No	2	1	No	1	6	
13	Double Hung	31 ¾" x 57 ½"	Wood	Yes	Poor	Yes	No	N/A	Poor	1	1	No	2	1	No	1	6	
14	Double Hung	31 ¾" x 57 ½"	Wood	Yes	Poor	Yes	No	N/A	Poor	1	1	No	2	1	No	1	6	
15	Double Hung	31 ¾" x 57 ½"	Wood	Yes	Poor	Yes	No	N/A	Poor	1	1	No	2	1	No	1	6	
16	Double Hung	31 ¾" x 57 ½"	Wood	Yes	Poor	Yes	No	N/A	Poor	1	1	No	2	1	No	1	6	
17	Double Hung	31 ¾" x 57 ½"	Wood	Yes	Poor	Yes	No	N/A	Poor	1	1	No	2	1	No	1	6

Staff does not recommend approval of the window replacement based on findings a through d. Staff recommends that the applicant repair the remaining existing wood windows in place. If there are assemblies that are deteriorated beyond repair, the applicant must submit evidence to that effect to staff in the form of an updated window schedule and photographs.
