HISTORIC AND DESIGN REVIEW COMMISSION

HDRC CASE NO: 2019-427
ADDRESS: 519 S PRESA ST
LEGAL DESCRIPTION: NCB 902 BLK LOT 24 AT 724 ST MARY'S
ZONING: IDZ,HL
CITY COUNCIL DIST.: 1
DISTRICT: Lavaca Historic District
APPLICANT: Rebekah Perez/Work5hop
OWNER: WONG WAY LLC
TYPE OF WORK: Reconstruction of 1-story front porch with extension
APPLICATION RECEIVED: July 17, 2019
60-DAY REVIEW: September 15, 2019
CASE MANAGER: Stephanie Phillips
REQUEST:

519 South Presa St. Repair

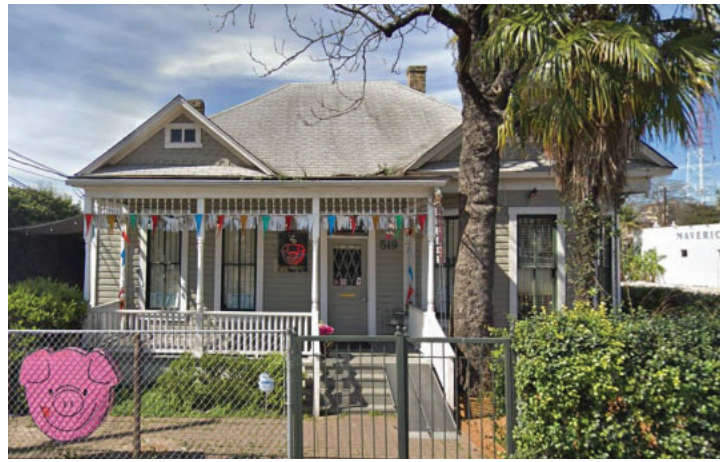
March 2019

A recent storm damaged a large tree on the near east side of the building. The damage caused the tree to fall on top of the existing front porch roof, destroying the roof structure, columns, railing, fascia, soffit, and decorative wood trim, as well as a portion of the iron gate and fence near the street.
