HISTORIC AND DESIGN REVIEW COMMISSION

HDRC CASE NO: 2019-575
ADDRESS: 119 ADAMS ST
LEGAL DESCRIPTION: NCB 931 BLK LOT 17 AND 18
ZONING: RM-4,HS, H
CITY COUNCIL DIST.: 1
DISTRICT: King William Historic District
LANDMARK: Koehler House
APPLICANT: Nicole Corwin/Tatanka
OWNER: Jarod and Celeste Oliver
TYPE OF WORK: Historic Tax Verification
APPLICATION RECEIVED: September 24, 2019
60-DAY REVIEW: November 23, 2019
CASE MANAGER: Huy Pham
REQUEST:

The applicant is requesting Historic Tax Verification for the property at 119 Adams.

119 Adams

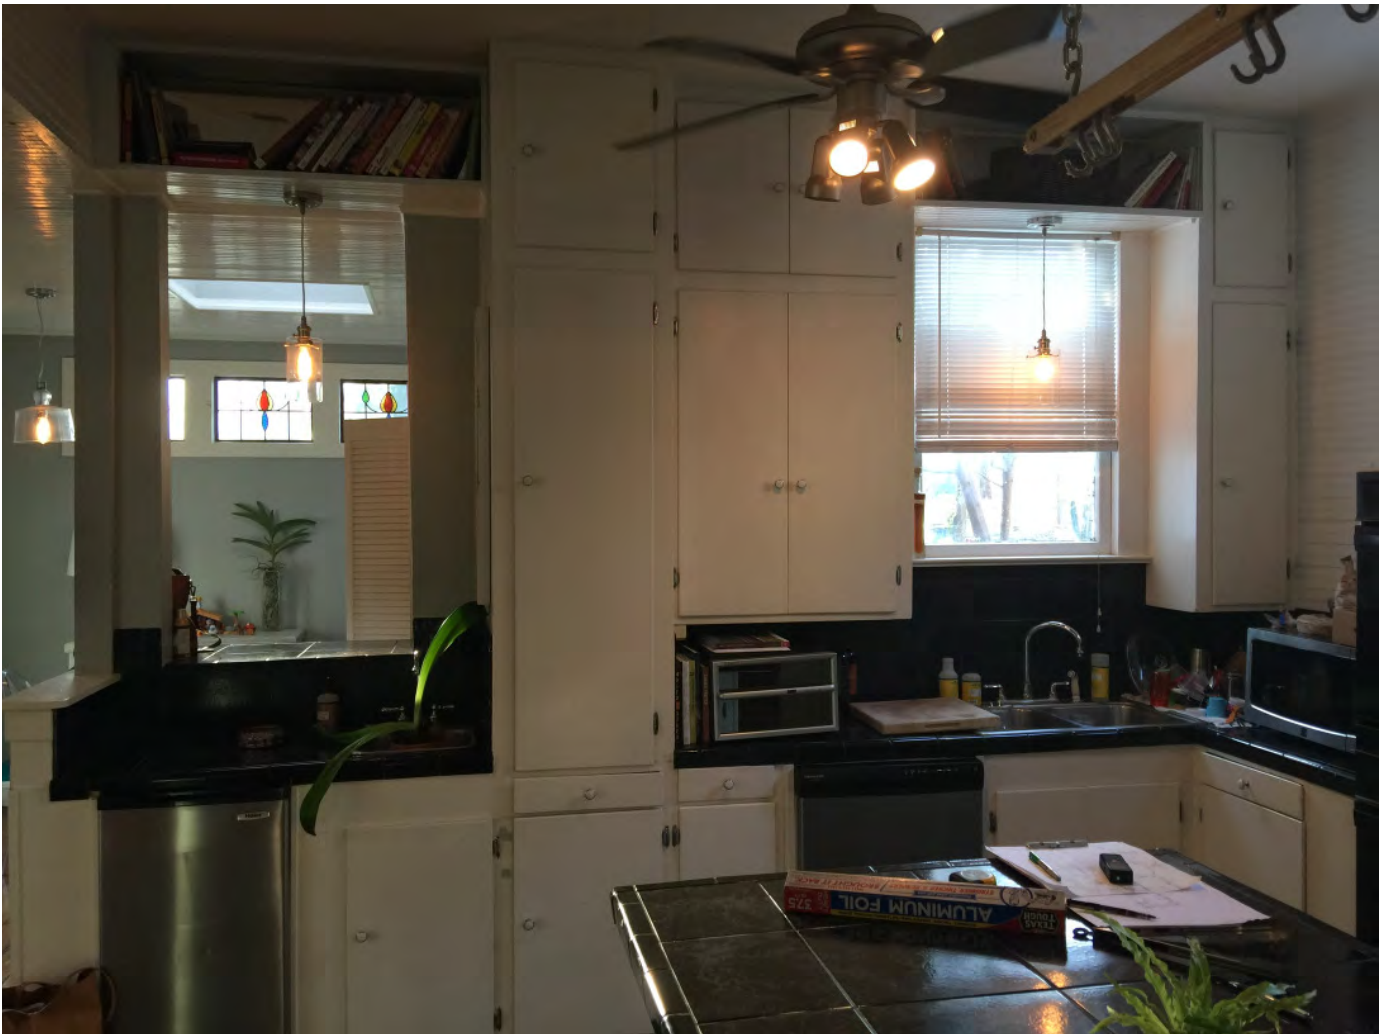
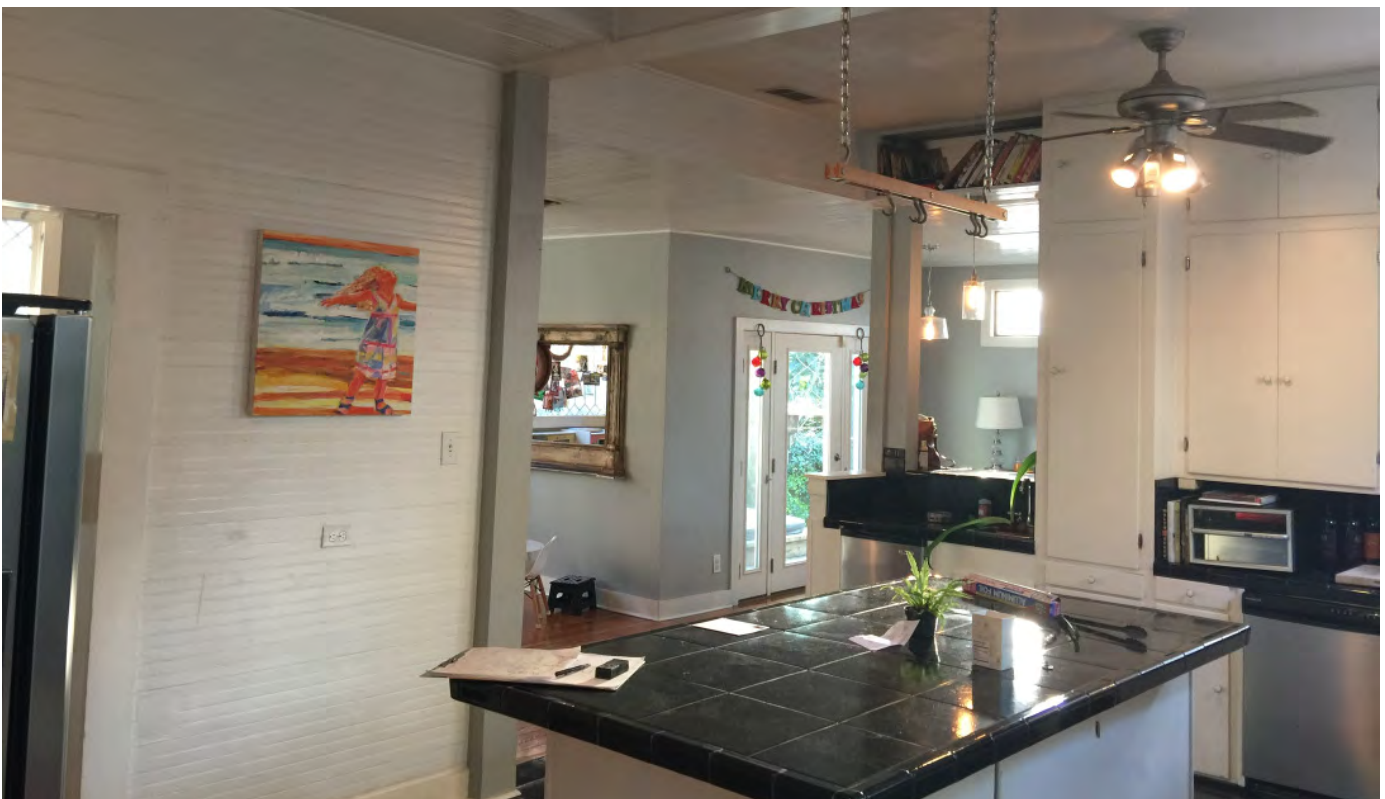
Pre-Remodel 1st Kitchen
wall dividing kitchen from living to be removed, all new kitchen finishes, fixtures and cabinets.

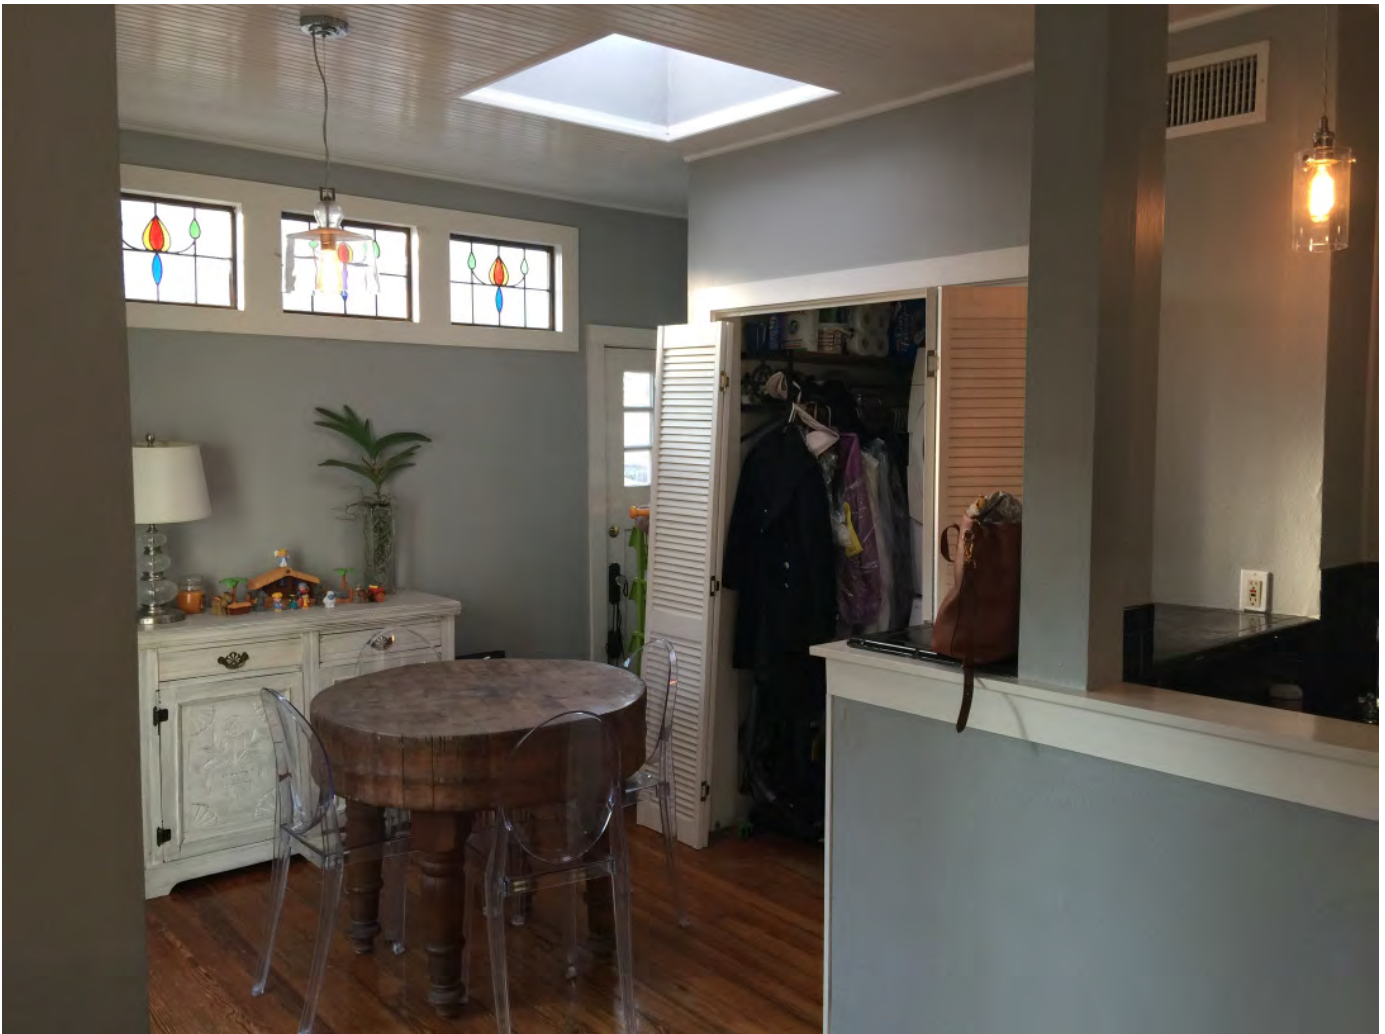
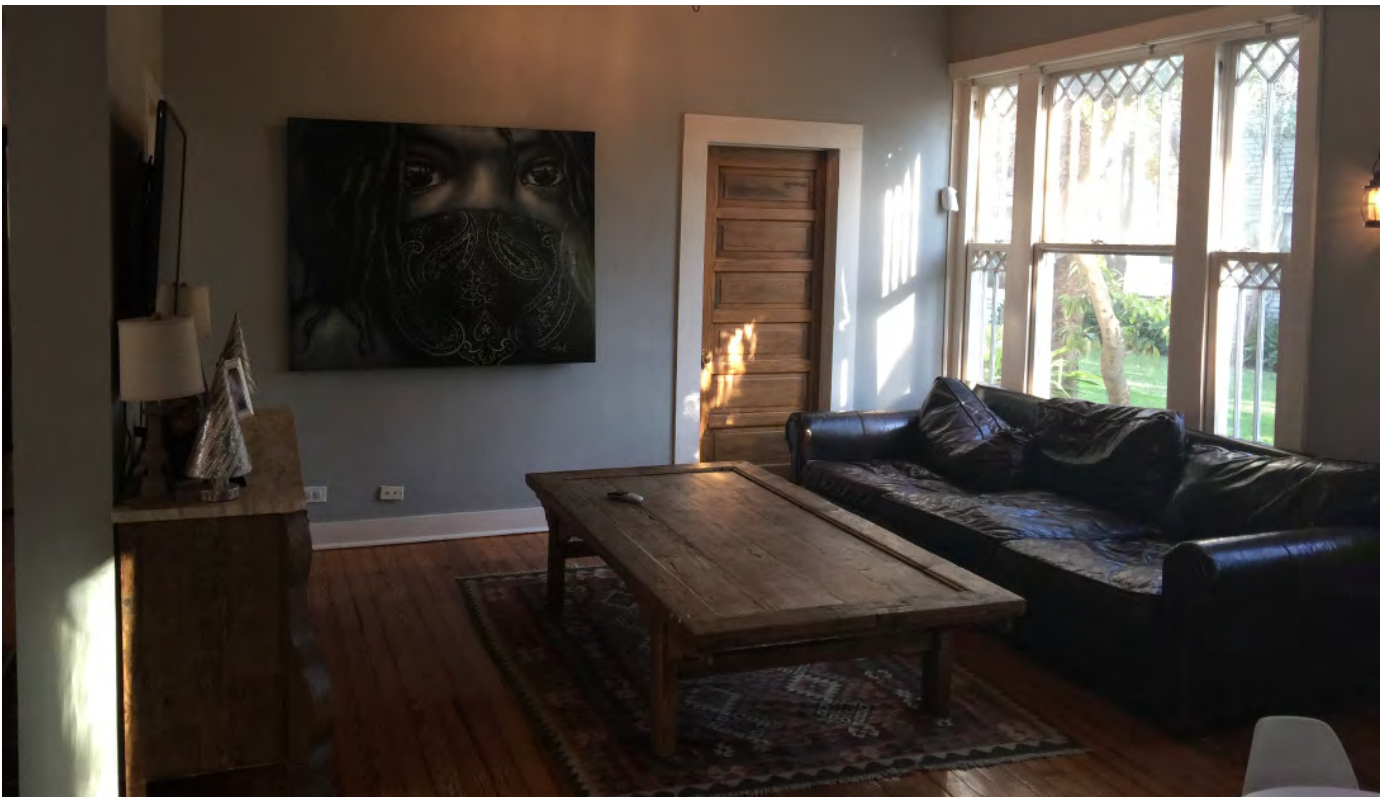
Pre-Remodel 1st Mudroom/Laundry & Living

reconfigure mudroom & laundry relocated, door to dining rm relocated & new cased opening to dining, relocated leaded windows.

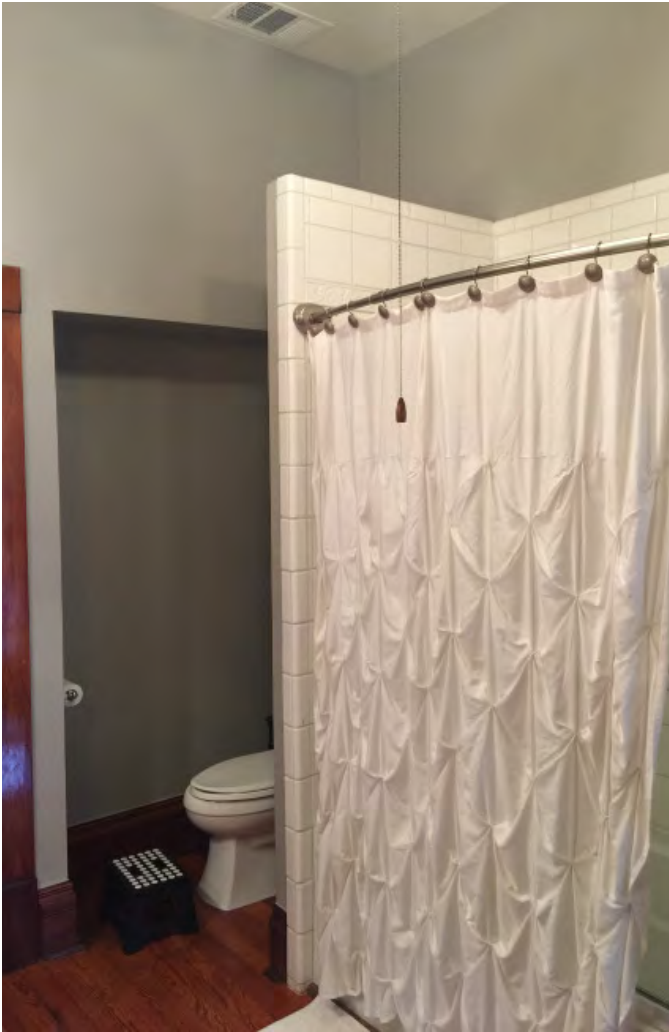
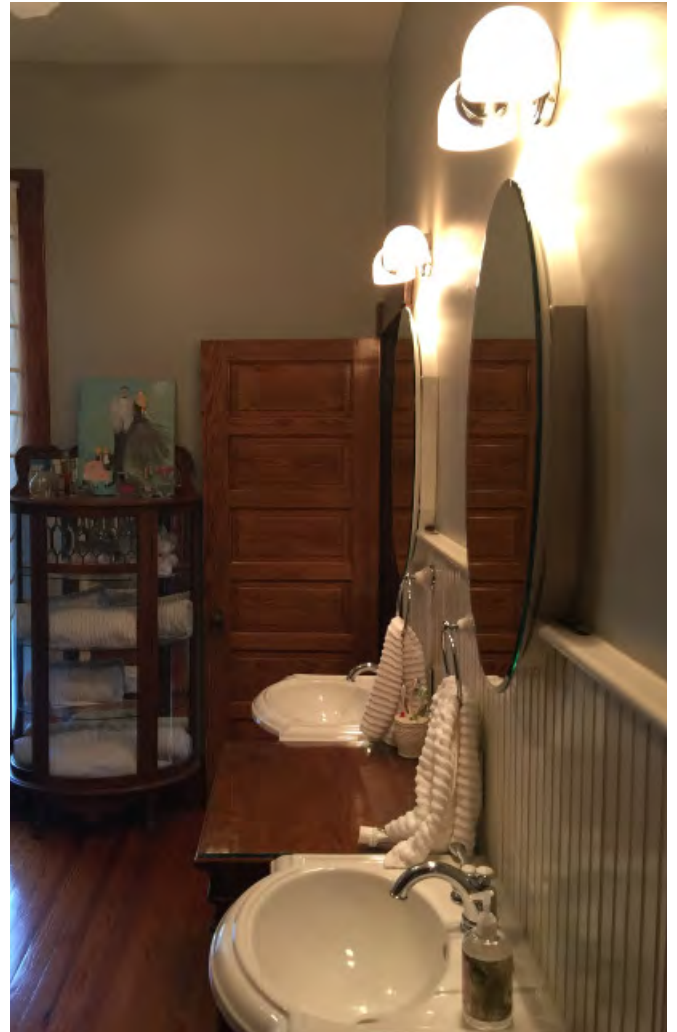
Pre-Remodel 2nd Floor Guest Bathroom A
to be reconfigured into guest bath and laundry room, all new finishes and fixtures.

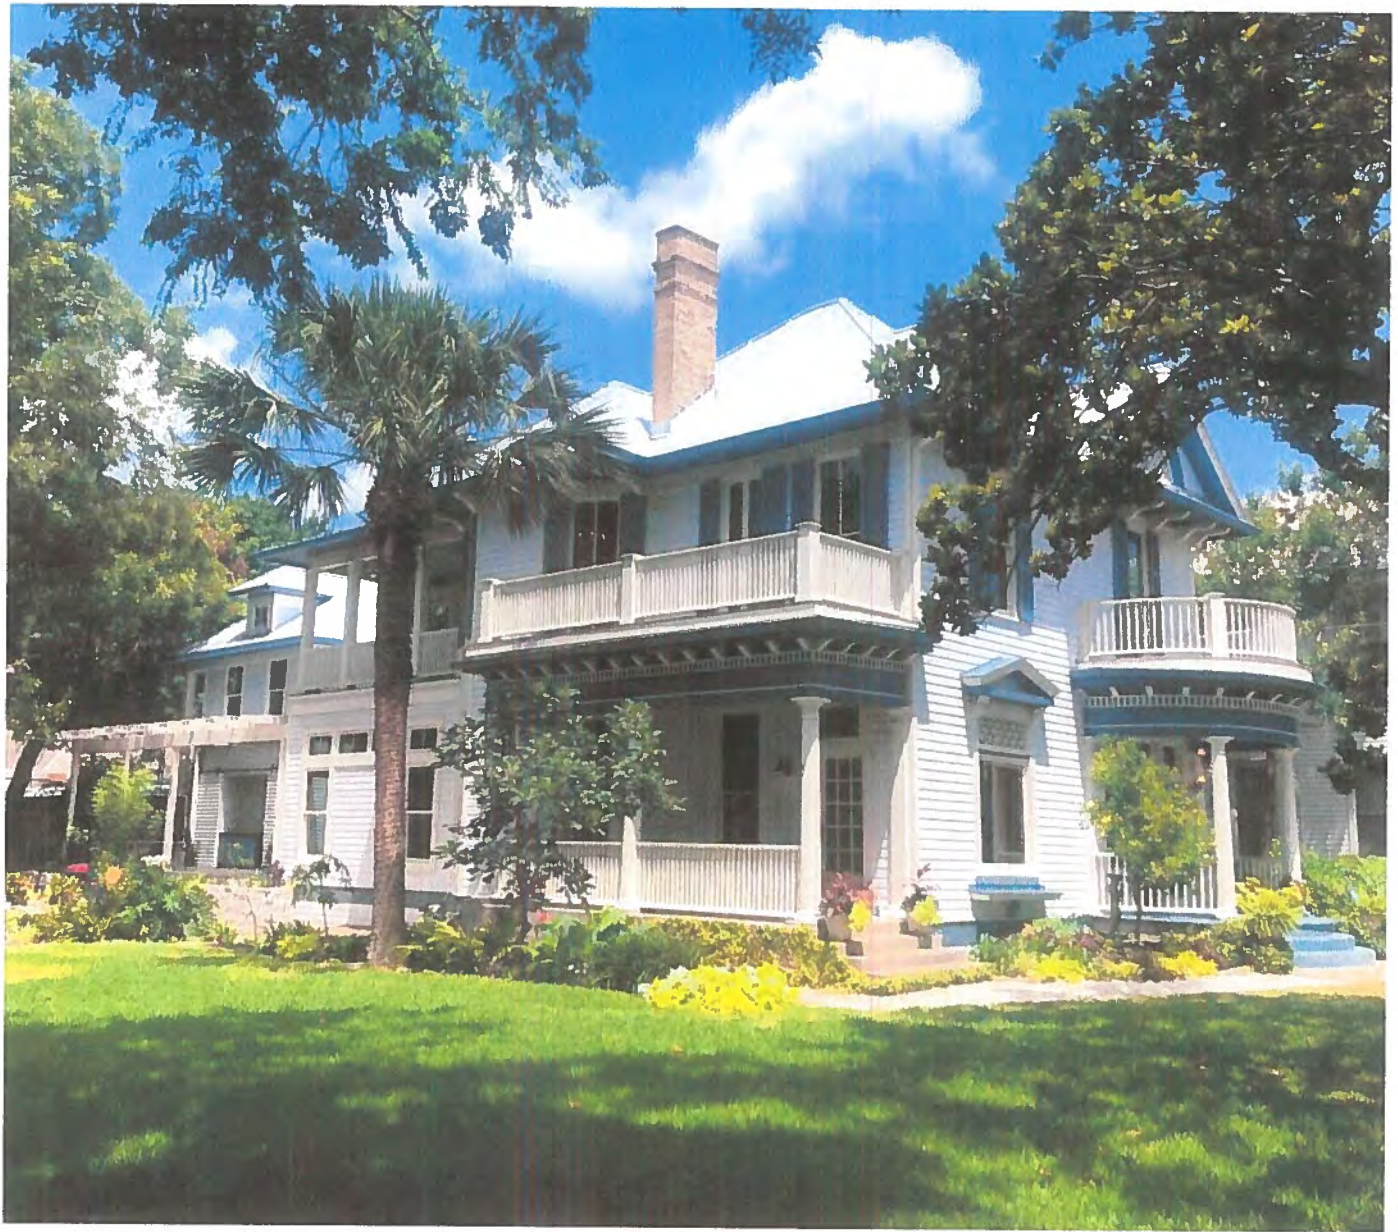
Exterior Side of House
new paint & maintenance, new back-porch addition, new accessory dwelling, relocated southwest balcony

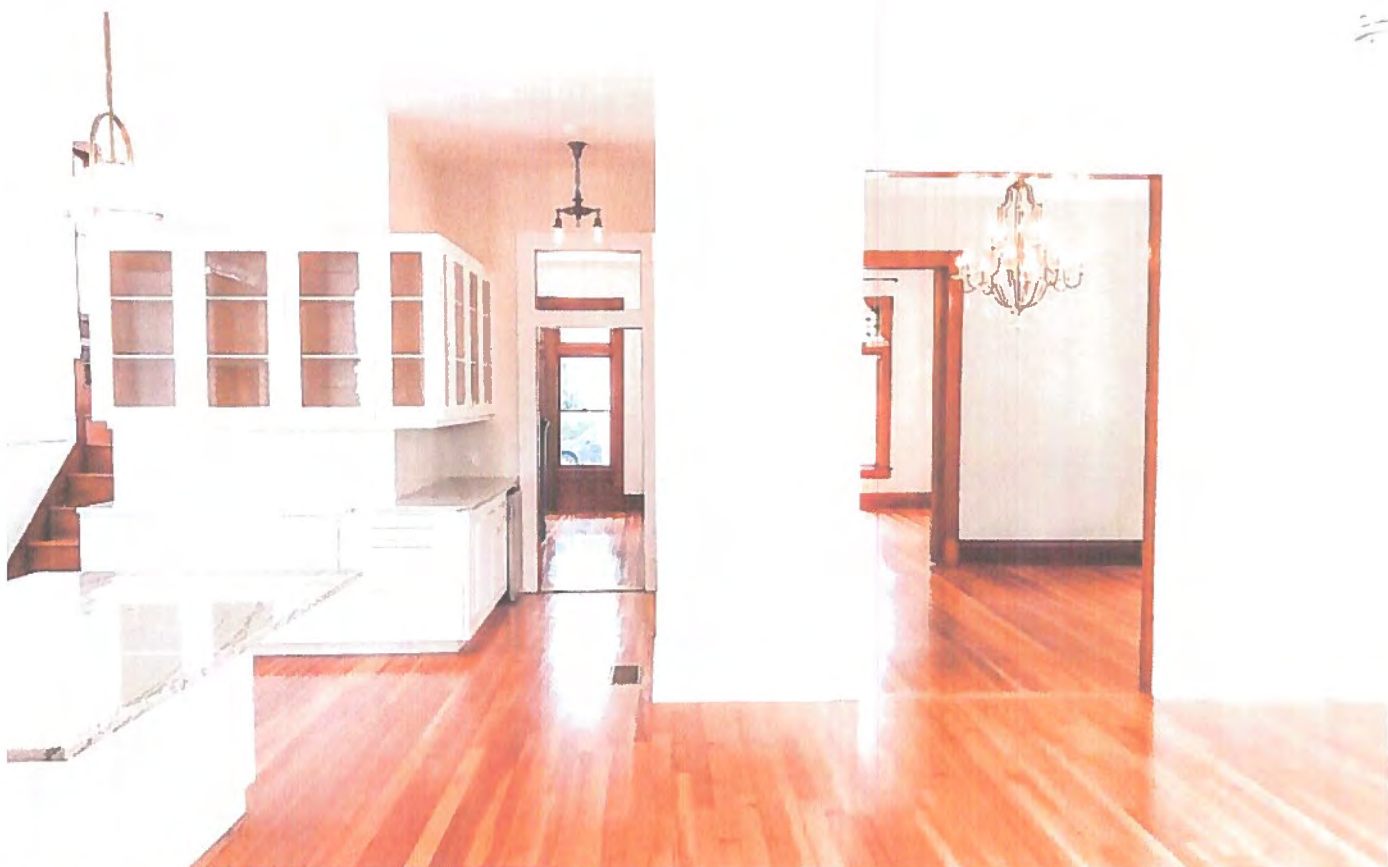
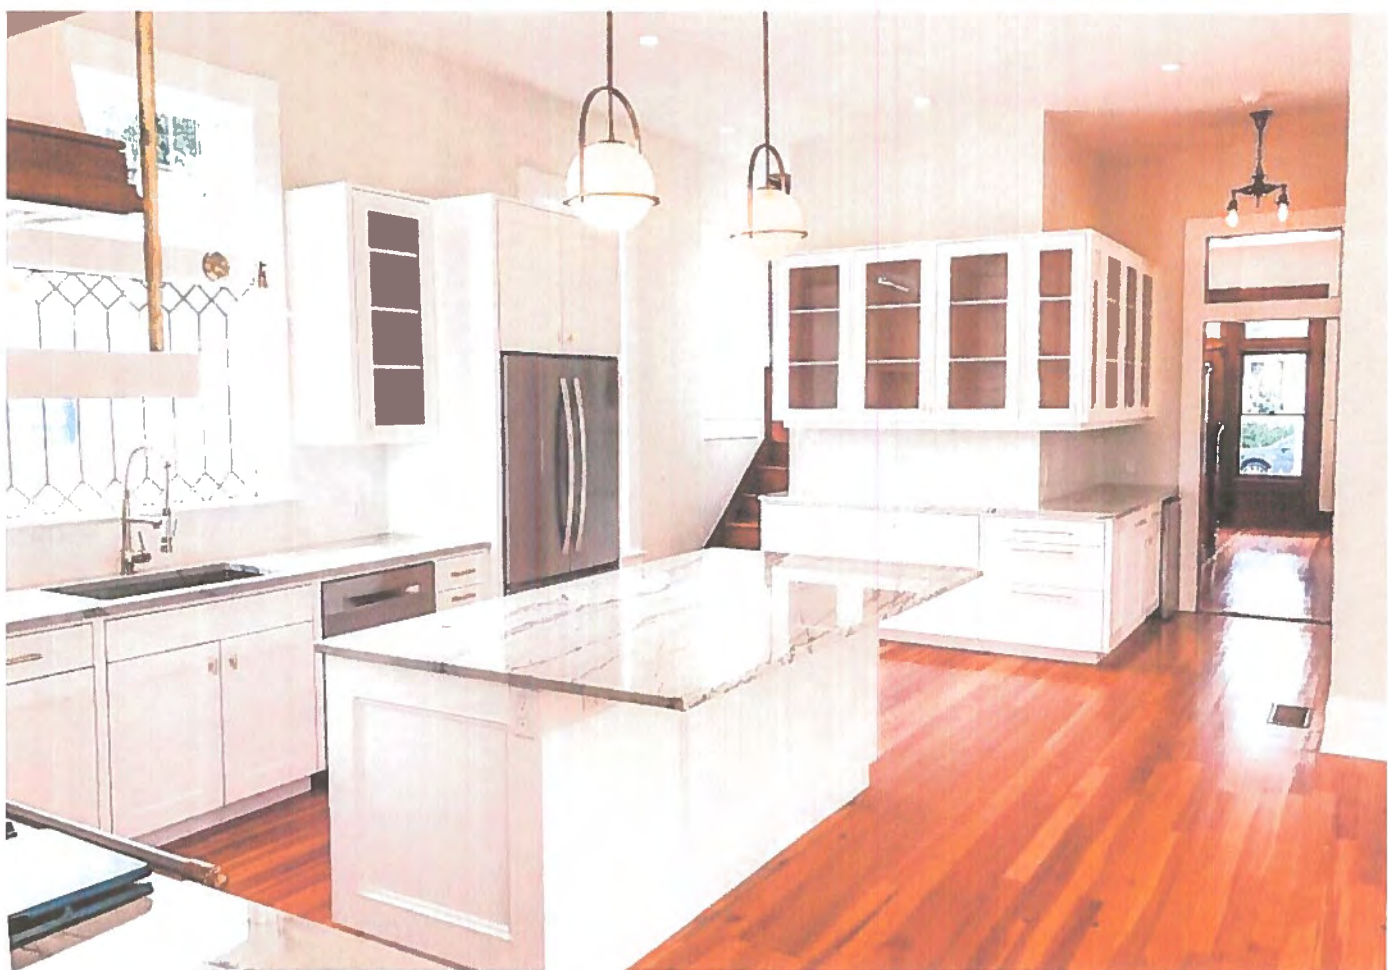
1st Kitchen & Living Room

New layout removed wall separating living and kitchen, added an opening to the dining rm and enlarged stair access opening..

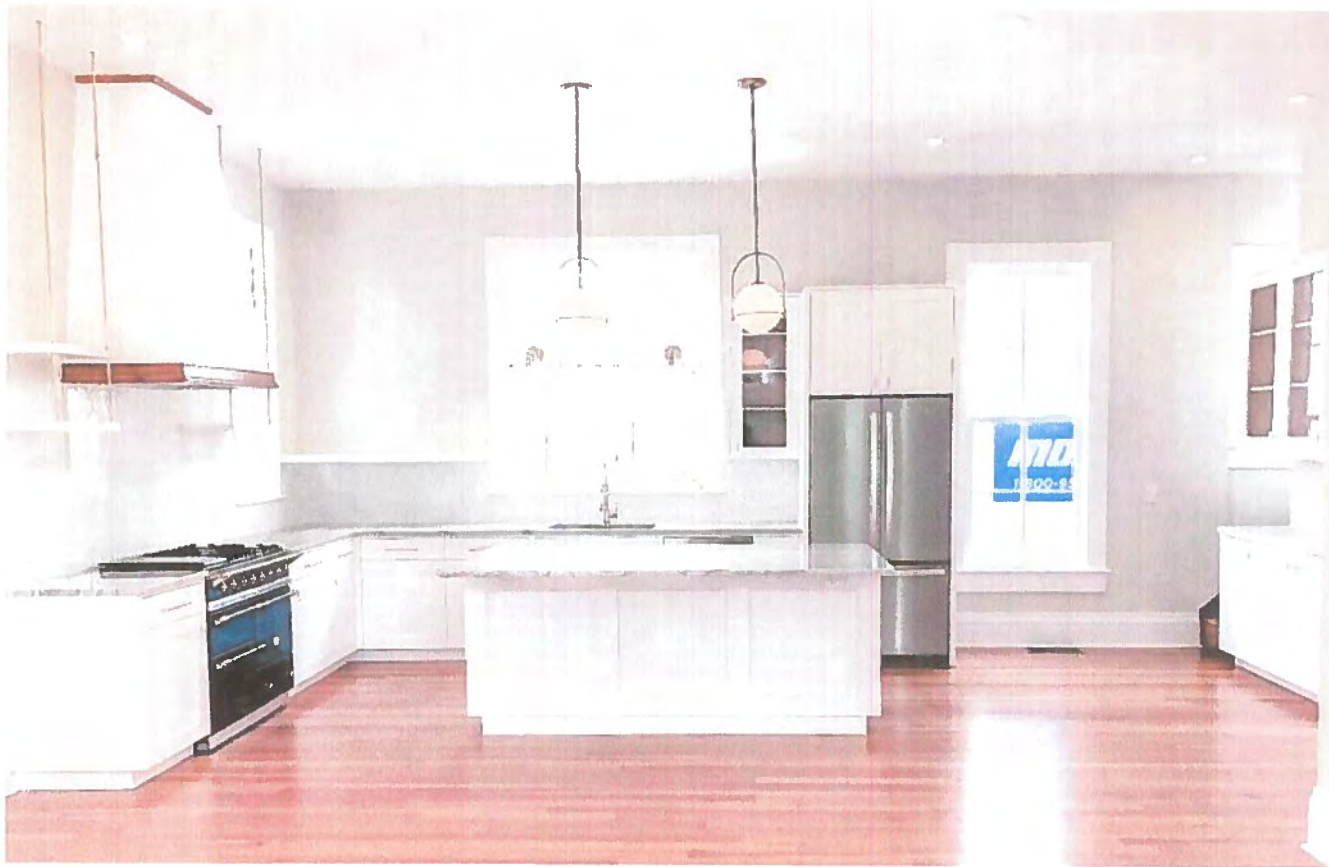
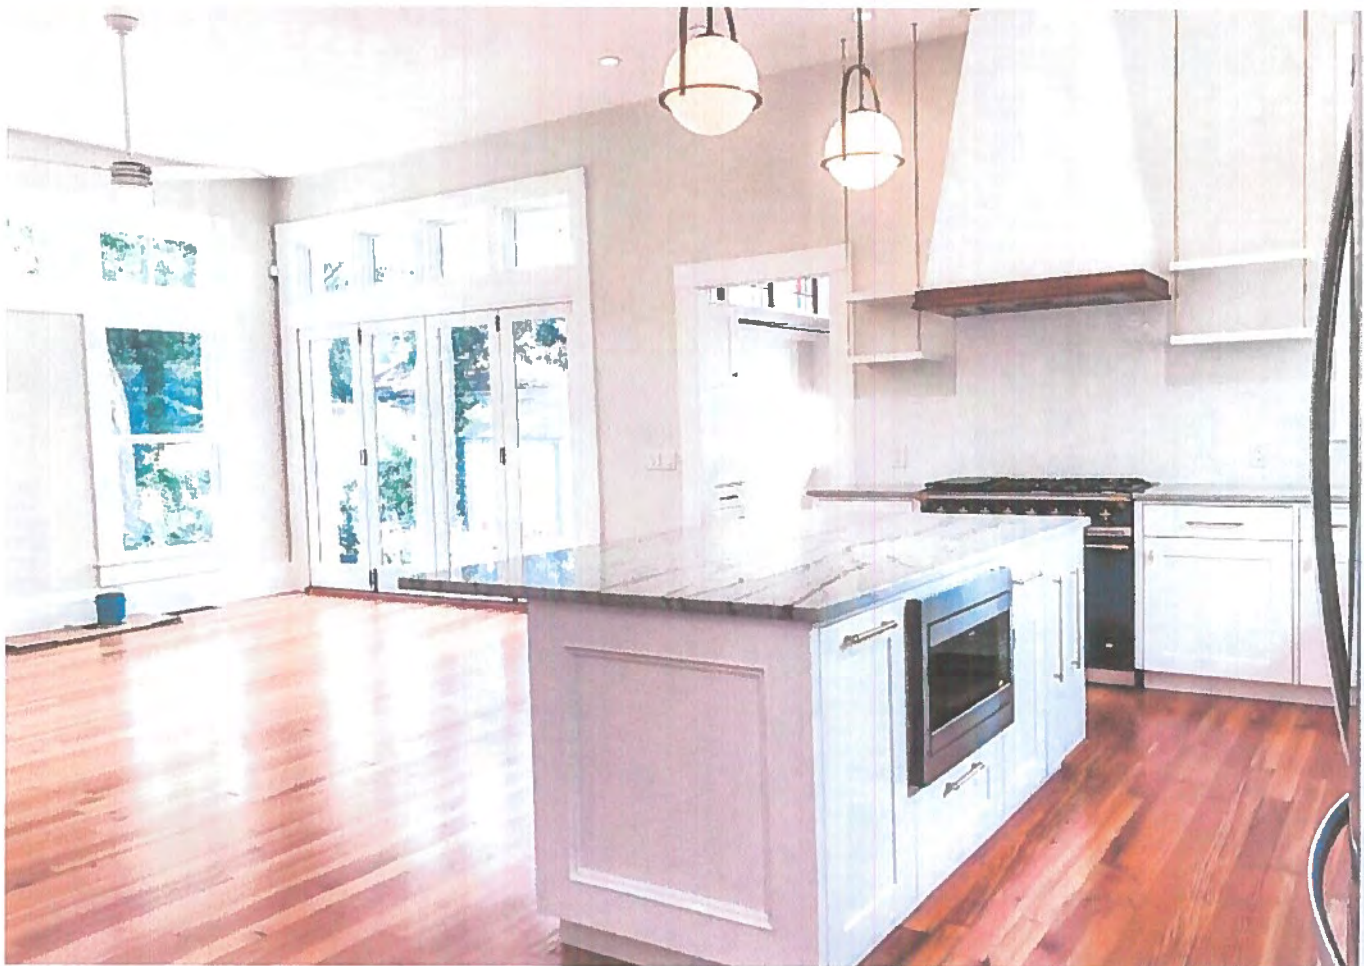
1st Kitchen & Living Room

New windows and French doors in the living rm. New mud rm, finishes and fixtures. Relocated historic leaded window to kitchen.

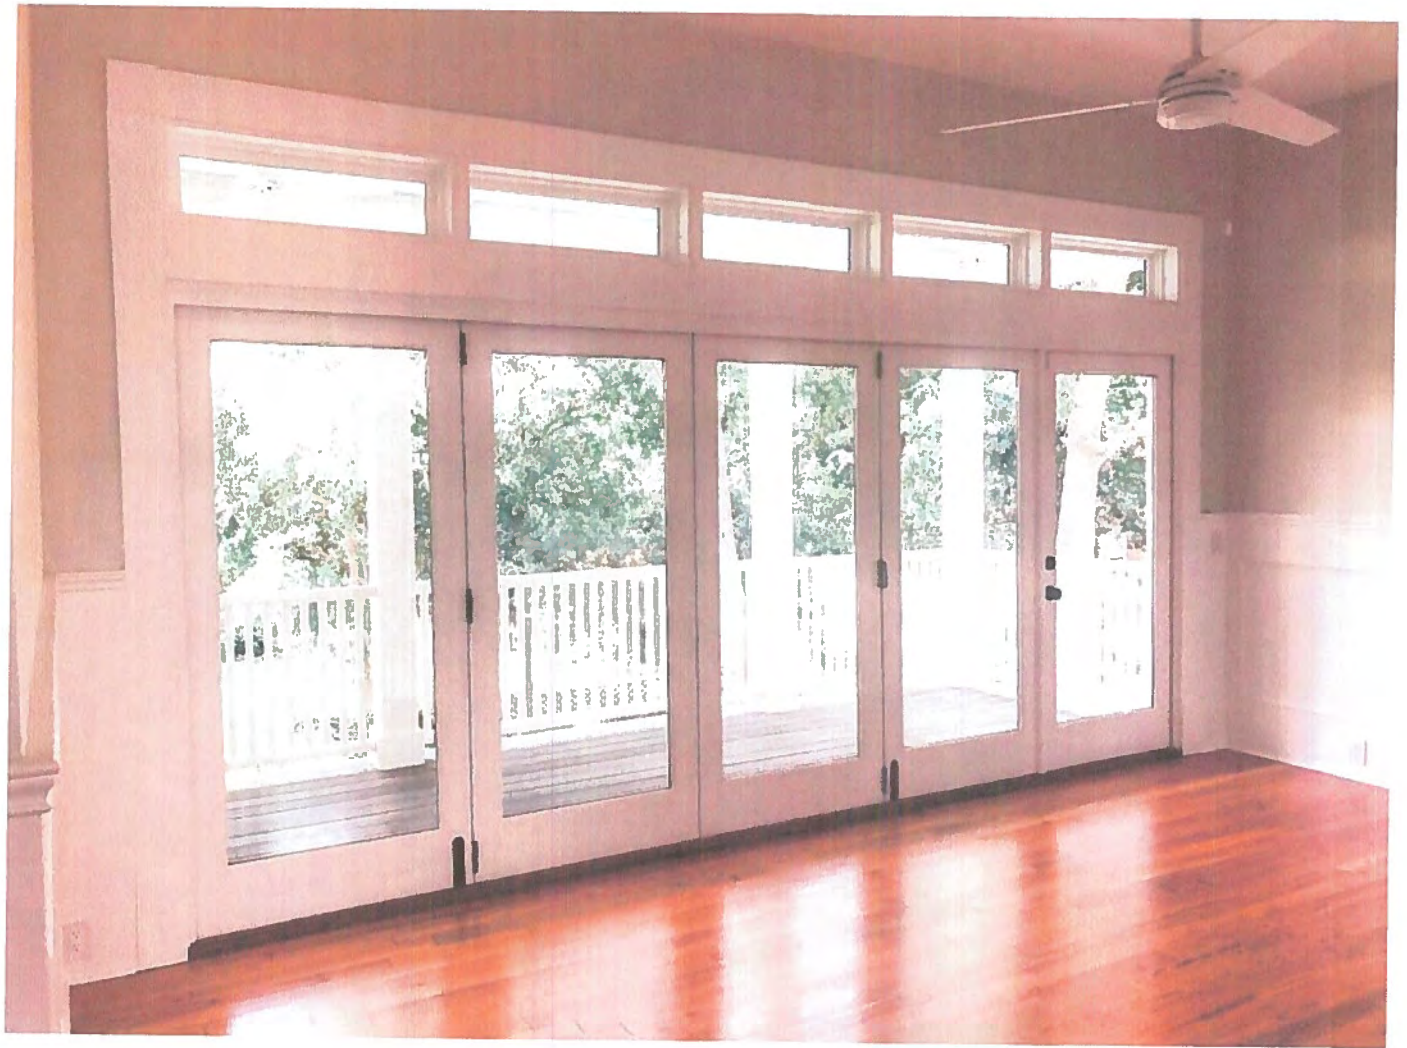
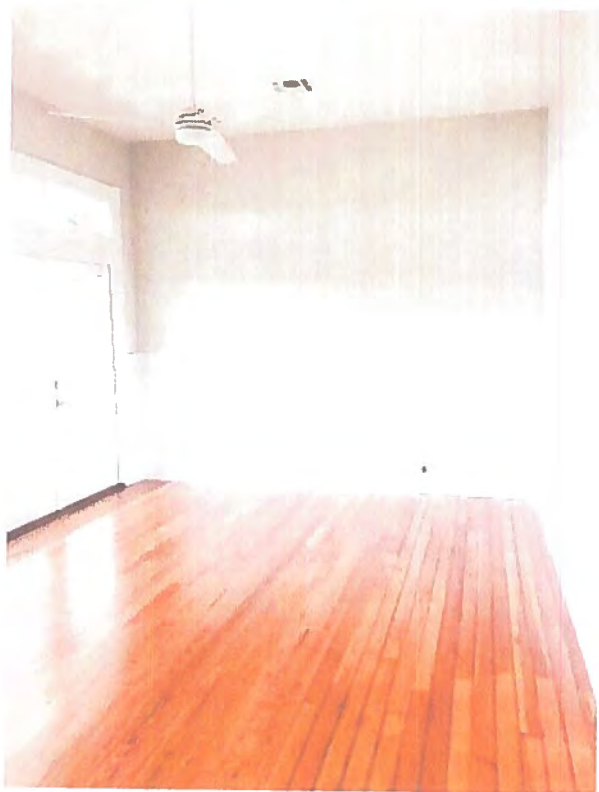
2nd Floor Master Bedroom & Balcony
New layout, French doors fixtures and finishes. Partial original flooring.

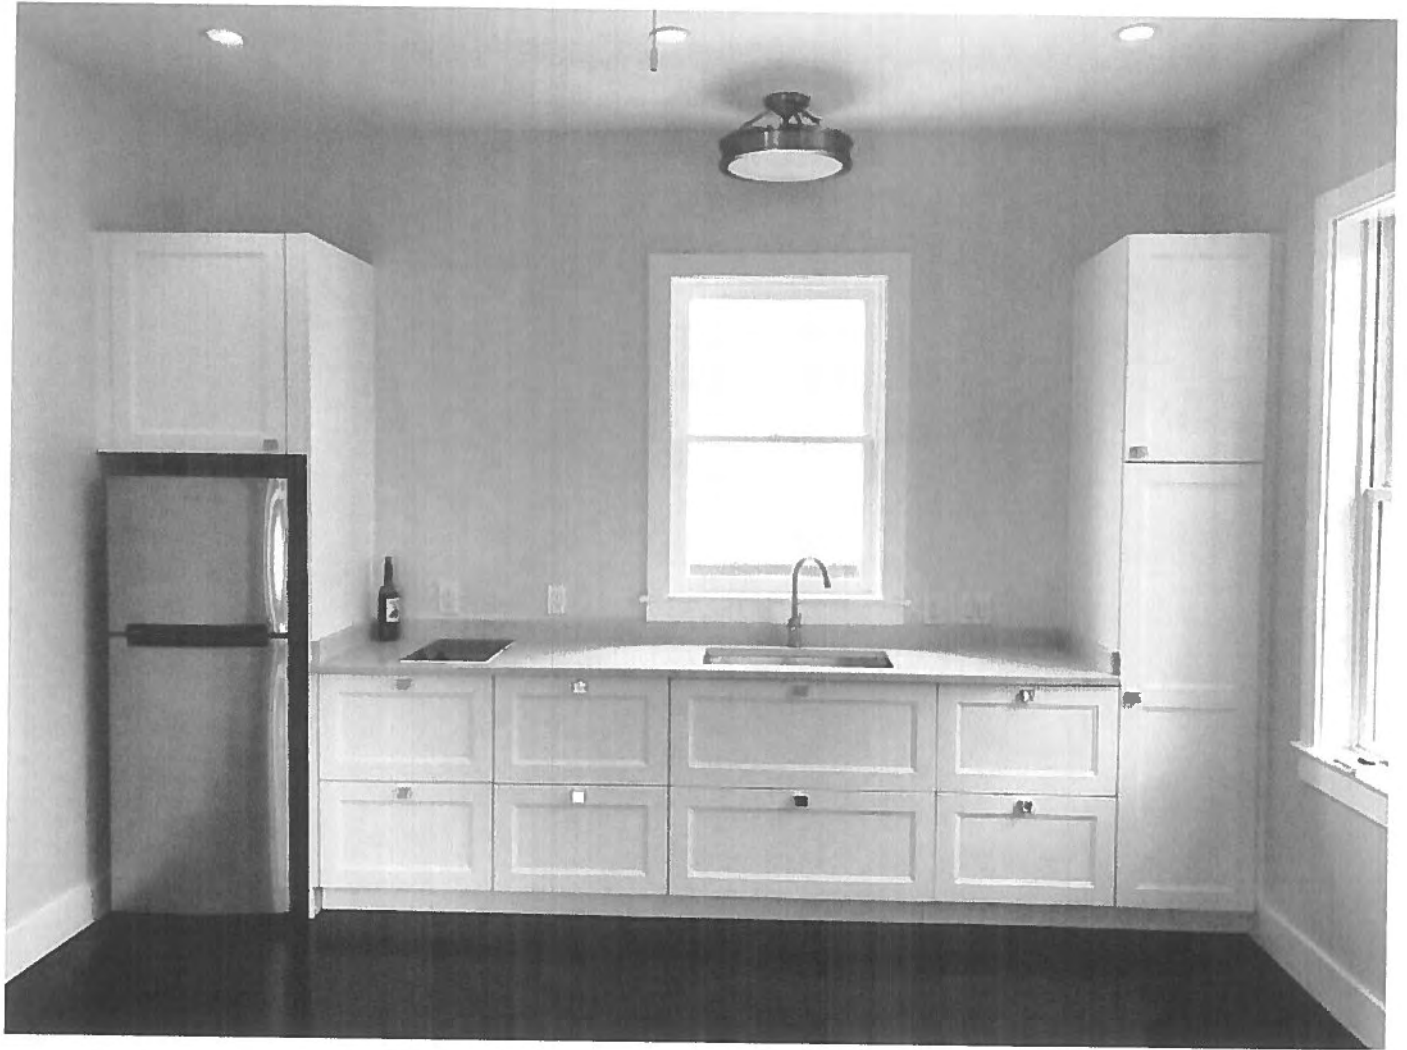
Accessory Dwelling Kitchen
New, Relocated Original Window
