HISTORIC AND DESIGN REVIEW COMMISSION October 16, 2019

HDRC CASE NO: 2019-570

ADDRESS: 508 MASON ST

DISTRICT: Government Hill Historic District

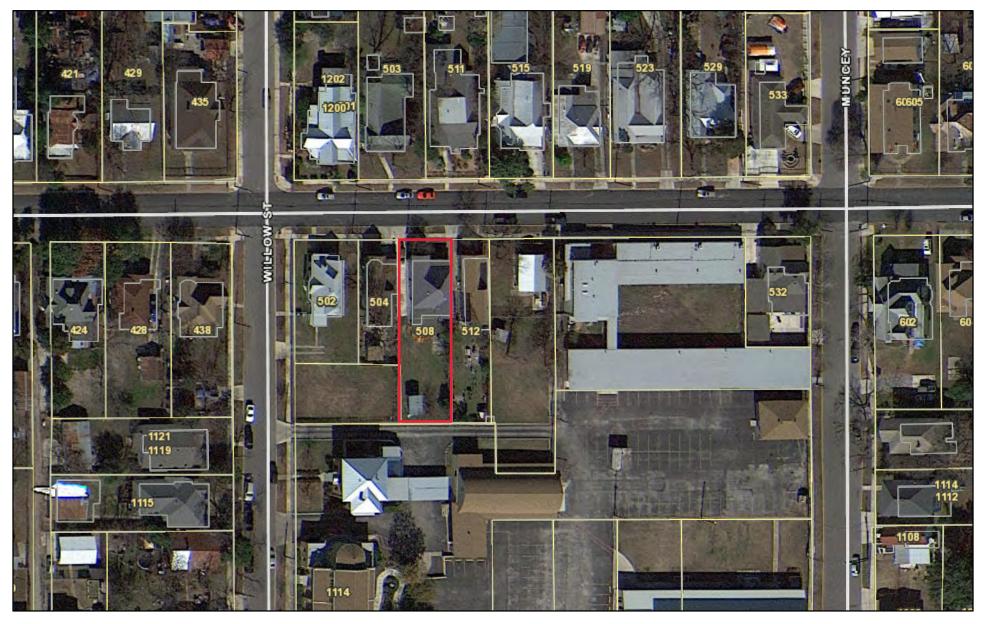
508 Mason St

- c. SIDING TREATMENT The applicant has proposed to install new siding, and plywood on top of the original wood siding to cover deterioration. On a site visit on October 4, 2019, staff found that the wood siding was in good condition, with minimal water or insect damage. Staff finds that the request is generally inconsistent with the Guidelines for Exterior Maintenance and Alterations 1.A and B. Wood siding should be repaired in-place and only replaced when beyond repair. Wholesale replacement or covering would require approval by the Historic and Design Review Commission.

Staff does not recommend approval of items 1 through 3 based on the findings. Staff recommends that wood windows be repaired and that wood siding should be repaired in kind. Wholesale replacement of either should not occur.
