HISTORIC AND DESIGN REVIEW COMMISSION

November 20, 2019

HDRC CASE NO: 2019-683
ADDRESS: 1418 W ROSEWOOD AVE
LEGAL DESCRIPTION: NCB 2763 BLK 68 LOT 8
ZONING: R-4, H
CITY COUNCIL DIST.: 1
DISTRICT: Keystone Park Historic District
APPLICANT: David Rodriguez/J D ROMI GROUP LLC
OWNER: David Rodriguez/J D ROMI GROUP LLC
TYPE OF WORK: Window replacement
APPLICATION RECEIVED: November 06, 2019
60-DAY REVIEW: January 05, 2020
CASE MANAGER: Huy Pham

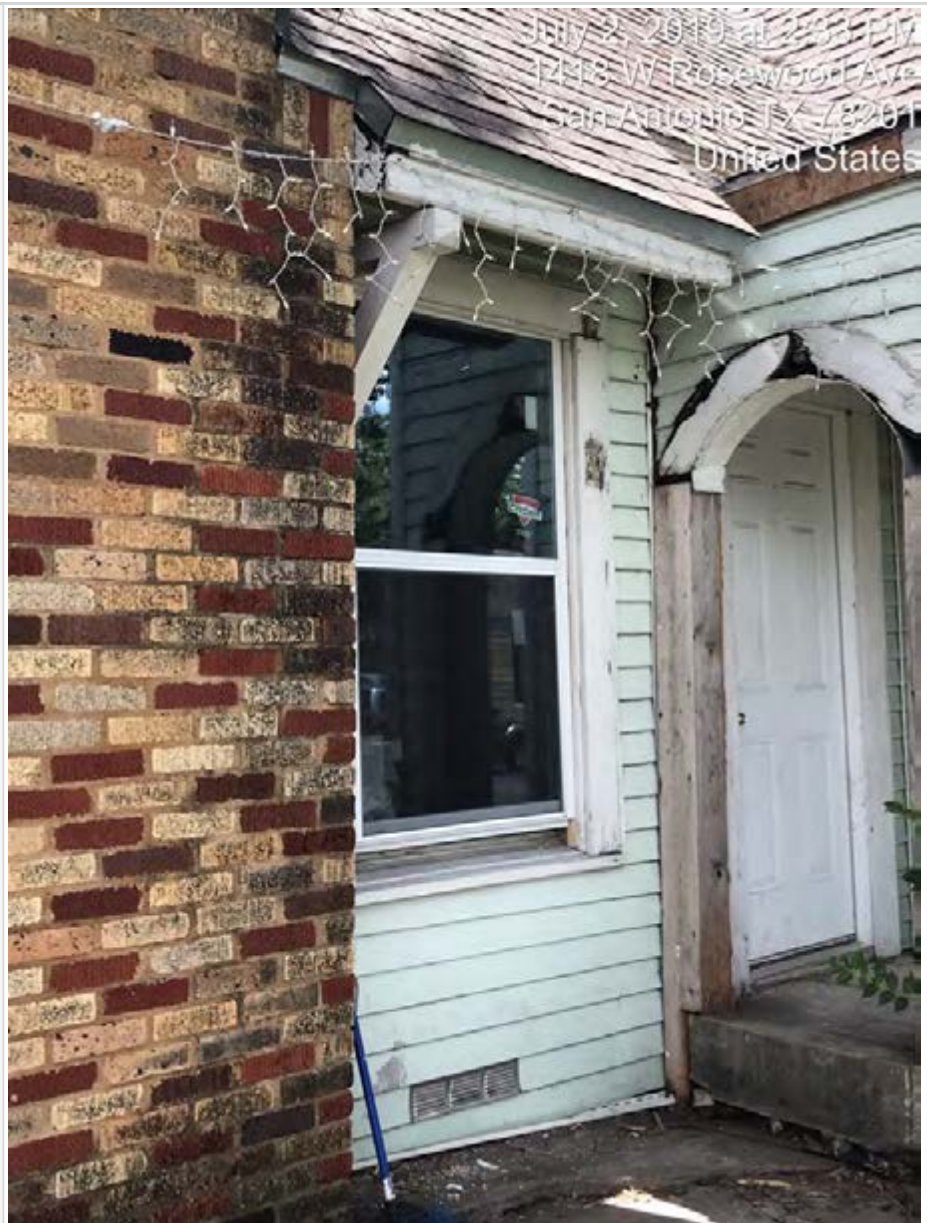
Date	07/02/2019
Time	02:39 PM (-5 GMT)
Context	citizen report
Present Staff	Huy Pham, Edward Hall
Present Individuals	None
Types of Work Observed	Exterior Maintenance and Alterations, Additions
Amount of Work Completed	75%
Description of work	Window replacement with modified size and material. Rear addition. Door replacement. Wood window sashes and door are still on site.
