HISTORIC AND DESIGN REVIEW COMMISSION

January 15, 2020

HDRC CASE NO: 2019-603
ADDRESS: 219 ADAMS ST
216 WICKES
218 WICKES
LEGAL DESCRIPTION: NCB 942 BLK 1 LOT 5
ZONING: RM-4, RM-4,HS
CITY COUNCIL DIST.: 1
DISTRICT: King William Historic District
LANDMARK: Le Laurin House
APPLICANT: Don Fry/RIVER CITY LOANS INC
OWNER: RIVER CITY LOANS INC
TYPE OF WORK: Demolition of primary structure addressed 216/218 Wickes with construction of a parking lot
APPLICATION RECEIVED: November 01, 2019
60-DAY REVIEW: December 31, 2019; 30 day decision period – January 30, 2019
CASE MANAGER: Stephanie Phillips
REQUEST:

1. Demolish the contributing primary structure addressed 216-218 Wickes.
2. Construct a rear parking pad to include spaces for six vehicles.

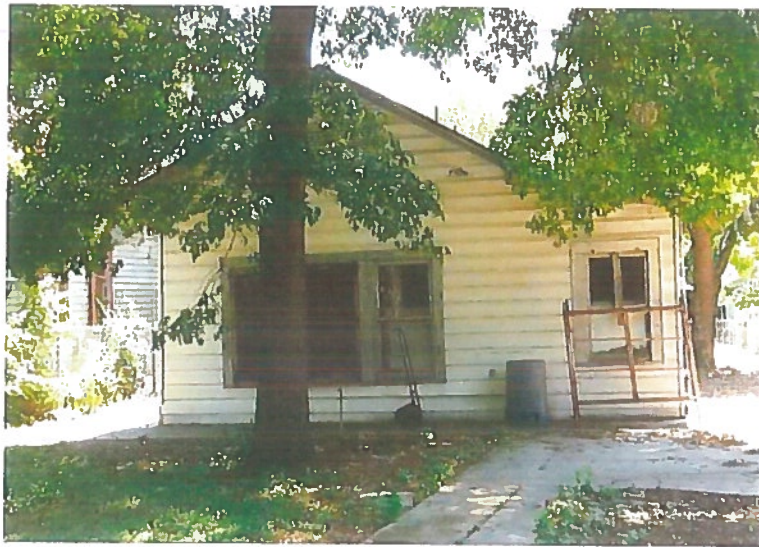
The subject structure is a pier and beam home, primarily constructed with 2x4 studs, 2x4 rafters, and 2x4 ceiling joists, all spaced approximately at 24" on center. At the time of our review it was not possible to determine size of the existing foundation beams due to soil burial and/or deterioration. Some of the floor joists have been provided with supplementary support through the use of unreinforced sack concrete as well as concrete rubble. The roof will require a retrofit, to include ridge supports and purlin supports, reducing the span of the existing rafters. The only visible collar tie was found at the midpoint of the 40' long ridge line. The roof deck, composed of flat 1x6 purlins supporting corrugated metal, has dime size perforations as well as deficient flashing at all penetrations, and as such would require a reroof.

Within the interior of building, multiple studs were found to be deteriorated at the base, to a point where they were suspended over the floor decking. The lack of a crawl space precludes a thorough investigation of the beam and floor members without tunneling from below or removal of the floor deck above. The

Ultimately, the settlement throughout the footprint of this building's foundation has caused the buried wood foundation beams to deteriorate at ground level and lose their vertical support of the building. Additionally this foundation system has been severely compromised due to age, inappropriate surface drainage, and questionable construction. To achieve the required repairs, the one story building would require a near total reconstruction of the original structure. Therefore it is the recommendation of this structural engineer that the most appropriate solution would be to raze the entire structure that is an existing hazard to future occupancy. From the foundation, to the load bearing walls, to the roof structures, and the interior fit and finishes; all elements, to a more or less degree, are in need of repair; so much so as to characterize the building mentioned in this report as a total loss in need of demolition.
