# HISTORIC AND DESIGN REVIEW COMMISSION

May 29, 2020

**HDRC CASE NO:** 2020-191  
**ADDRESS:** 320 N HACKBERRY ST  
**LEGAL DESCRIPTION:** NCB 584 BLK W 1/2 7 LOT 5 ARB A5  
**ZONING:** RM-4, H  
**CITY COUNCIL DIST.:** 2  
**DISTRICT:** Dignowity Hill Historic District  
**APPLICANT:** Johnrudy Balderrama/JRM CONSTRUCTION LLC  
**OWNER:** Johnrudy Balderrama/JRM CONSTRUCTION LLC  
**TYPE OF WORK:** Window and siding replacement  
**APPLICATION RECEIVED:** April 24, 2020  
**60-DAY REVIEW:** Not applicable due to City Council Emergency Orders  
**CASE MANAGER:** Huy Pham  
**REQUEST:**

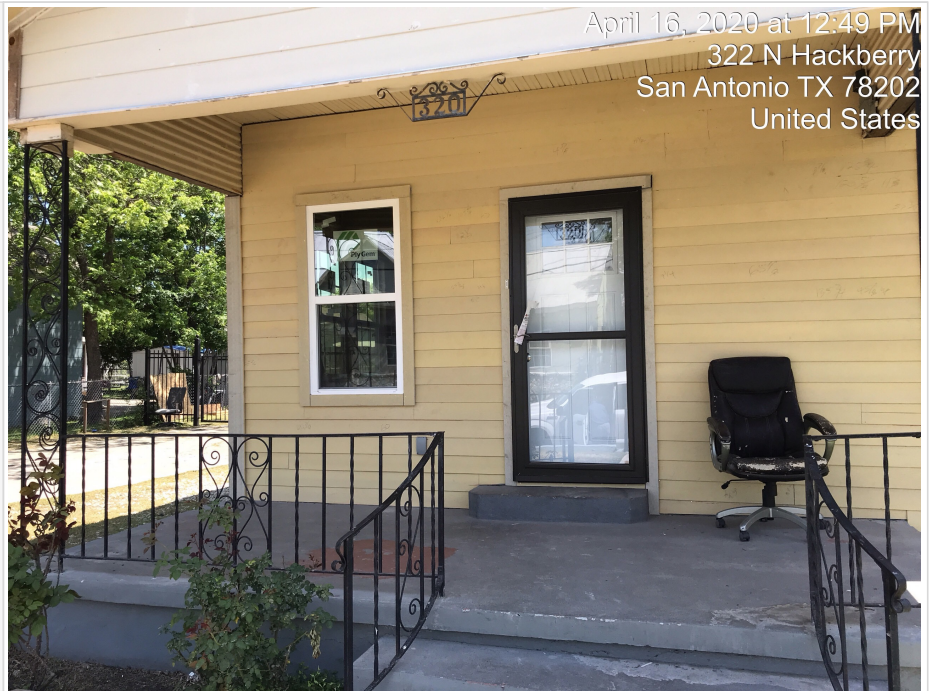
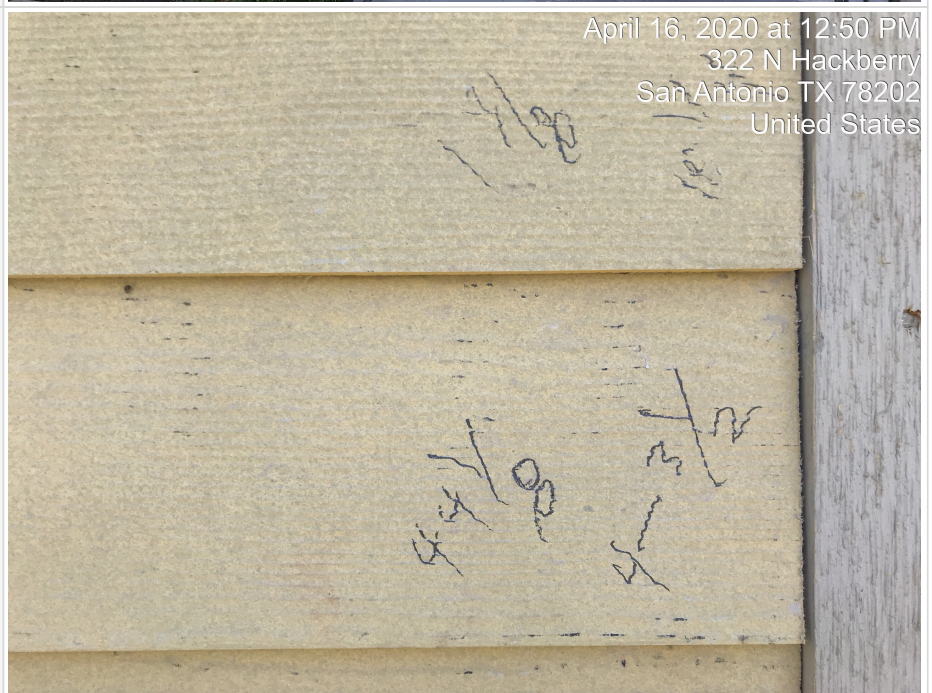
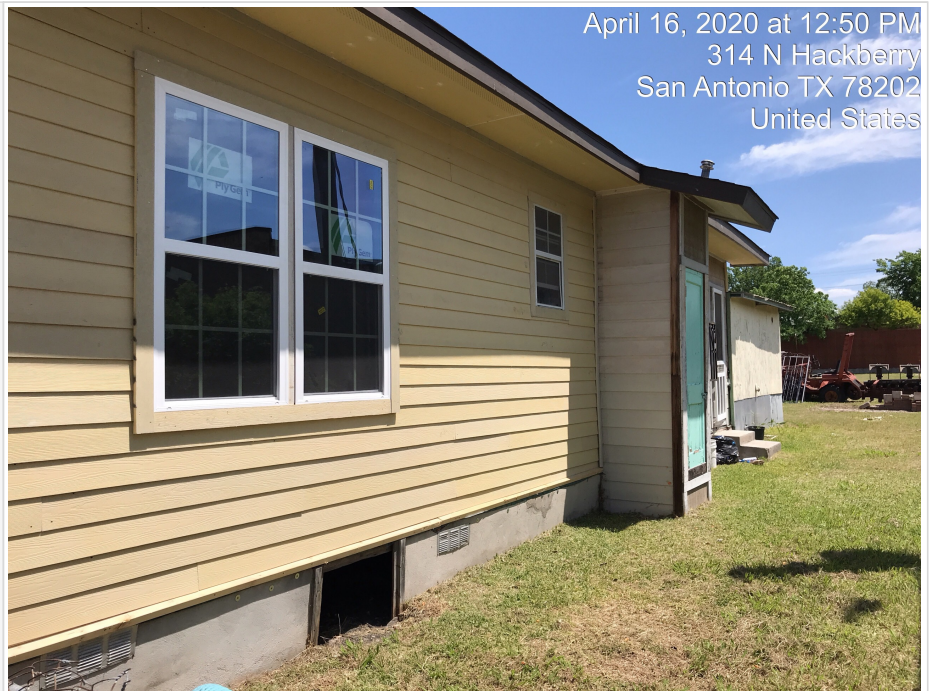
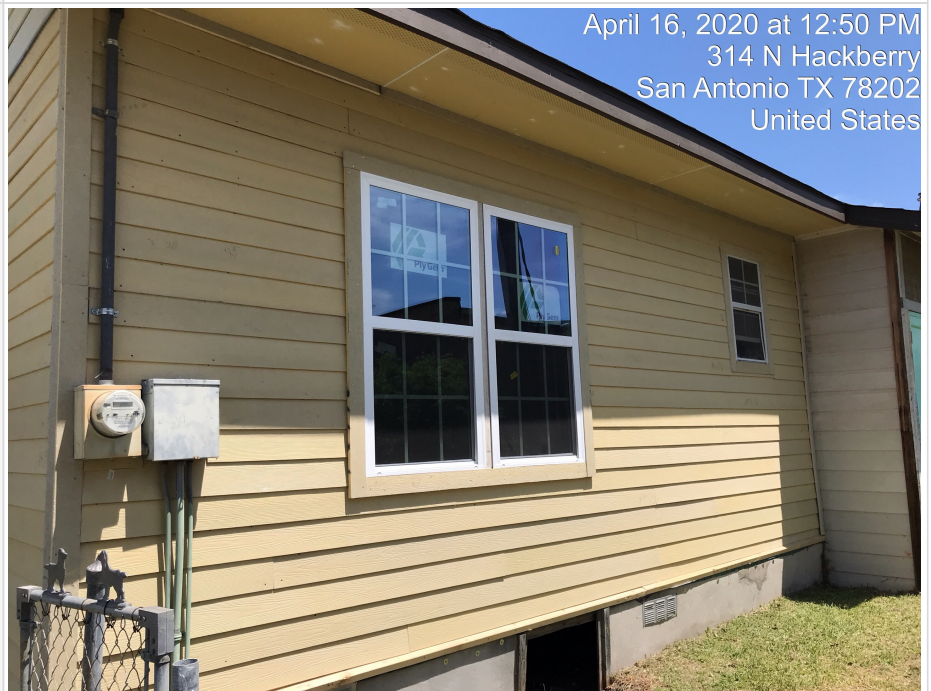
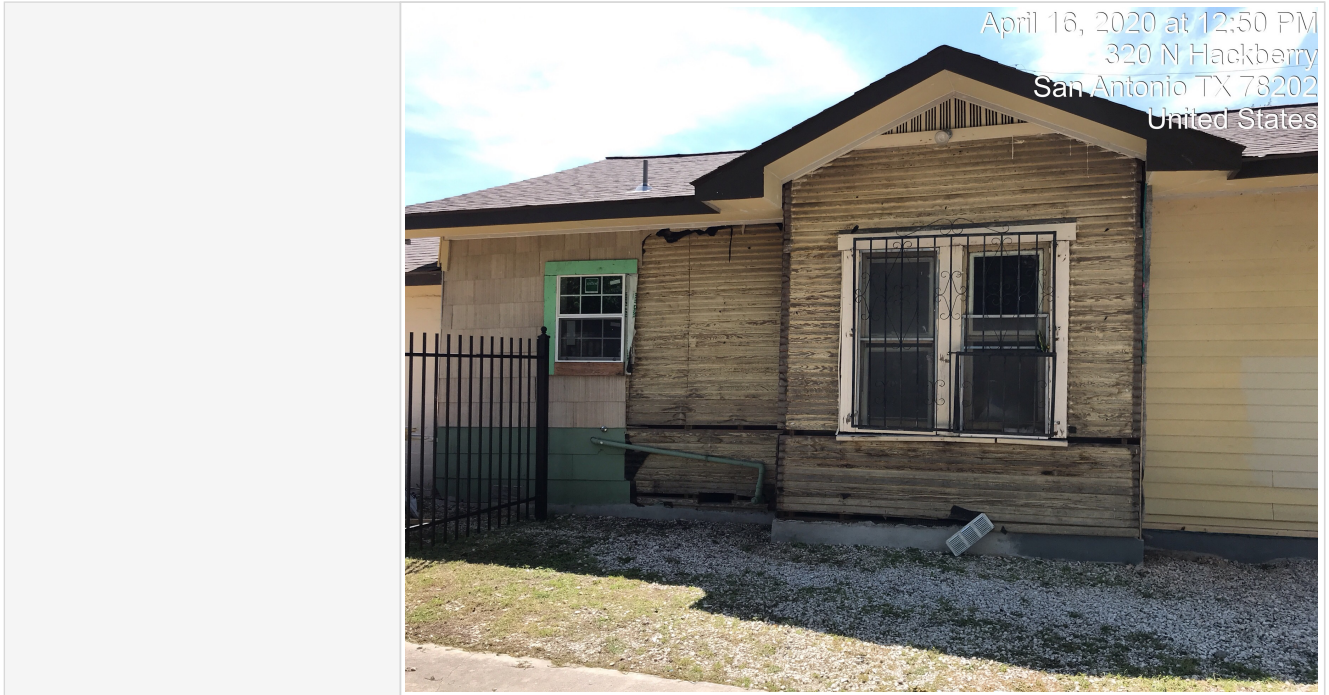
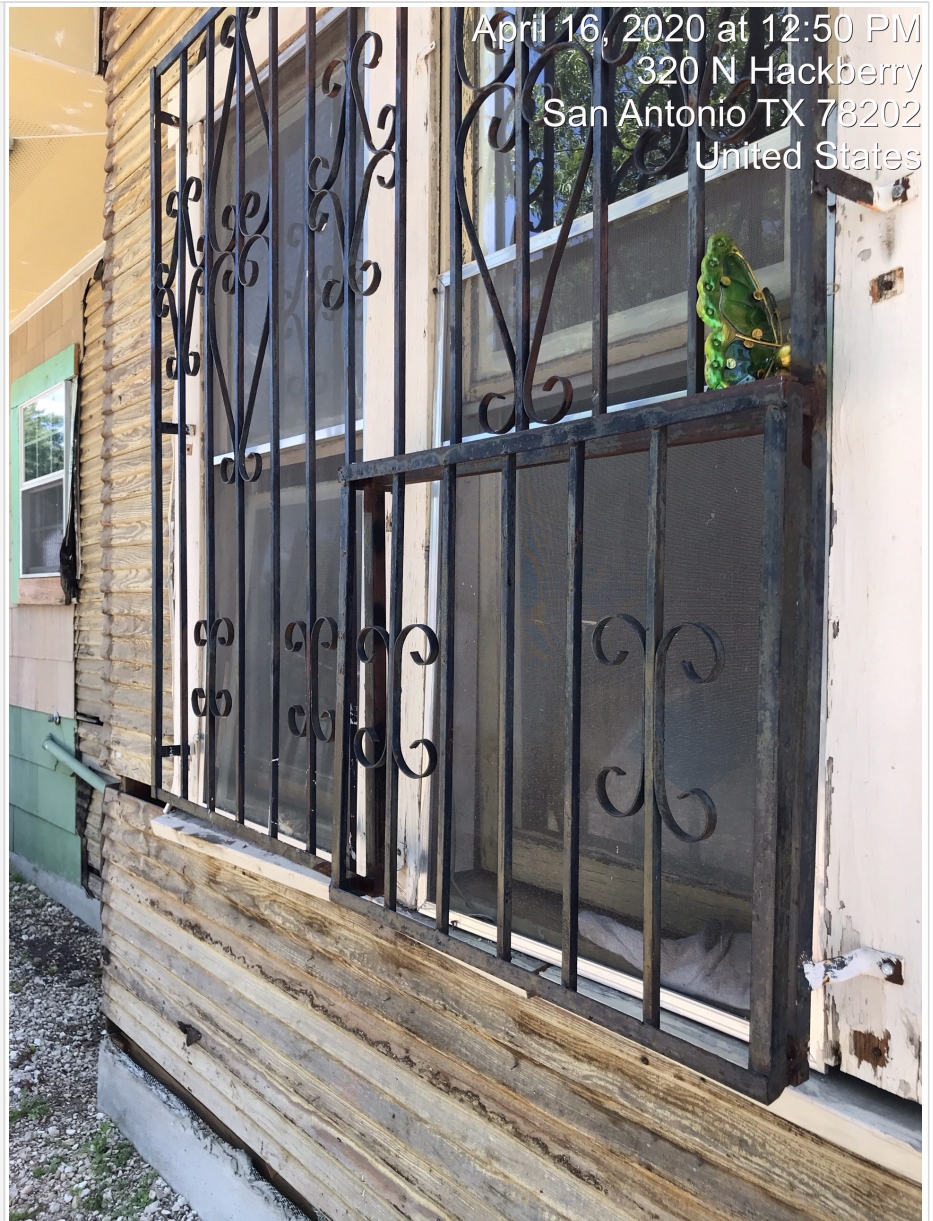
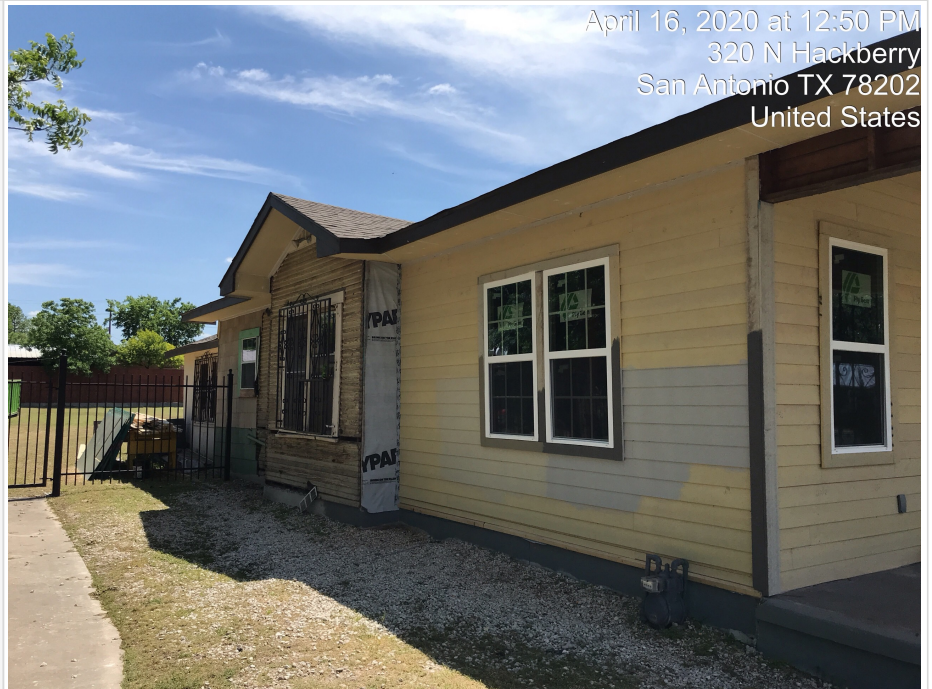
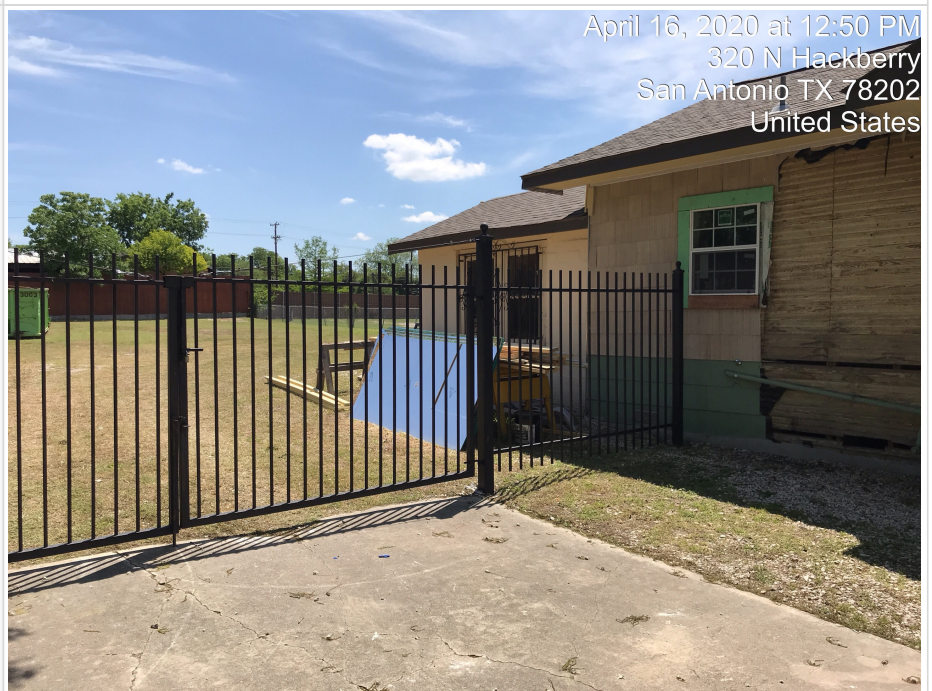
Date	04/16/2020
Time	12:51 PM (-5 GMT)
Context	citizen report
Present Staff	Huy Pham, Edward Hall
Present Individuals	None
Contractor/Realtor Companies	JRM Construction
Types of Work Observed	Exterior Maintenance and Alterations
Amount of Work Completed	75%
Description of work	Window replacement, siding removal and replacement

Violation Type	No Certificate of Appropriateness (Code 35-451a)
OHP Action	Posted "Notice of Investigation", Posted additional "Stop Work Notice"
Will post-work application fee apply?	Yes
