HISTORIC AND DESIGN REVIEW COMMISSION

HDRC CASE NO: 2020-575
ADDRESS: 732 N PINE ST
LEGAL DESCRIPTION: NCB 1659 BLK G LOT 1 AT 732 PINE N
ZONING: RM-6, H
CITY COUNCIL DIST.: 2
DISTRICT: Dignowity Hill Historic District
APPLICANT: John Perez/Castilla's Construction
OWNER: Adeel Riaz/MAJESTIC INVEST LLC
TYPE OF WORK: Demolition of accessory structure, rear porch enclosure
APPLICATION RECEIVED: December 18, 2020
60-DAY REVIEW: Not applicable due to City Council Emergency Orders
CASE MANAGER: Edward Hall
REQUEST:

**Mitigating Irreplaceable Loss by Reclaiming
from
Proposed Demolition of Detached Garage**

**By John Paul Perez
Project Manager Castilla's Construction**

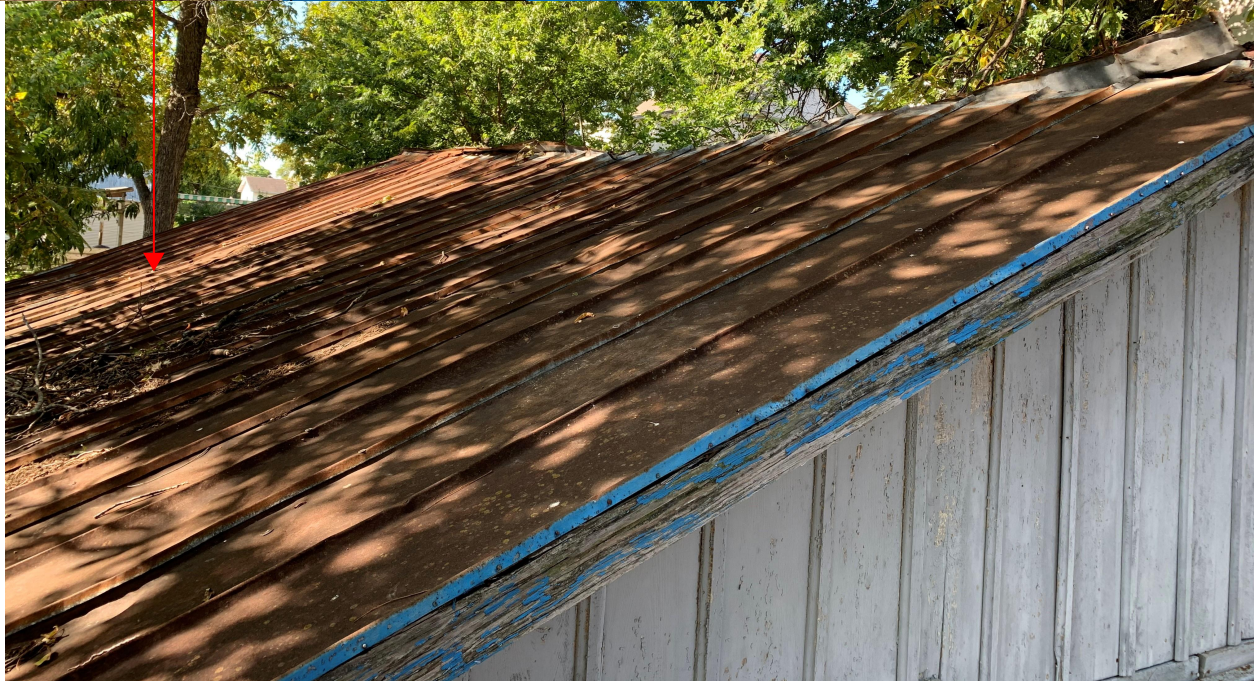
Exhibit I

Dead vegetation contributing to roof deterioration

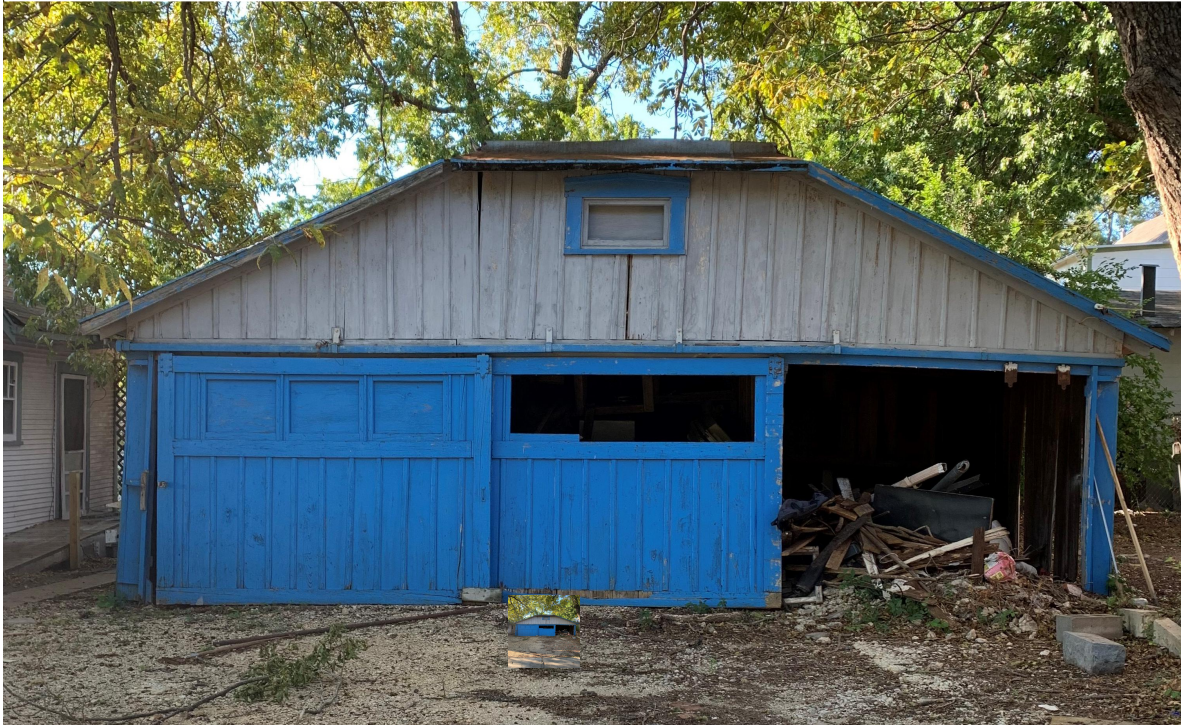
DEMO SALVAGE PLAN

732 N PINE STREET DETACHED GARAGE

It is the owner's intent, if COA is approved, to reclaim usable lumber that is not damaged from the detached garage. The reclaimed lumber will be used at the interior and exterior rehabilitation of building A and B. This includes an addition at existing porches at building A. This addition will change the existing porches to a conditioned / insulated interior space.
