## HISTORIC AND DESIGN REVIEW COMMISSION

March 3, 2021

**HDRC CASE NO:** 2021-047  
**ADDRESS:** 2211 N ST MARYS ST  
**LEGAL DESCRIPTION:** NCB 1735 BLK 14 LOT 15  
**ZONING:** C-3NA, H  
**CITY COUNCIL DIST.:** 1  
**DISTRICT:** Tobin Hill Historic District  
**APPLICANT:** Jason Balderas/S.A.C.S  
**OWNER:** GARZA YOLANDA BEATRICE &  
**TYPE OF WORK:** Front yard fencing  
**APPLICATION RECEIVED:** January 22, 2021  
**60-DAY REVIEW:** Not applicable due to City Council Emergency Orders  
**CASE MANAGER:** Huy Pham  
**REQUEST:**

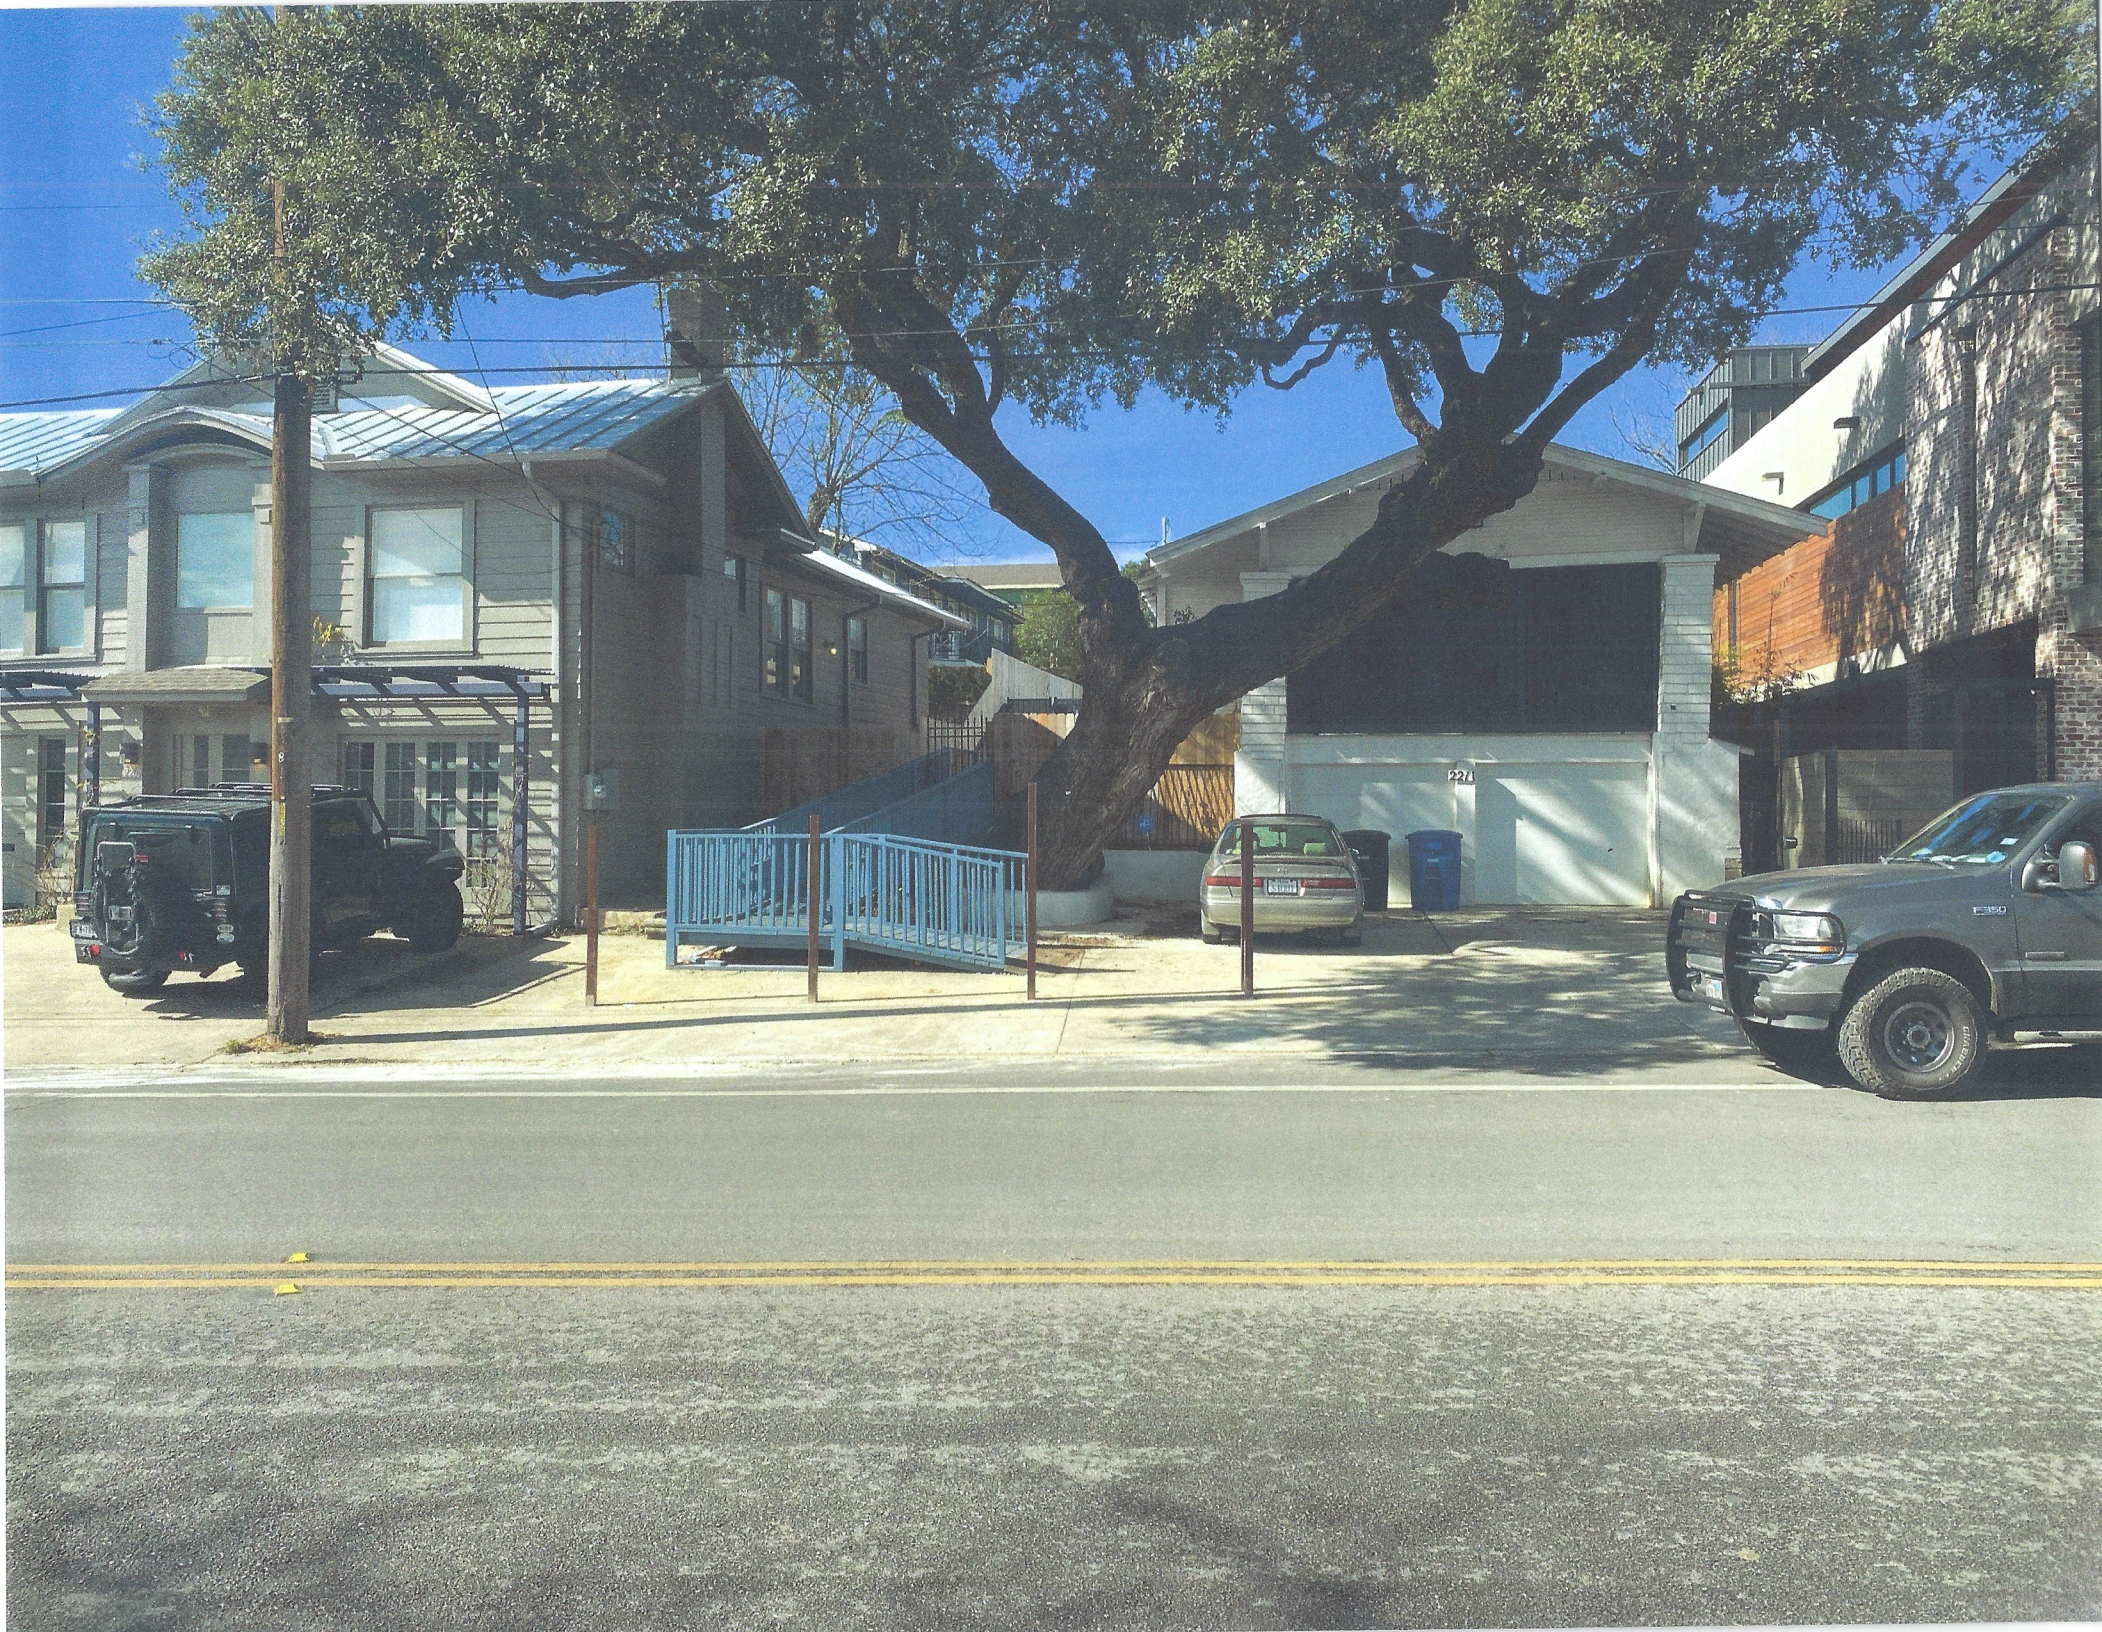
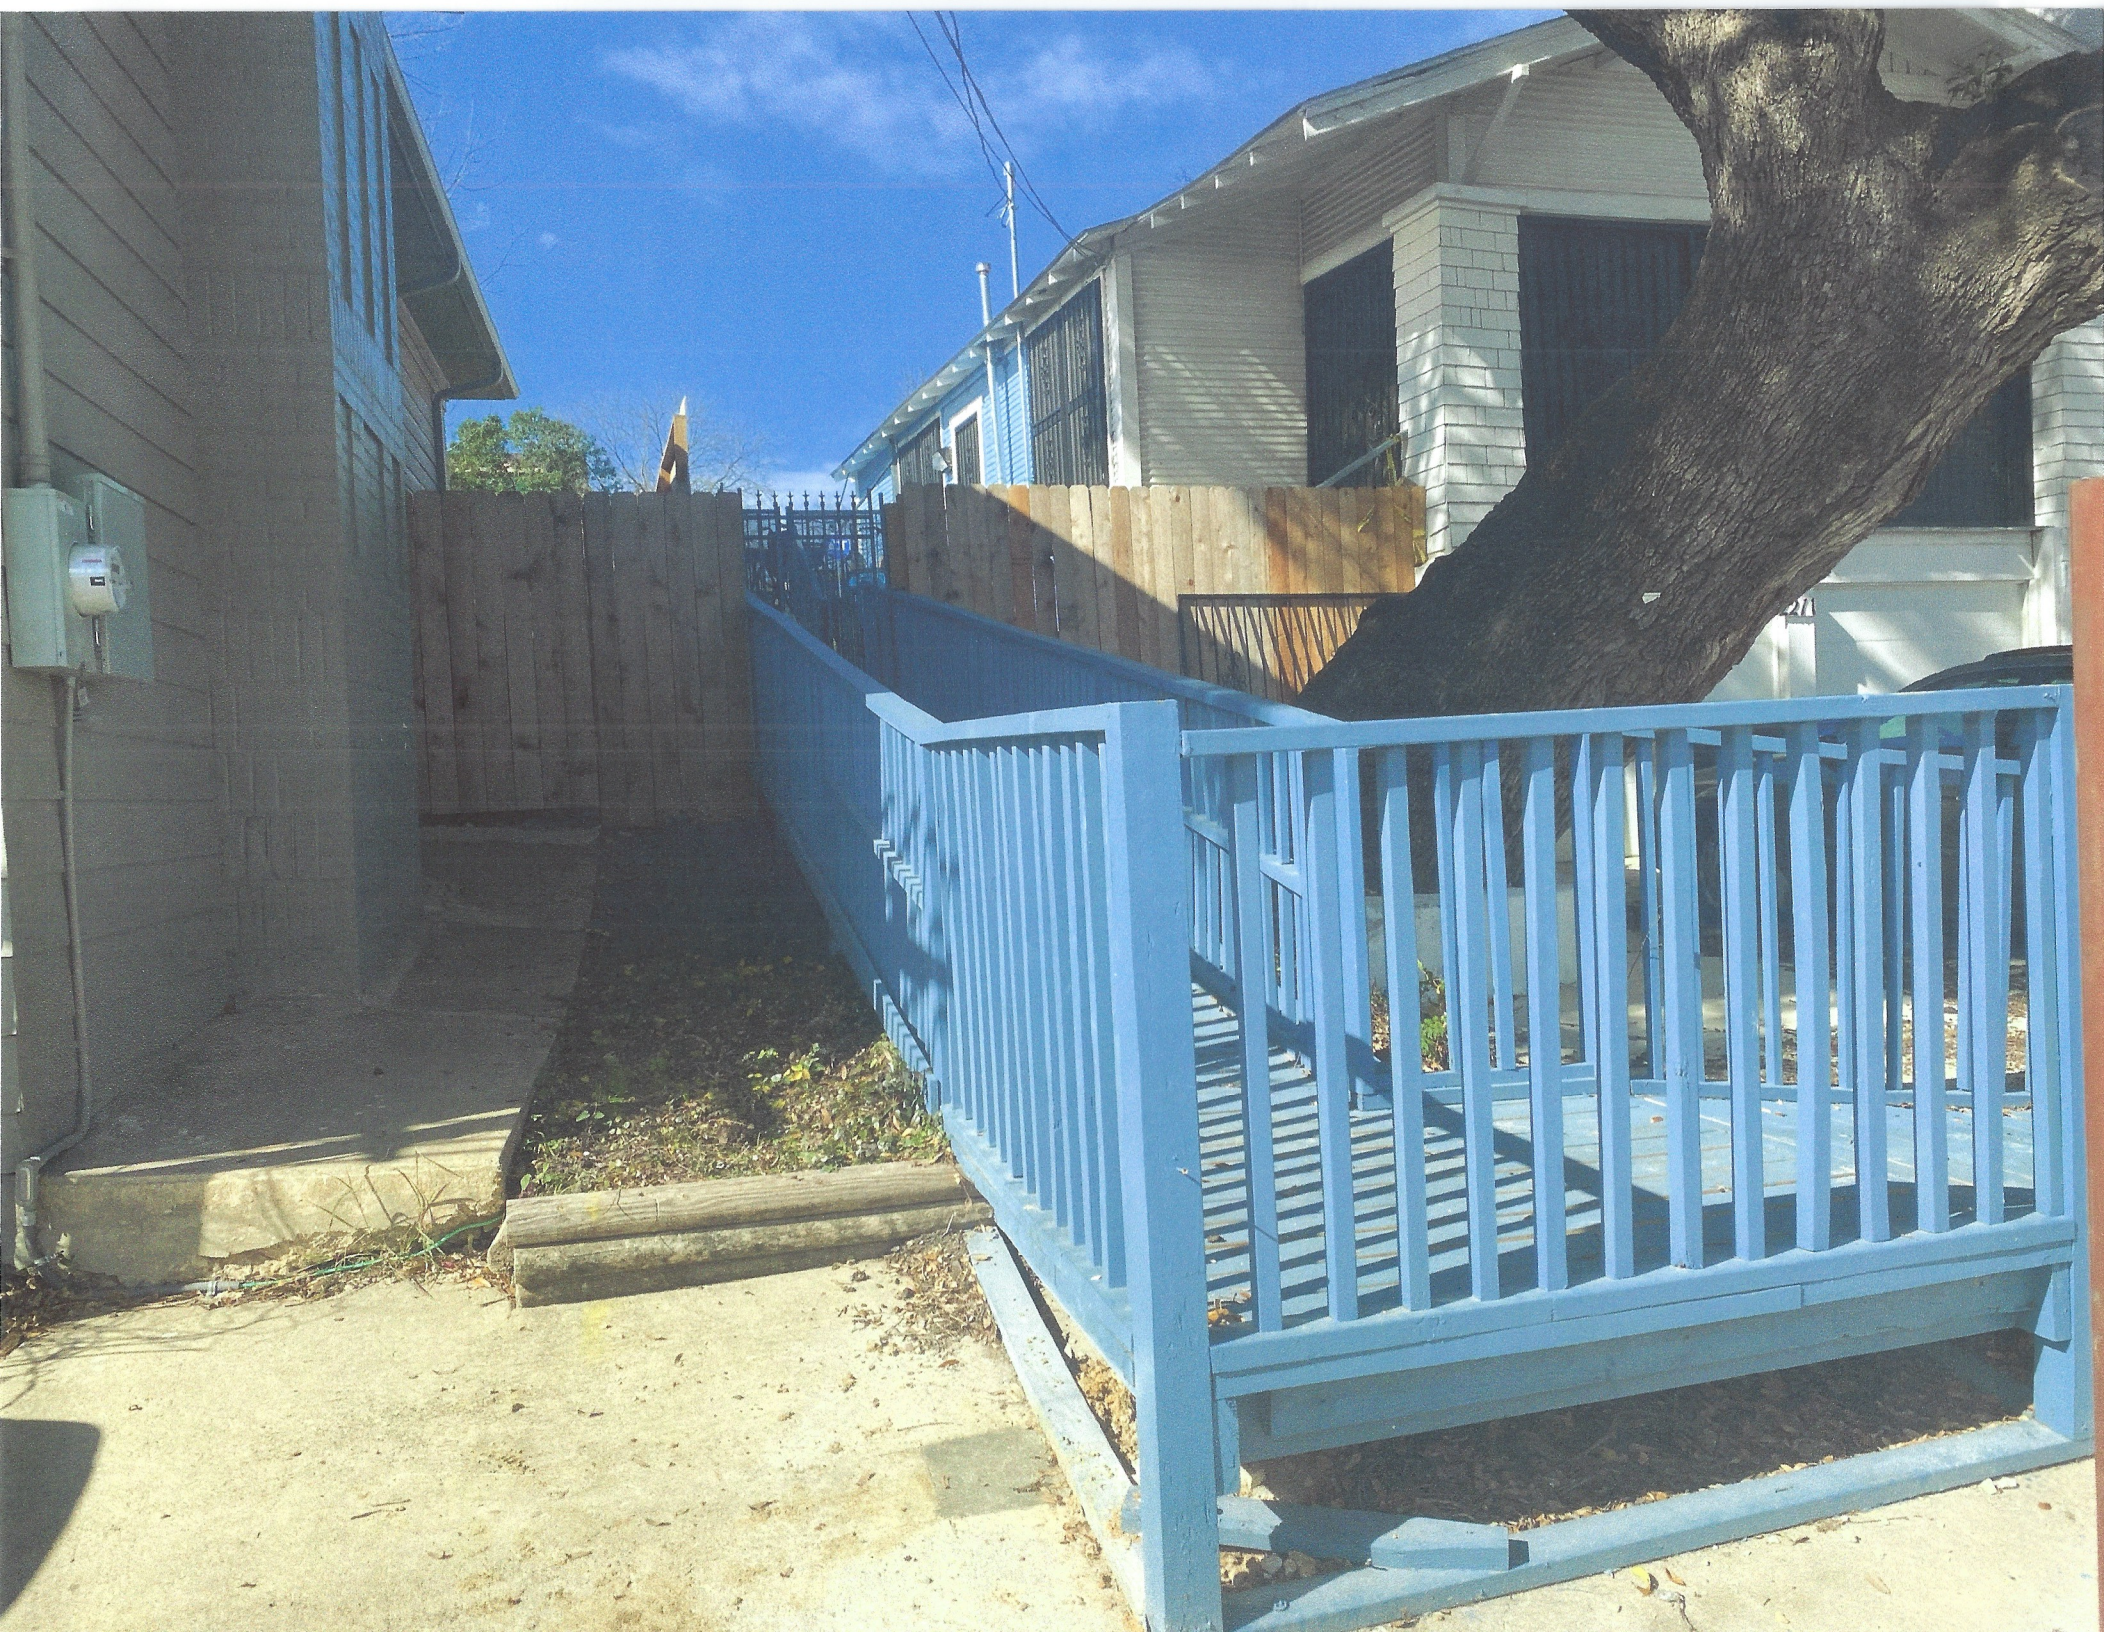
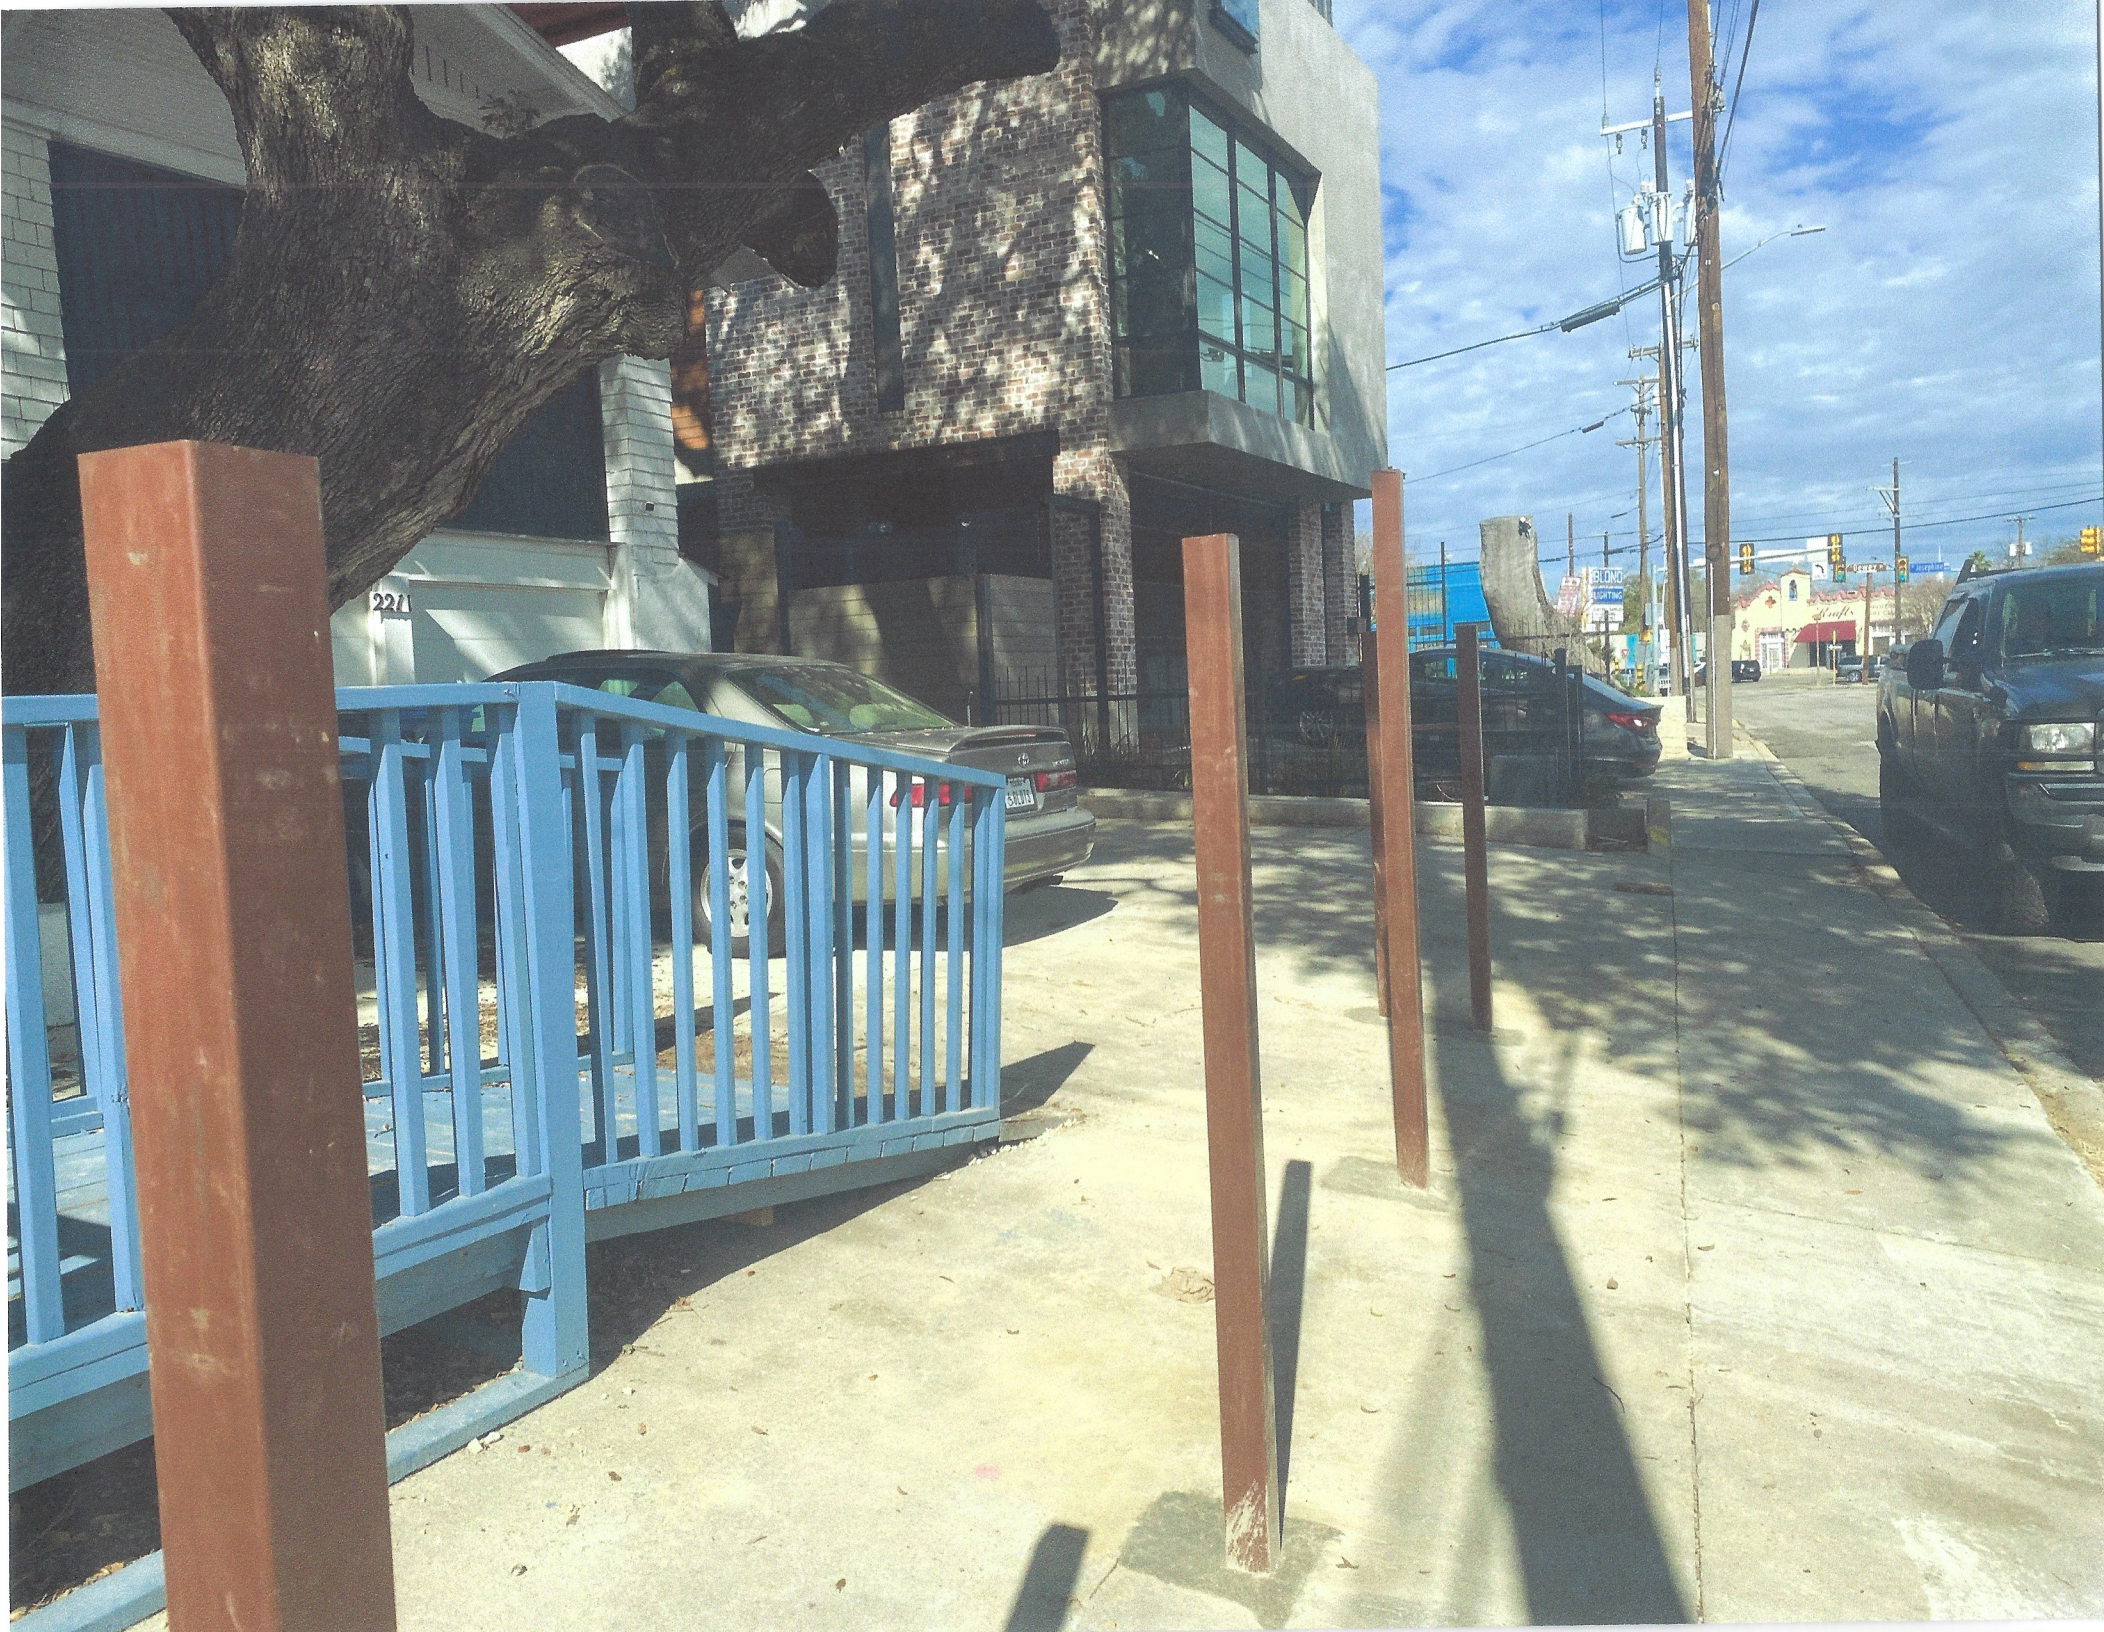
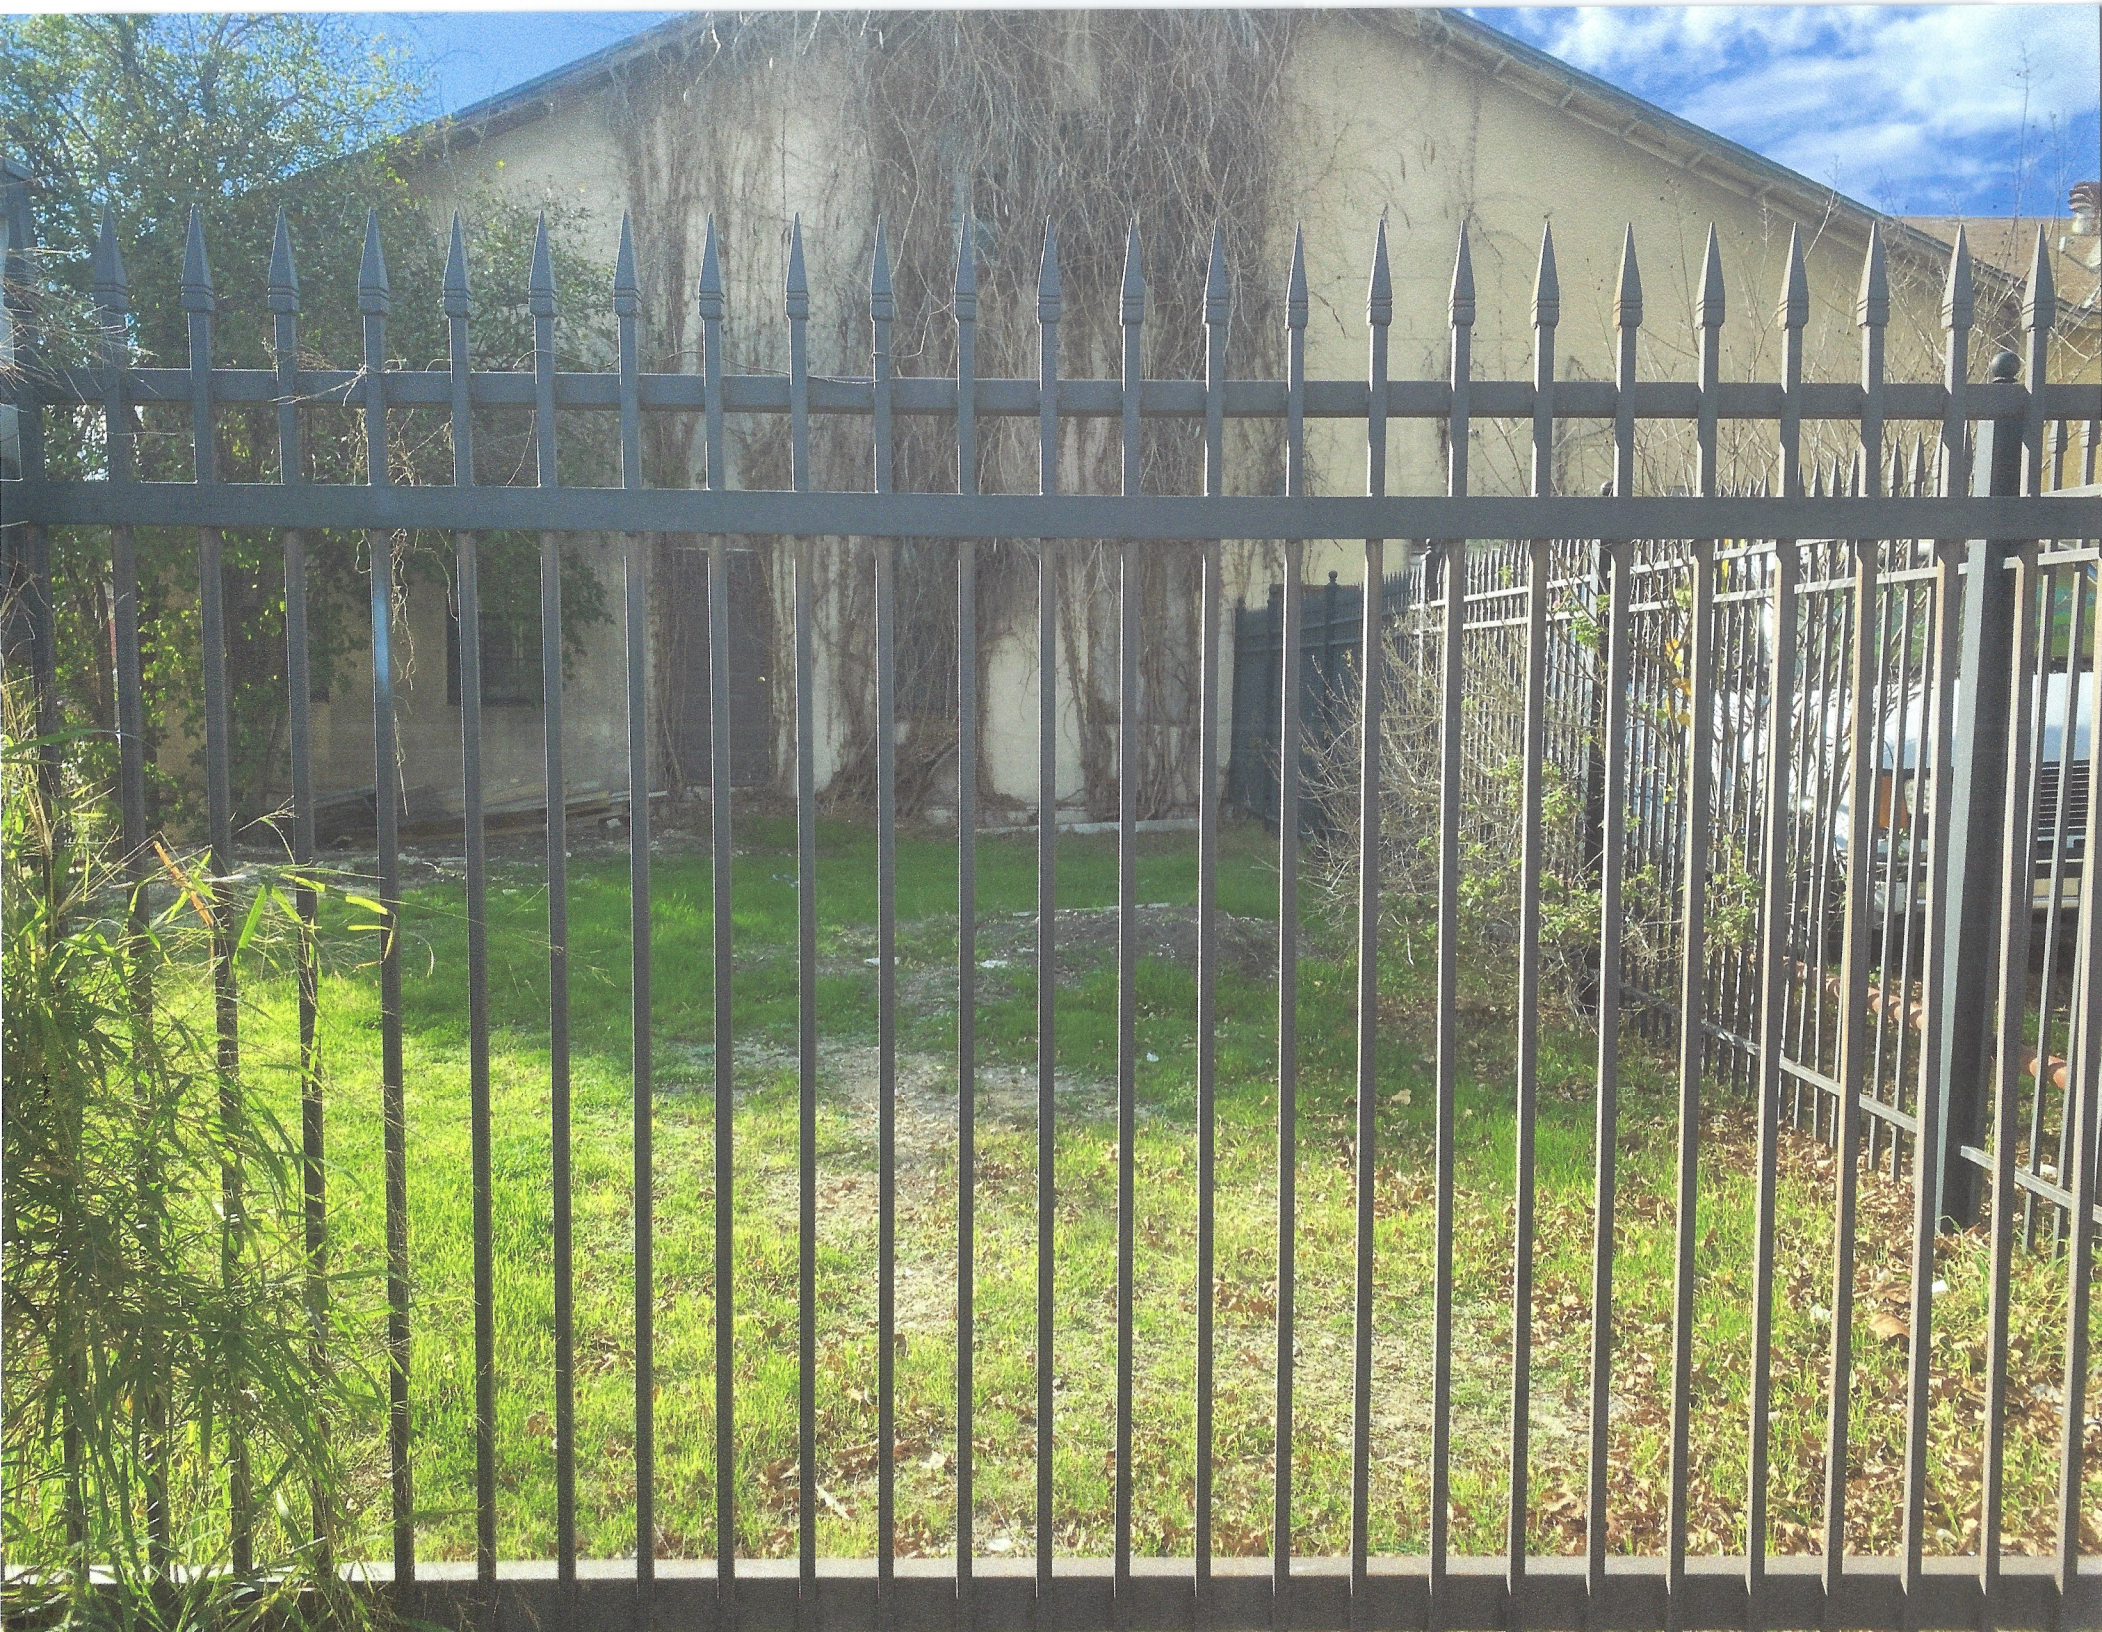
- b. COMPLIANCE – On a site visit on January 21, 2021, staff found that fence posts have been installed and that the front porch railing was removed and then full enclosed with black wrought iron screens prior to approval and permitting. Upon issuance of a Stop Work Order, the applicant submitted an application on January 22, 2021, to be heard at the next Historic and Design Review Commission hearing.

Staff does not recommend approval of item 2. porch enclosure based on finding d. The porch railing should be restored and the screens should be removed.
