HISTORIC AND DESIGN REVIEW COMMISSION

June 16, 2021

HDRC CASE NO: 2021-264
ADDRESS: 922 E CROCKETT ST
LEGAL DESCRIPTION: NCB 583 BLK 8 LOT 3 & E 3.71 FT OF 4
ZONING: RM-4, H
CITY COUNCIL DIST.: 2
DISTRICT: Dignowity Hill Historic District
APPLICANT: Ligaya Thompson
OWNER: THOMPSON LEE CAPITAL LLC
TYPE OF WORK: Window replacement
APPLICATION RECEIVED: May 26, 2021
60-DAY REVIEW: Not applicable due to City Council Emergency Orders
CASE MANAGER: Edward Hall

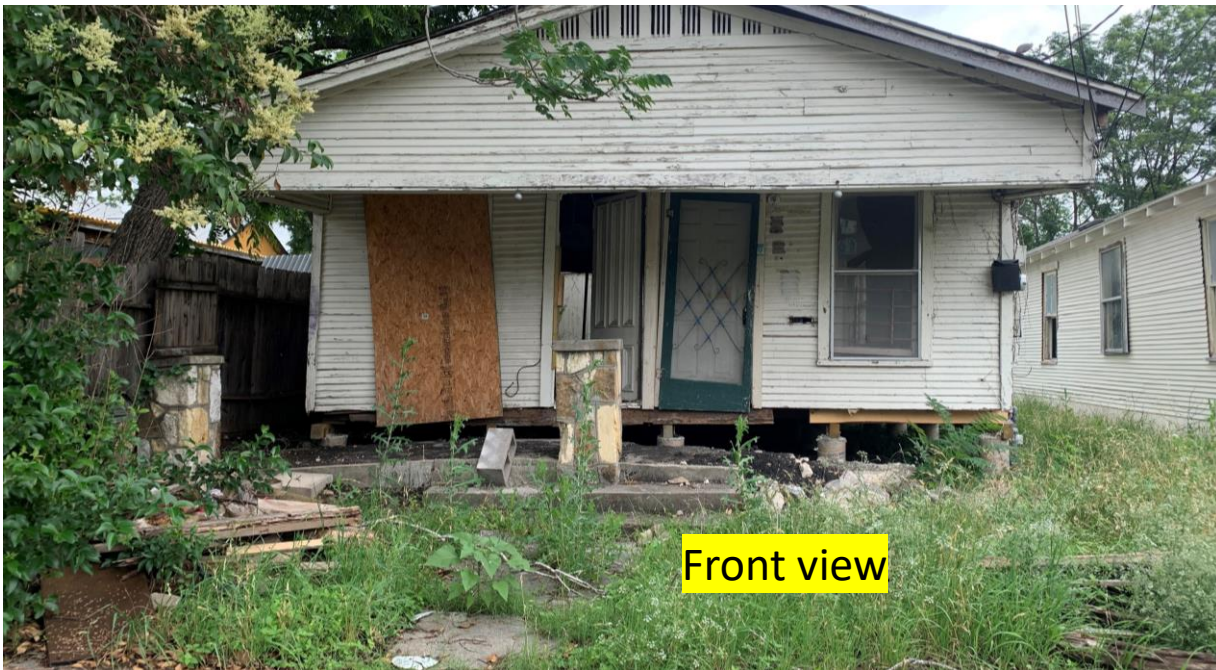
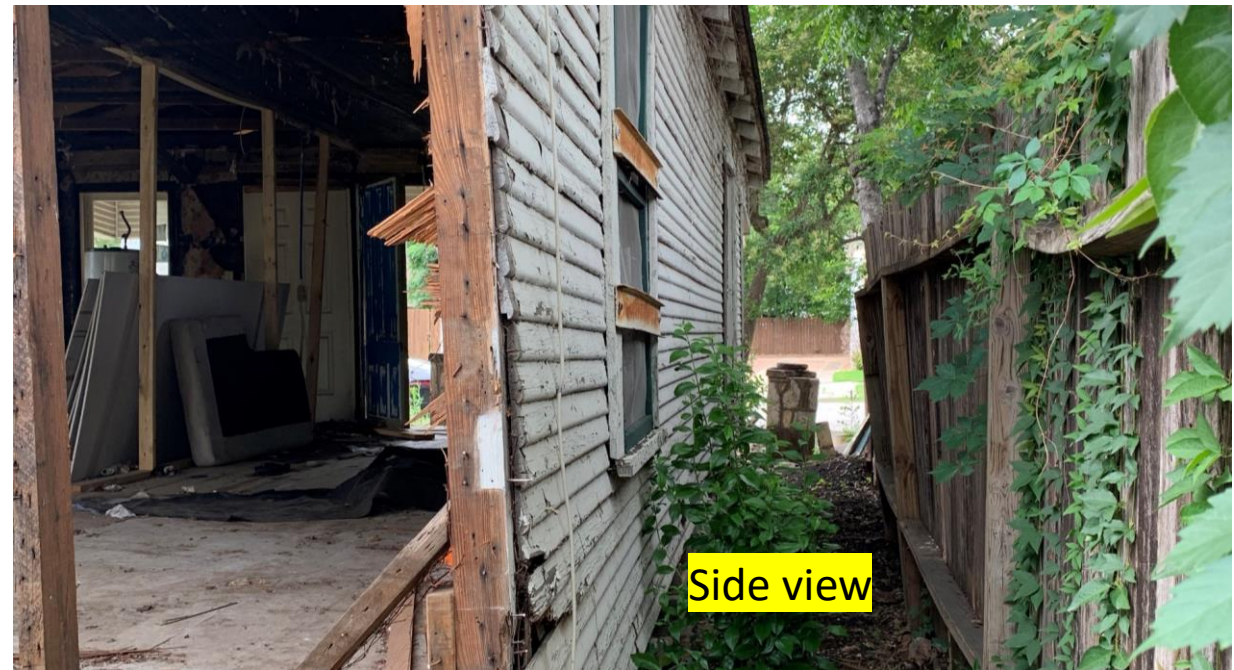
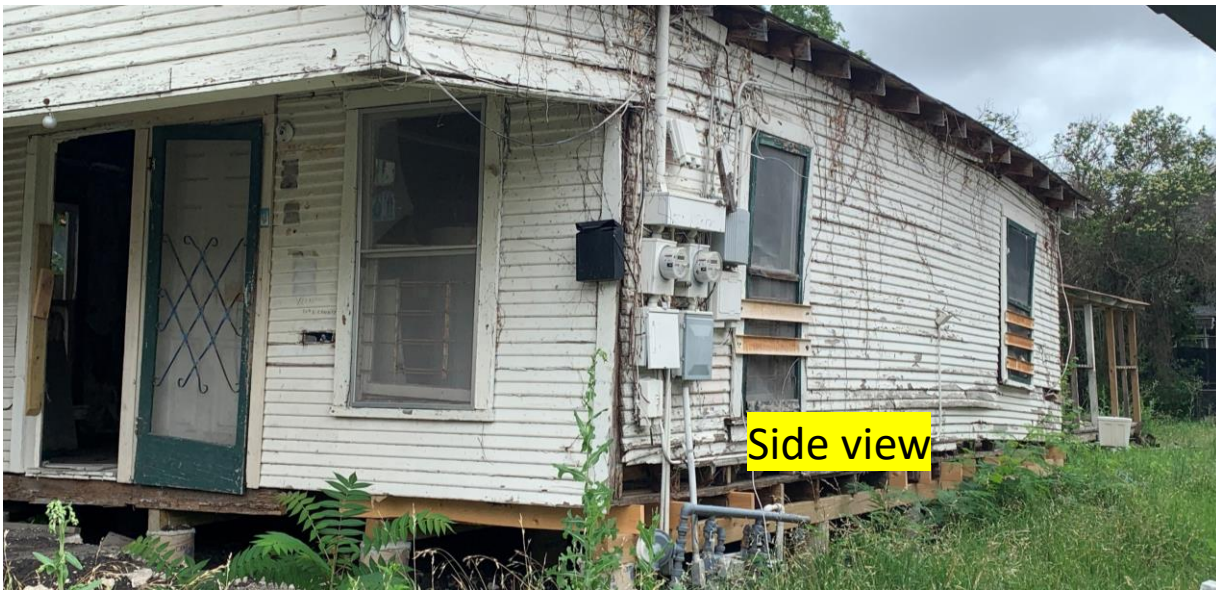
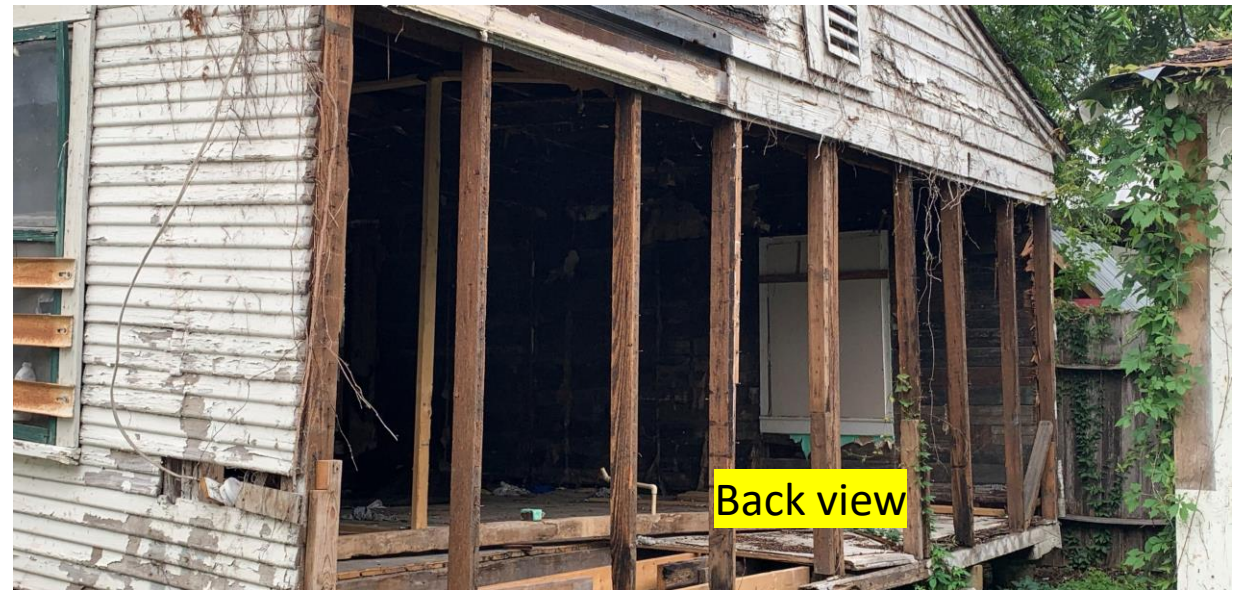
As we began to replace the siding and begin working on the addition our findings are:
Framing is uneven and the home is not properly supported to the rear.
This has caused the home to shift and misaligned the entire house.

In order for us to continue restoring the home back to livable condition, the house will need to be braced to prevent the home from collapsing entirely as siding and framing is completed.

Due to need to reframe the entire home and the cost required to brace the house, we are no longer looking to add any previously approved extensions to the home. We will keep the home in its original form and continue to restore siding, windows, roof, and the interior. However, with the home needing to be reframed it will require us to replace the windows entirely. In summary, the current structure is unsafe and needs to be addressed so we can move forward with repairs.

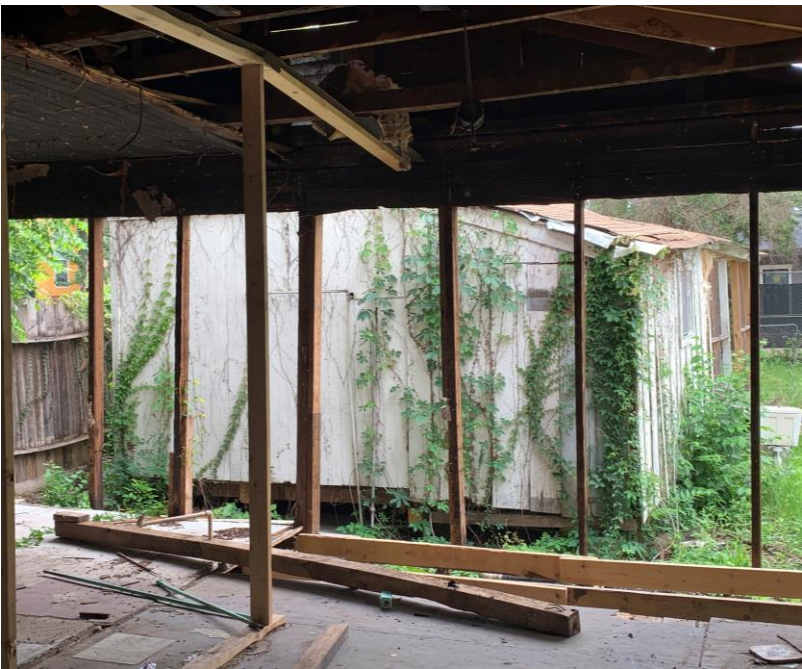
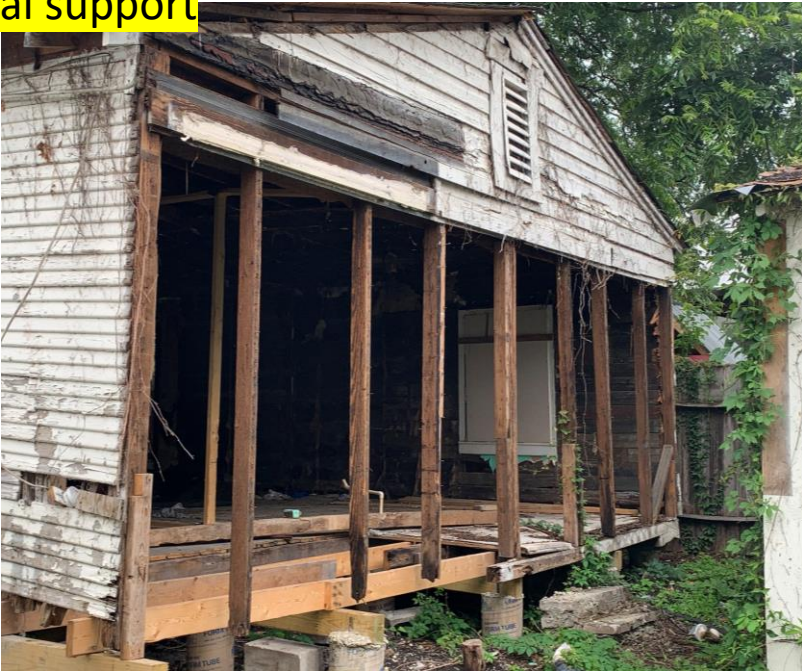
Poor structural support
