# HISTORIC AND DESIGN REVIEW COMMISSION

**HDRC CASE NO:** 2019-365  
**ADDRESS:** 517 E HOUSTON ST  
**LEGAL DESCRIPTION:** NCB 422 BLK 26 W 26 FT OF 5 ARB A2  
**ZONING:** D,HS, H  
**CITY COUNCIL DIST.:** 1  
**DISTRICT:** Alamo Plaza Historic District  
**LANDMARK:** Rosenberg, Frank Building  
**APPLICANT:** Michael Litofsky  
**OWNER:** Michael Litofsky  
**TYPE OF WORK:** Storefront Modification  
**APPLICATION RECEIVED:** June 24, 2019  
**60-DAY REVIEW:** August 23, 2019  
**CASE MANAGER:** Huy Pham  
**REQUEST:**

The applicant is requesting a Certificate of Appropriateness for approval to modify a previously approved design to include a glass storefront on the E Houston Street side.

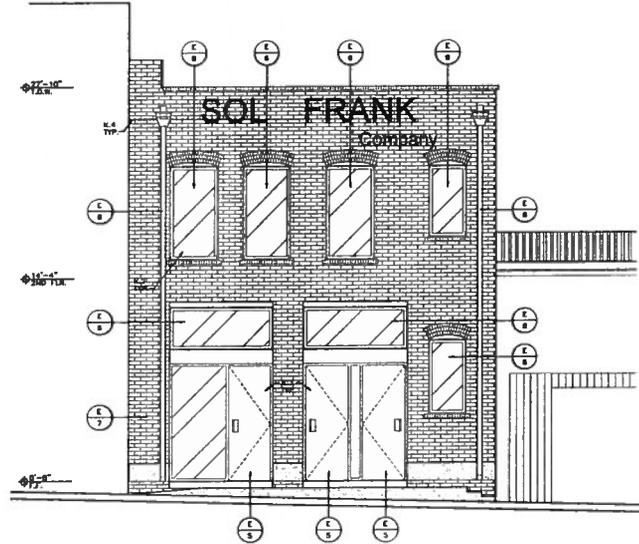
2.A2.1 NORTH ELEVATION

- K.1 EXISTING PERIMETER WALLS
- K.2 EXISTING BRICK TO BE RESTORED TO ORIGINAL CONDITION USING LIKE MATERIALS
- K.3 EXISTING DOOR TO BE RESTORED TO ORIGINAL CONDITION USING LIKE MATERIALS
- K.4 ROOF LINE SUBJECT TO FOLLOW EXISTING STRUCTURE
- K.5 INTERIOR WORK
- K.6 NEW CONSTRUCTION

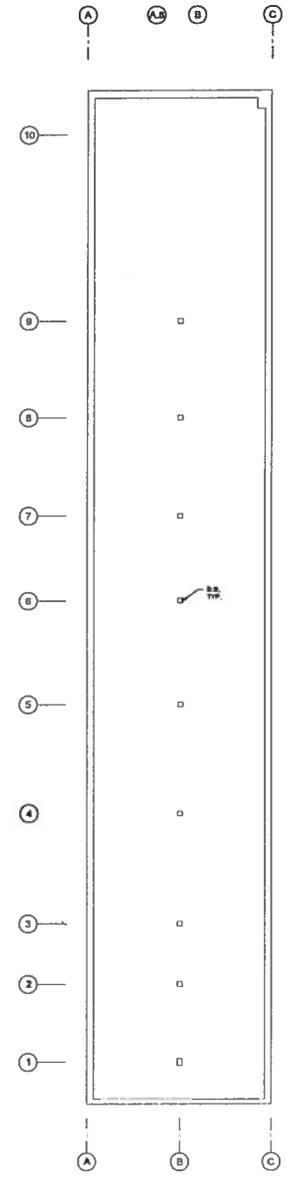
1.D1.1 BASEMENT DEMOLITION PLAN  
SCALE: 1/8" = 1'-0"

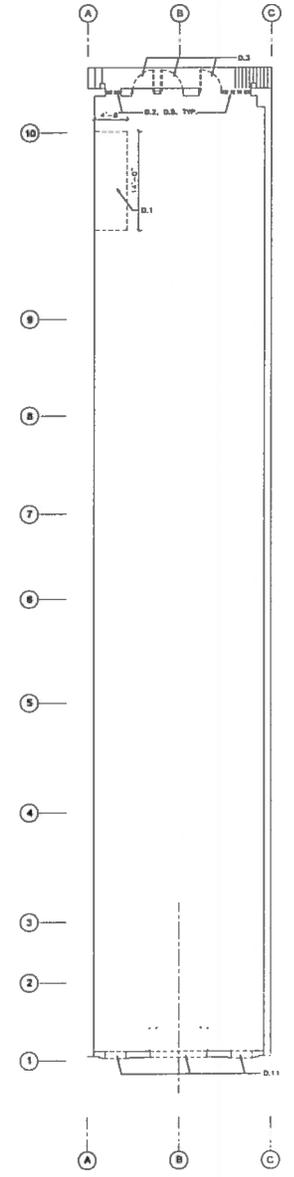
2.D1.1 LEVEL 1 DEMOLITION PLAN  
SCALE: 1/8" = 1'-0"

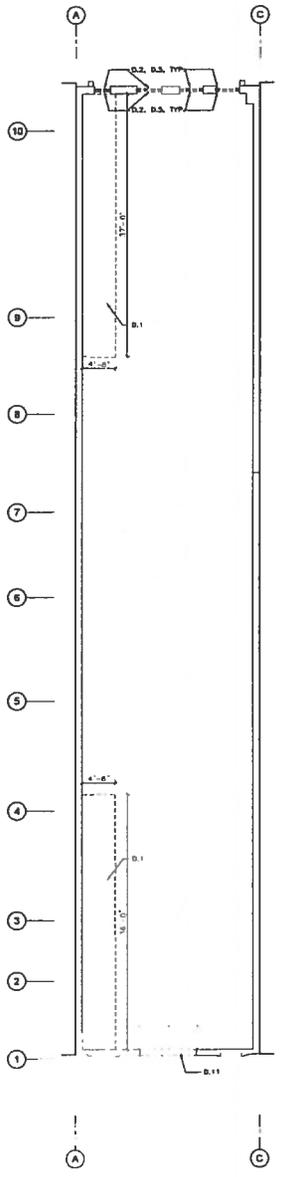
3.D1.1 LEVEL 2 DEMOLITION PLAN  
SCALE: 1/8" = 1'-0"

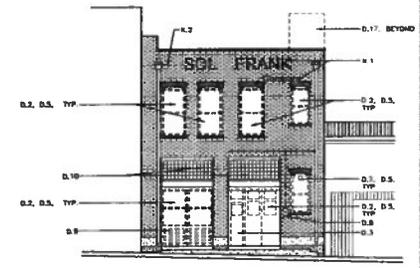
6.D1.1 NORTH DEMOLITION ELEVATION  
SCALE: 1/8" = 1'-0"

**NOTE**  
CONTRACTOR TO REMOVE ALL SURFACE MOUNTED PLUMBING, MECHANICAL AND ELECTRICAL LINES, PIPES AND FIXTURES.

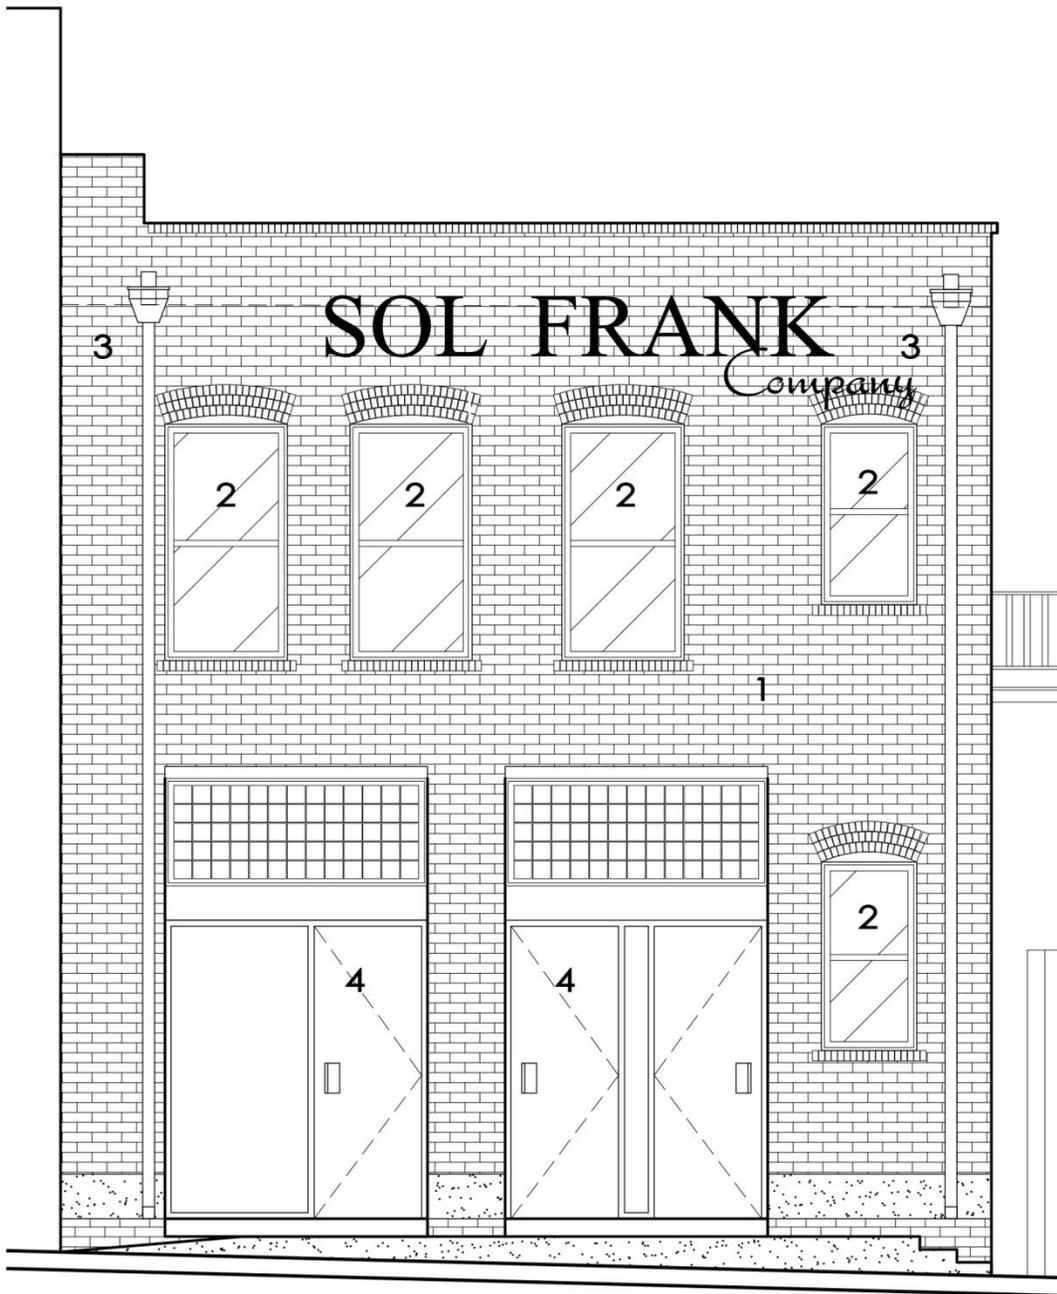
- 1 CLEAN AND RESTORE EXISTING BRICK
- 2 REPLACE WINDOWS
- 3 RESTORE SCUPPER, DOWNSPOUT AND DOWN LEADER
- 4 NEW DOORS

- h. GUTTER SYSTEM - The applicant has proposed to restore the scuppers, downspouts and down leaders of the existing gutter system. While those that are currently on the façade are not historic, their repair is consistent with the Guidelines for Exterior Maintenance and Alterations 4.A.

- m.** NEW DOORS - The applicant has proposed to install two (2) new doors on the Peacock Alley façade. While this is the rear of the building, in this instance the rear is proposed to be treated as the front also. The Guidelines for Exterior Maintenance and Alterations 6.A.i. does not recommend that new entrances be created where visible from the public right of way. This proposal is not consistent with the Guidelines. Staff recommends that the applicant keep the existing door openings and widths.
