HISTORIC AND DESIGN REVIEW COMMISSION

July 19, 2017

HDRC CASE NO: 2017-341
ADDRESS: 1201 E CROCKETT ST
LEGAL DESCRIPTION: NCB 1373 BLK 1 LOT W 77.4 FT OF 9 & 10
ZONING: MF-33, H
CITY COUNCIL DIST.: 2
DISTRICT: Dignowity Hill Historic District
APPLICANT: Todd Worrich
OWNER: Todd Worrich/Tondra Ball, LLC
TYPE OF WORK: Exterior modifications, porch modifications, window replacement, fencing and rear carport construction

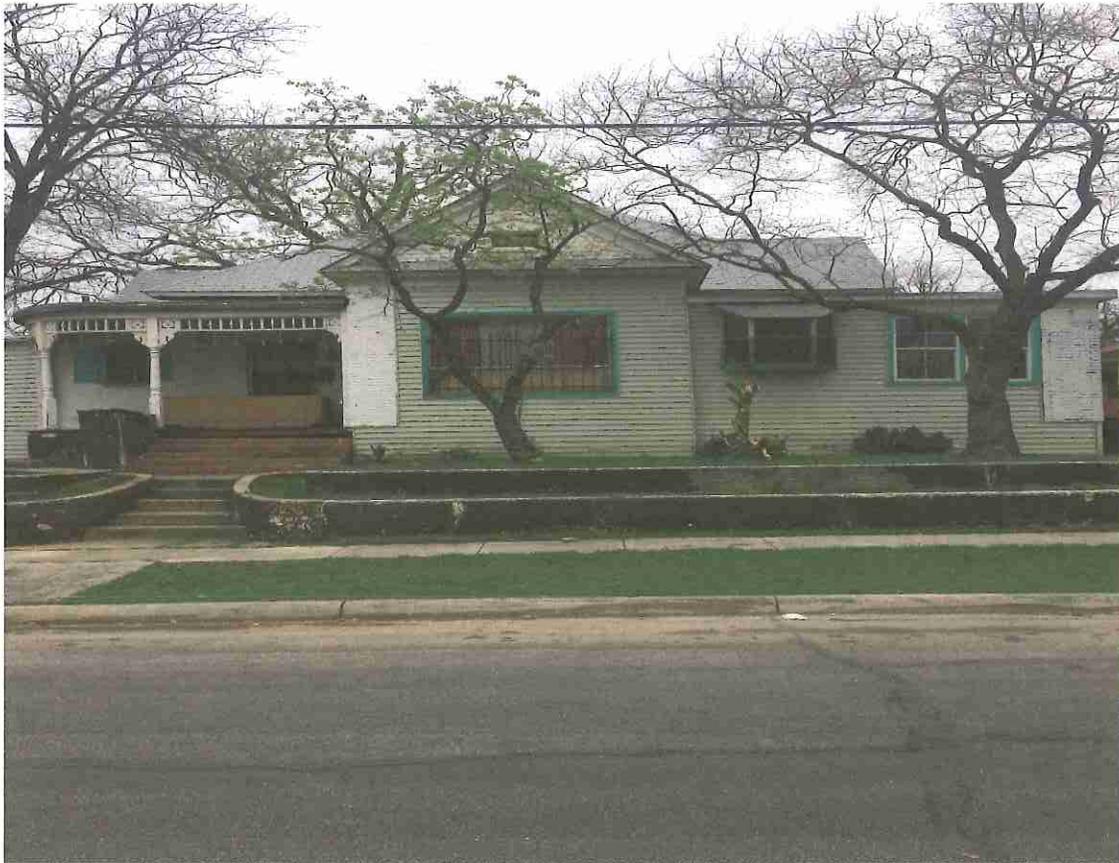
The Crockett St. elevation was modified at an unknown time in several ways which changed the facade from the original home. The modifications included the enclosing and modification of a portion of the front porch and the addition of plastic siding with faux brick columns over the original wood siding. Additionally a half bay window was added at some time to the kitchen area of the home. Below is a current picture of the Crockett St. elevation.

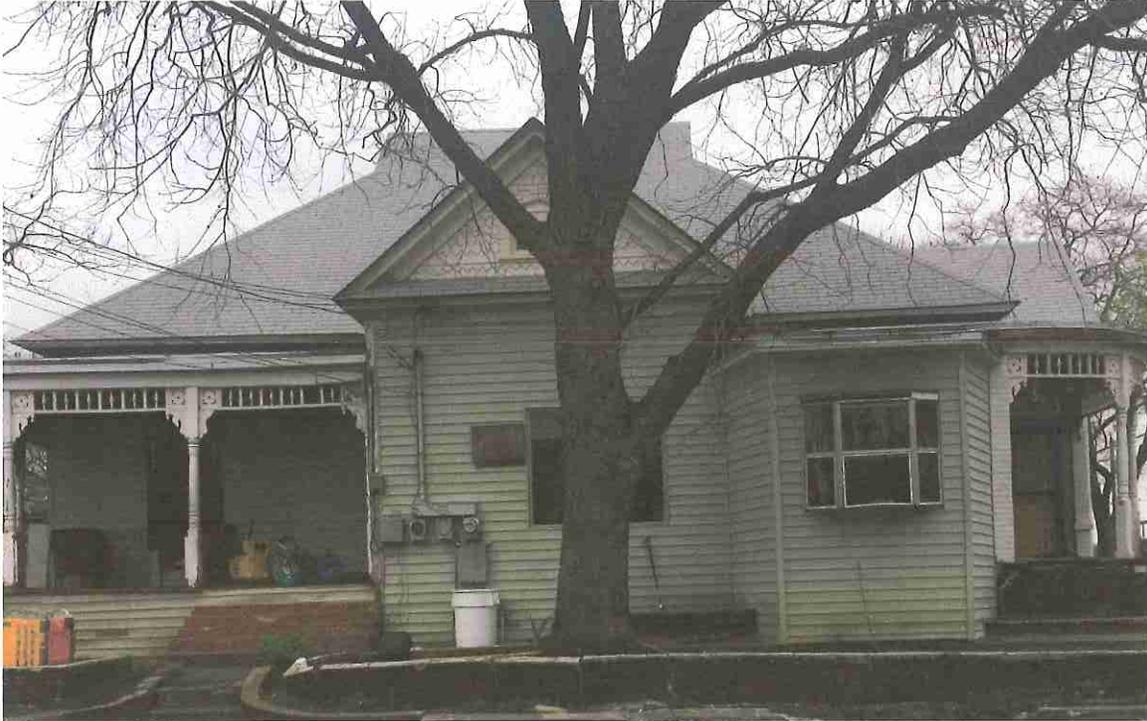
The Pine St. elevation was modified at an unknown time in several ways which changed the facade from the original home. The modifications included the enclosing and modification of a portion of the front porch and the addition of plastic siding with faux brick columns over the original wood siding. Additionally a large picture window was added which is off centered. Below is a current picture of the Pine St. elevation.

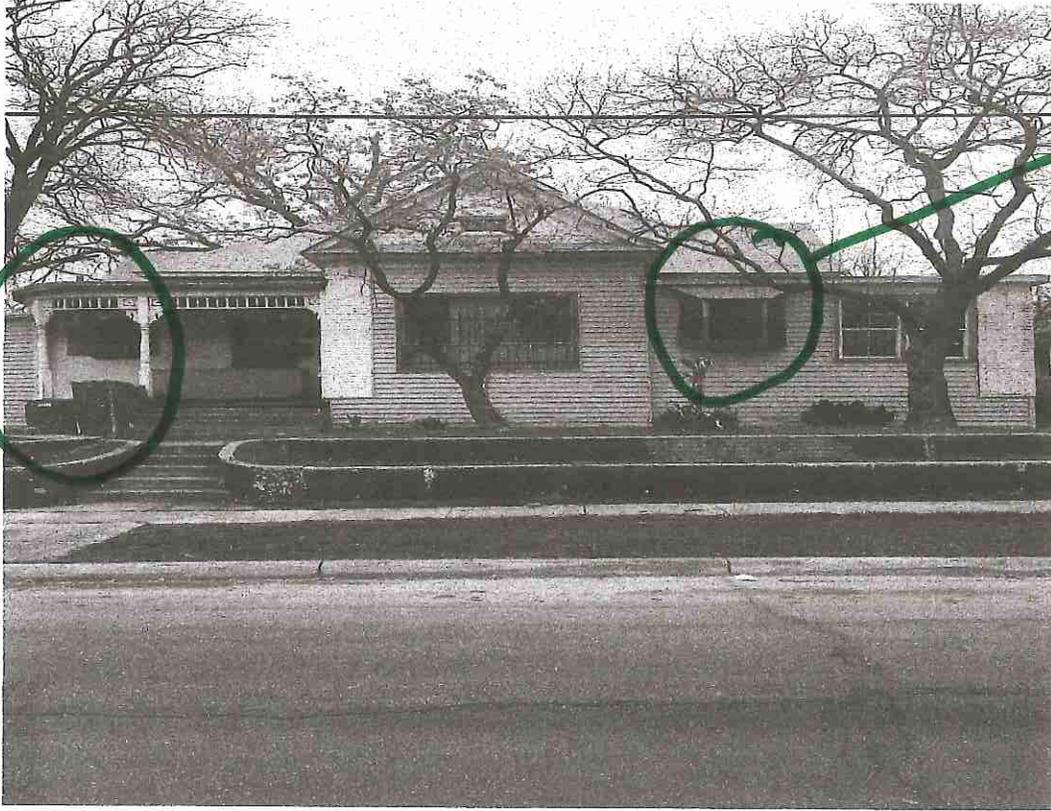
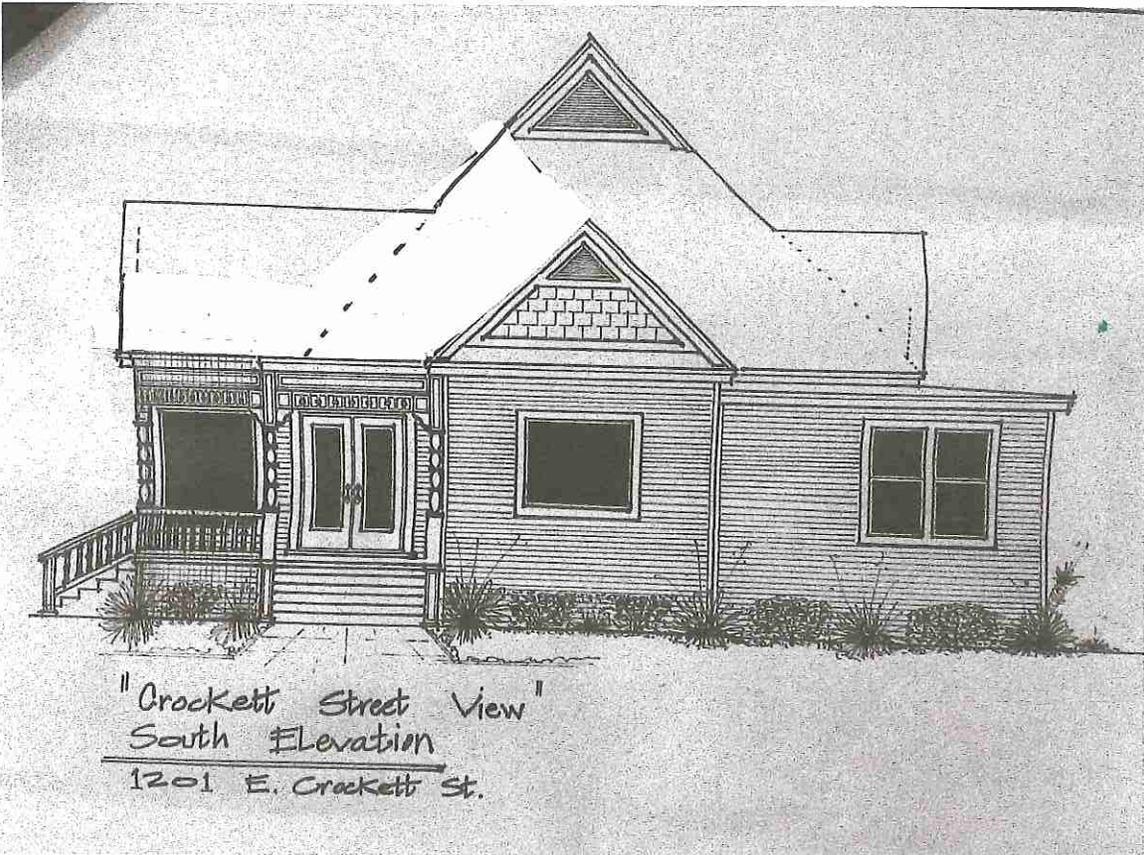
Crockett St. Elevation

Patio enclosed

Bay Window added

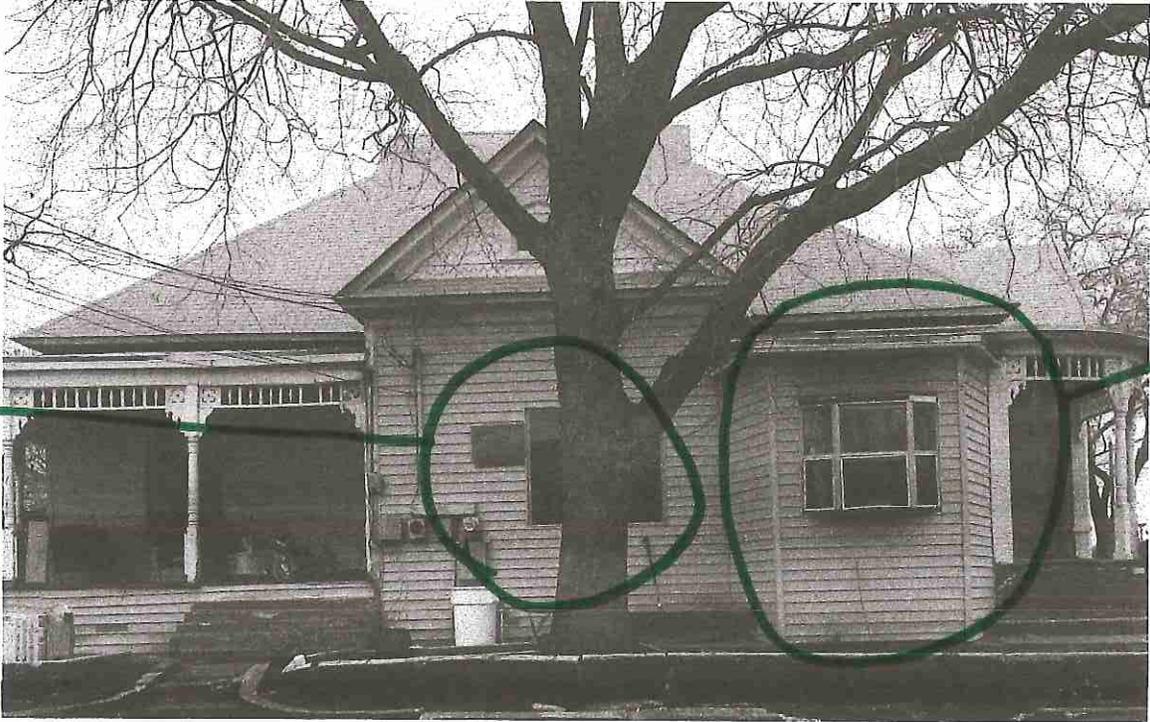
"Crockett Street View"
South Elevation
1201 E. Crockett St.

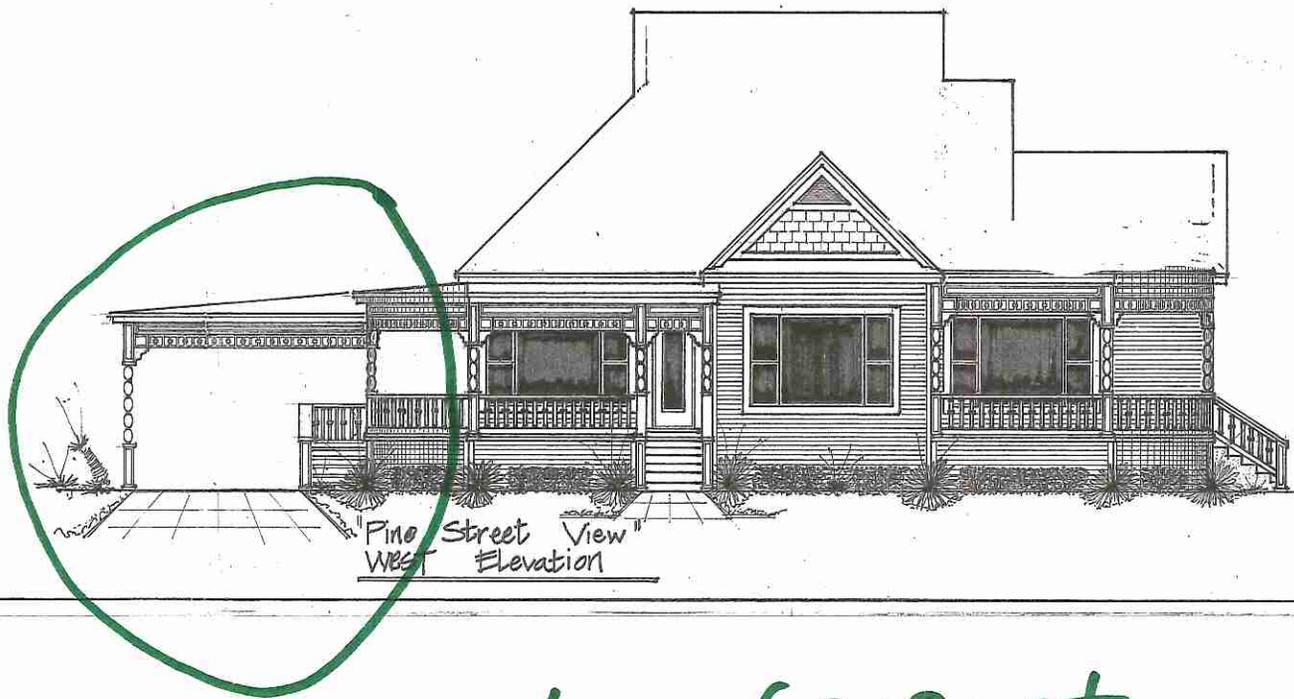
"Pino Street View"
WEST Elevation

Worrich Remodel
1201 E. Cracket St.

proposed Carport

10. Add carport on Pine St. side of property towards rear of home. The carport will be made of wood and of the same architectural style as the original structure.

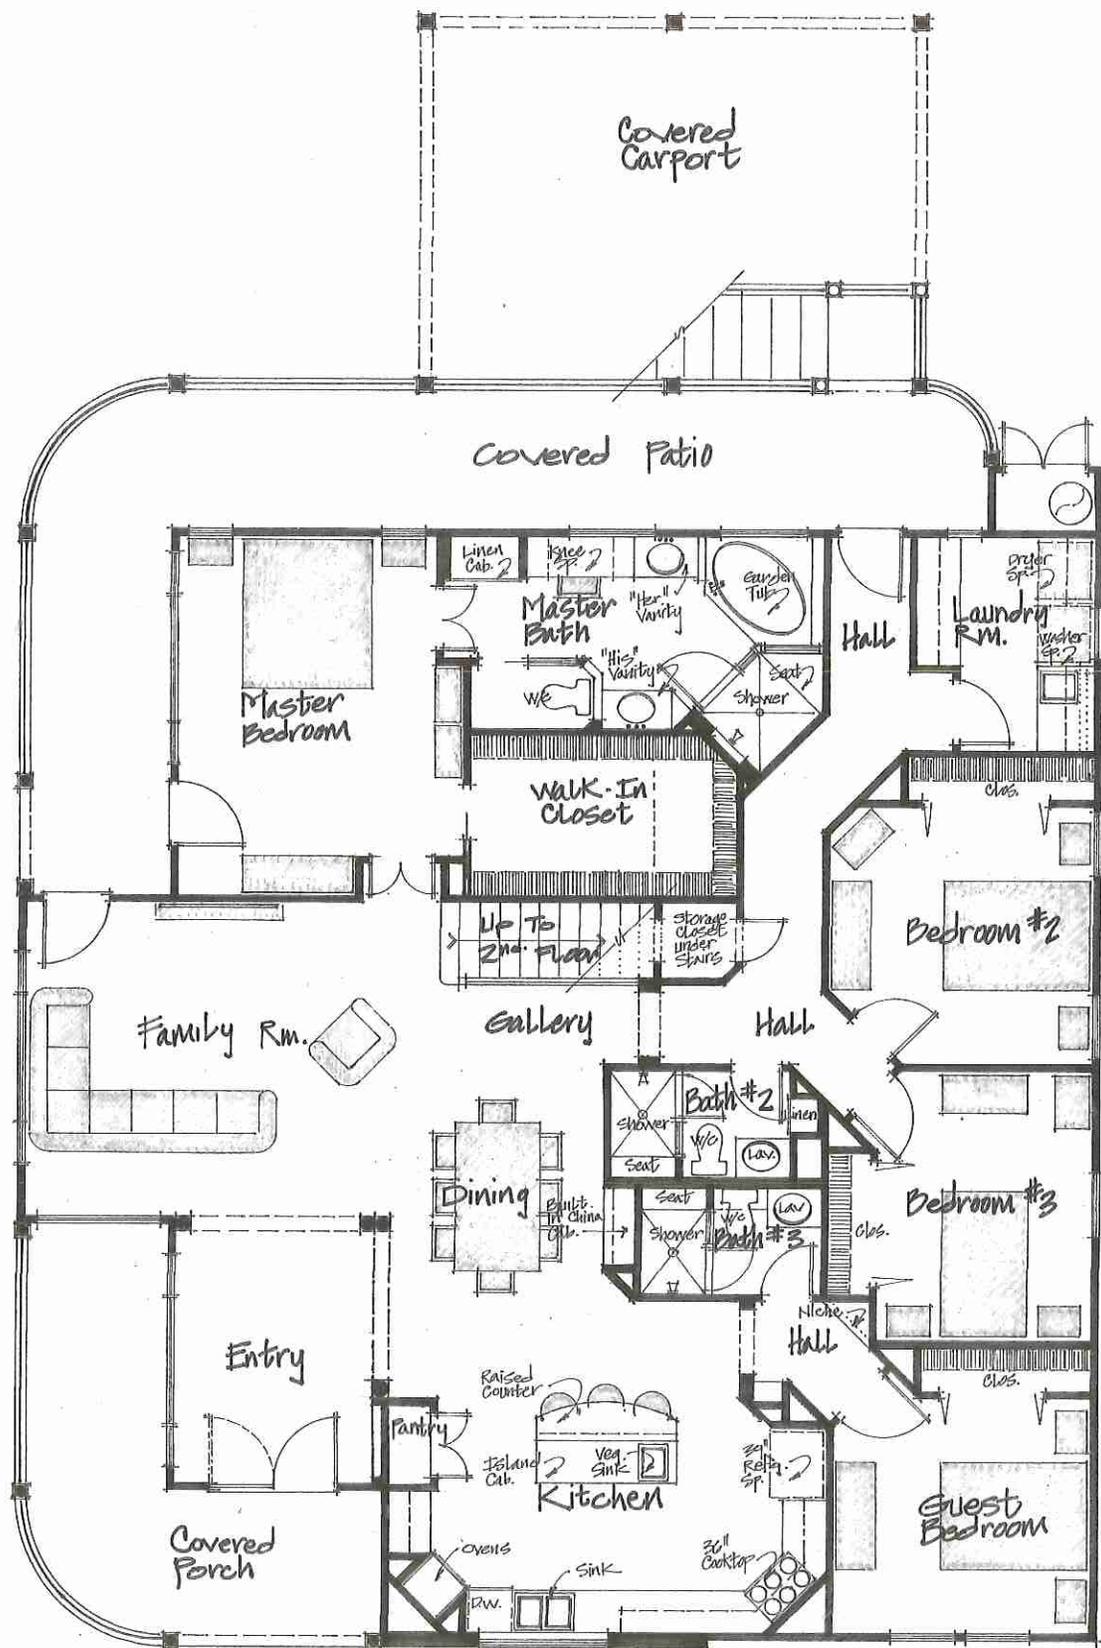
Proposed 1st. Floor,
 Floor Plan
 Preliminary Designs

"Worrich Remodel"
 1201 E. Crockett St.
 "Peña Design Group"

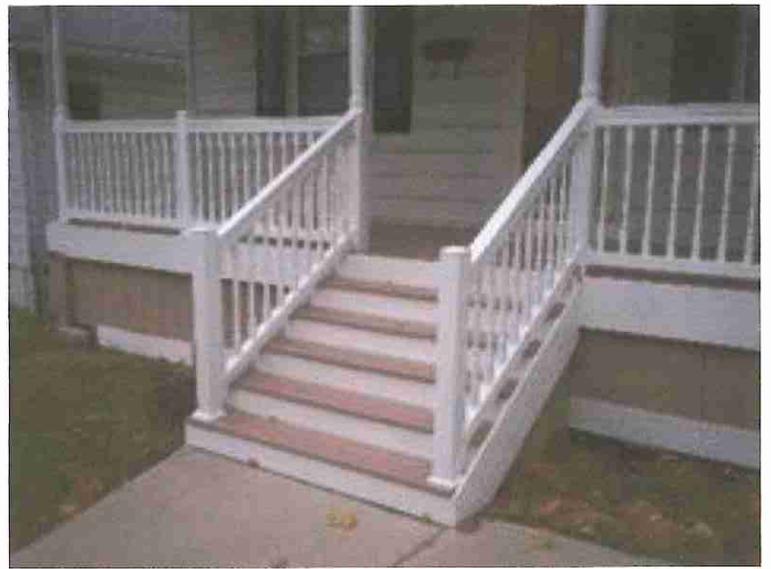
Proposed stairs
and railings

6. The existing railings on the patios have been deteriorated/or are missing and need to be replaced. The railings will be replaced with wood railings.

7. The existing stairs are poured concrete and are deteriorated. They don't appear to be original to the house and were added at a later date. The stairs will be removed and replaced with wood stairs with wood railings.

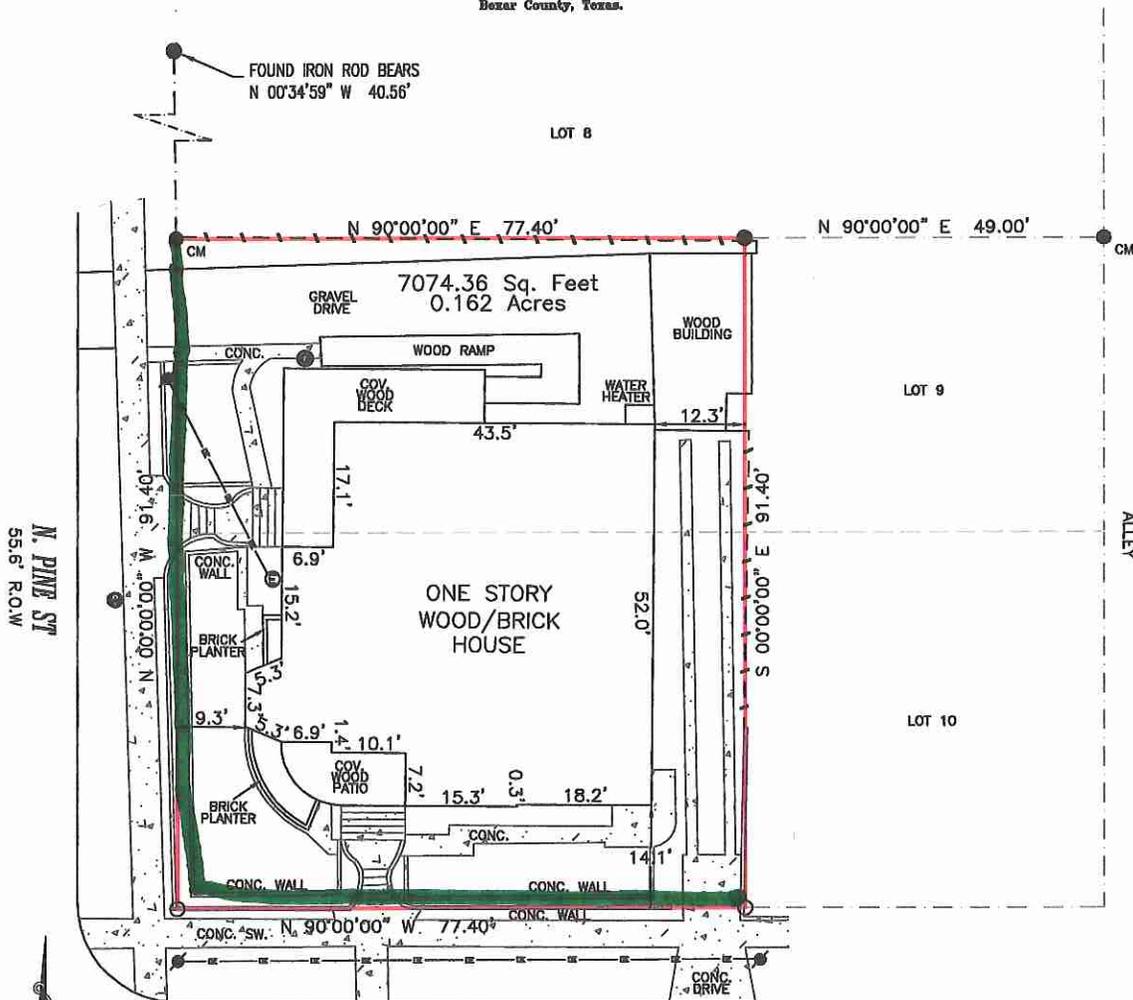
E. CROCKETT
55.6' R.O.W.

add fence on top existing retaining wall. Fence to be 4'

8. Existing retaining wall is deteriorated in several areas and will be repaired.
9. 4' wrought iron fence will be added on top of retaining wall on Crockett and Pine elevations.

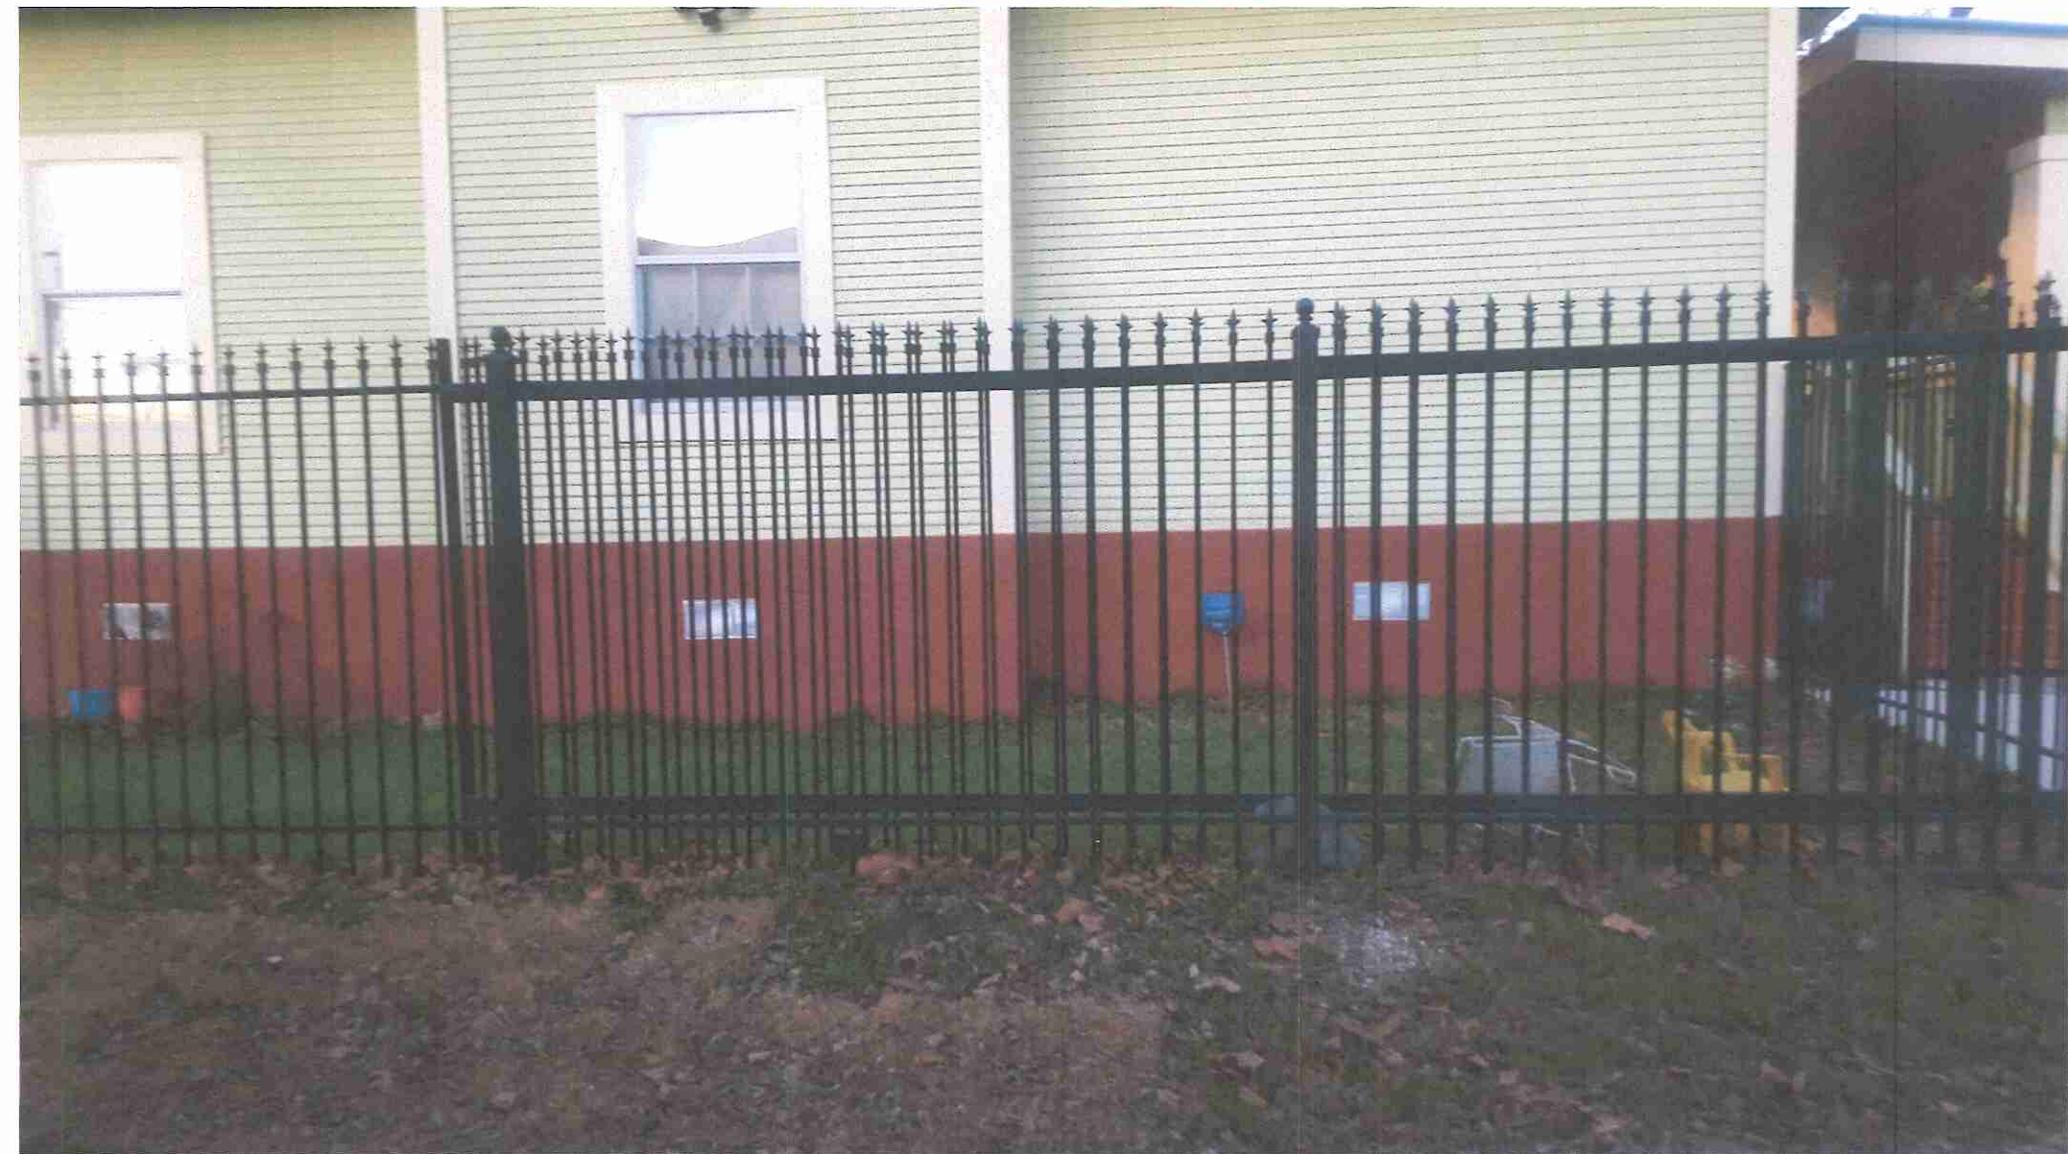
- fence next door @ 1203 E. Crackett
- proposed fence style

- l. WROUGHT IRON FENCING – Atop the retaining wall, the applicant has proposed to install a wrought iron fence. The applicant has not specified a specific fence height; however, the existing retaining wall is approximately 40 inches in height. Retaining walls are a common front yard elements along E Crockett due to slope and draining conditions. Recently, fences have been approved by the HDRC for installation atop retaining walls on E Crockett. Staff finds that the applicant should install a fence consistent with the height of the neighboring fence.
