# HISTORIC AND DESIGN REVIEW COMMISSION

**HDRC CASE NO:** 2018-204  
**ADDRESS:** 611 N OLIVE ST  
**LEGAL DESCRIPTION:** NCB 562 BLK 8 LOT N 60 FT OF 16,17,&18 & E 52.08 FT OF W 104.16 FT OF 10 ARB 21  
**ZONING:** R-6, H  
**CITY COUNCIL DIST.:** 2  
**DISTRICT:** Dignowity Hill Historic District  
**APPLICANT:** John Speegle/SKDA  
**OWNER:** Y Designs LLC  
**TYPE OF WORK:** Exterior alterations - Conceptual Approval  
**APPLICATION RECEIVED:** April 26, 2018  
**60-DAY REVIEW:** June 25, 2018  
**REQUEST:**

The applicant is requesting conceptual approval to:

611 NORTH OLIVE STREET  
 DIGNOWITY HILL HISTORIC DISTRICT

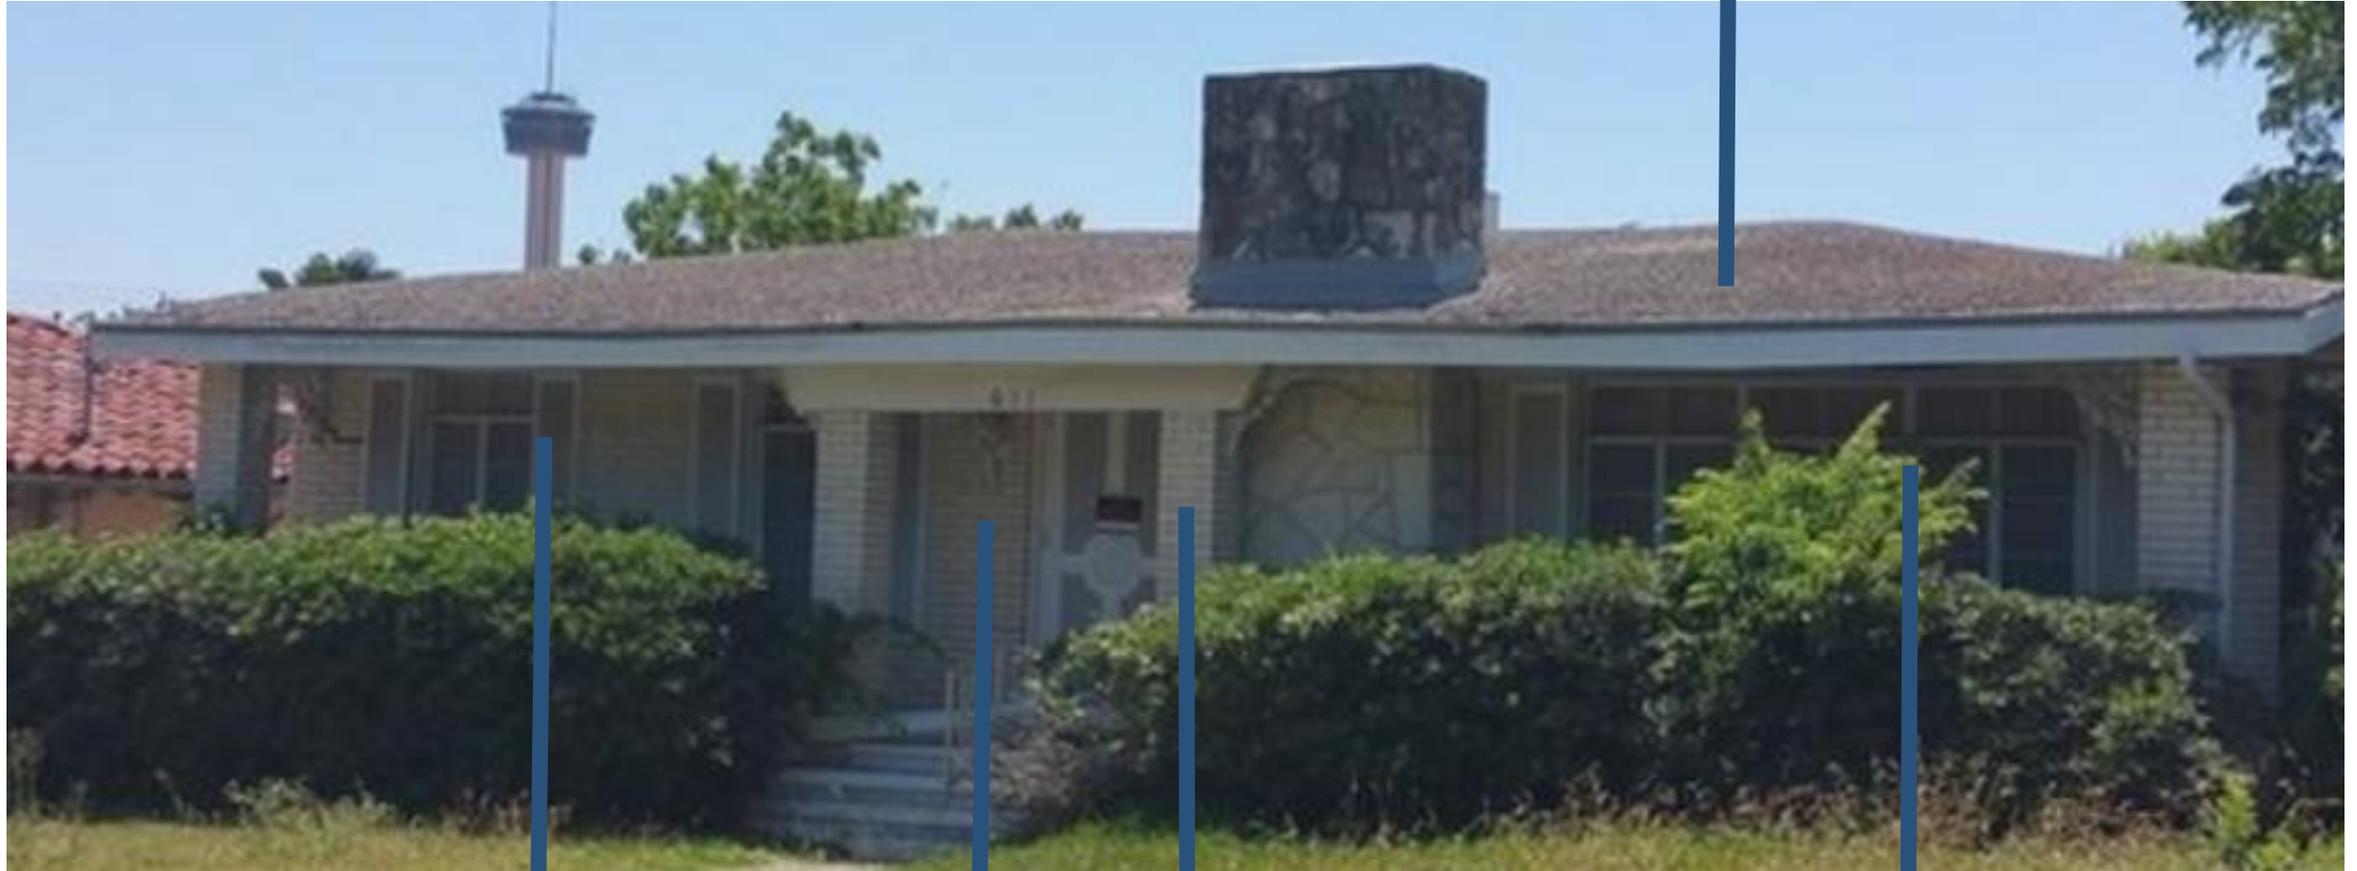
REMOVE FRONT EXTERIOR BRICK VENEER AND EXPOSE ORIGINAL WOOD SIDING UNDERNEATH

REPLACE EXISTING GRAVEL ROOF WITH METAL STANDING SEAM ROOF

REPLACE BROKEN SHUTTERS AND PAINT

REMOVE FRONT BRICK VENEER

The single-story residence was built in 1951 (as per B.A.D. records). It has a brick veneer on the front elevation that has failed and separating from the wall. Behind the brick is the original 1x8 horizontal wood siding. The brick will be removed and the wood siding will be restored on all elevations.

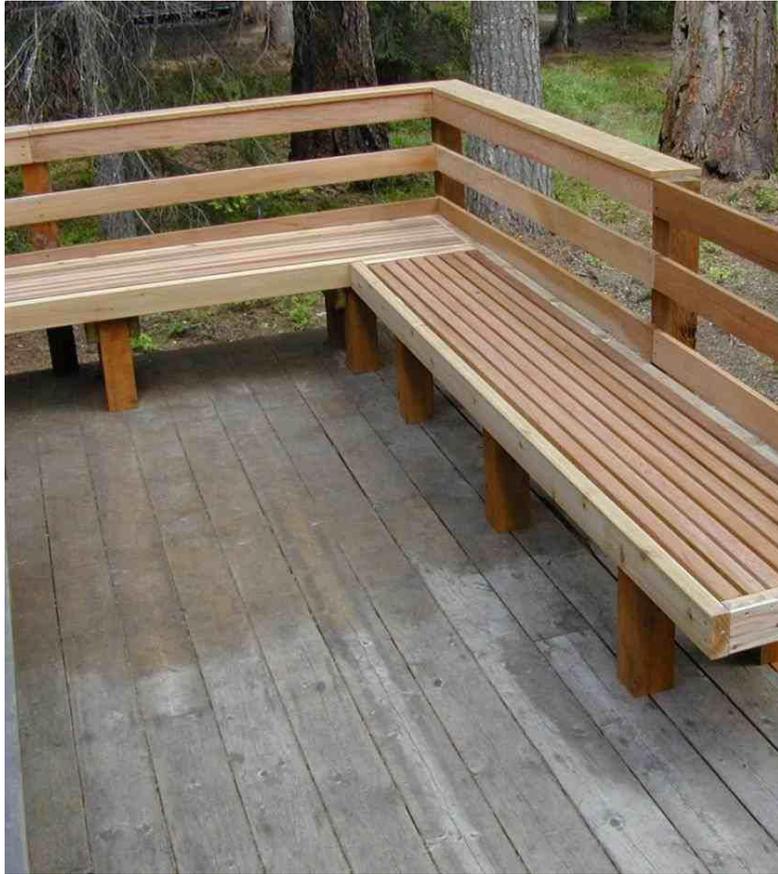
# FLOOR PLAN/DECK

CEDAR DECK WITH RAILING

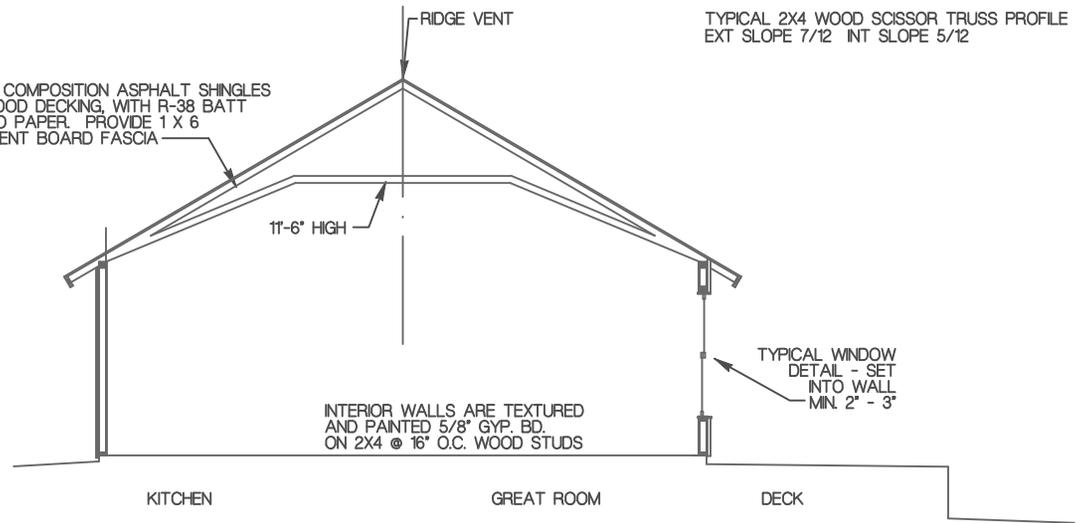
## REAR SECTION

ROOFING SHALL BE COMPOSITION ASPHALT SHINGLES  
 ON 5/8" C-D PLYWOOD DECKING, WITH R-38 BATT  
 INSULATION WITH NO PAPER. PROVIDE 1 X 6  
 PAINTED FIBER-CEMENT BOARD FASCIA

TYPICAL 2X4 WOOD SCISSOR TRUSS PROFILE  
 EXT SLOPE 7/12 INT SLOPE 5/12

ADJUSTED FOR PROPOSED ROOF FRAMING

The wood framing throughout the residence has also structurally failed and has sagged along the front elevation. The rear middle section of the residence has undersized built-up wood trusses and also sagged in its chord members.

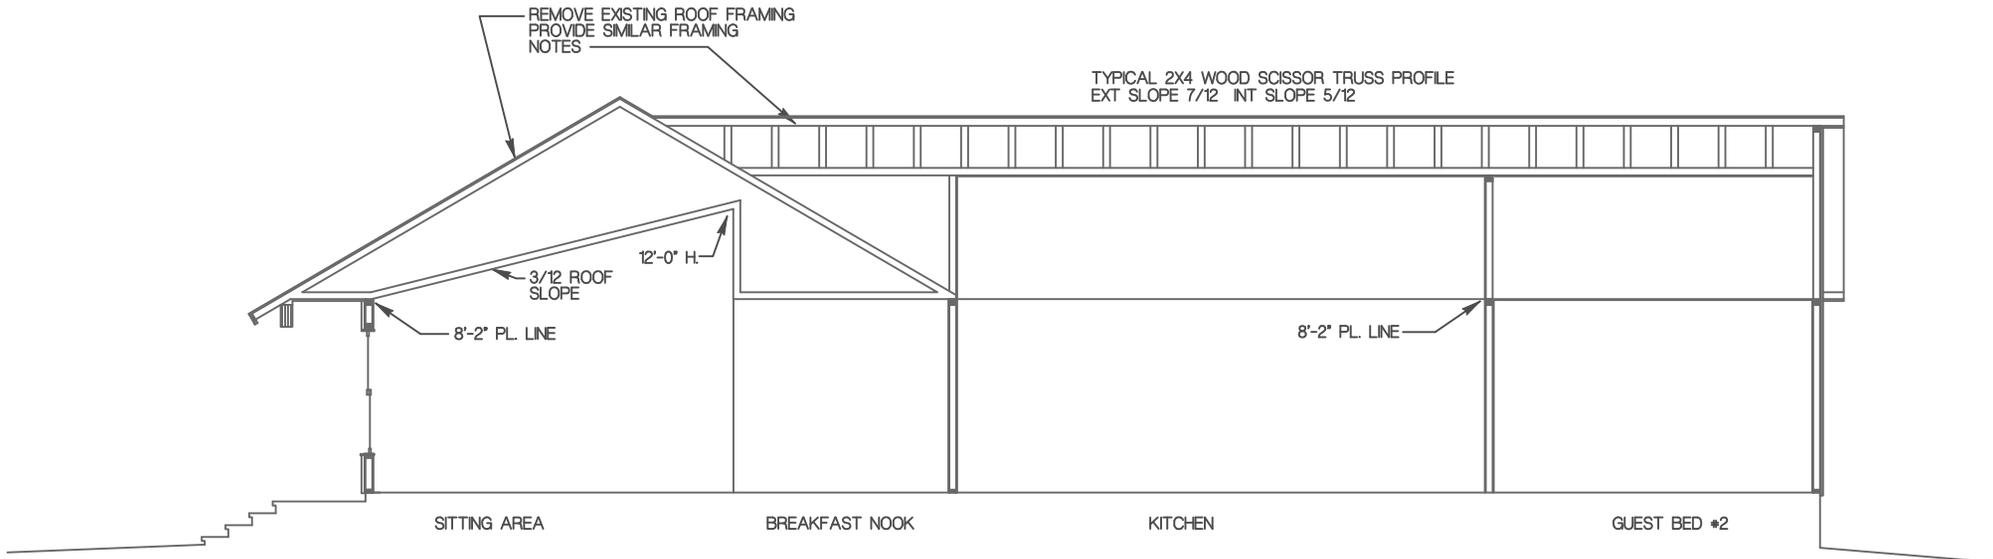
## FRONT TO REAR SECTION

ADJUSTED FOR PROPOSED ROOF FRAMING
