# HISTORIC AND DESIGN REVIEW COMMISSION

**HDRC CASE NO:** 2019-343  
**ADDRESS:** 414 DONALDSON AVE  
**LEGAL DESCRIPTION:** NCB 1932 BLK 39 LOT 26 AND 27  
**ZONING:** R-6,H  
**CITY COUNCIL DIST.:** 7  
**DISTRICT:** Monticello Park Historic District  
**APPLICANT:** KKW Donaldson  
**OWNER:** San Antonio San Antonio/KKW Donaldson  
**TYPE OF WORK:** Window replacement, painting brick, replace siding  
**APPLICATION RECEIVED:** May 22, 2019  
**60-DAY REVIEW:** July 21, 2019  
**CASE MANAGER:** Stephanie Phillips  
**REQUEST:**

The applicant is requesting a Certificate of Appropriateness for approval to:

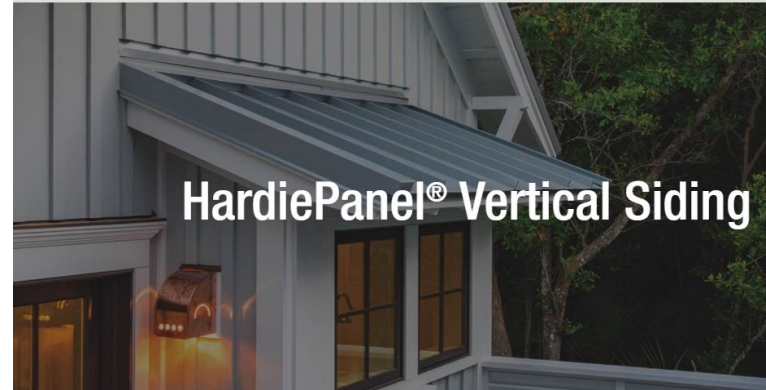
At (1) exterior wall, existing siding is bowed, due to decay. Wall does not face street.

Proposed product: HardiePanel Vertical Fiber Cement Siding, to match profile of existing siding.

- b. **SIDING REPLACEMENT** – The applicant has proposed to replace approximately 20 feet of wooden board and batten siding with new Hardie siding to match the same configuration. The siding is located on a side façade and is not visible from the public right-of-way. The siding also appears to be an infill condition of a former garage. Based on the location and the minimal impact from the public right-of-way, staff finds the replacement appropriate.

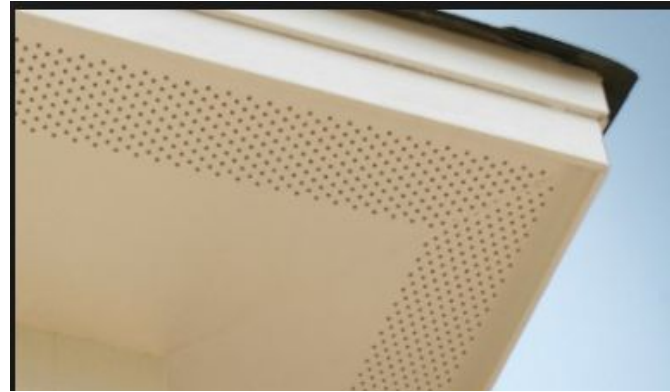
Roof line/trusses are exposed, not protected from moisture or pest.

Proposed product: Hardie vented cement board, to allow for ventilation.

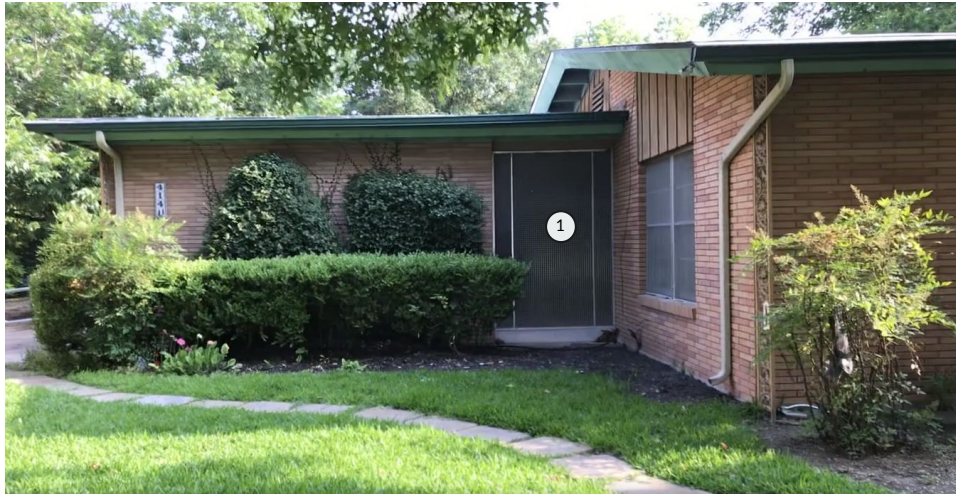
- ① Removal of (1) non-historic window to replace with windows that match the original windows as closely as possible in material and design. The existing window appears to have been installed in the early 1980s during a garage conversion, is a metal aluminium frame and heavily corroded, and does not match the appearance of the other 1950s era windows. No structural modifications required.

- d. **WINDOW REPLACEMENT** – The applicant has proposed to replace an existing rectangular aluminum picture window on the front façade with a new vinyl window. The new window will feature a modified size and be square in proportion. According to the Guidelines, when windows are deteriorated beyond repair and necessitate replacement, new windows should match the size, configuration, proportion, and detailing of the original. Staff generally finds that replacement is appropriate, but finds the proposed size modification to be inconsistent with the Guidelines. Staff finds that the existing opening size should be retained.

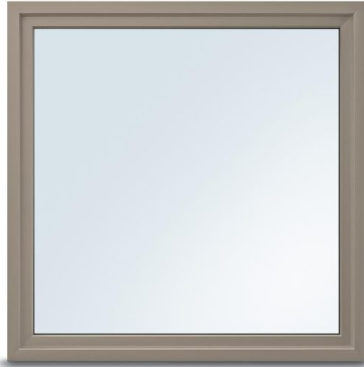
Andersen  
Installed 100 Series Picture Windows

Proposed product: Anderson 100 - Series window, to match size of original window opening.

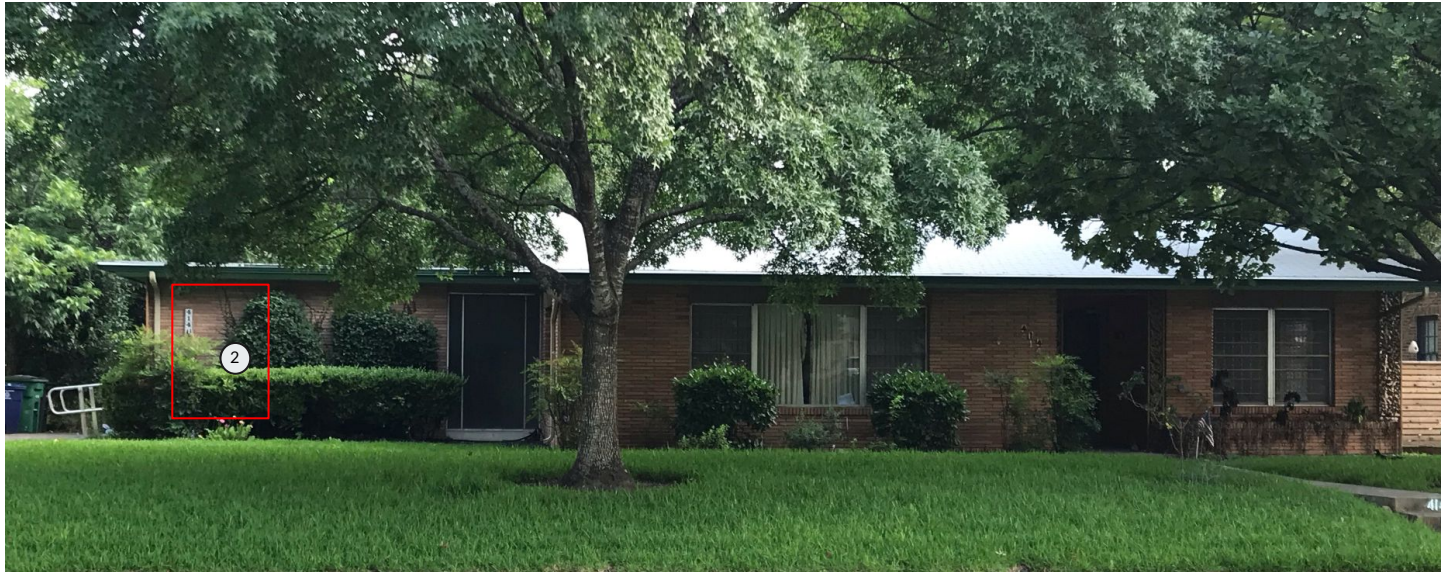
View of entire elevation

- ② Add (1) window to balance out the exterior elevation. Currently, the existing window is asymmetrical. See next page of view of entire facade

- e. WINDOW INSTALLATION – The applicant has proposed to install a new window on the front façade. The window is to match the size, material, and configuration of the proposed replacement window noted in finding d. The new window will be visible from the public right-of-way. Staff generally finds the location appropriate, but does not find a square window to be appropriate. Staff finds that a rectangular window that matches the existing size of the adjacent window in finding d be installed to add balance and maintain the original proportionality of the windows.

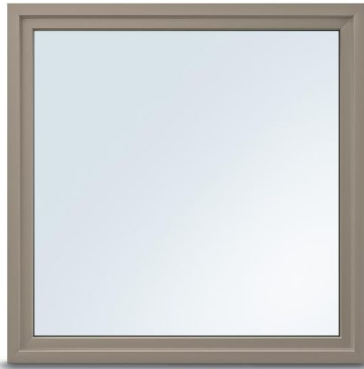
Andersen  
Installed 100 Series Picture Windows

Proposed product: Anderson 100 - Series window, to match size of adjacent window.

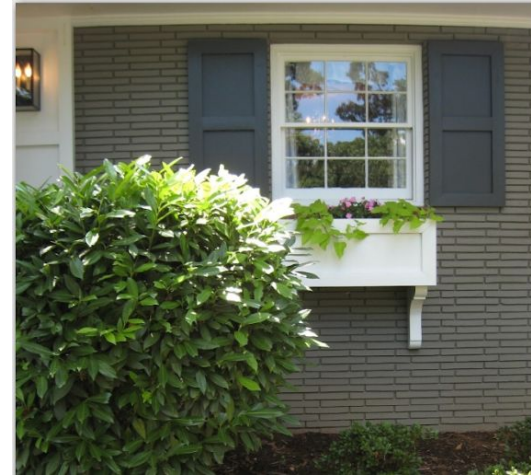
Proposed treatment

Exterior treatment was selected in order to coordinate home appearance to be consistent with the district characteristics, see next slide for methodology.

- g. BRICK PAINTING – The applicant is requesting approval to paint the brick façade of the structure. The original brick, a rusty red color, is exposed. According to the Secretary of the Interior’s Standards for Rehabilitation, historically unpainted brick should not be painted. Brick structures built prior to the 1870s were largely constructed of handmade bricks, which were generally softer, more porous, and weaker than bricks made at the turn of the 20th century. These handmade bricks were frequently painted or coated because the strength of the brick was insufficient without a coating for stabilization. However, as machine-made bricks became the norm during the latter half of the 19th century, bricks became inherently stronger and did not require paint or coatings for protection and strength. These bricks commonly featured harder “dress” surfaces, which were meant to face the exterior of the structure and remain unpainted. 414 Donaldson was constructed in the early 1950s and was historically unpainted. Painting historically unpainted brick on structures of this era can lead to trapped water in the porous material, eventually destroying the brick due to the damaging effects of water infiltration and freeze-thaw cycles. Unpainted brick of this era is inherently high strength and low-maintenance on its own. Once these structures are painted, consistent repainting is required to maintain the aesthetics of the brick. Per the Guidelines for Exterior Maintenance and Alterations, 2.B., surfaces that were historically unpainted should not be painted. Staff does not find the painting of the façade to be appropriate.
